Citation: Corradi, Marco, Borri, Antonio, Castori, Giulio and Coventry, Kathryn (2015) Experimental analysis of dynamic effects of FRP reinforced masonry vaults. *Materials*, 8 (12). pp. 8059-8071. ISSN 1996-1944

Article

Experimental Analysis of Dynamic Effects of FRP Reinforced Masonry Vaults

Marco Corradi ^{1,*}, Antonio Borri ², Giulio Castori ² and Kathryn Coventry ¹

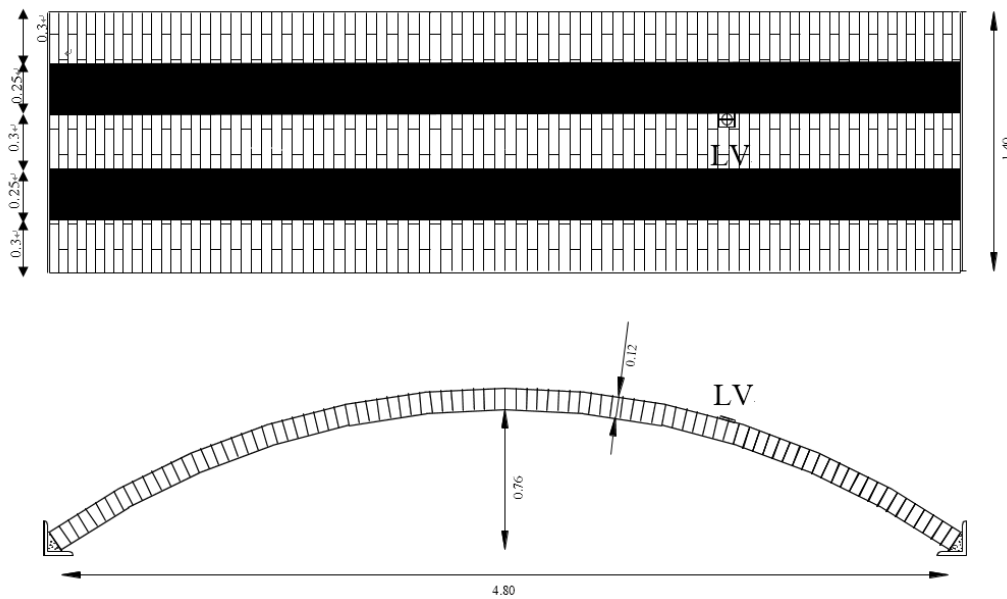
Figure 1. Configuration of the two barrel vaults (LV point is the position of the target point of the laser beam of the vibrometer) (dimensions in m).

The experimental vaults were constructed with a span of 4.80 m, a rise of 0.76 m and a depth of 1.40 m, respectively. The wall thickness for vaults BV1 and BV2 was 12 cm (Figure 1), while a thickness of 5.5 cm was adopted for RV3 (thin vault).

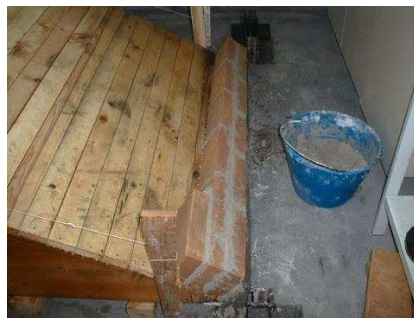
Figure 2. Construction detail for the masonry barrel vaults spring (of BV1-type).

The specimens were built on a wooden framework, with the barrel vaults springing constructed from L shaped steel profile and effectively fixed to the floor. A triangular concrete cast block was utilised along the vault's depth to commence the masonry work with full bricks for both springings (Figure 2).

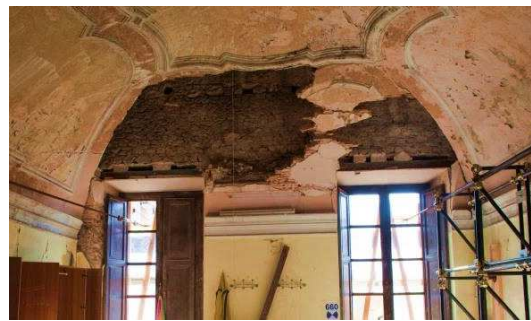
Figure 3. The thin vault tested in the city of L'Aquila.

Field tests were carried out on the vaults of an historical building in L'Aquila, Italy. This building, an aristocratic residence dating back to 18th century with important decorative features (frescos, marble window seals, fire-places, decorative mouldings, *etc.*), was heavily damaged by the 2009 earthquake. The large rooms of the main floor were characterized by thin tile vaulted ceilings, partially filled at the extrados with light in-fill material to ensure structural stability (Figure 3). This is a typical arrangement for brick vaults in the city of L'Aquila: very large in-folio (thin) brick vaults partially filled with building rubble. These structural masonry elements usually exhibit weak behavior under seismic loads, highlighting the necessity for reinforcement and retrofitting.

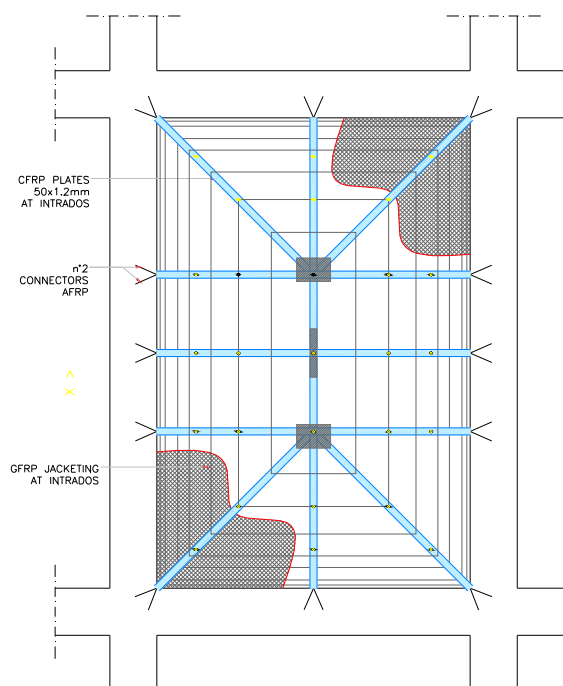
Figure 4. Layout of reinforcement for the L'Aquila vault.

The tests in this study were carried out on a large damaged thin vault. Dynamic tests were performed before and after the application of the composite materials. Reinforcement was applied at the vault's intrados due to the presence of a high-historic value ancient floor over the vault, thereby preventing any kind of work at the vault's extrados. The vault was not decorated with frescos, which facilitated the application of the reinforcement. However, the imposition of constraints by the Italian body for preservation and conservation of historic monuments (Soprintendenza per i Beni Architettonici e Paesaggistici) did not allow an extensive use of polymeric adhesives (epoxy resins) to bond the composites at the vault intrados, despite being aimed at guaranteeing the non-destructive removability of reinforcement and compatibility with historic masonry. For this reason, a GFRP textile reinforced mortar coupled with a non-polymeric cement-based matrix was used and applied over the entire vault intrados surface (Figure 4).

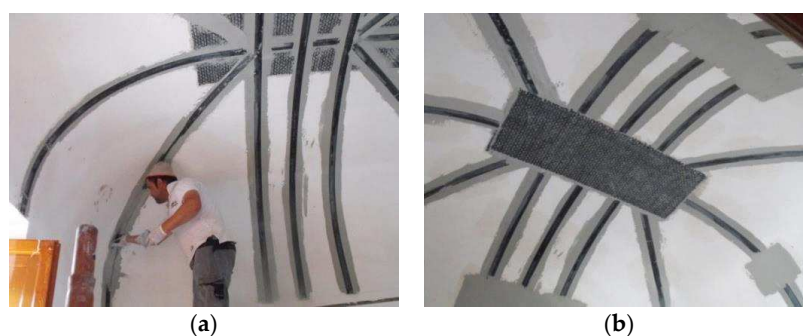
Figure 5. Reinforcement application: (a) CFRP strips; (b) CFRP sheet at vault crown.

In order to improve the structural behavior of the vault, Carbon FRP strips (CFRP) were applied at the vault's intrados over the GFRP mesh, to form an internal FRP-reinforced arch (Figure 5a). The intention was to create a structural element with a similar structural mechanism to that of an umbrella: the thin-tile GFRP reinforced vault represented the fabric of the umbrella while the CFRP strips acts as the spokes. In addition, local reinforcement in form of CFRP sheet crossing was applied

over the GFRP mesh. The CFRP sheets were bi-directional with a dimension of 500 mm × 600 mm and a density of 300 g/m² (Figure 5b).

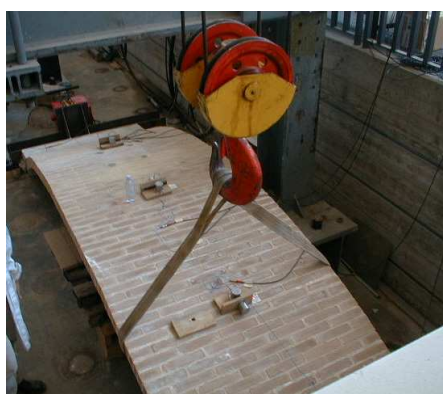
Figure 6. Raising of the vault to allow free vibrations.

For the laboratory tests, the dynamic excitation is achieved through the use of a sling which allows the “vertical raising” of the vault followed by the release of the sling to enable the vault to vibrate (Figure 6) until rest. Individual resonance peaks are detected on the Frequency Response Function (FRF) plot and the frequency of maximum response is taken as the mode natural frequency.

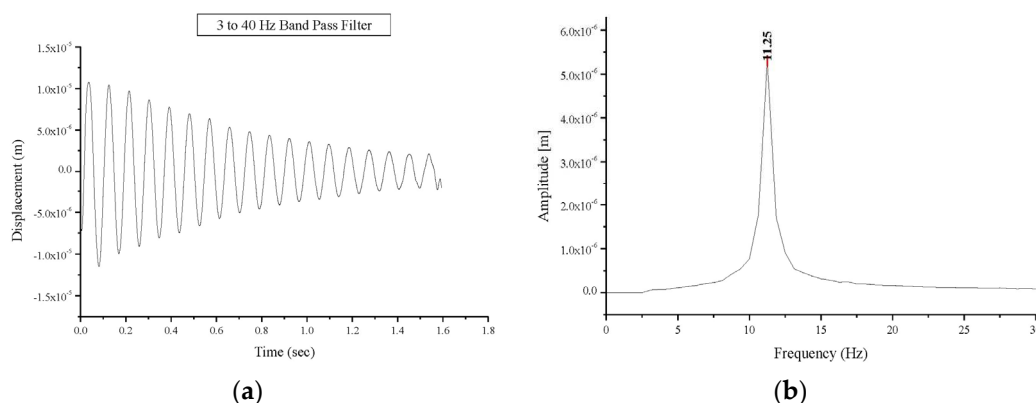
Figure 7. Free oscillations response of the undamaged vault BV1: (a) displacement versus time; (b) Fourier transform: amplitude versus frequency.

Testing of the masonry vaults occurred 45 days post-construction. The first modal frequencies values of 11.25 Hz and 10.00 Hz were recorded for BV1 and BV2 respectively (Figure 7) while a much lower natural frequency value, 6.25 Hz, up to 40% lower, was recorded for BV3. These frequency values can be also compared with those obtained from a numerical simulation: frequencies of 10.66 and 9.62 Hz were found from the numerical simulation for BV1- and BV3-type vaults, respectively. For a BV1-type vault, these values are in a very good agreement with experimental ones. The difference in dynamic behavior illustrated by the first-mode natural frequency of BV3 when compared with BV1 and BV2, can be explained by the difference in vault thickness and the presence of the ribs.

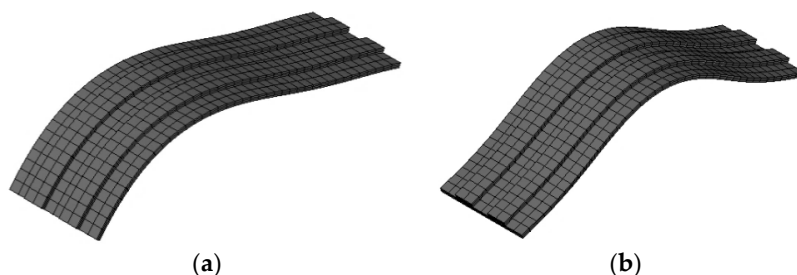
Figure 8. Numeric simulation: the first (a) and second (b) mode of vibration (BV3).

The main aim of this simple model was only to determine the natural frequencies and modes of vibrations. Figure 8 shows the first two natural modes of vibration of BV3. For undamaged vaults, this analysis demonstrated that the experimental value of first natural frequency is very similar to the numerical one: the first natural frequency from the model was 11.12 Hz (compared to 11.25 and 10 Hz measured for BV1 and BV2, respectively). For damaged vaults, the results of numerical and experimental tests highly differed for the difficulty of modelling the vault damage and the hinges. This difference (in terms of first natural frequency value) reduced for strengthened vaults (numerical 11.84 Hz, average experimental 10.93 Hz) due to the mitigation of non-linear effects.

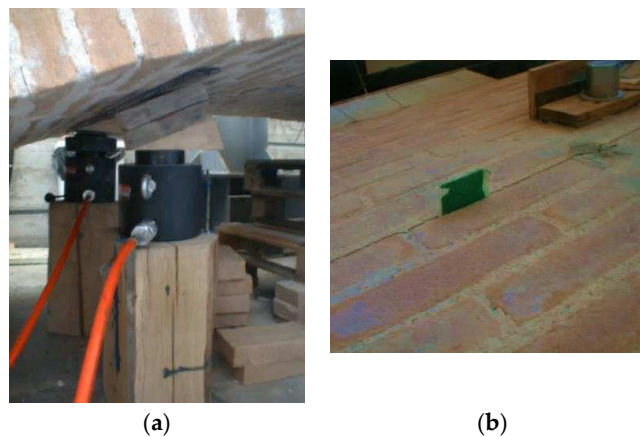
Figure 9. (a) Application of hydraulic cylinders to promote damage; (b) Hinge formation.

Free oscillation tests were also performed on the damaged vaults. Damage was caused by a vertical load through the application of two hydraulic cylinders and a spreader beam under one haunch (Figure 9). The static vertical loading was increased until hinges formed at three locations along the curved length of the vault; one hinge occurred around the vault springing, another hinge formed over the position of the vertical load, and the third hinge formed in the opposite haunch 11 brick lengths from the crown (for BV1-type vault).

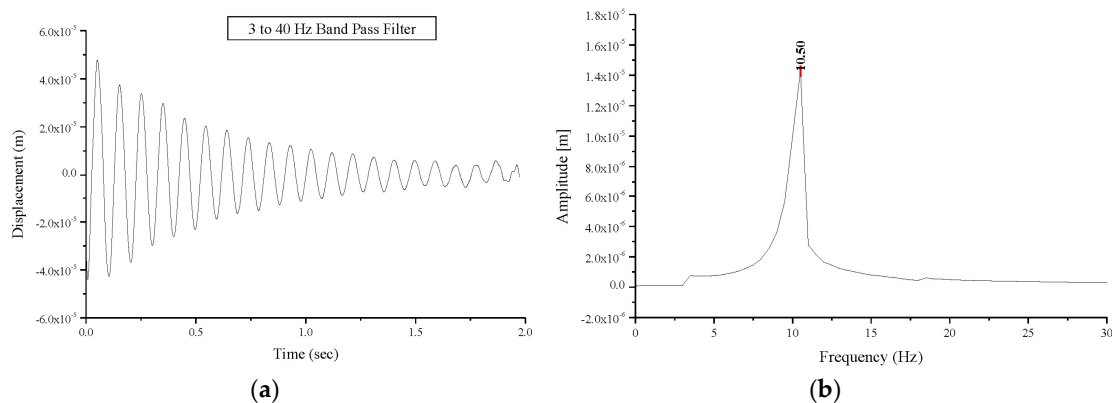
Figure 10. Free oscillations' response of the damaged vault BV1: (a) displacement versus time; (b) Fourier transform: amplitude versus frequency.

The global behavior of the damaged vaults was predominantly elastic allowing for analysis of the vault's behavior via free oscillation tests, as previously done for the undamaged vault. A decrease in the frequencies of the first natural mode was recorded in all tests carried out on the damaged vaults compared to the values recorded for undamaged vaults. Natural frequencies values of first and second mode for the tested masonry vaults are presented in Table 2. The first natural mode frequency value for specimen BV1 experiences a decrease from 11.25 Hz (undamaged vault) to 10.50 Hz (damaged vault) as shown in Figure 10, while a decrease from 10.00 Hz to 6.25 Hz and from 6.25 Hz to 3.50 Hz was recorded for specimens BV2 and BV3, respectively. The decrease in the first-mode natural frequency is a consequence of the damage sustained. This value depends on the positions of the hinges and the extent of structural damage. This explains the different values

(10.50 and 6.25 Hz) recorded for vaults BV1 and BV2. It must be highlighted that if damage does not progress, this value remains constant with time. Similarly, an increase in the damping values was experienced in the damaged vaults compared to the undamaged vaults. The damping values are summarized in Table 3. Corresponding values were recorded for undamaged vaults (average value 1.25 s^{-1}). The damage resulted in an increase in the damping value between 17.1% and 66.4%.

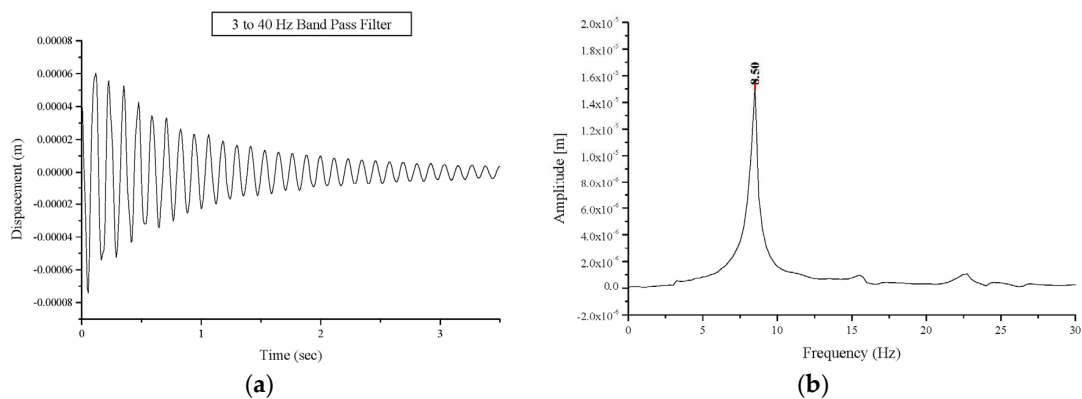
Figure 11. Free oscillations' response of the strengthened vault BV3: (a) displacement versus time; (b) Fourier transform: amplitude versus frequency.

The test procedure, applied to the undamaged and damaged vaults was repeated on strengthened vaults, and the results are presented in Tables 2 and 3. Due to the strengthening, an increase in the frequencies of the first natural mode compared to those for damaged vaults was recorded. The first mode frequency values for the strengthened vaults were almost the same as that of the undamaged vaults. The first natural mode frequency for specimen BV3 after strengthening, reached the value of 8.50 Hz compared the 6.25 Hz and 3.50 Hz for the same vault in the undamaged and the damaged configurations, respectively (Figure 11). The cracks where the three hinges formed are still present, but tensile stresses are now transferred to the GFRP reinforcements (Figure 12).

Strengthening with GFRP sheets has resulted in a decrease of the damping value (Table 3) for the repaired vault compared to the vault that is damaged but has had no strengthening interventions. However, the application of the GFRP at the vault extrados has not re-established the original damping values due to the presence of the mortar joint cracks. This could be considered as an additional advantage to be gained from strengthening. Reinforcement can greatly enhance the tensile strength of masonry while re-establishing the original dynamic response of the undamaged structure.

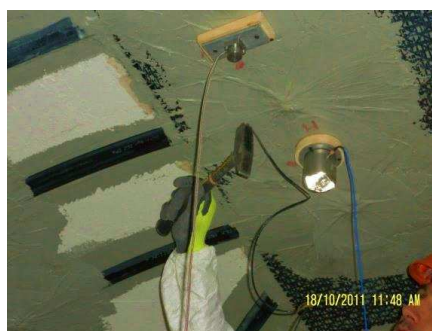
Figure 13. Sledge hammer applied to the crown of the vault intrados.

A 2 kg sledgehammer instrumented with a piezoelectric force transducer was used for the forced excitation of the vault. The response of the structure was measured using three low-frequency Monitran MTN/7100 accelerometers with nominal sensitivity of 5.39 mV/g.

Both force and response signals were filtered using a 16th order low-pass Butterworth filter with a cut-off frequency of 200 Hz. Accelerometers mounted on steel blocks were attached to the masonry vault with an adhesive. Hammer excitation was concentrated on the vault key-stone, as it was almost level, and, therefore, easy to balance on (Figure 13). The magnitude of the accelerations were recorded at the vault haunches on a direction perpendicular to the vault surface at that point. The Frequency Response Function (FRF) for each location was obtained from an average of ten hammer blows for a spectral resolution of 0.0625 Hz.

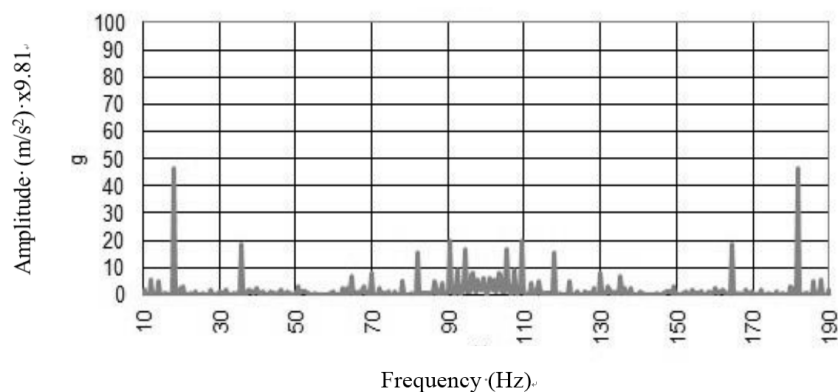
Figure 14. Free oscillations' response to the *in situ* test on the damaged vault.

Typical FRF spectra for un-reinforced vault (Figure 14) are presented showing their component magnitudes. The damage to the vault promoted an inelastic dynamic response and any natural frequency could be recorded for the vault. Dynamic pounding between closely spaced parts of the vault resulted in the recording of high peaks for the amplitude of acceleration, but any dynamic analysis could be executed.

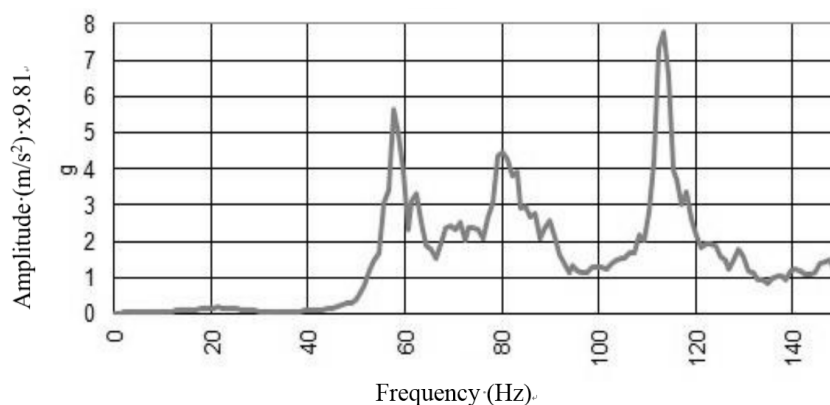
Figure 15. Free oscillations response to the *in situ* test on the reinforced vault.

For the reinforced vault, an elastic behavior was restored and the vault exhibited a clear dynamic behavior (Figure 15). Modal peaks in the spectra indicated the presence of a number of modes of vibration below 120 Hz. The well-defined peaks represent individual modes, and their repeatability across the full spectral set facilitated a modal analysis. Re-establishing the elastic behavior of the vault through application of reinforcement is considered to be a positive result of the investigation.
