Non-Destructive Evaluation Using Ultrasonic Technique And Distributed Blackboard System

Patrick Wong

Intelligent Computer Systems Research Group

The Open University, 2002.

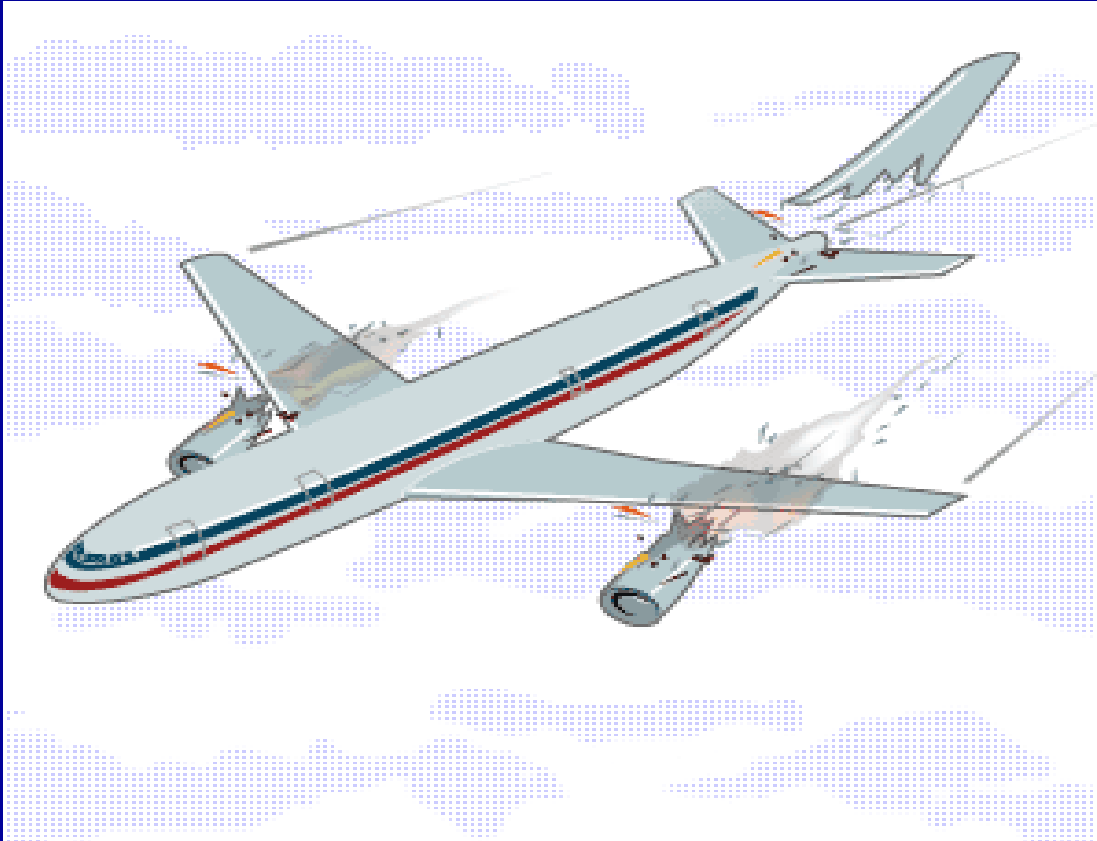
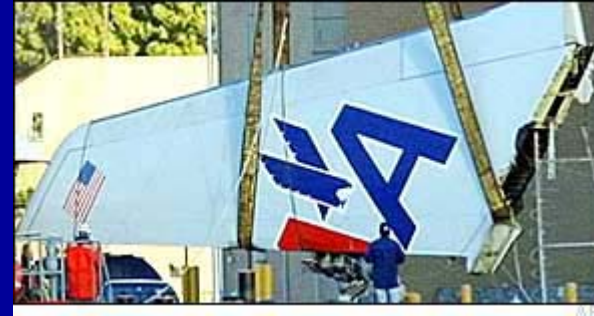
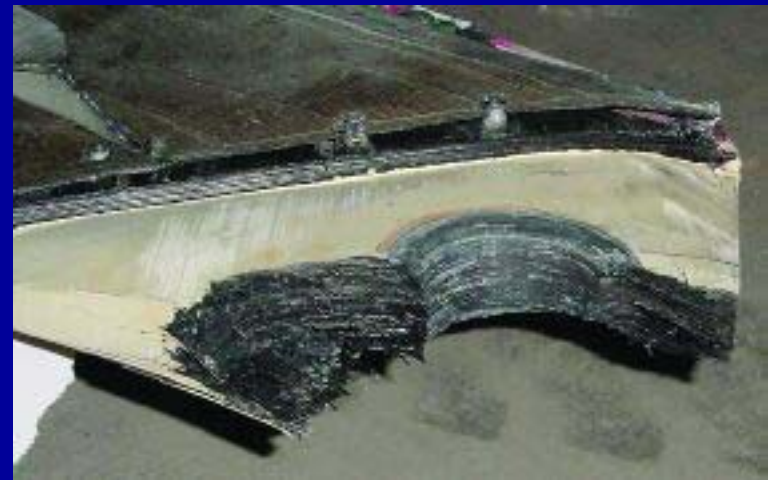
Plane Crash

An American Airlines passenger jet (AA587) crashes near John F Kennedy airport killing at least 260 people in October 2001.

Metal failure is the suspected caused of the crash.

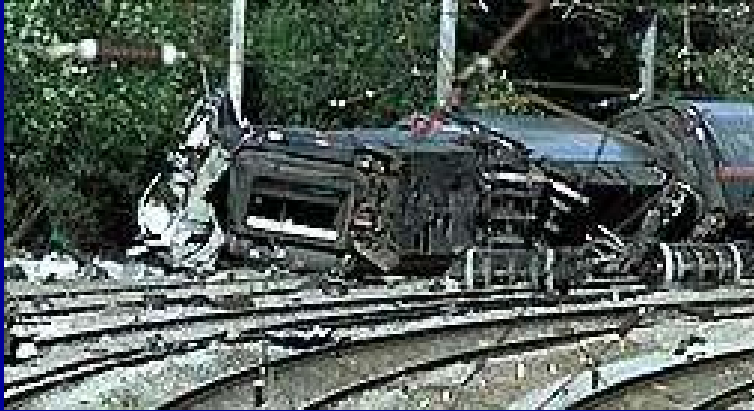
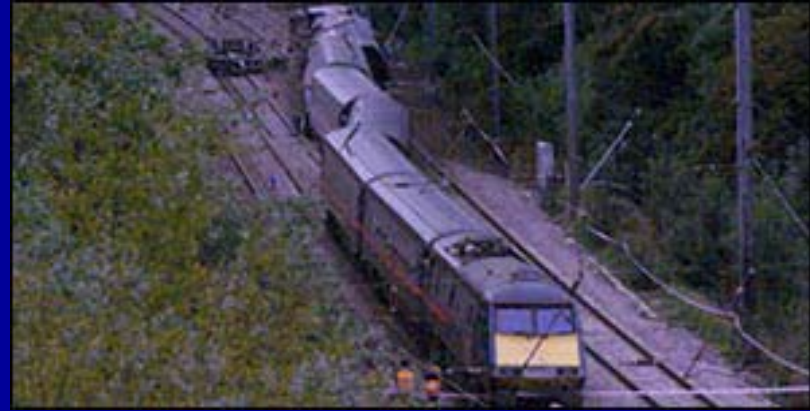
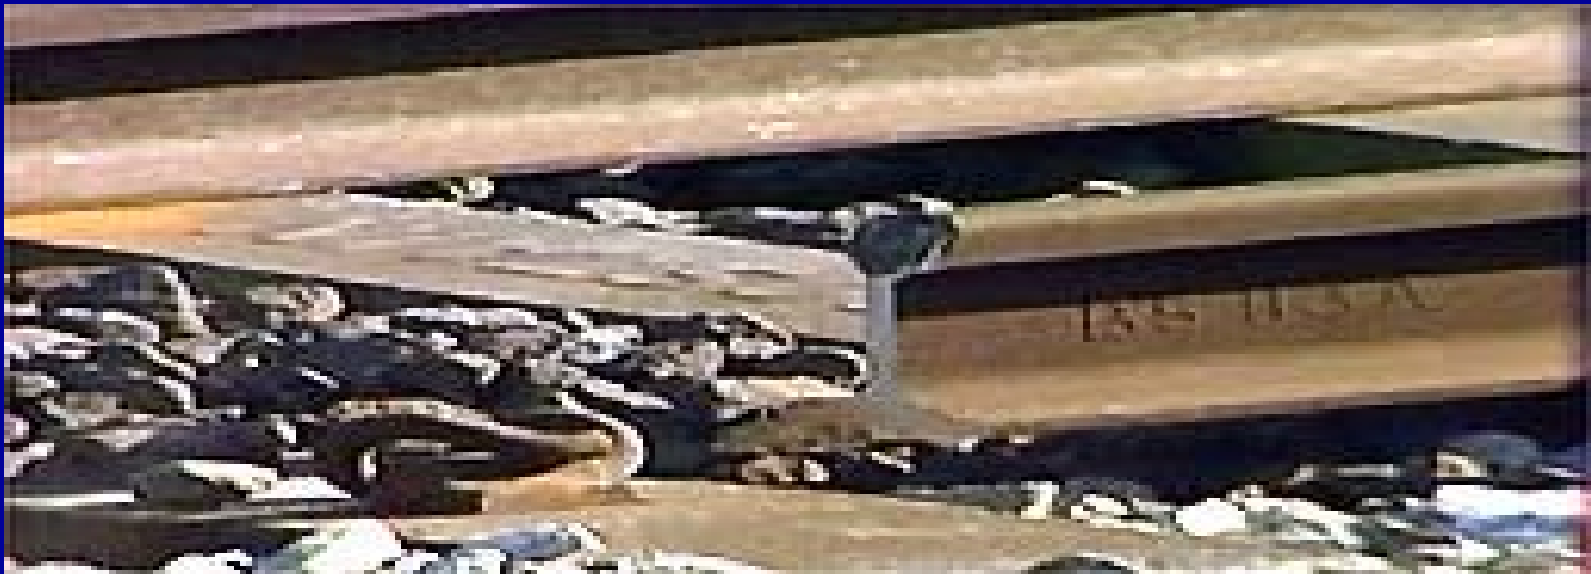
Rail Crash

Hatfield train crash killed four people and injured 70 in October 2000.

Crash caused by defected rail.

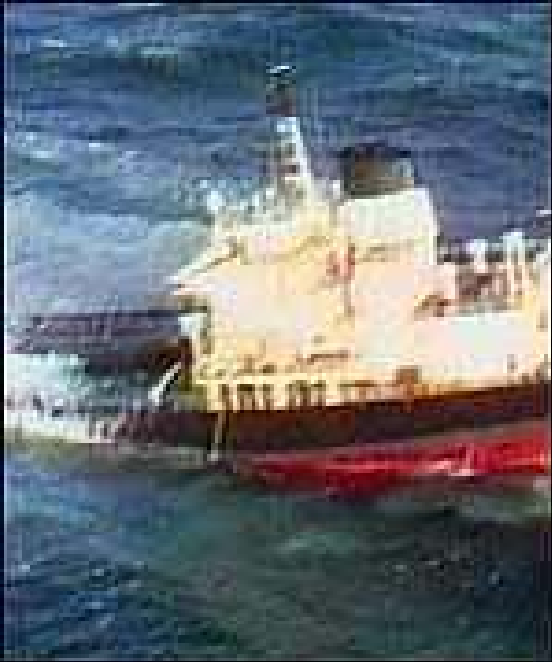
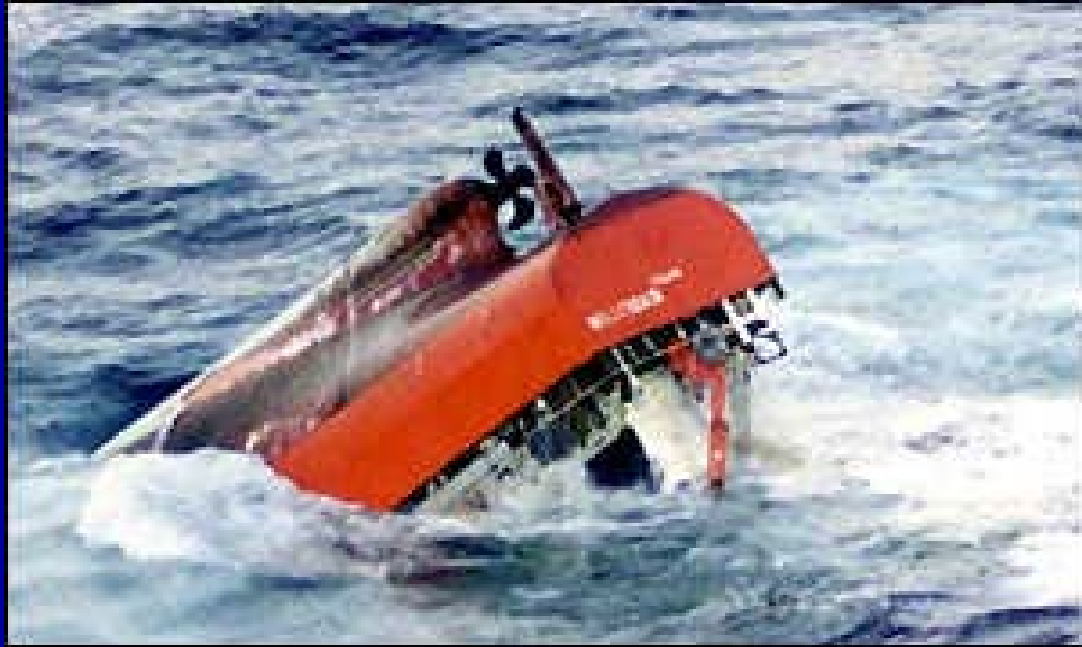
Sunken Tanker

Tanker Erika sank and released oil which caused serious pollution in December 1999.

Caused by structural weakness.

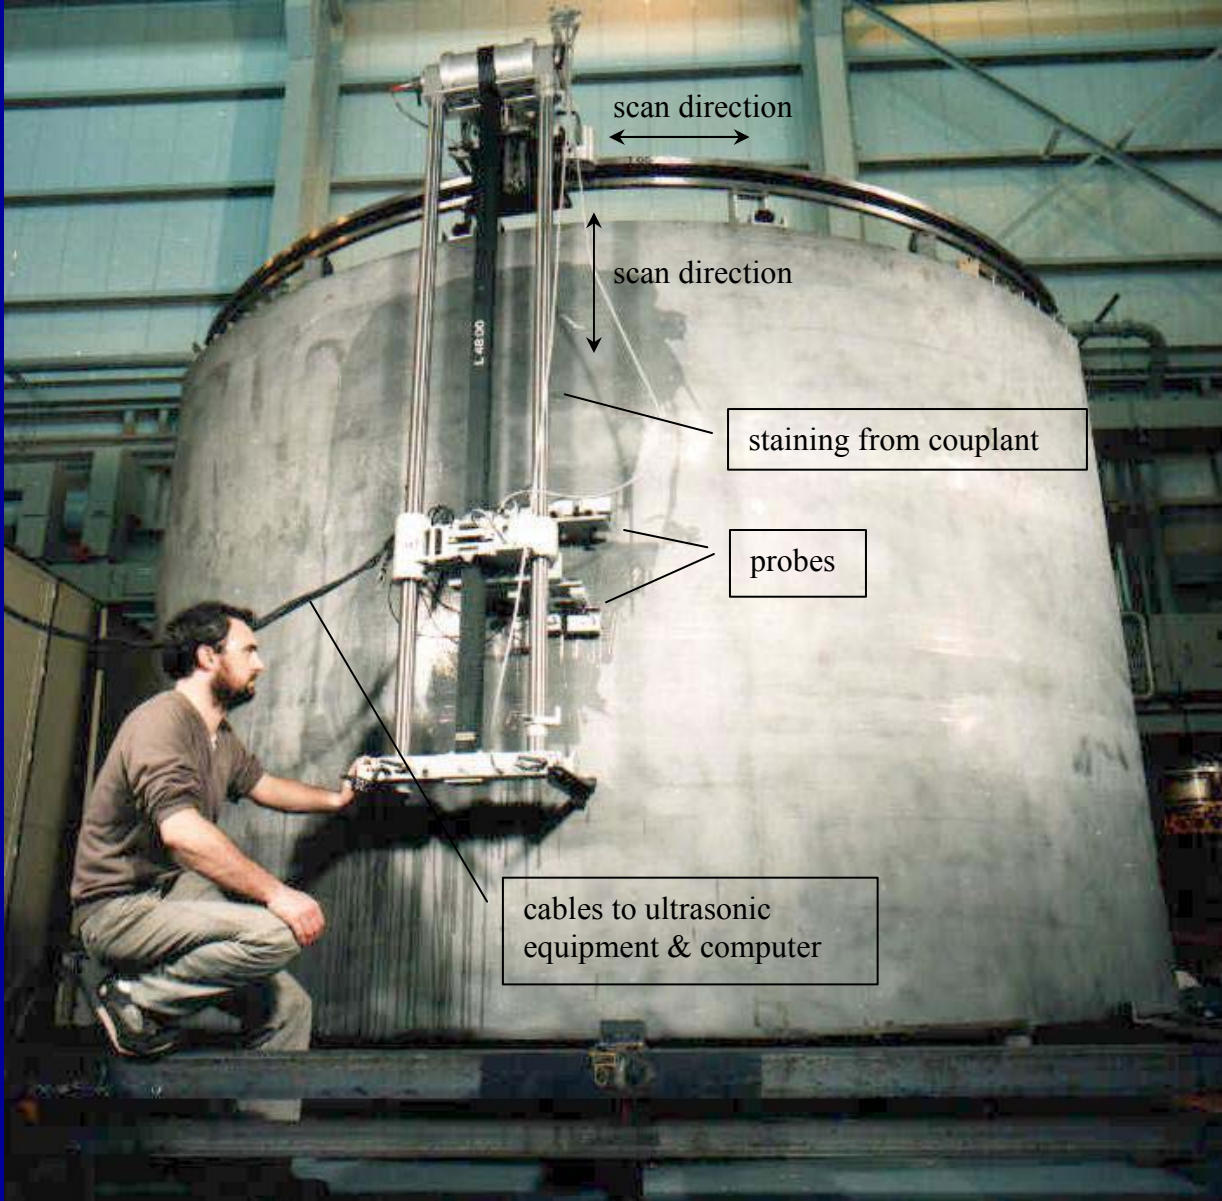
Equipment

- **Ultrasonic Inspection**
can visualise the inside of a metal specimen without damaging it.
- **Image Creation**
record the ultrasonic data and produce an visible image.
- **Evaluation**
using AI techniques to evaluate the ultrasonic image.

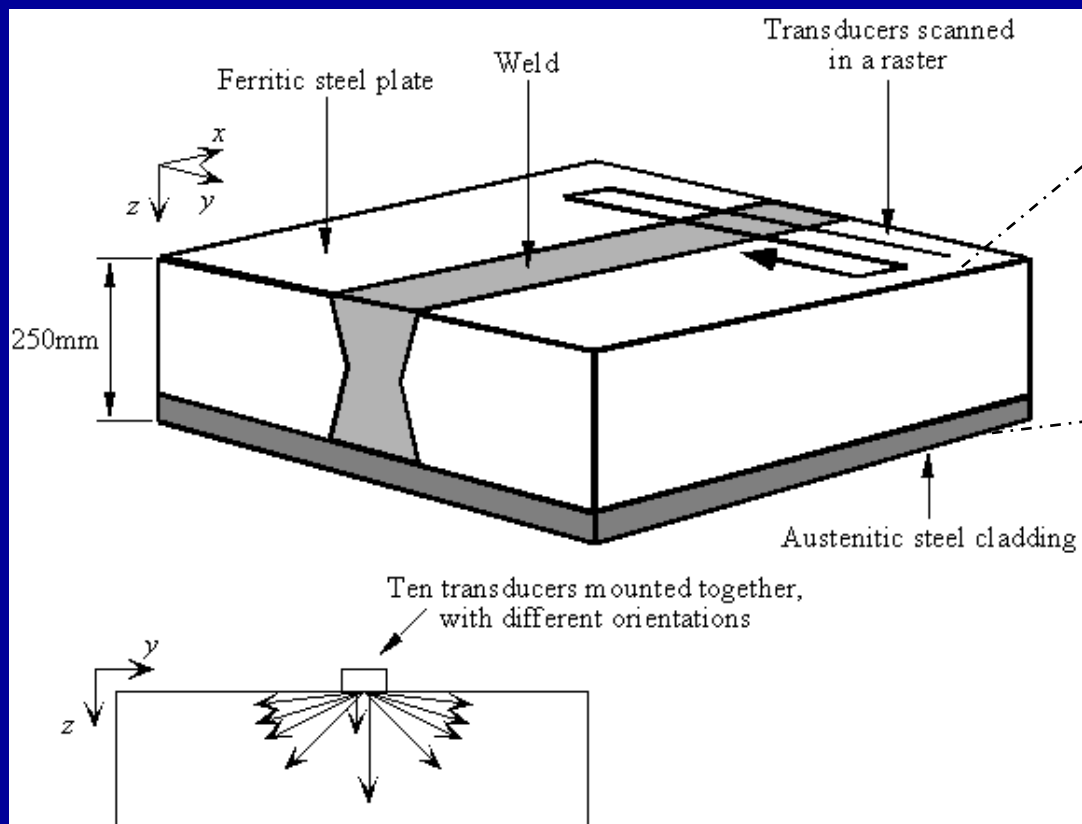
- To find hidden cracks inside this ferritic steel plate.
- An array of ten transducers scanned across the surface of the plate in a raster fashion.

B-Scan:
Cross-section view

- A 2-D image of the cross-section view of the specimen is produced each pass of the probes across the surface of the plate.
- To reduce the effect of noise, only indications of intensity $> -30\text{dB}$ were recorded.
- Echoes caused by a defect in the specimen leads to a feature in the image, but features may also occur which are not directly associated with defects.

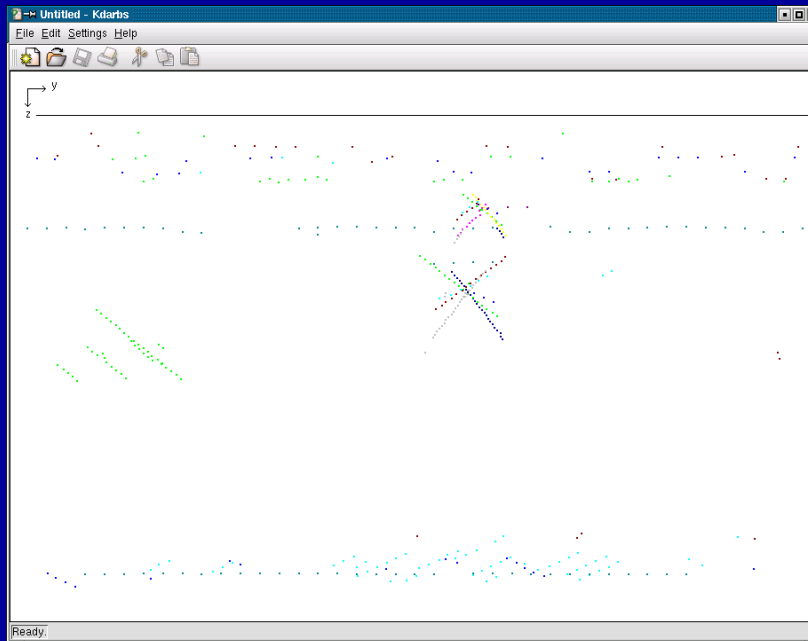
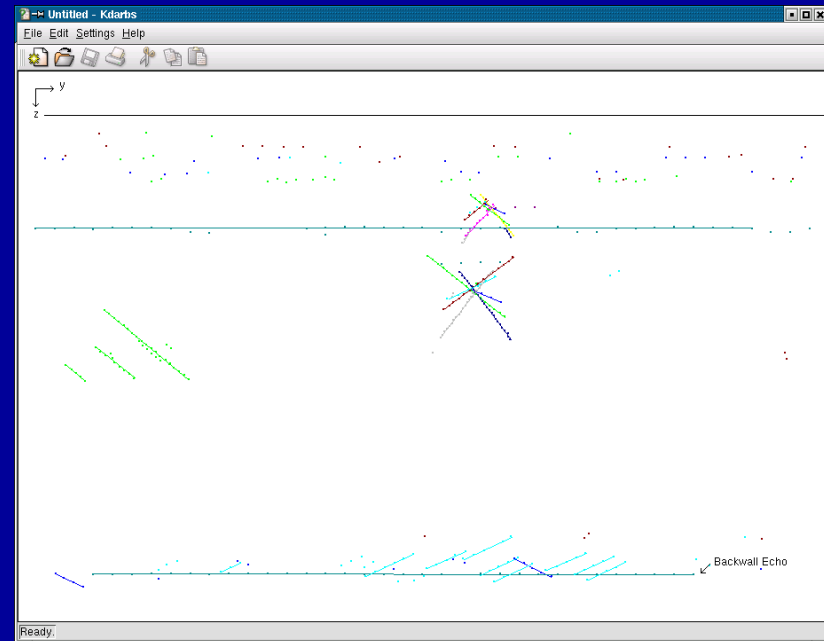
- Find lines of indications

These lines are caused by echoes from a point in the sample detected by a transducer in contiguous positions.

- Extract readily identifiable features

Some features may be immediately identified, such as the “back wall” or the reverberations in the transducers.
