Deployment of the Northern Fish Cage and Mooring, University of New Hampshire — Open Ocean Aquaculture Program Summer 2000

Technical Report

WHOI-2001-01

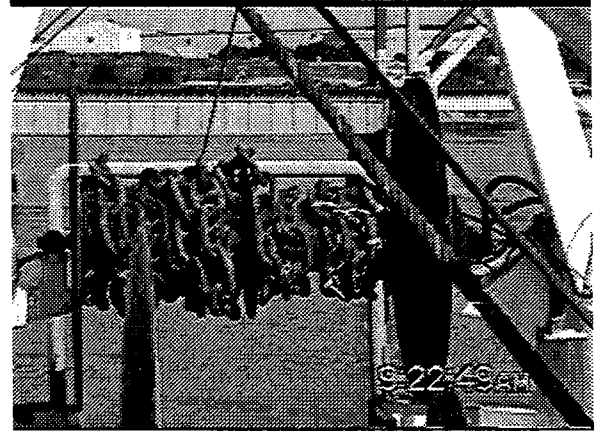
Picture 3. Anchor chain wound on aft net reel ready for deployment.

The FV *Nobska* was loaded in a specific order and in a specific way to ease in the subsequent mooring deployment. First, the shore-based crane swung aboard a 90-foot length of 2¼-inch steamer chain. This chain was then wound on the aft net drum so that it paid out forward of the drum (Picture 3). To allow this chain to be disconnected from the drum, a 100-foot length of 1 1/8 inch Samson 2-in-1 Nylon line was used. One end was attached to one side of the net drum, and the second end passed through the steamer chain, on the fourth link from the end (Picture 5). Then the second end of the rope was attached to the other side of the net drum. The drum was then wound up, first reeling in 50 feet of line on each side of the drum, then the 90 feet of steamer chain. The free end of the steamer chain was then attached back on itself and secured with rope so that it wouldn't shift as the drum was rotated further. The anchor line was then shackled into the end of the anchor chain, and was wound up on the aft net reel on top of the steamer chain (Picture 4). The anchor chain was marked with red and yellow tags near each end. The convention used was that the yellow end would be the upward end of each mooring.

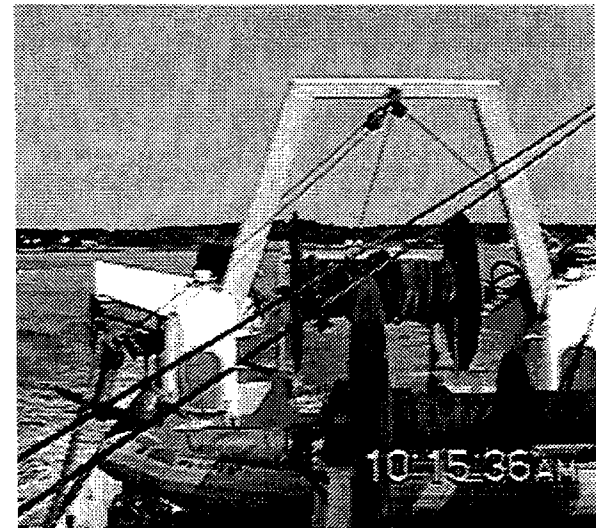
Picture 4. Anchor chain and line wound on aft net reel ready for deployment.

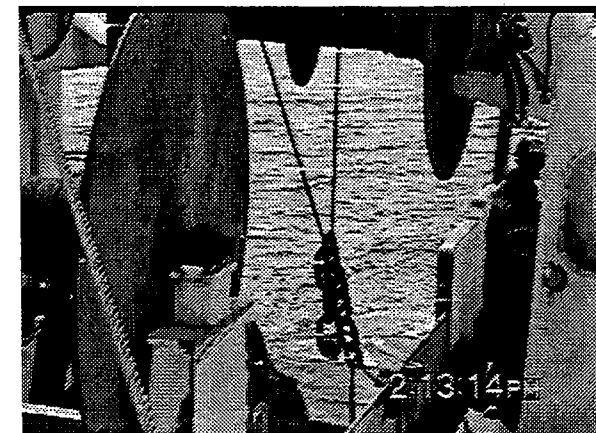
Picture 5. Line holding chain to net reel with four free links left loose at end for easy handling to attach chain to anchor.

When the anchor line on the aft net drum was spooled out, the net reel continued to pay out the 2¼-inch stud link anchor chain until the end with the last three free links was reached (see Figure 3 and Picture 5). With the steamer chain paying out from the forward end of the net drum, these links were reachable from deck for attachment to the anchor. The 30 feet of 7/8 inch Grade 80 chain was then run from the 2¼- inch stud link steamer chain, around the rail and shackled into the anchor and welded (Picture 15 and 16). The net drum then slacked out the chain until the weight was taken on the anchor, and the 100 feet of rope was loose. It was detached from one end of the drum and pulled free. The slip line on the anchor's shank was eased out and the anchor and chain were then entirely on the trawl winch, which was capable of working with the entire mooring load (Picture 17).

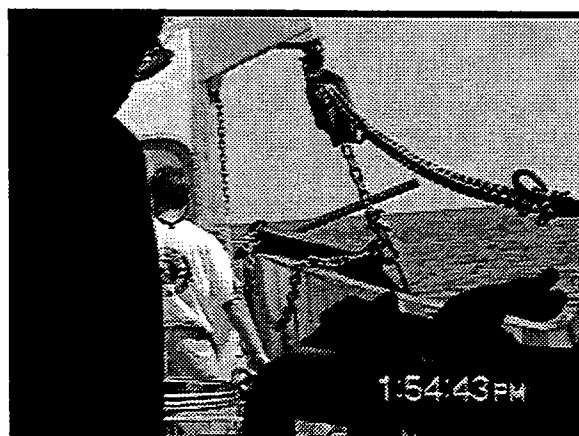
Figure 8. Anchor secured to rail. Back chain is visible hanging over rail. Chain runs to trawl winch on right with free link.

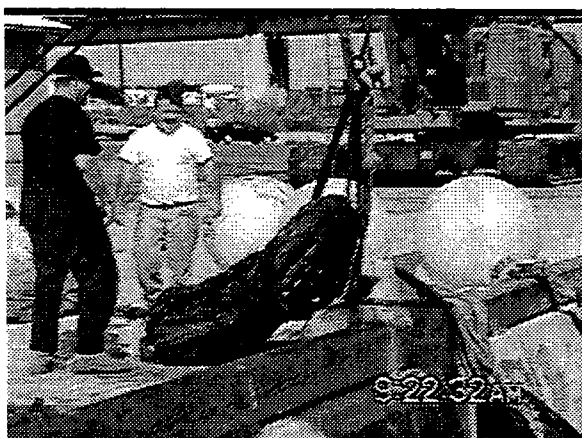
Picture 9. Loading grid line. Steel and polypropylene floats, grid corner rings and hardware will be loaded next.

The second anchor chain was loaded onto the *Nobska* and faked out on deck under the mid-deck net reel. The second anchor and chain were assembled on the trawl winch on the other side of the ship so that two anchors were rigged ready to go. The second anchor line, shackles, grid lines, corner ring and 37 inch steel buoys were loaded on the deck to complete the required components for two moorings (Picture 9). Then the ship was able to sail to the site for mooring deployment.

A key to smooth operation at sea was the shoreside rigging and setting the hardware on the ship in optimum location and order so that a minimum amount of time had to be spent at sea rigging and moving hardware around (Pictures 9, 18 and 31).

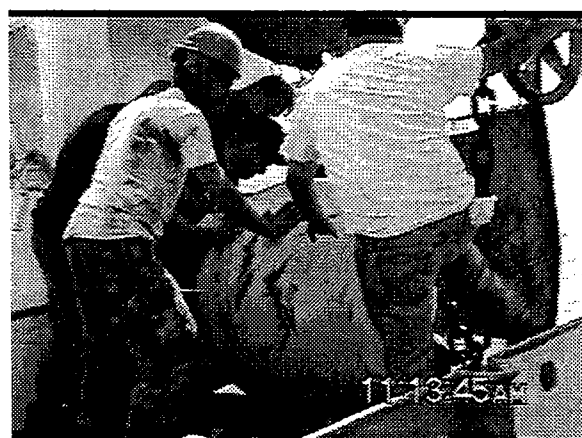
Picture 10. The grid ring (upper right) is attached to the steel ball and deployed.

Once at the site, the mooring deployment commenced. On Tuesday, the southwest anchor was deployed first, then the southeast. The first operation was rigging the steel corner float and grid corner ring (see Figure 3). The float was attached to the ring with 2 meters of chain (Picture 10). The anchor line was attached to the

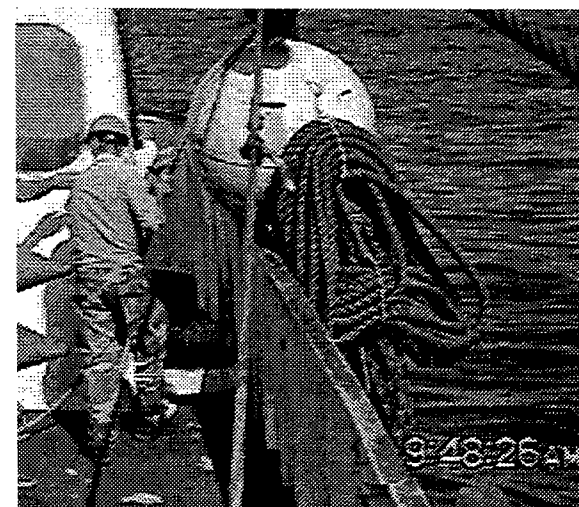
Picture 13. Grid line and lower riser lines attached to steel grid corner buoy.

load cell that was shackled to the rope ring (Pictures 11 and 12). All shackles above the grid lines were seized with stainless wire. On some of the buoys, the grid line was attached, coiled and tied to the side-eye on the buoy for later deployment (Picture 13). The steel grid corner float was then picked by the ship's outhaul winch and the ring lowered down the stern ramp (Picture 10). When released, the buoy and rope ring floated away from the ship that was steaming at about ½ knot (Picture 14). This forward motion pulled the mooring components away from the ship and streamed them out behind in line so that they would not tangle. All shackles below the anchor rope and

As first job the *Nobska* prepared the mooring for the fish cage by picked up the Southwest, Southeast and Northwest grid buoys and suspended a lower bridle line as a coil from each grid buoy (Picture 13). At the same time a grid line was attached to the Southwest and Northeast buoys to close the grid once the fish cage was in position. The Northeast riser line had the electrical telemetry cable and was deployed and attached to the cage later with the assistance of the *Galen J*. This is the telemetry cable connecting the more heavily instrumented Northeast grid corner (Figure 8 and Picture 36). to one of the Northeast bridle lines to the telemetry transmitter on the fish cage.

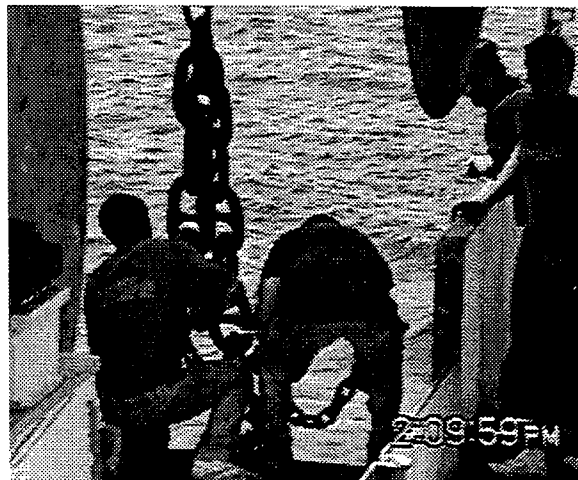
Picture 16. Attaching 7/8" chain from 2 1/4" anchor chain to anchor at rail.

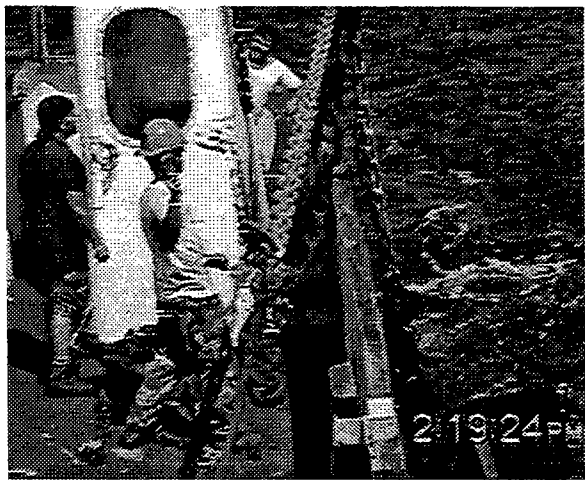
Picture 20. Lifting $2\frac{1}{4}$ " chain links above rail with trawl winch.

first section of chain was attached (Picture 19). A 4 foot section of $\frac{3}{4}$ inch chain run through the steamer chain allowed it to be shackled into the 1 inch long-link chain without having to lift the heavy steamer chain from the deck (Picture 18). The trawl winch then raised this above the rail (Picture 20), and the lower end was attached by a 12-inch section of $\frac{3}{4}$ inch chain and $\frac{3}{4}$ inch shackle (Picture 21). The trawl winch then went up and down lowering about 8 feet each time to attach and deploy six sections of steamer chain of four links each. This nicely filled out the 30 feet of 1 inch long-link chain to give the spar

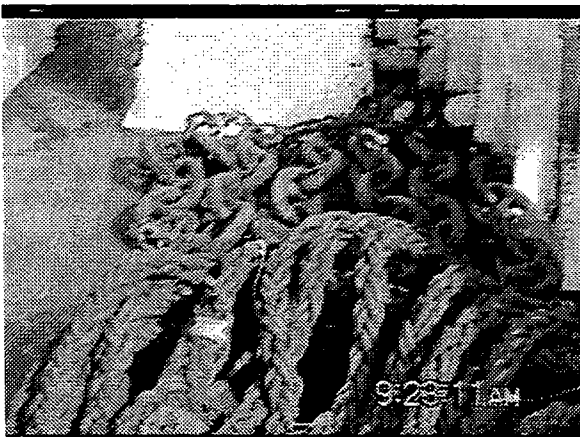
Picture 18. Four link sections of steamer chain with $\frac{3}{4}$ " chain on deck ready to use.

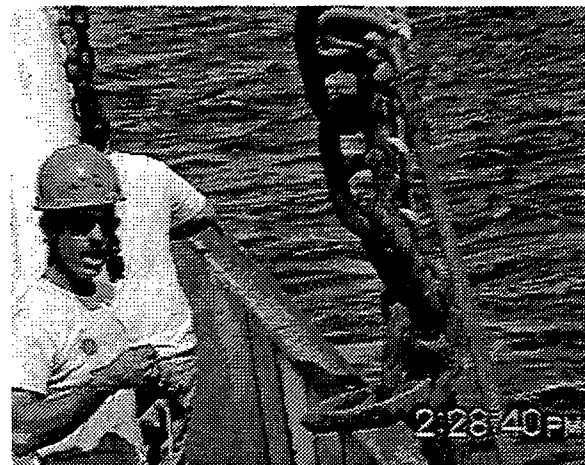
Picture 21. Attaching bottom of shot of four links of $2\frac{1}{4}$ " chain to 1" crown line chain.

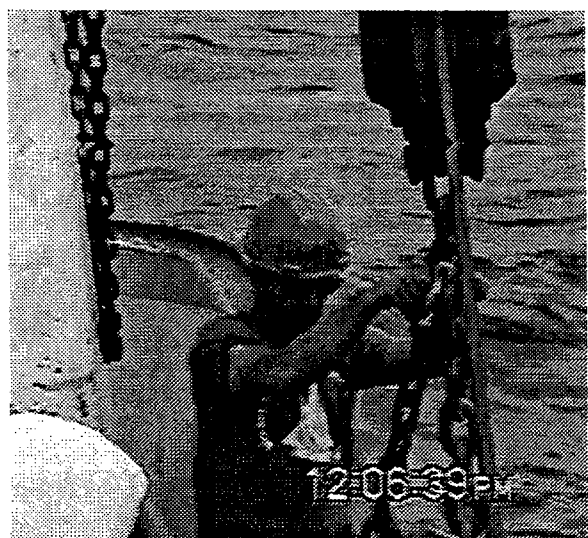
Picture 19. Will Ostrom attaching $\frac{3}{4}$ " chain to 1" long link chain on crown line.

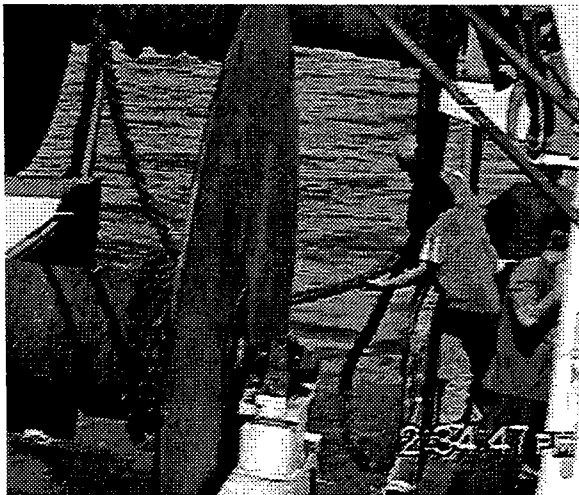
Picture 22. Crown line being wound on aft net drum.

While this steamer chain was being attached to the 1-inch long-link chain, the crown line was spooled on the aft net drum (Picture 22). A tag line of about 100 feet of $1\frac{1}{4}$ inch Samson 2-in-1 line was spooled on the drum, then the 41-meter crown line (see Figure 4) attached (with the rope ring first) and wound up. The trawl winch was then paid out until the wire was through the block, and the chain hanging at the rail with the last link free. A 1-inch shackle was put

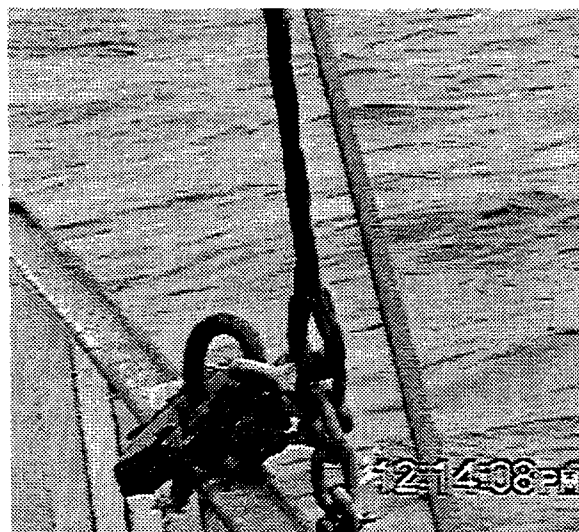
Picture 23. The crown line is shackled into the 1" chain on the trawl winch.

into the chain and attached to a 1½-inch shackle that fit into the thimble in the crown line on the aft net reel (Picture 23). The trawl winch was then paid out until the crown line took the strain. The aft net drum was reeled in so that the trawl wire could be disconnected from the mooring (Picture 24). Now the entire mooring was hanging off the aft net reel. The crown line was lowered until the end was reached, and the ring was shackled into the trawl winch. The load was transferred back to the trawl winch (Picture 25) as the ship prepared to tow the mooring into position.

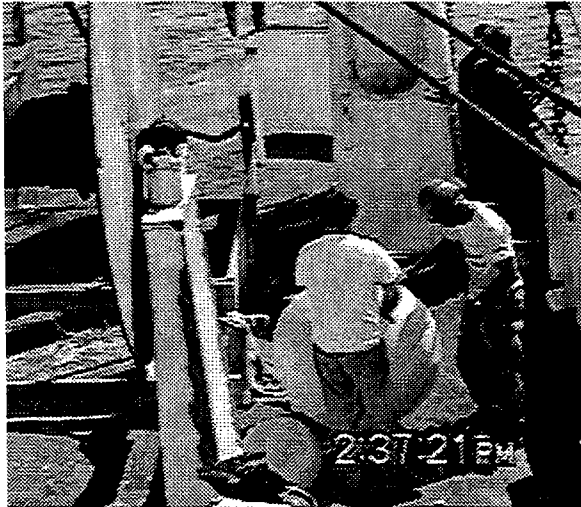
Picture 26. The small Norway ball and larger polypropylene temporary marker crown marker buoy are attached with chain.

The 37-inch polypropylene temporary crown buoy and a Norway marker ball were then assembled to the 9 meter length of long-link adjustment chain (Picture 26), and attached to the ring in the top of the crown line. The ship then steamed toward the deployment position. A slip line was rigged through the steel ring for the final deployment (Picture 25). As the site was approached the poly ball and Norway ball were lifted over the rail and allowed to float behind the boat (Picture 27). The trawl winch wire was removed, and the mooring held on the slip line. As the site was reached the slip line was released and the mooring deployed (Picture 28).

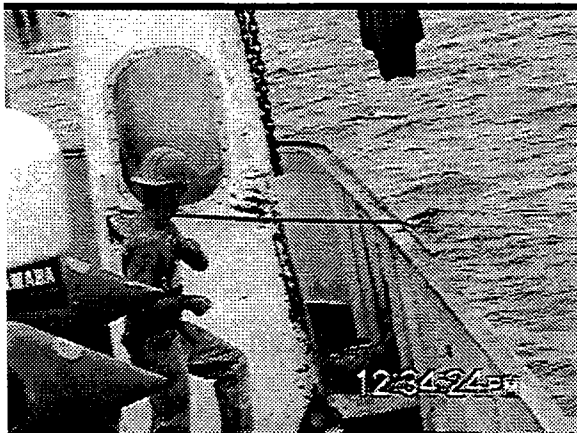
Picture 28. Will Ostrom releasing the slip line to deploy the mooring.

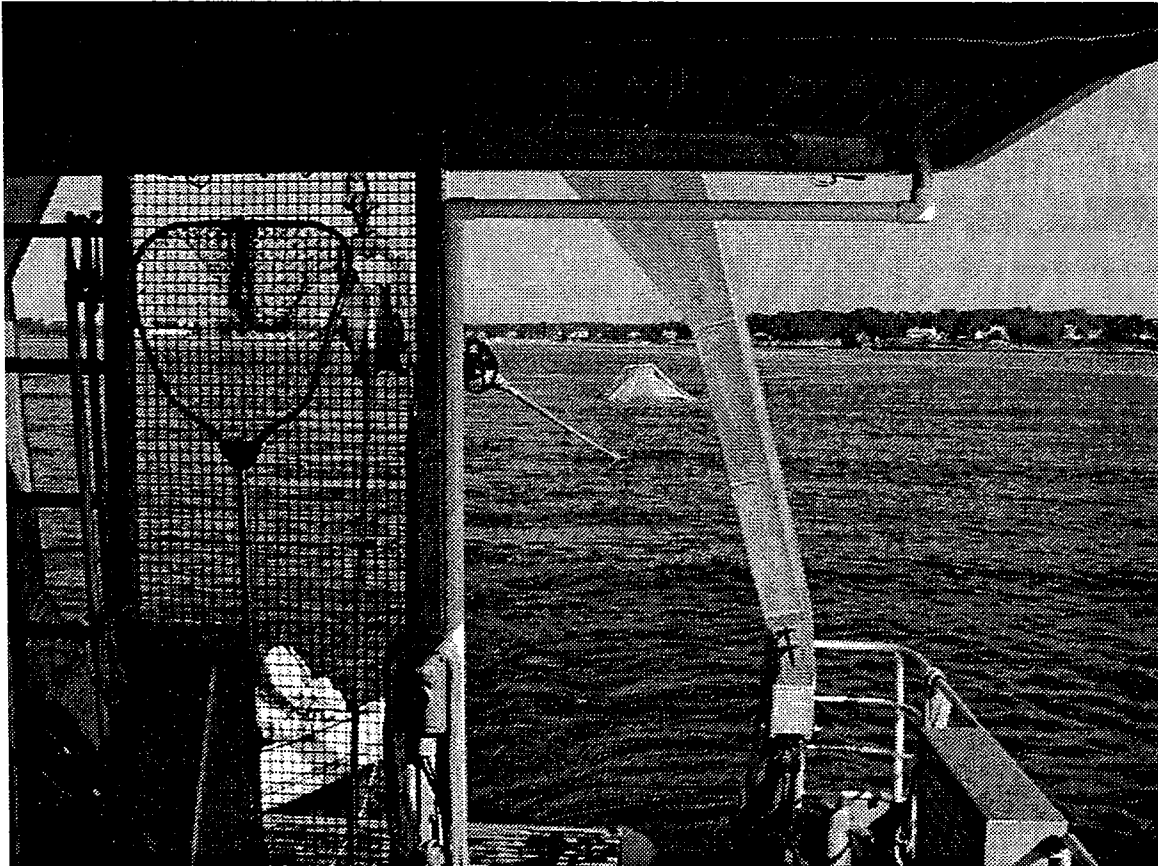
Picture 33. The fish cage can be seen being towed behind the Gulf Challenger in the Piscataqua River. The towing cable seen was attached to the bridle lines on the fish cage on one end and a load cell on the other. The load cell is in the dark open frame seen at the left end of the tow rope above the deck. The other end of the load cell was restrained by a line running over a block in the A-frame and down to the winch and cleat on deck.

The tow was started near the slack water of the high tide, and progressed seaward as the tide ebbed. During this tow, a load cell was connected in the towline aft of the a-frame as show in Picture 33. This load cell allowed the drag versus current velocity to be measured, as well as keep track of the tension in the line so that the line was in no danger of breaking and the peak tension was low enough that it did not damage the A-frame of the *Gulf Challenger*.

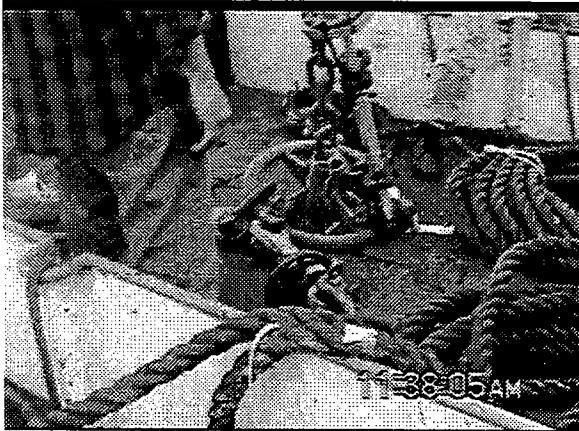
Picture 36. Northeast corner grid ring with four load cells and recorder strongback.

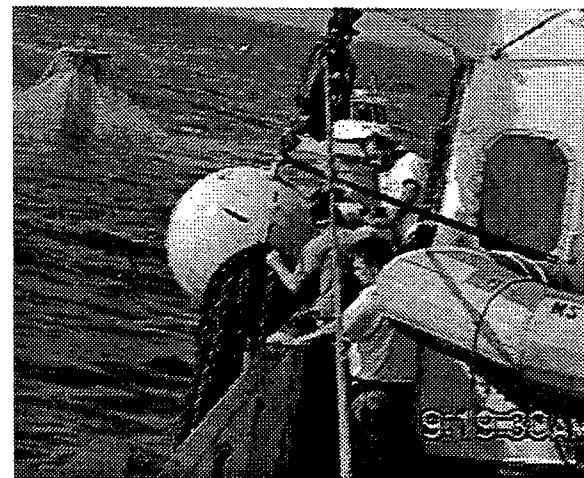
Picture 38. The Northwestern corner grid buoy with riser line attached. The line is being attached to the fish cage in the back left while the *Galen J.* stands by.

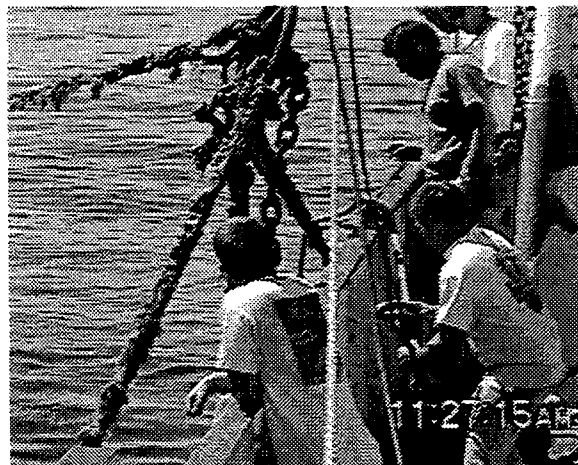
Picture 41. The Northeast grid corner ring with tangled lines and biofouling is recovered and untangled. Wear on the lower grid line is seen in upper left.

The South Cage mooring was inspected by divers earlier in the month and they found that the northeast lower bridge line was fouled around the corner buoy (Picture 41). This was untangled, but was redeployed with a badly chafed rope splice. Afterwards, the old remaining spar crown buoys (northeast and southeast) were brought on board and cut into several pieces for storage. The old buoys were replaced with 37-inch polypropylene floats and shorter chain adjustment links added. The northwest and southwest crown buoys (polypropylene floats) were also pulled and shorter adjustment chain replaced the old crown line chain. Upon replacement of each crown line chain, the *Nobska* would pull and tighten the anchor leg.

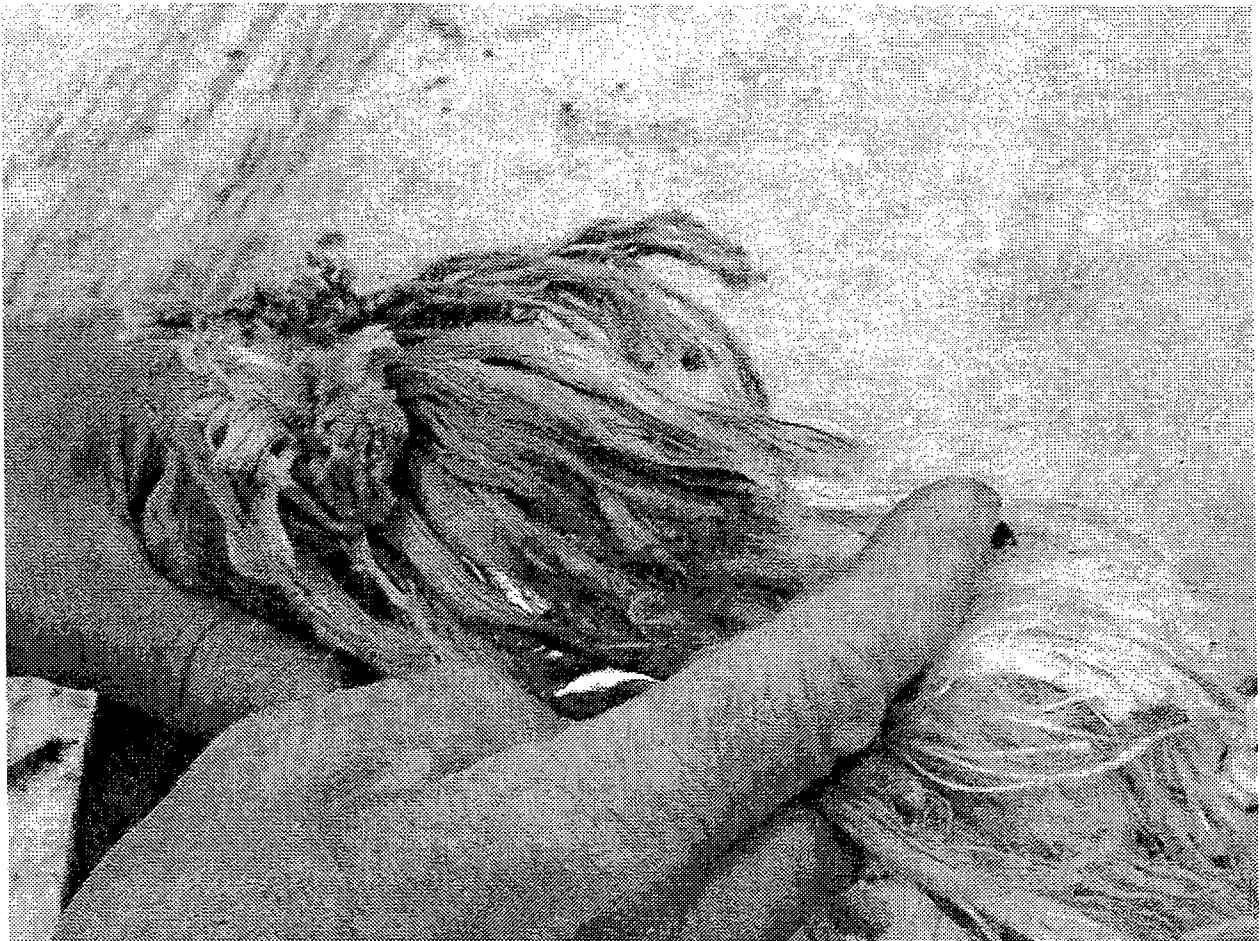
Photo P001272 - The cut end of the anchor line. There is one main cut most of the way through the line seen at the left. Another cut is visible just to the left of Walter Paul's finger, and at least two more cuts at the far right. The cuts were clean indicating that it was not torn apart or cut by rubbing against a rusted wire rope. The location of the break, close to the anchor end, and its appearance suggests possible cutting by the fairly sharp edges of the Sampson anchor.

The end of the cut anchor line was retrieved with the mooring "C" and was inspected. It looked as if about 3/4 of the line was cut cleanly with one cut, and that there were at least two more lesser cuts in the remaining fibers (See photo P001272 below). There is the possibility of cutting the rope with the anchor during deployment or more probably during relaxing of the grid if the anchor was lifted off the bottom and carried too far toward the cage. The cut was clean and probably not caused by a fisherman dragging it aboard. This is an interesting mystery that we may be able to further study by examining the cut end. The end was bagged in plastic to protect it from picking up other dirt and materials from the ship and pier.

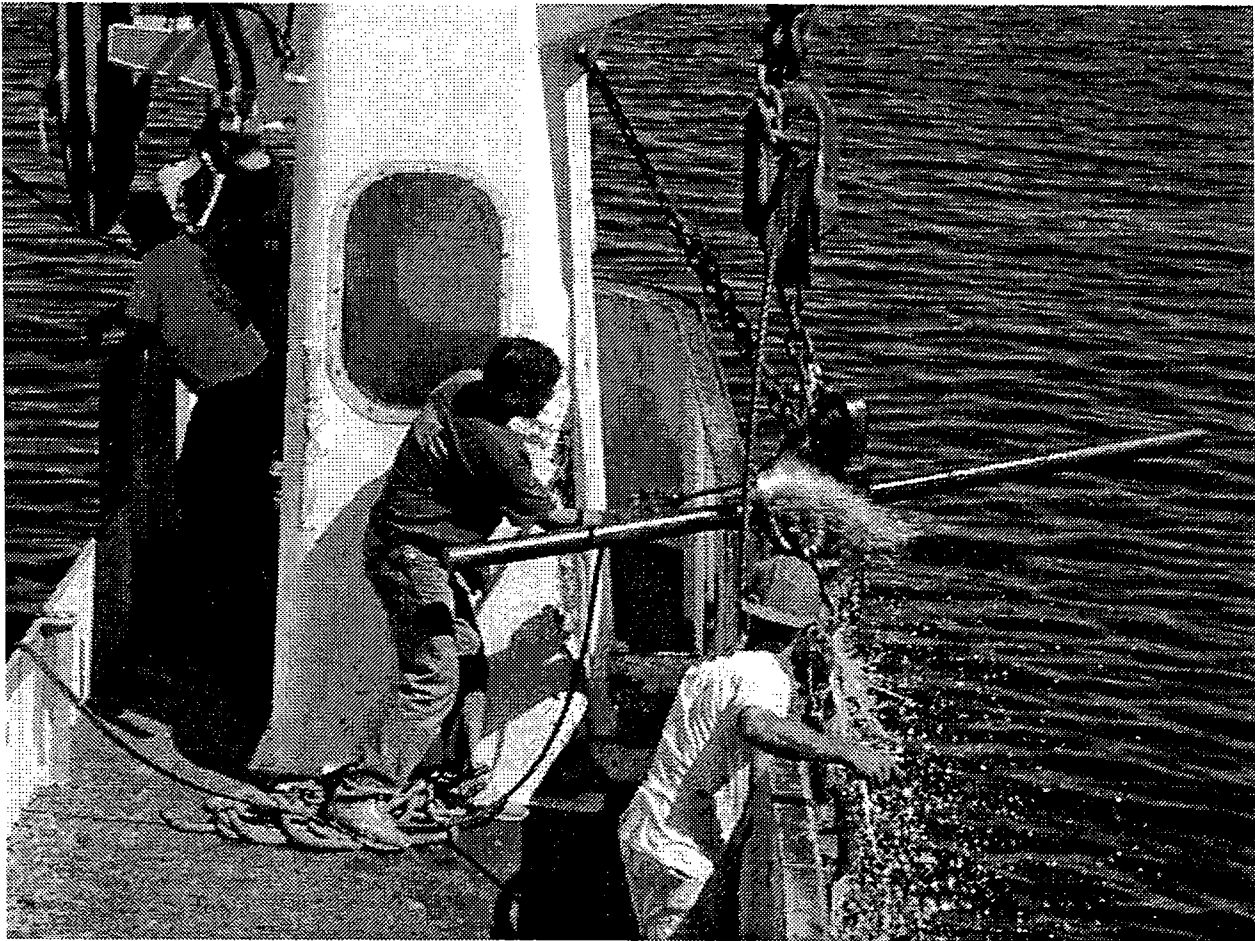
Photo P001189 - Mat Stommel (left) cutting chain wrapped around anchor while Will Ostrom (right) keeps water on line so that sparks from the cutting torch will not burn line holding the anchor chain for recovery on the aft fish reel.

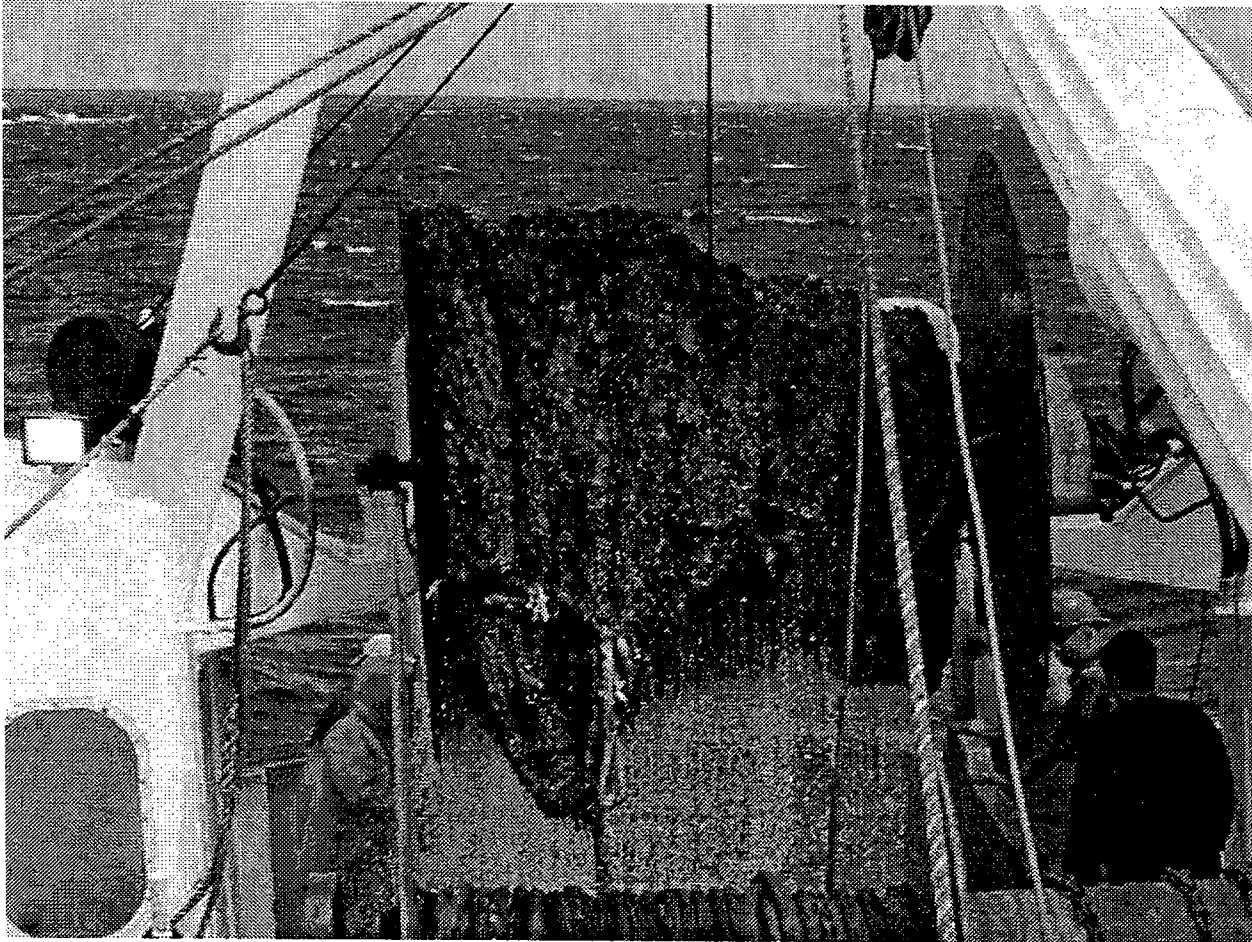
Photo P001240 - winding the northern fish cage net onto the Nobska aft net reel. The whole operation from pickup of the buoy to net wound upon the net reel took about two minutes.

1500 – net aboard OK - wrapped up on aft reel in less than two minutes (see photo P001240 below)
