WHOI-87-8

DEEP SEA MOORINGS FISHBITE HANDBOOK

WOODS HOLE OCEANOGRAPHIC INSTITUTION
Woods Hole, Massachusetts 02543

TECHNICAL REPORT

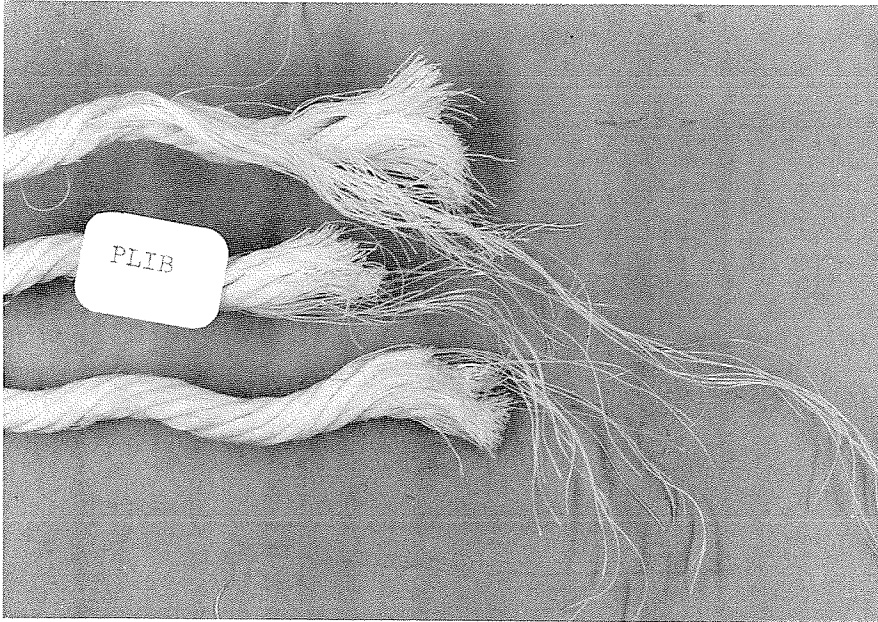
Figure 2.6 Parted mooring line (washed and dried).

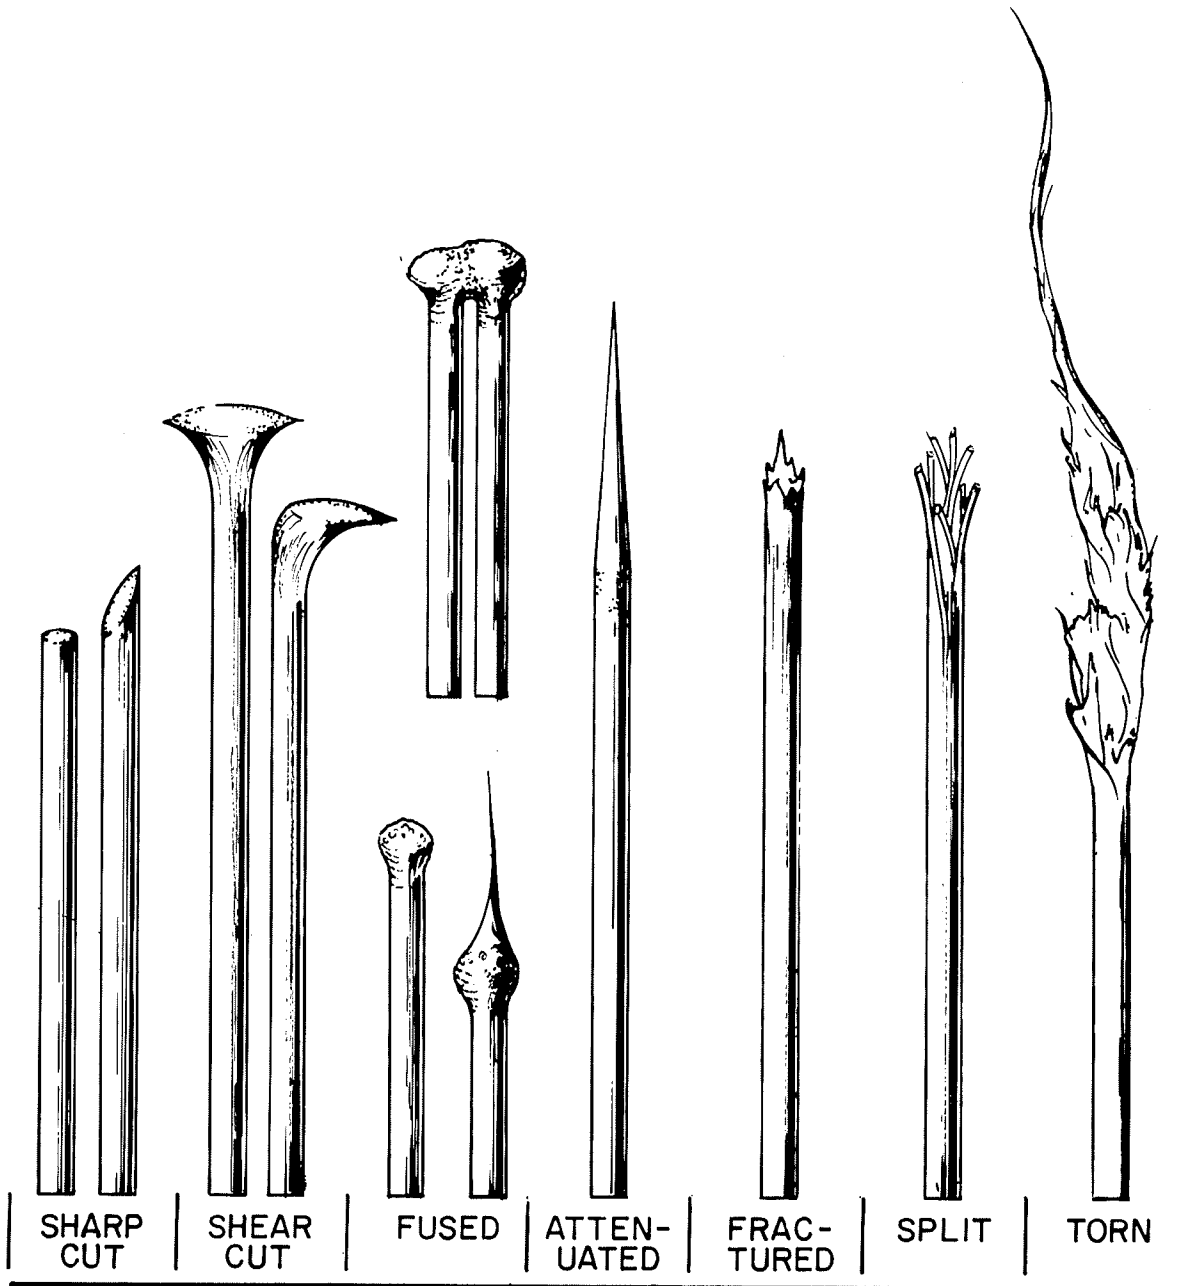
2.3.3.2. Microscopic examination. The fibers should be observed at 100X magnification. In a given sample, each fiber should be identified and cataloged as belonging to one of the following types or categories (See Figure 2.10):

Figure 2.10 Types of failed fiber ends.

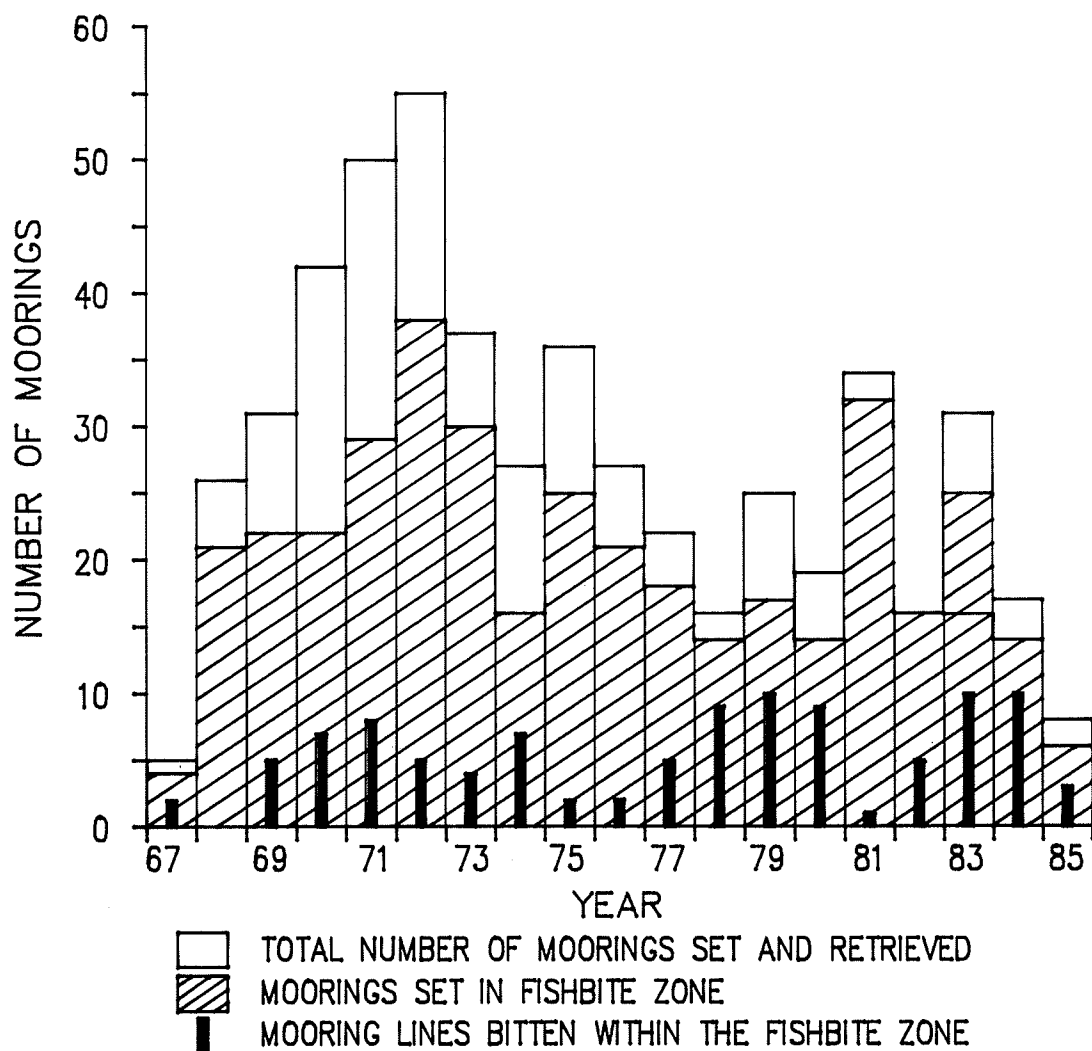
the same location (Site D, 39°N, 70°W), with a like number of lines exposed, the attack rate was 27%. From 1975 through 1978, the rate of attack at all stations appears to have been on the increase, rising from 8% to 62% of lines placed within the Fishbite Zone. Interesting, if true.

Figure 3.1 Yearly distribution of fishbites from WHOI mooring station logs (1967 - 1985).

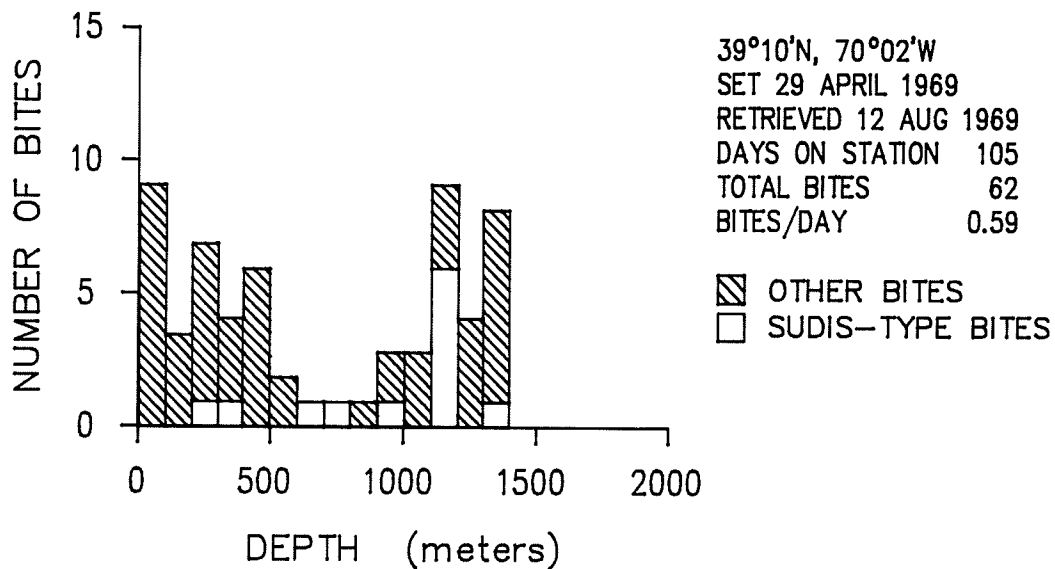
The total number of cuts in the moorings was 115, much less than in the previous (Bermuda) case. In terms of bites per day of exposure, a less concerted attack was noted. In addition, most of the bites were closer to the surface. A different species of biter seems indicated. A number of the bites were severe. Four gashes in the line on moored station #298 bared the wire; and in the case of moored station #300, one bite pierced the jacket.

Figure 3.7 Number of bites vs. depth (Station #298).

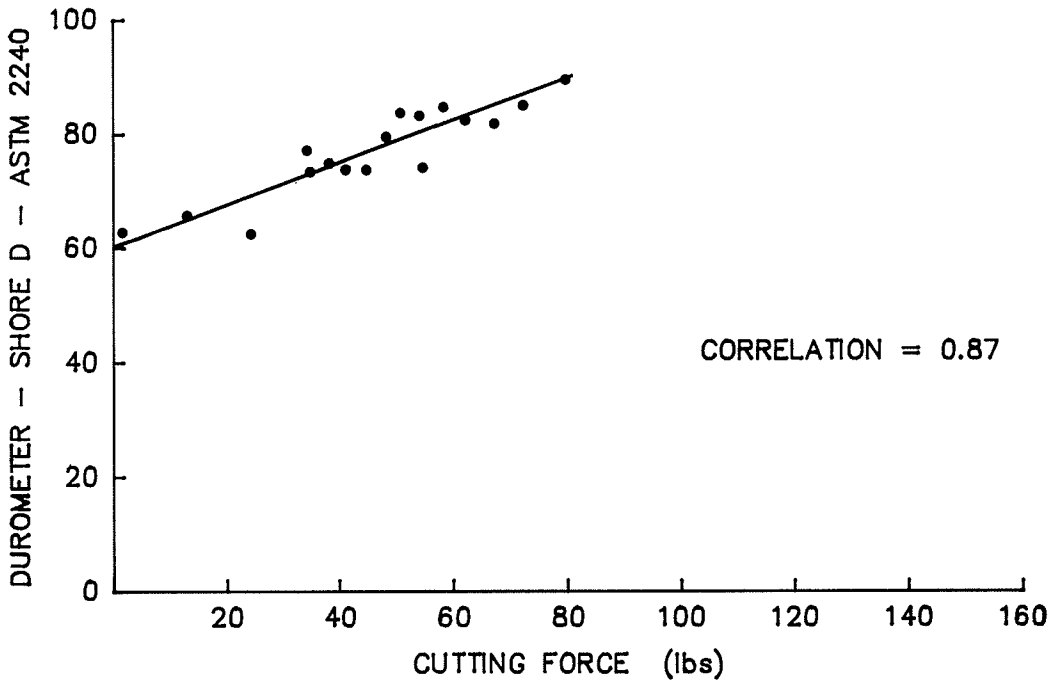
Figure 5.7 Durometer D versus cutting force.
