At Sea Test 2 Deployment Cruise Cruise 475 On Board R/V *Oceanus* September 22 – 26, 2011 Woods Hole – Woods Hole, MA

Technical Report

WHOI Technical Report 2012-03
CGSN Document 3207-00031
Coastal and Global Scale Nodes
Ocean Observatories Initiative
Woods Hole Oceanographic Institution
Woods Hole, Massachusetts 02543

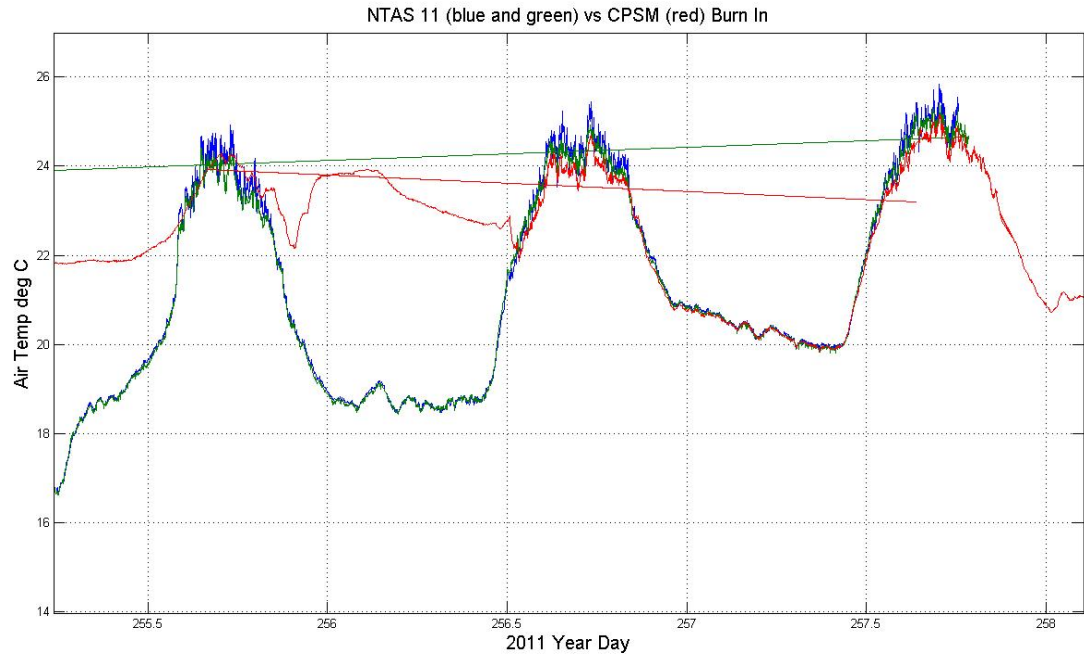
Figure 8: Plot of air temperature from 3 adjacent systems, Logger L03 = Blue and Logger L06=Green installed on the NTAS-11 Buoy burning in on the test pad. The CPSM Logger (OOIL-001 = Red) was installed near the NTAS=11 Buoy on day 256. Note the good correlation of air temperature data on day 256-257. Prior to day 256 the CPSM buoy logged temperatures in the highbay.

After the modules were mounted on the buoy tower, the buoy was moved outside where it was placed adjacent to the UOP buoy scheduled for the NTAS11 deployment. The NTAS11 buoy also had a similar ASIMET system which was burning in on the pad and served as a good comparison for the CPSM sensors. Data from the NTAS 11 buoys (L-03/L-06) and the AST2 surface buoy (OOIL-001), are shown on the following plots. All three systems were plotted together and compared for performance. The results can be seen in the following plots (Figures 8-18.) Note that the CPSM buoy was moved outside

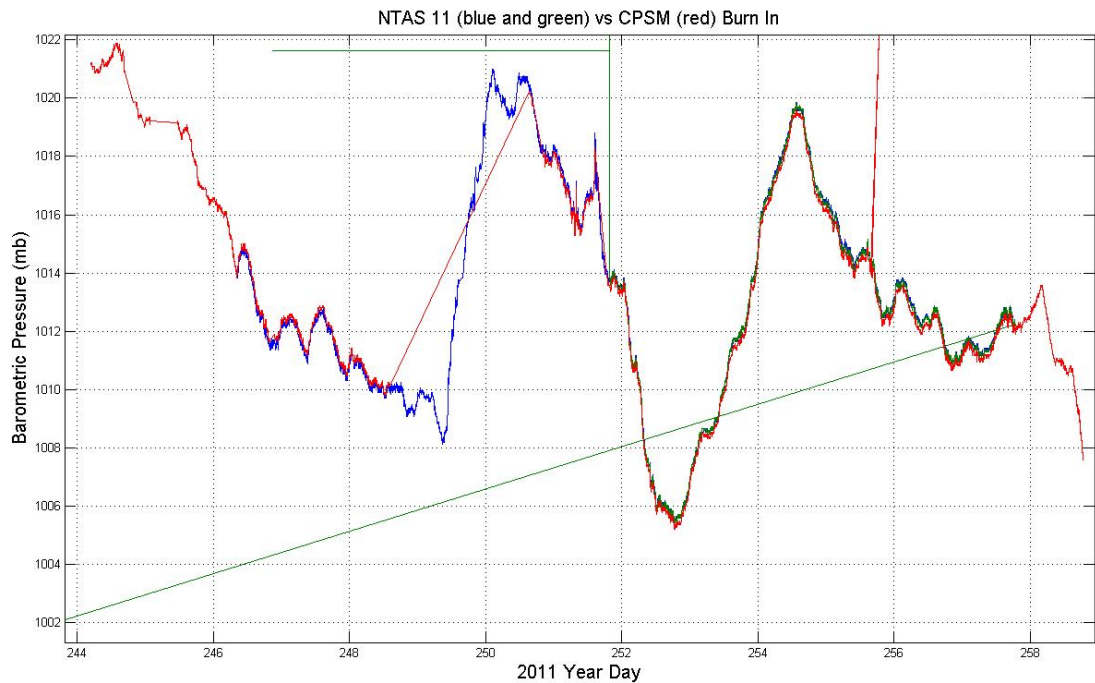
Figure 9: Plots of Barometric pressure from three adjacent systems. NTAS-11 buoy with Loggers L03 = Blue and L06= Green compared to OOIL01-001 installed on the CPSM buoy. Note the good correlation of pressure data day 246-257, 2011.

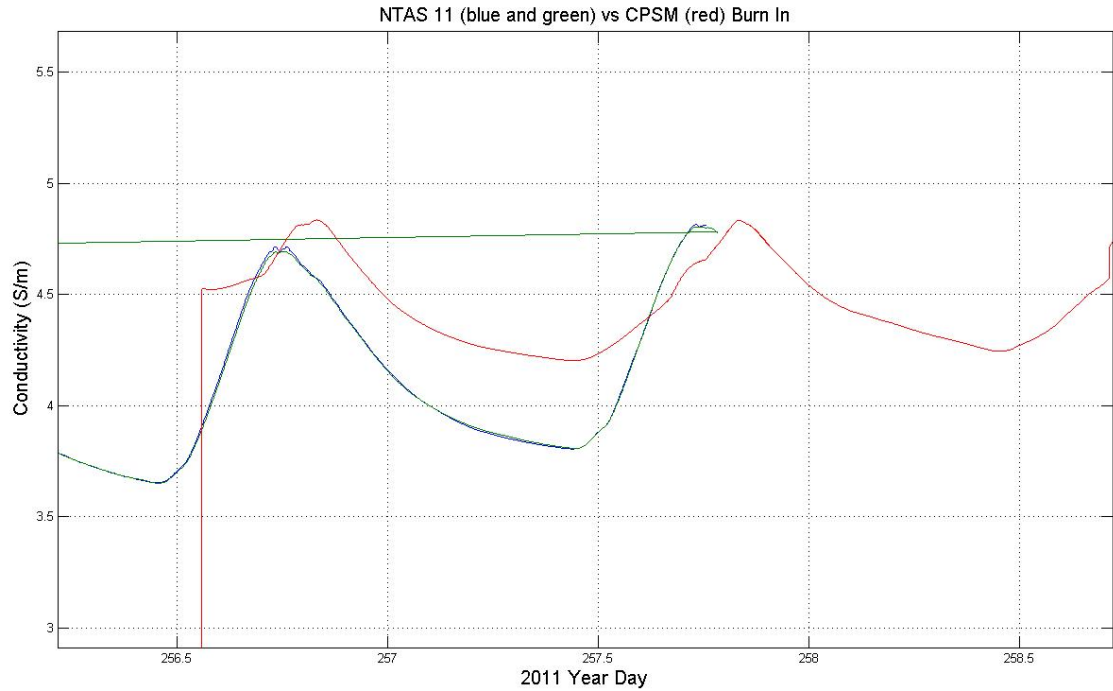
Figure 10: Plots of Conductivity from the two systems mounted on the NTAS-11 buoy (Blue and Green) and the CT sensor mounted on the CPSM buoy. The CPSM CT sensor was located in a separate test bucket and correlation is not expected.

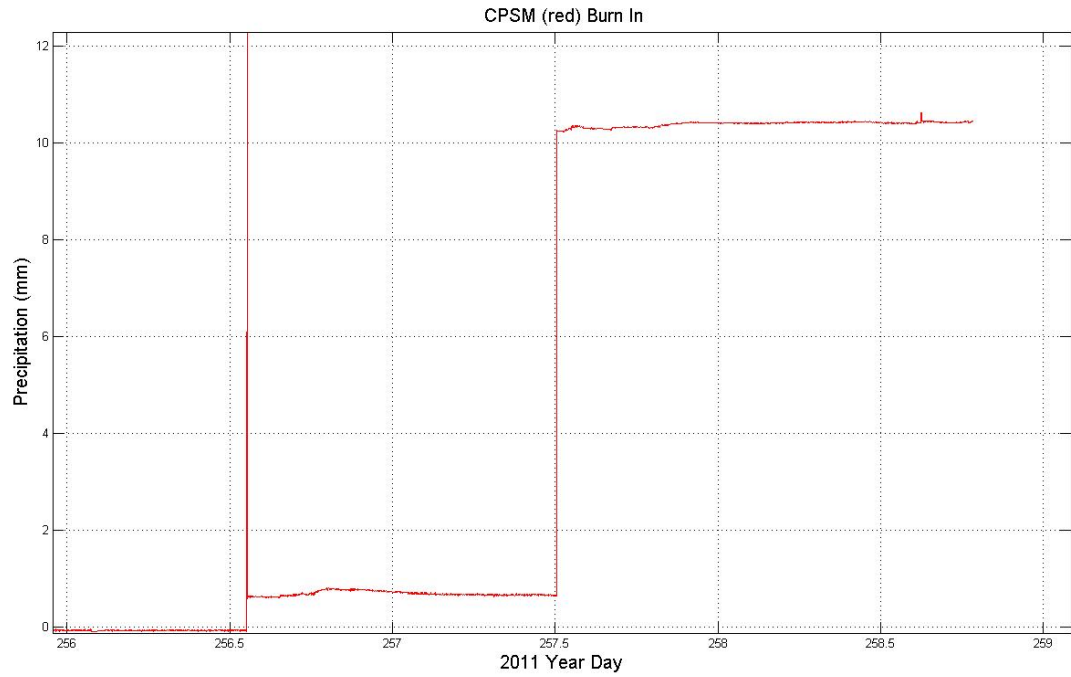
Figure 12: Precipitation data plot from the CPSM buoy.

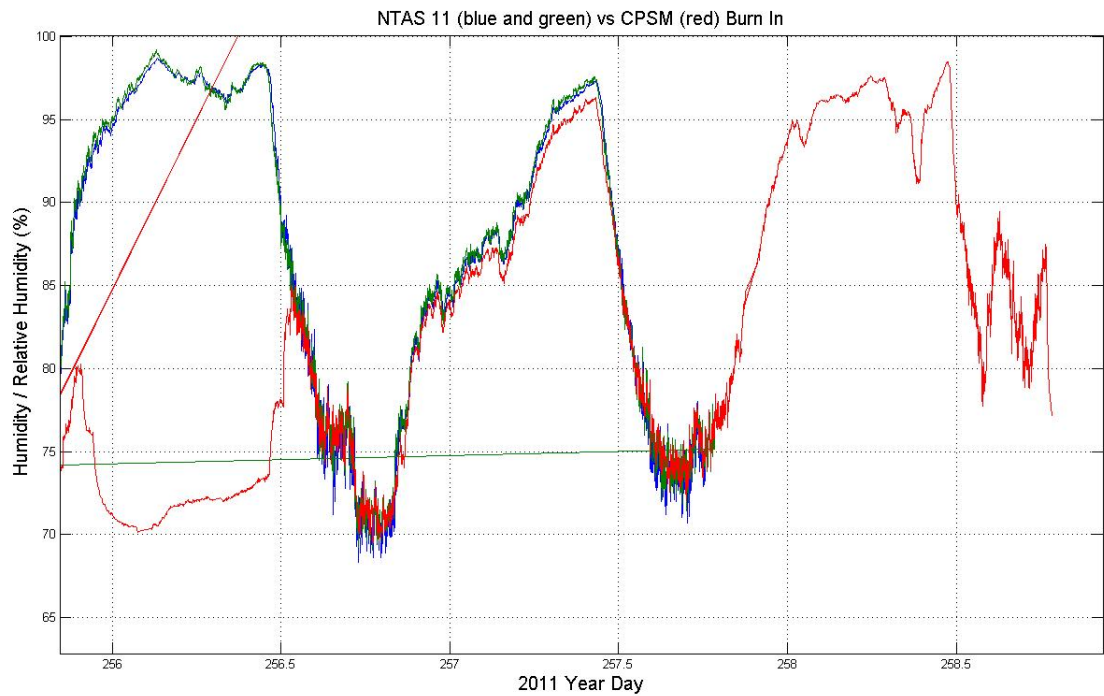
Figure 13: Plots of Humidity and Relative Humidity from the NTAS-11 Buoy (Blue and Green) compared to the CPSM buoy Red. On day 256 systems were co-located and show good data correlation.

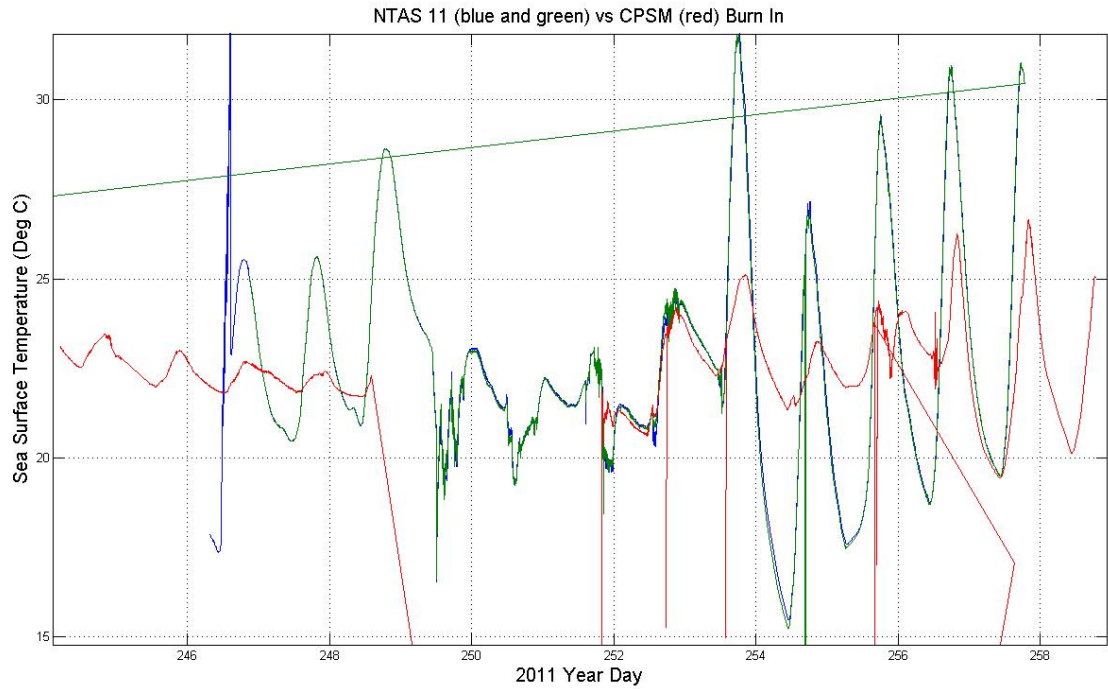
Figure 14: Sea Surface Temperature Data from SeaBird microcats (SBE-37). Note instrumnets were not in the same bucket and therefore correlation is not expected.

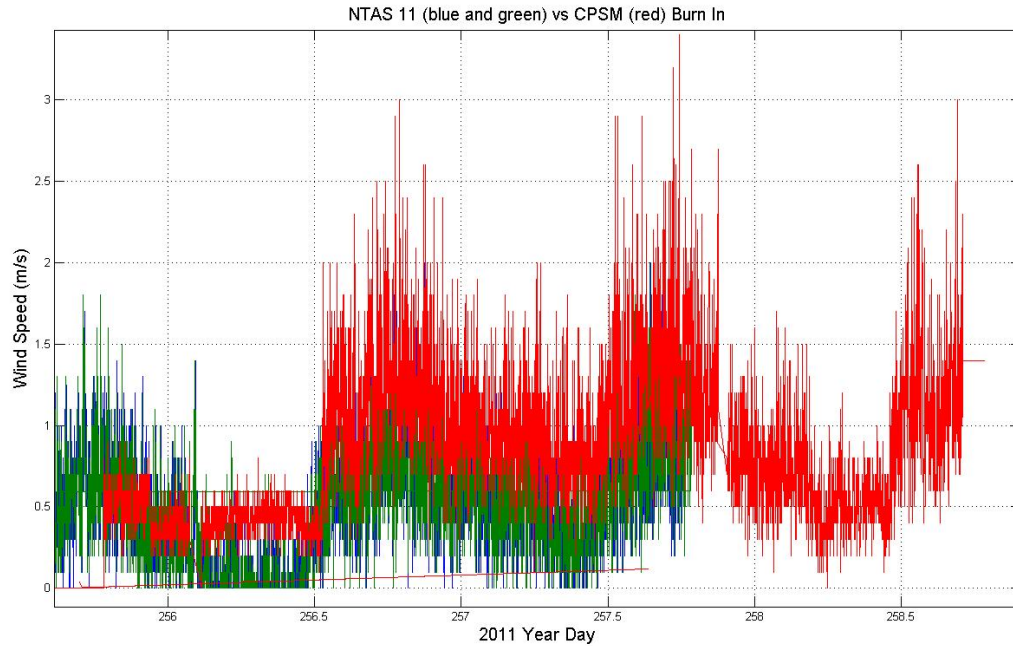
Figure 18: Wind speed from the NTAS-11 systems (Blue and Green) compared to the CPSM sensor (Red). The CPSM buoy was moved from the Clark South Highbay on day 256 to the test pad where the system installed on the NTAS-11 buoy was burning in.

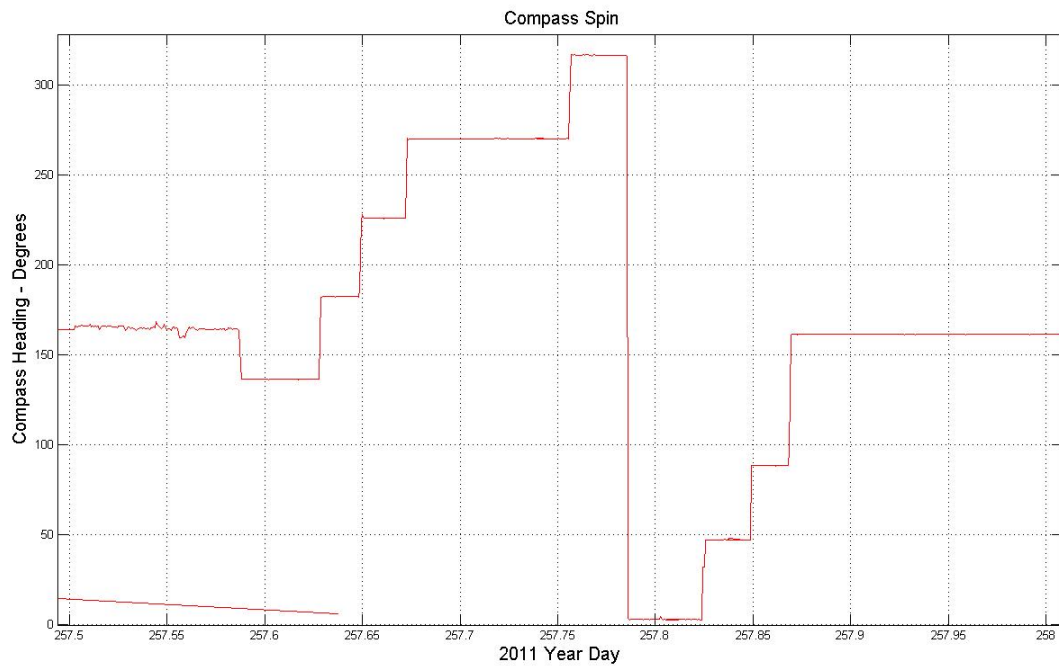
Figure 19: Plot of compass headings during the buoy spin test. Buoy was rotated in 45 degree steps for a complete rotation. Each heading was maintained for a minimum of 15 minutes.

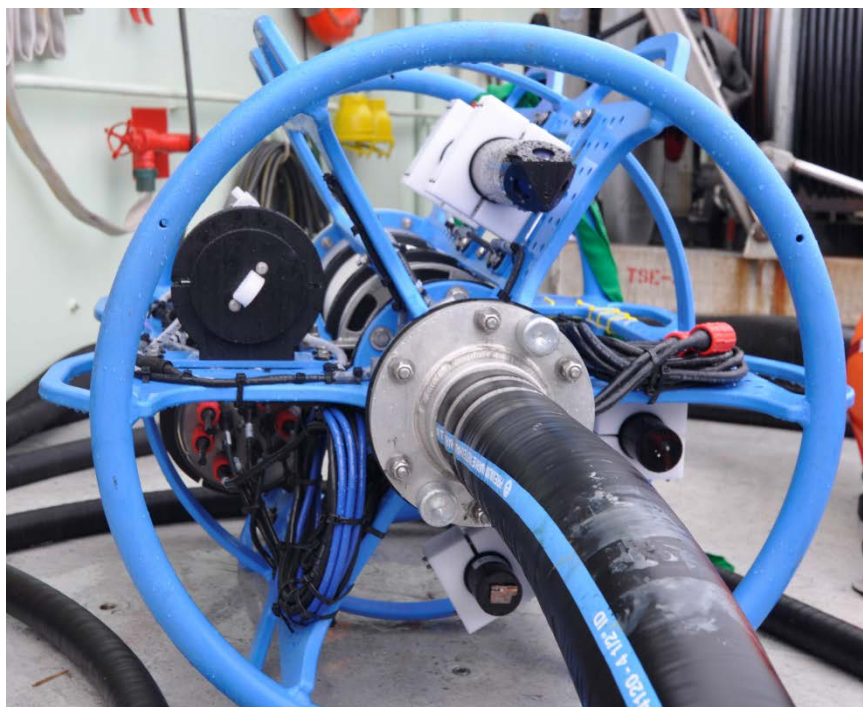
Figure 20: End view of the NSIF loaded on *R/V Oceanus*. EM Chain is mechanically electrically connected to the Surface Buoy. Instruments mounted in the frame include: Nortek Point Velocity (twelve o'clock), Fluorometers (three and six o'clock), and CTD (ten o'clock.)

The NSIF resides at the bottom of the EM chain (see figure 72 mooring diagram). For the AST2 experiment this is approximately 7 meters below the surface. The frame is a cylindrical aluminum frame with a six spoke pattern for mounting a variety of instruments (figure 20.) For the AST2 deployment the frame held four sensors and a high pressure DCL enclosure (figure 21.) The table below lists the sensors.

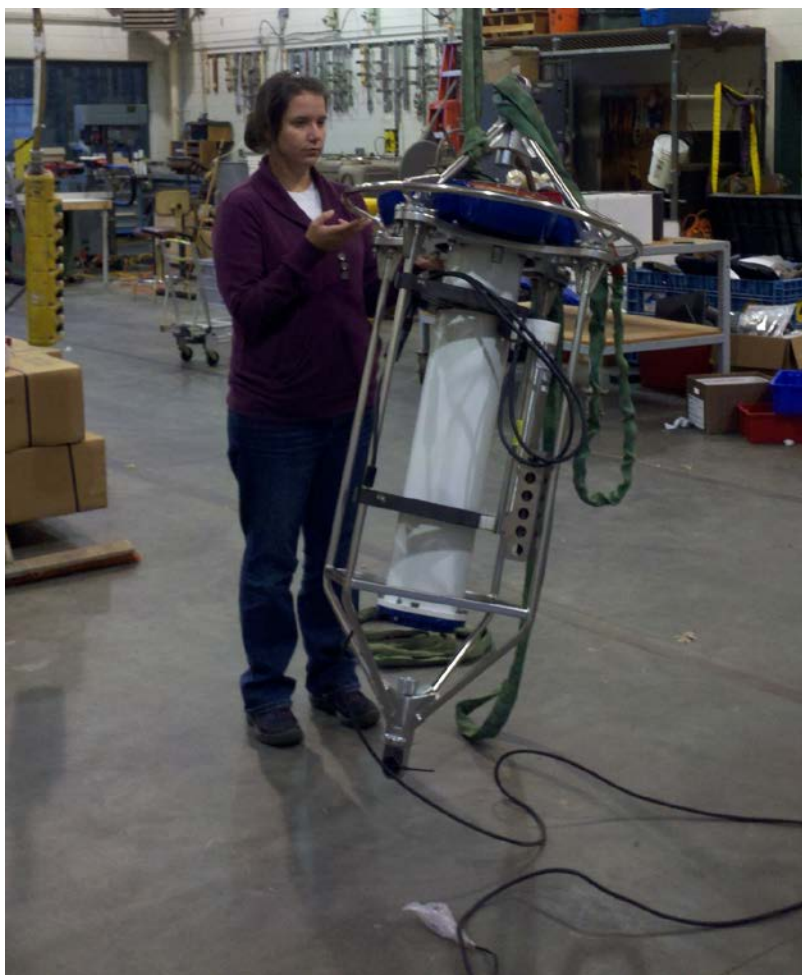
Figure 22: Engineer Kathleen McMonagle spins the ADCP frame during a compass calibration.

The 75 KHz Long Ranger was configured as an upward looking ADCP. The setup file was created using the deployment planning software that comes with the instrument. The ADCP will collect a profile of velocities that includes the surface. Bin sizes and spacing, as well as sampling intervals, were selected by OOI project scientist Dr. Al Plueddemann (Appendix 7.) A compass calibration was performed on the ADCP with the SBE37-IM and ADCP mounted into the frame.

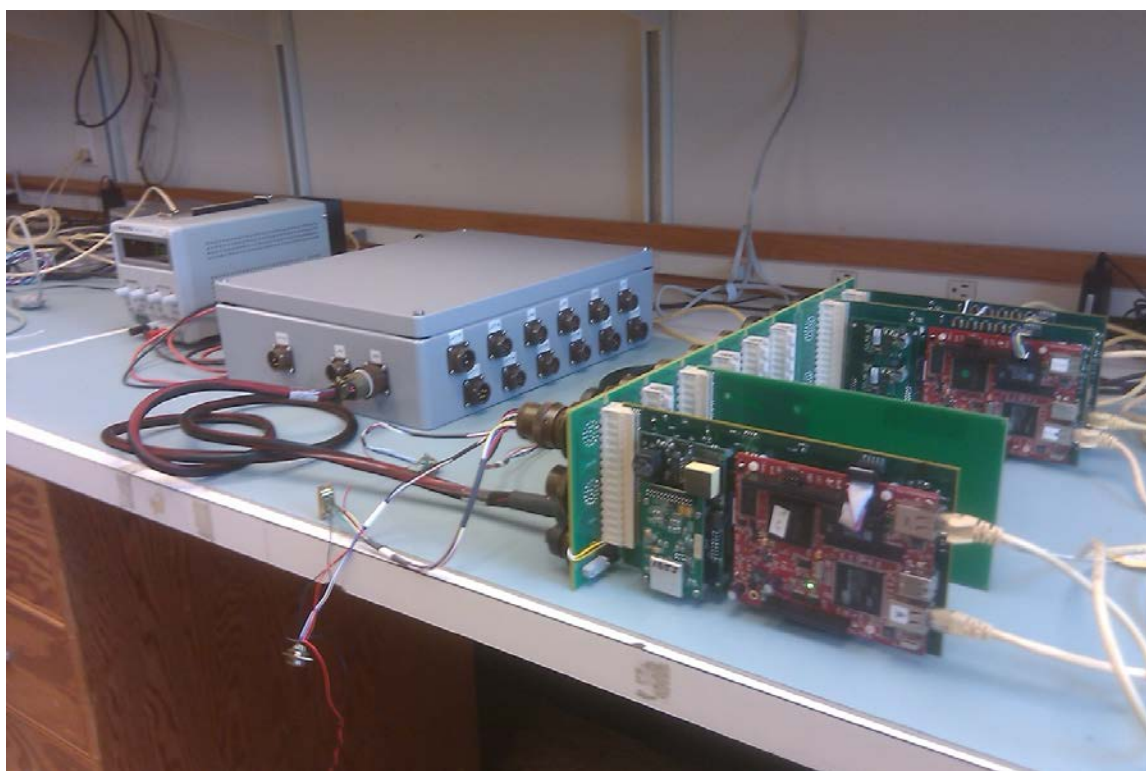
Figure 32: PlatCon-PSC I V and T

Prior to full sub-system integration, the PlatCon was interfaced to a PSC development board and a bench power supply. A bench power supply was connected to the PSC as a substitute for the battery connection. The PlatCon-PSC cable built for the CPSM was connected to the PSC and left unconnected at the PlatCon. The PlatCon-PSC cable had been previously tested for proper connectivity. The PSC was powered and the open end of the cable was tested for proper voltage levels and passed. The PSC was powered down. The PlatCon-PSC connection was made, the PSC was powered up, which in turn powered up the PlatCon. An initial problem was discovered; the PlatCon was holding the PSC in reset. The PSC reset line from the PlatCon was inverted from the required logic. A quick re-program of the control firmware to invert control polarity fixed this. After a restart, normal operation was established. The PSC delivered power and status messages to the PlatCon, and the capability for the PlatCon to override the PSC settings was confirmed. The PSC and PlatCon were left connected for the duration of integration to allow for as much burn-in time as possible.

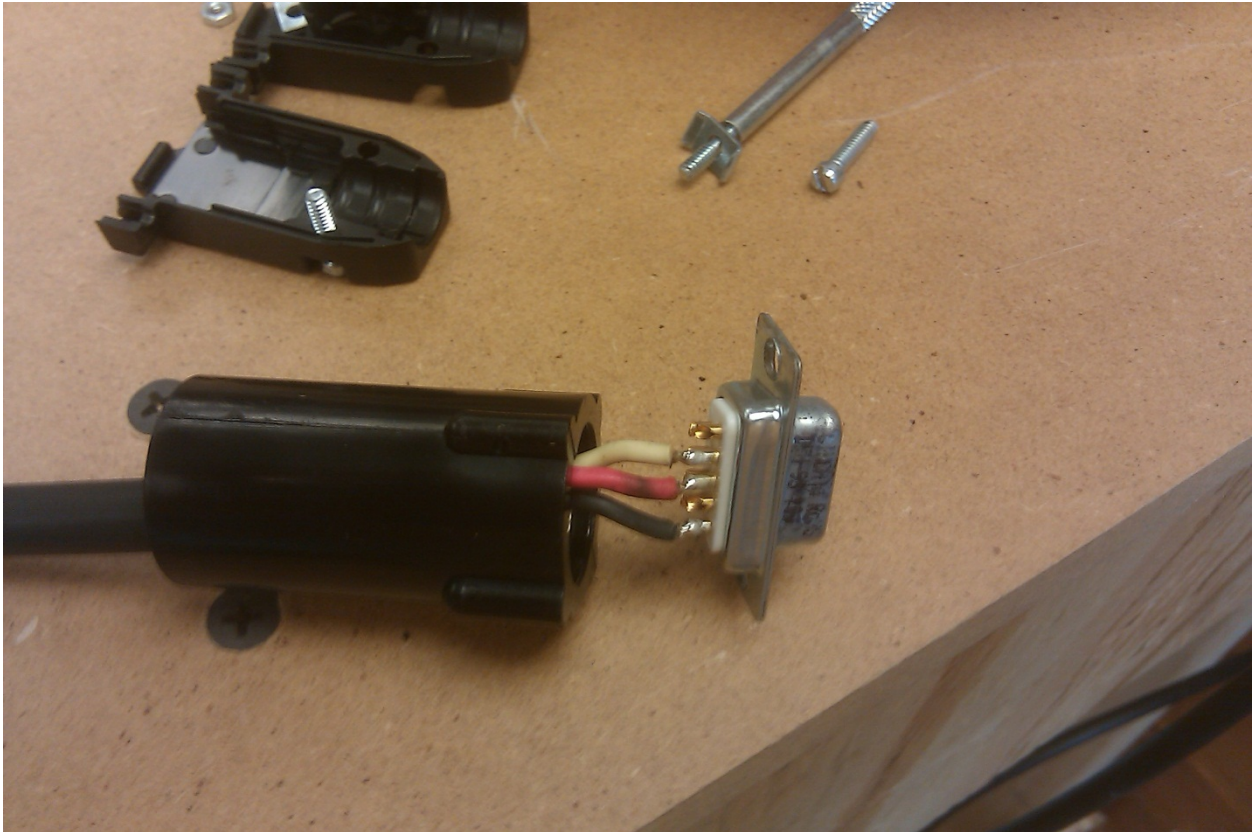
Figure 33: pCO2 DB-9 serial connector disassembled to confirm serial wiring.

Note: did confirm that there are no extraneous wires (such as a ground connection) in the pCO₂ serial connector:

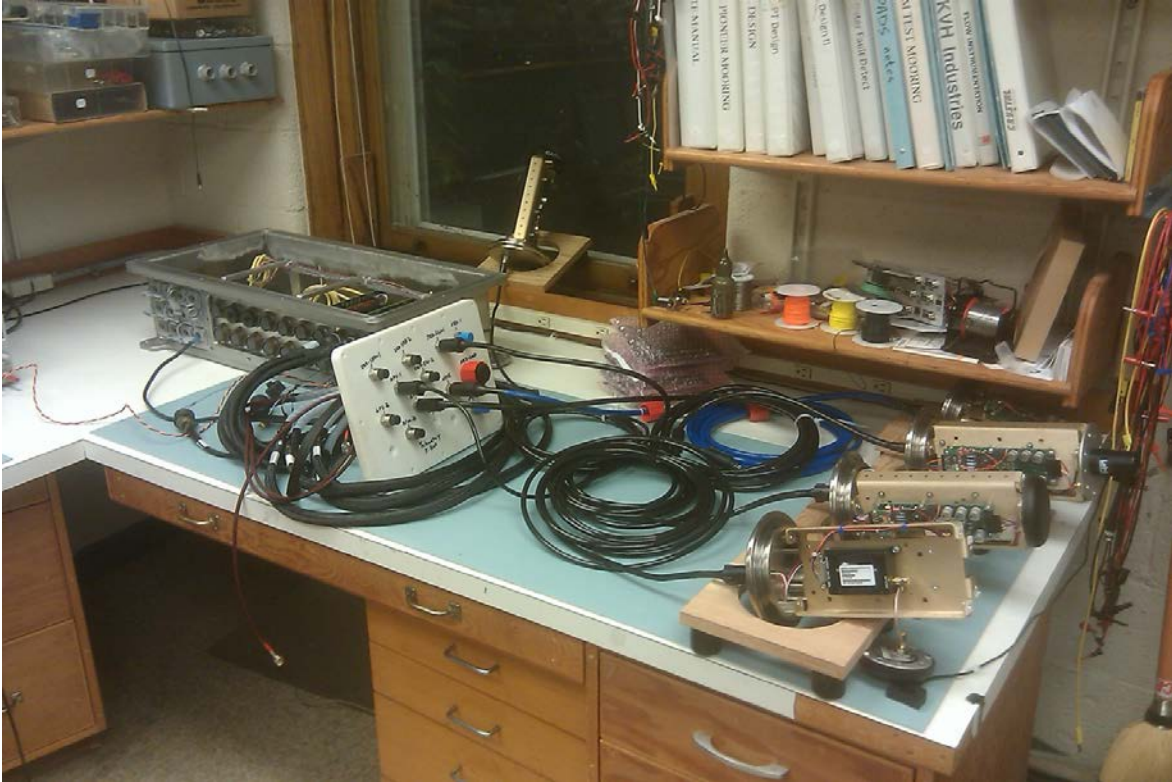
Figure 412: PlatCon, wiring and Telemetry Verification and Test. Platcon (left), buoy junction panel (white), and telemetry modules (right) with covers removed.

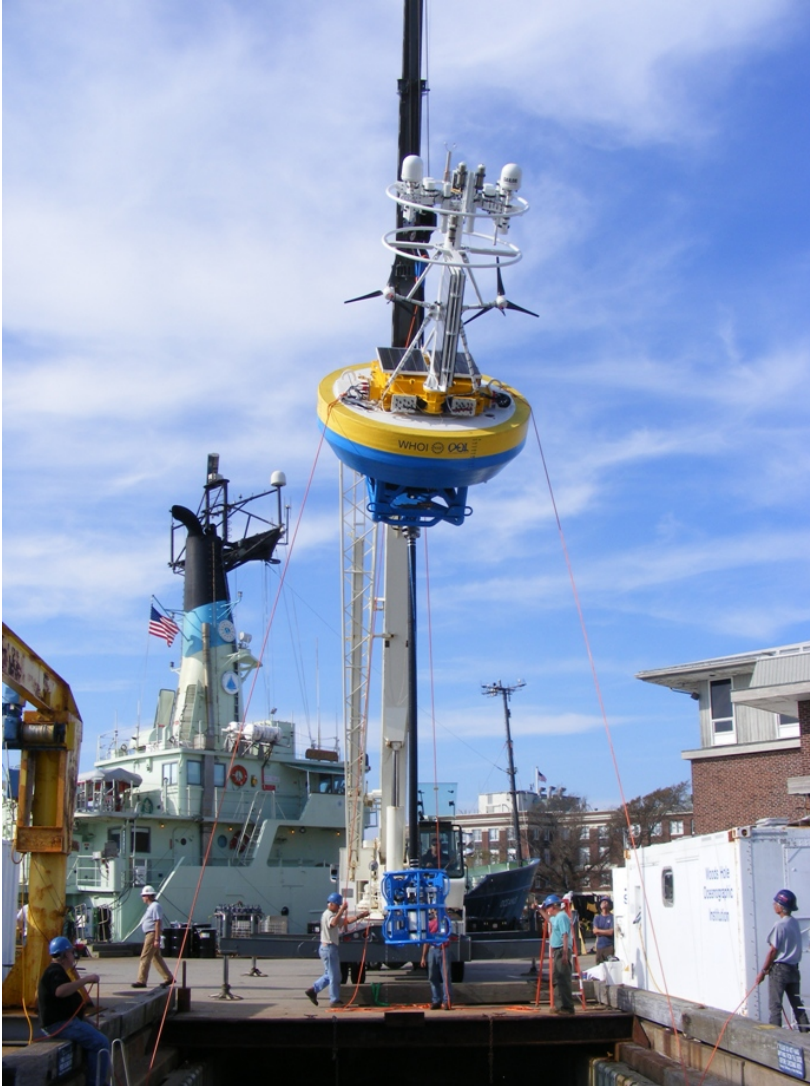
Figure 43: The surface mooring, em-chain, and NSIF are lowered into the well for testing.

CPSM assembled down to the Near Surface Instrument Frame (NSIF). The wiring was completed as per drawing number 3718-00065 (note: extension in drawing number 3718-00086-00001 was not needed and not used.) The mooring was lifted by crane and was in the well from 18:00 to 21:00 (UTC) (figure 43.)

The em-chain and NSIF were attached to the buoy. The crane lifted the assembly and put it into the large well in the WHOI dock (Figure 43 above). An inclinometer mounted to the tower oscillated between 0 and 3 degrees of tilt (bow up) when the buoy, em-chain, and NSIF were in the water. It should be noted that the PCO2 sensor was not installed in the outer edge of the floatation at the bow of the buoy. The large mass of the instrument would have provided the necessary moment arm to restore the buoy to the proper trim.

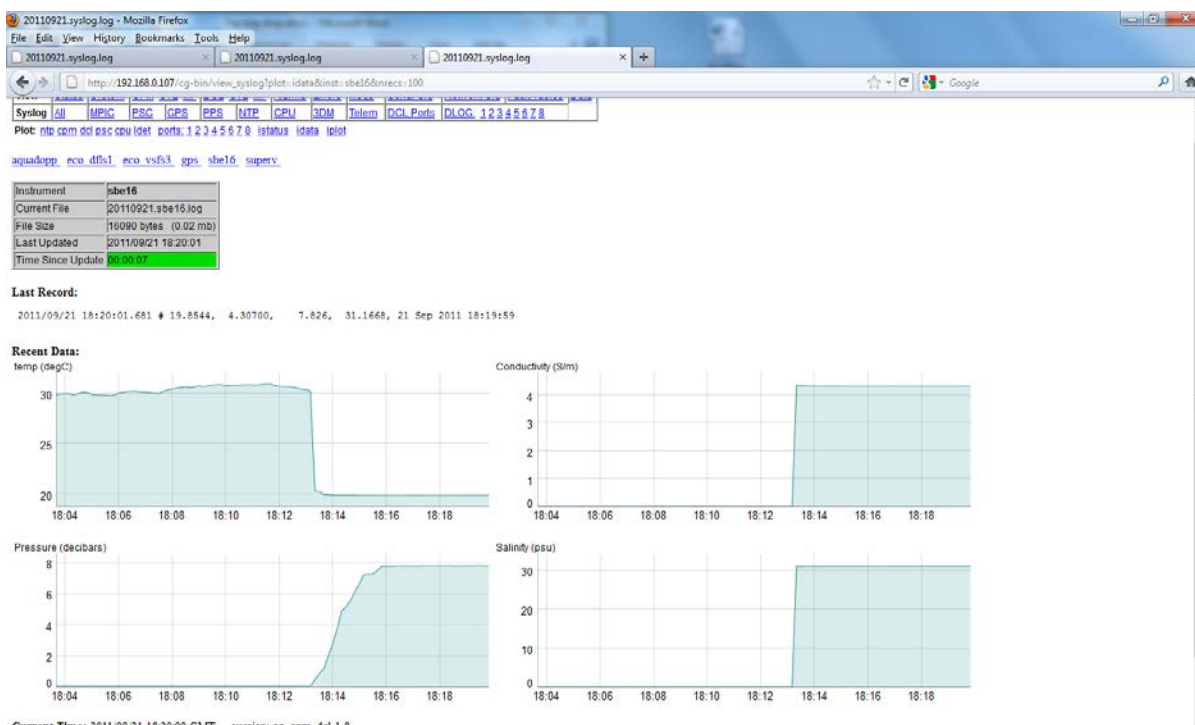
Figure 44: Near Surface Instrument Frame CTD Data

The Platform Controller was powered and operating normally during the lift, while in the well and was left on continuously since. Figures 44-46 show plots of the buoy immersed in the well.

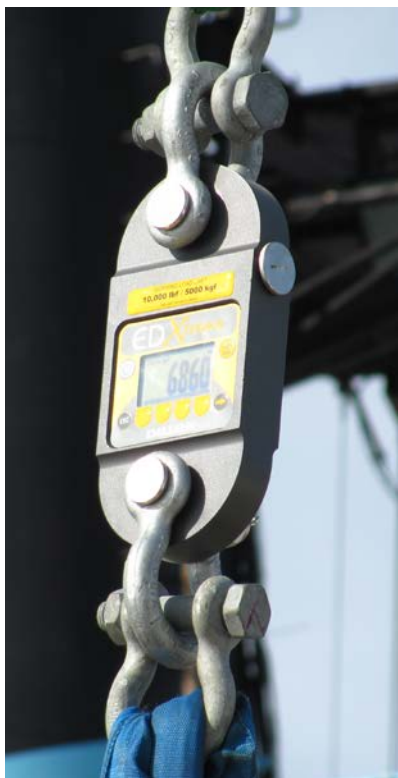
Figure 427: Surface mooring load cell measuring dry weight (6860 lbs.) prior to loading on the *R/V Oceanus*.

Prior to loading the buoys on the ship dry weights were measured using a load cell in-line with the lifting straps and the crane hook. The surface buoy dry weight was 6860 lbs. (Figure 47.) The profiler mooring dry weight was 1280 lbs.

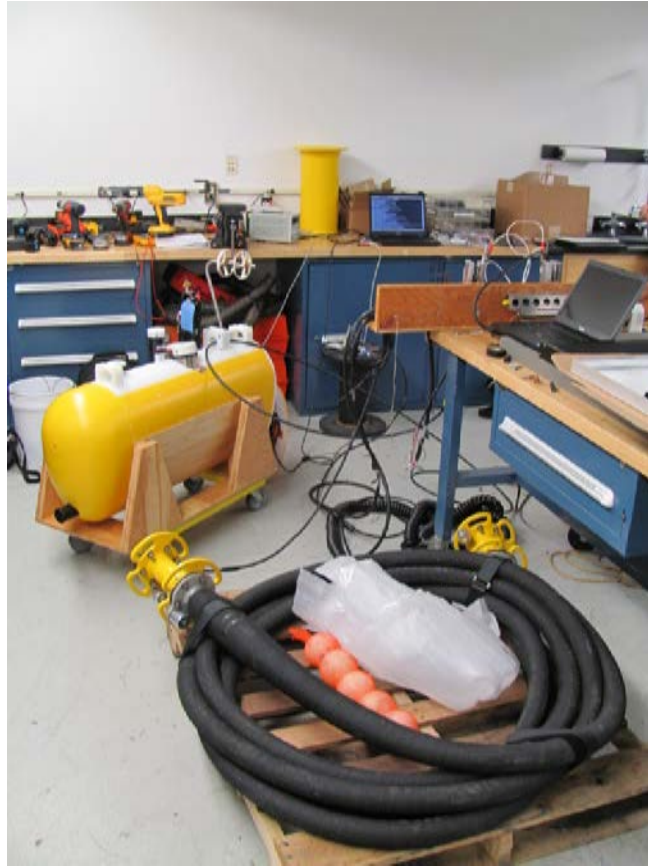
Figure 50: Photo showing the initial integration test at CRL with the components of the Profiler Mooring laid out on the floor including the 50 ft whale stretch hose, 451m inductive cable with special inductive terminations, jumpers, and custom loop

The McLane Moored Profiler (MMP), Seabird SBE37-IM CTD, and 451m EM cable and special inductive terminations were interconnected in the Coastal Research Laboratory (CRL) and connected via inductive modem to Jeff O'Brien's laptop. O'Brien ran his software on the laptop and retrieved both the profile data stored in the MMP and data stored in the CTD.

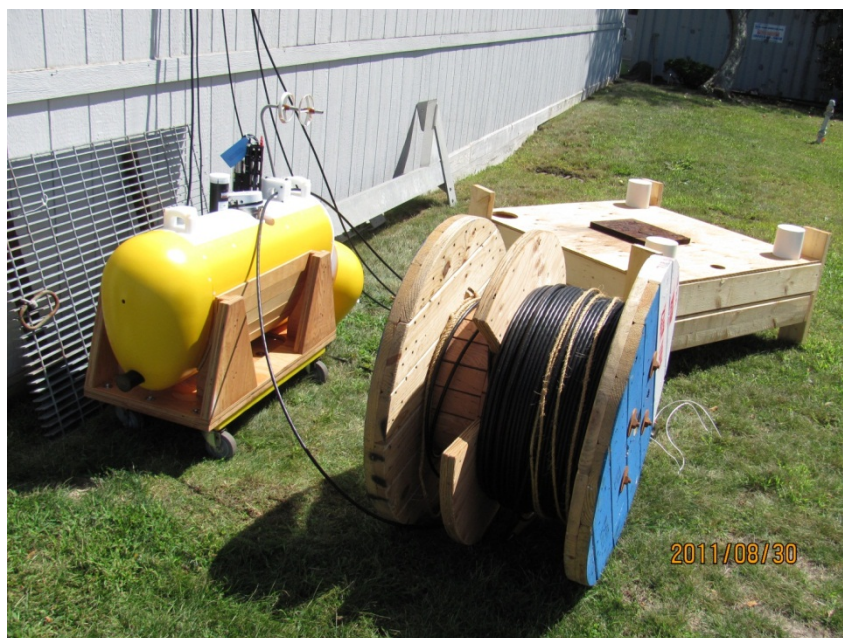
Figure 51: Photo showing profiler inductive cable on the wooden reel, the telemetry test stand in the background and the MMP in its special handling cart. Testing outside Jeff O'Brein's office included testing the platform controller (STC) with the instruments.

The second phase of integration testing included a test of the platform controller (STC) with the telemetry devices. The STC circuit card assembly was assembled onto the submersible buoy well end cap with the inductive modem and SubConn bulkhead cables. The end cap was then connected to the telemetry devices, EM chain, whale stretch hose, 451m cable with special inductive terminations and custom loop cable. The McLane Moored Profiler (MMP) and Seabird SBE37-IM CTD were assembled on the inductive riser near the dock outside Jeff O'Brien's lab (figure 51).

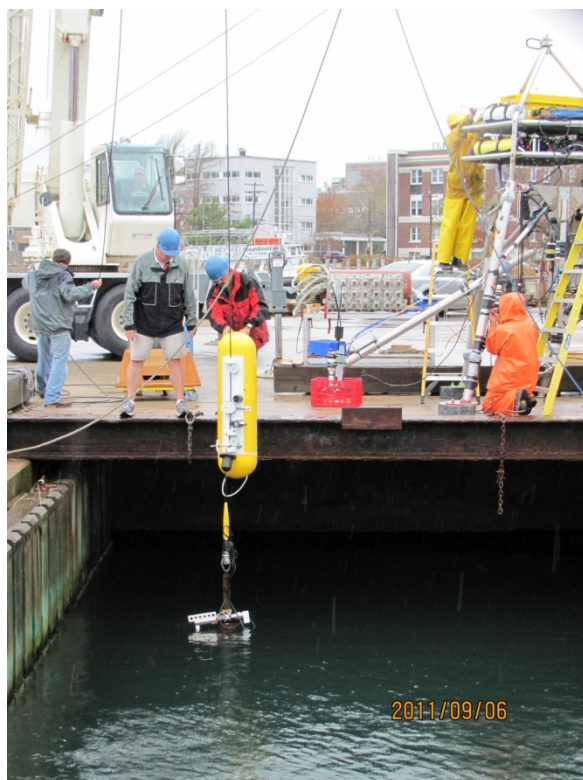
Figure 52: Photo showing the anchor, SBE37-IM (mounted on the anchor frame) and MMP being 'deployed' lowered by the crane into the WHOI well.

The final integration test 'deployed' the components of the CPPM in the WHOI well to simulate a full field deployment and verify that all the components were functioning. The STC end cap assembly, riser components, MMP profiler, and CTD were brought to the large well at the WHOI dock. The end section of the inductive cable was attached to a 300 lb. anchor. The SBE37-IM was attached to the anchor and connected into the inductive cable using the custom loop back cable. The profiler was attached to the cable and scheduled to execute a single 10m profile every 30 minutes. Once all components were attached the crane lifted them into the well (figure 52) and they were secured to the I-beam. O'Brien again ran the software and monitored performance between September 6th and 12th. The MMP was visually observed traversing the wire. Data from the MMP and CTD was collected and transmitted via satellite telemetry to the temporary server.

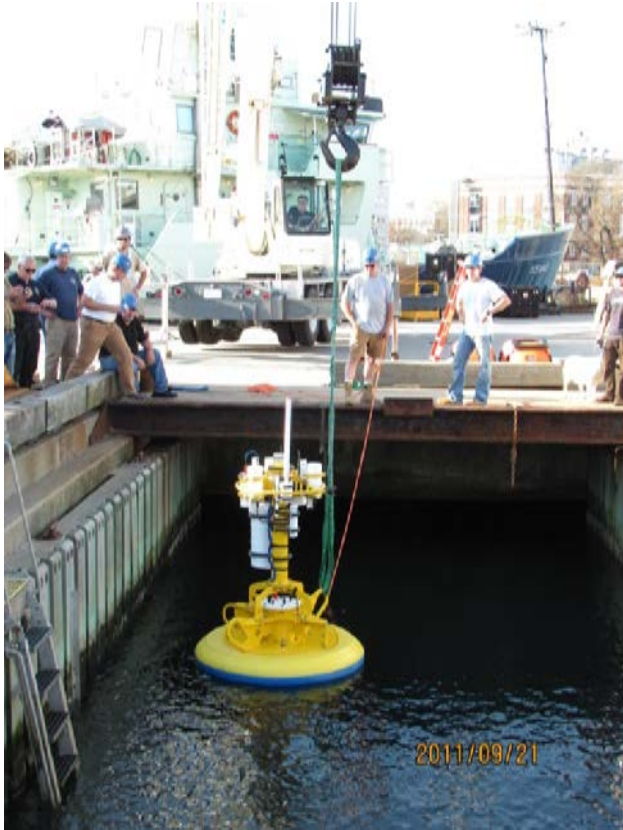
Figure 60: Photo showing the float test Profiler Mooring in the WHOI well. This test established that the weight and balance of the buoy was correct according to the design.

Similarly the profiler buoy was floated in the well. The float characteristics and waterline location of the buoy were as expected (Figure 60.)

Prior to loading the ship the complete CPPM buoy was weighed in air and floated in the well to establish check the waterline. The Buoy weighed 1280 lbs. in air and floated at the expected level (figure 60.)

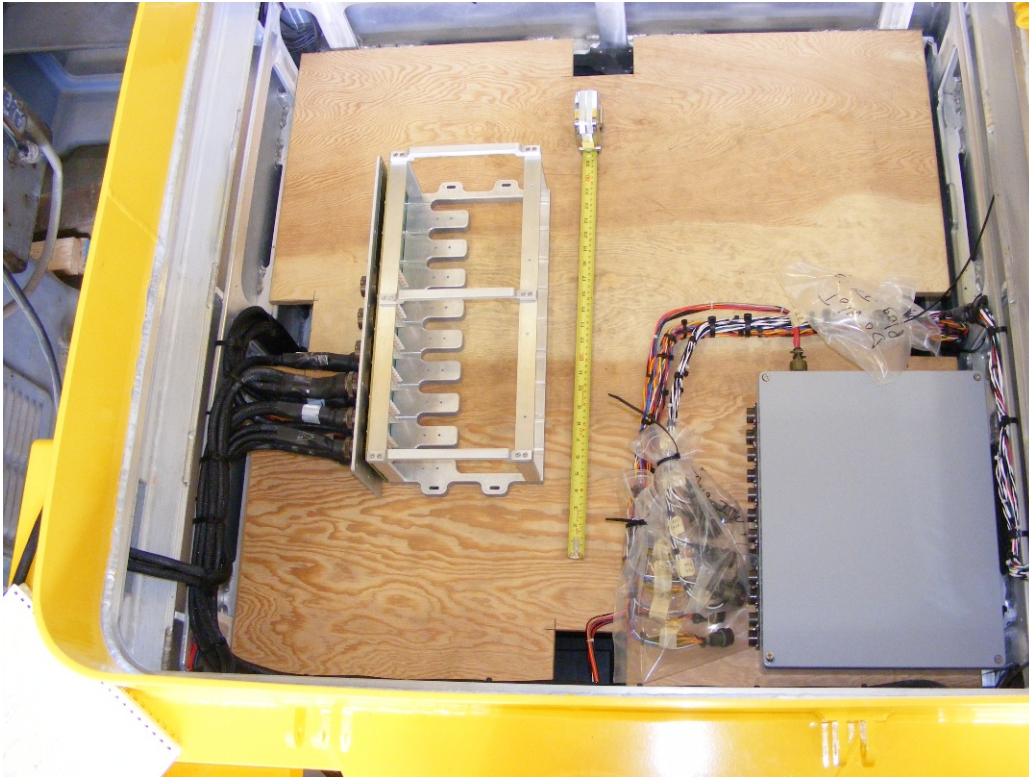
Figure 62: Photo showing the temporary plywood shelf that was used to establish the locations of the platcon and PSC to determine wire harness lengths.

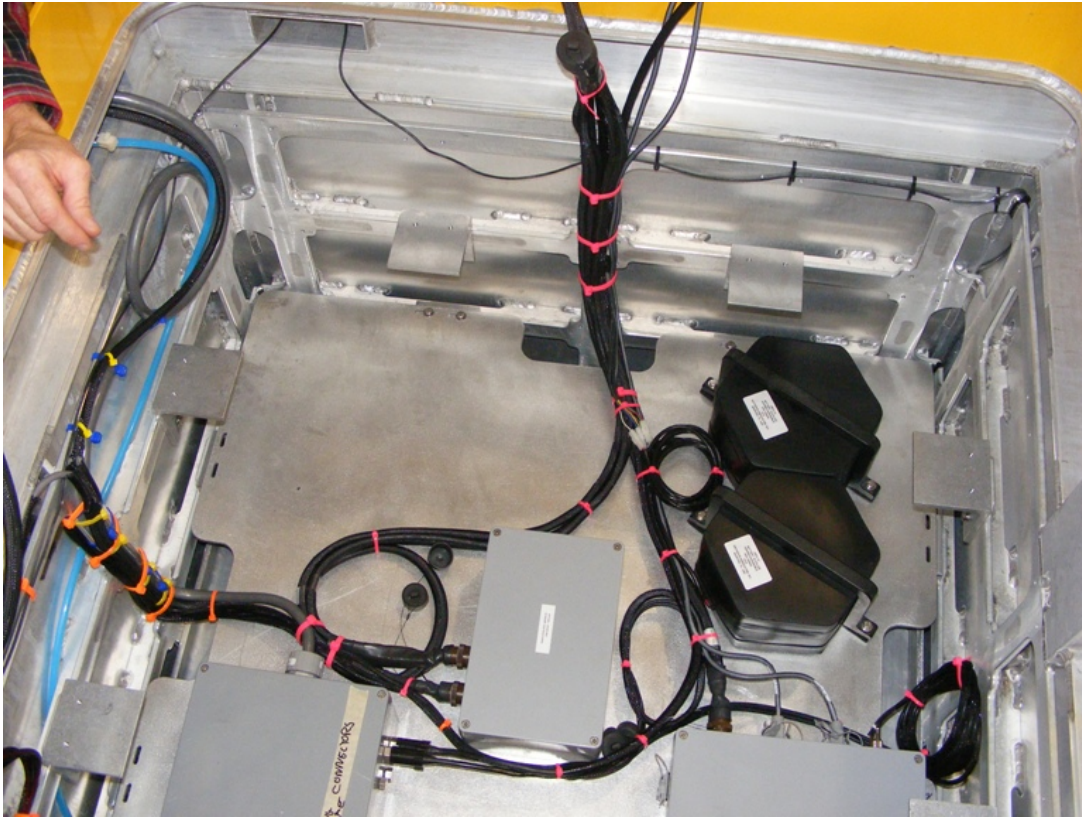
Figure 63: Middle layer holding the bulk met data logger back up batteries and engineering sensor box.

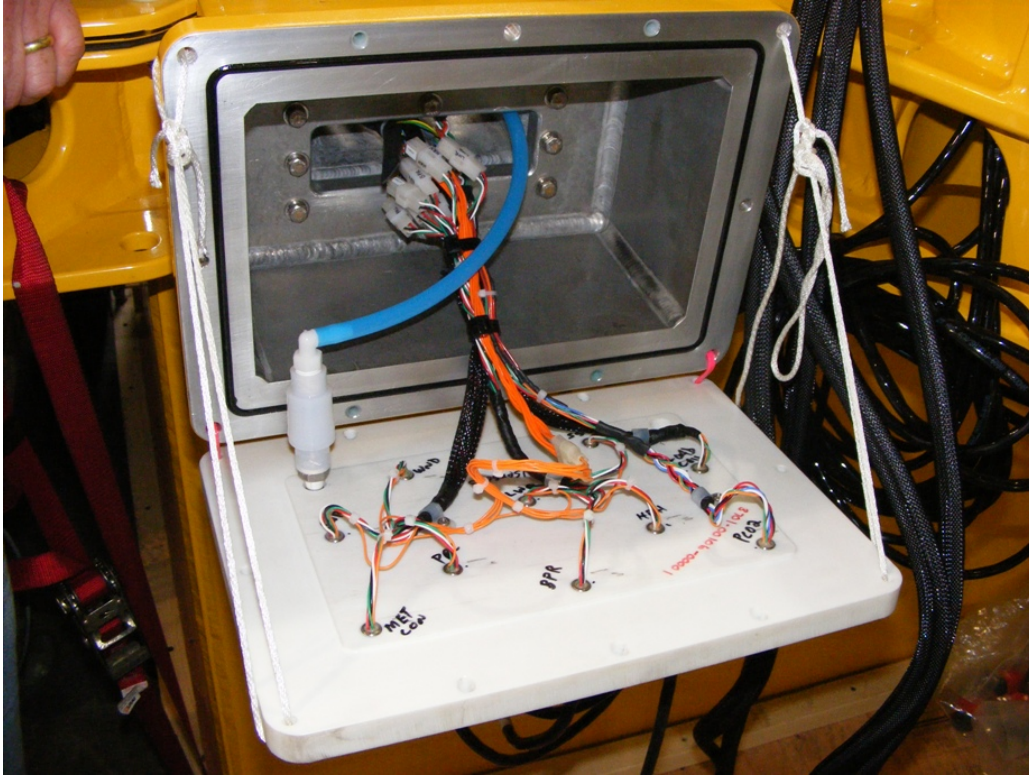
Figure 65: Bulk met junction panel being wired.

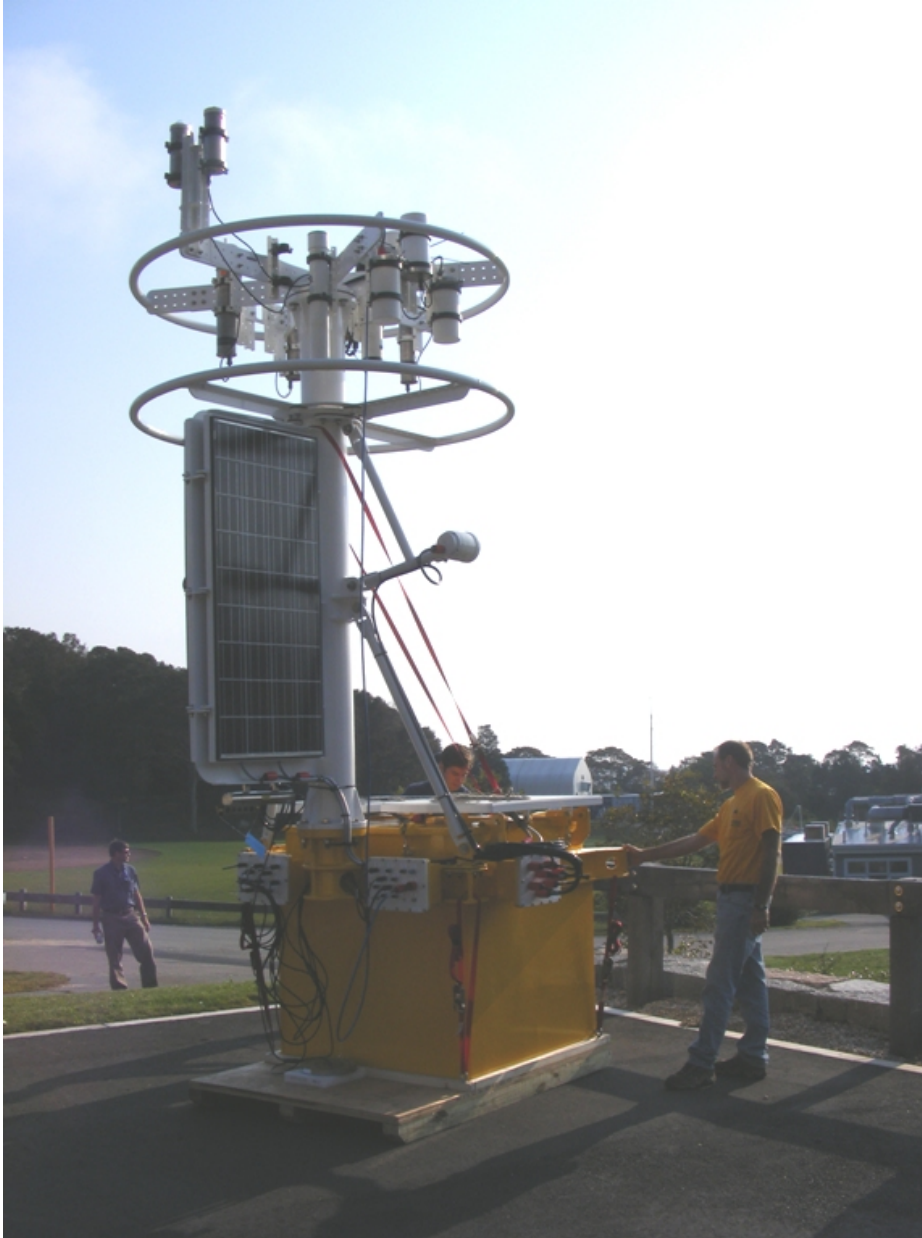
Figure 66: Completed surface mooring well on the burn in pad prior to the compass spin test.

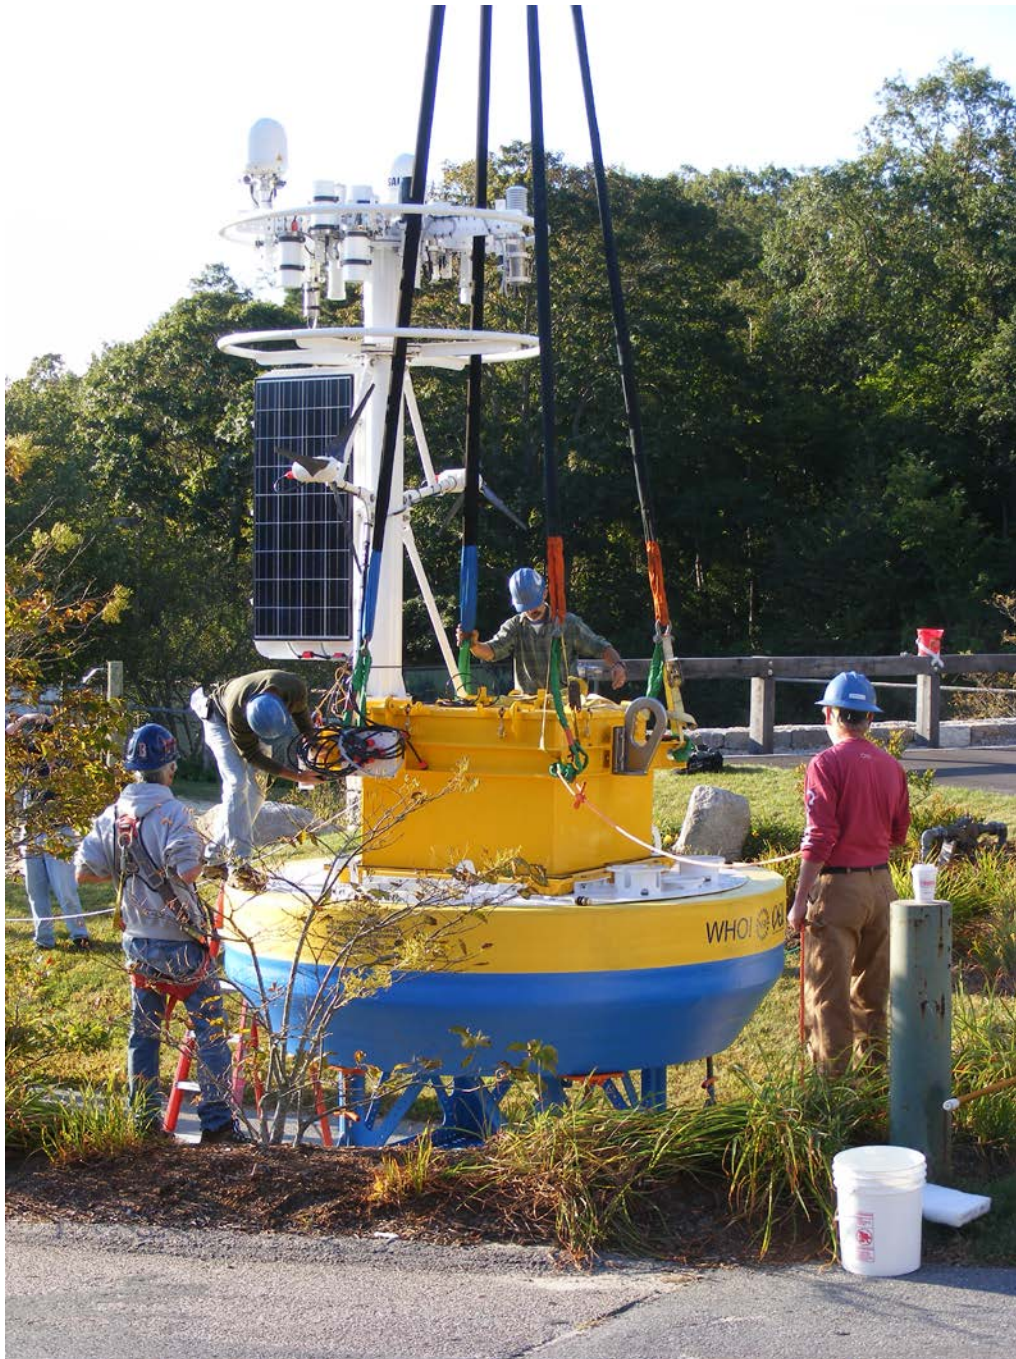
Figure 67: Buoy well being inserted into the foam buoy.
