At Sea Test 2 Deployment Cruise Cruise 475 On Board R/V *Oceanus* September 22 – 26, 2011 Woods Hole – Woods Hole, MA

Technical Report

WHOI Technical Report 2012-03
CGSN Document 3207-00031
Coastal and Global Scale Nodes
Ocean Observatories Initiative
Woods Hole Oceanographic Institution
Woods Hole, Massachusetts 02543

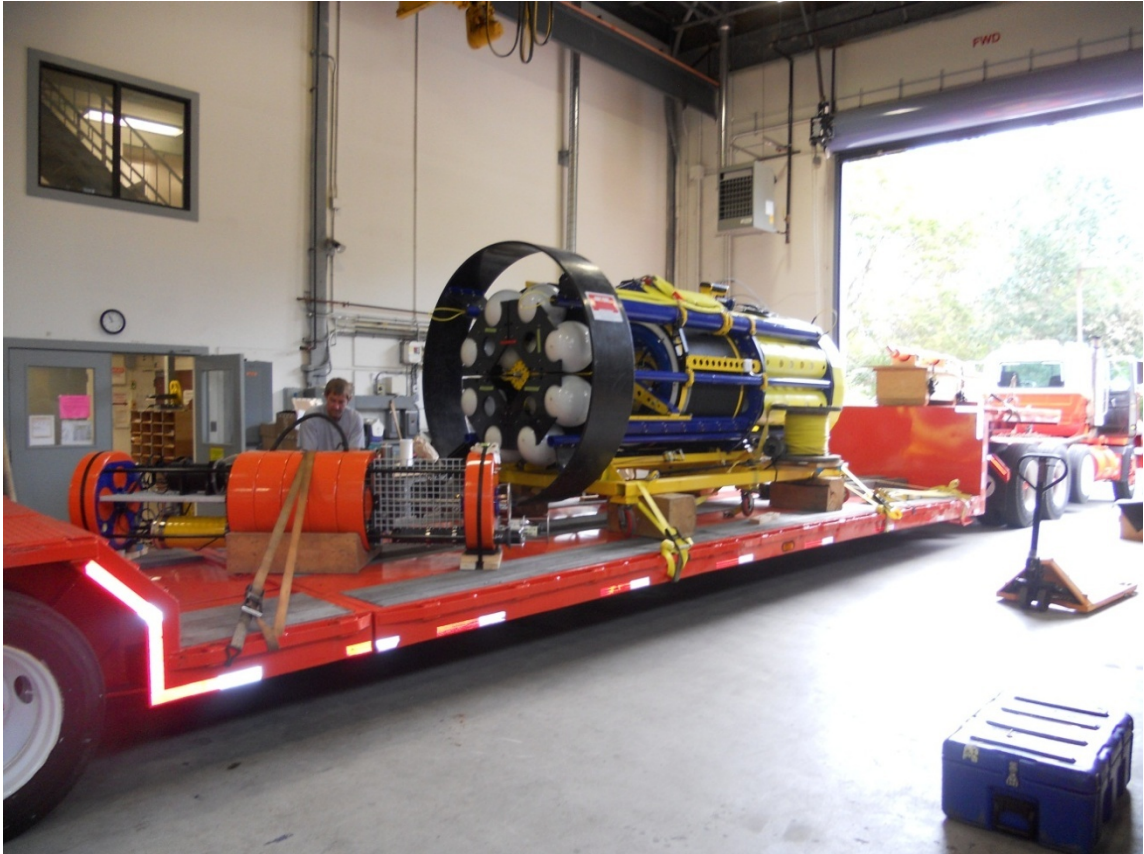
Figure 69: A flat bed trailer was required to move SeaCycler from CRL to the dock.

Loading took place on Sept. 20-23, 2011. The AST2 surface buoy, hybrid profiler winch assembly were transported from the Coastal Research Center via a double drop commercial trailer. This trailer style shown in Figure 69 was required, due to over road restriction of large size components.

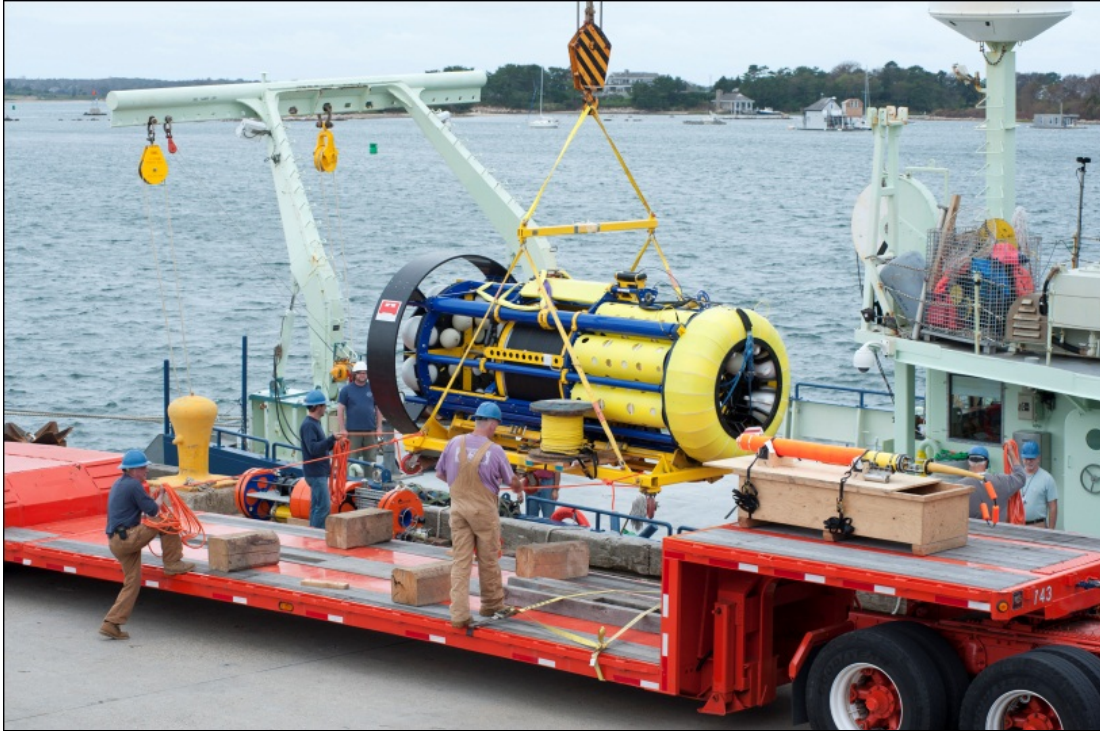
Figure 70: SeaCycler being lifted from trailer to load onto the deck of R/V Oceanus.

The hybrid profiler was transferred from the double drop trailer shown in Figure 70 to the ship directly from the trailer using the ship's crane.

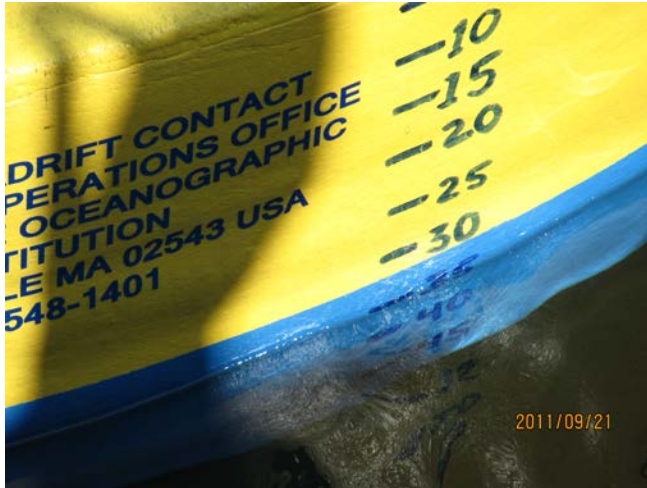
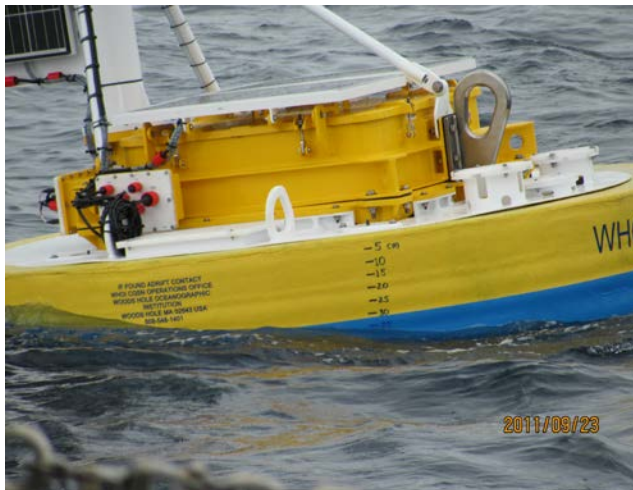
Figure 75: Photos showing the plimsoll on the buoy during the dock well test (left) and deployed (right). The deck height above the water line is 32cm and was used in the above equation to correct the height of the bulk met sensors above the surface.

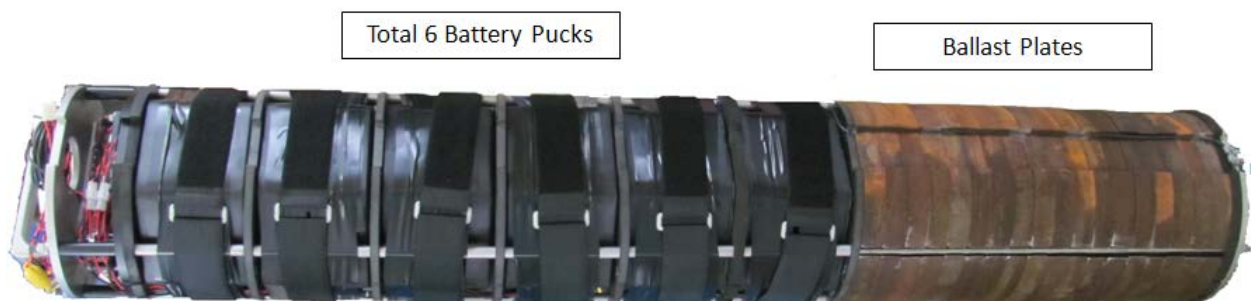
Figure 84: Alkaline Battery Pack used in Coastal Pioneer Profiler Mooring

The Alkaline Battery pucks were configured into two packs for use in the Coastal Pioneer Profiler Mooring. One consists of 4 pucks diode-isolated and wired in parallel for powering the Coastal Pioneer Profiler Mooring electronics and telemetry. The second one consists of 2 pucks diode-isolated wired in parallel to power the radar transponder. Each pack is fitted with a 5A fast blow fuse to protect the battery pack from accidental load short circuit.

Each battery pack is terminated with either 2-pin or 4-pin Molex connector. Power monitoring and control is performed by the Profiler Mooring STC and power data is reported to shore via satellite telemetry links.

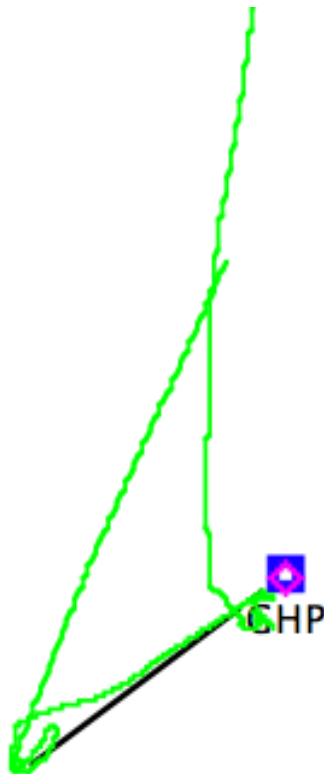
Figure 92: Deployment of the GHP. The ship was initially set up to steam from the north but was repositioned to steam from the southwest due to a wind shift.

The ship initially set up for the deployment to the north, but during the preparations, an atmospheric front passed through and with the wind out of the northeast the decision was made to reposition and steam from the southwest to the northeast for the deployment (Figure 92).

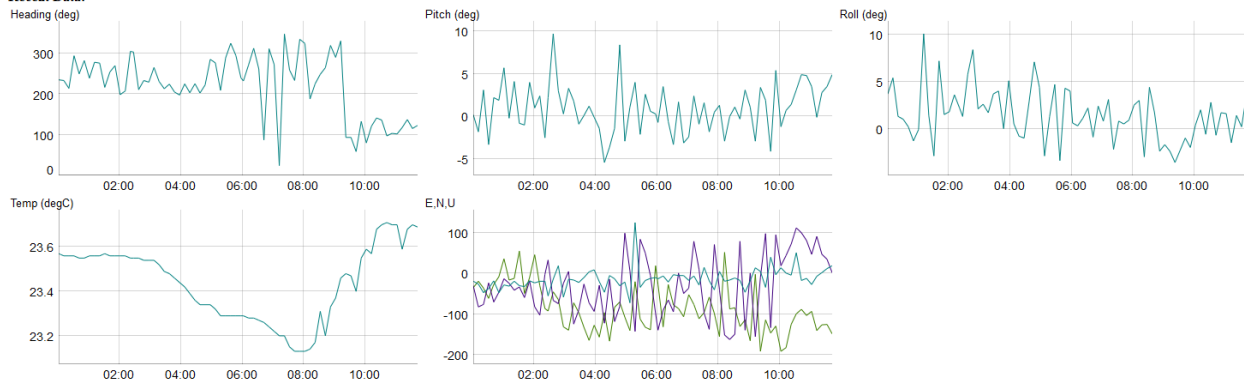
Figure 121: Aquadopp current data E, N, U in mm/s
