Tire crumb rubber in soil surrounding artificial turf fields

Hosle, Nadderud og Føyka artificial turf fields, Norway

NIBIO REPORT | VOL. 7 | NO. 79 | 2021

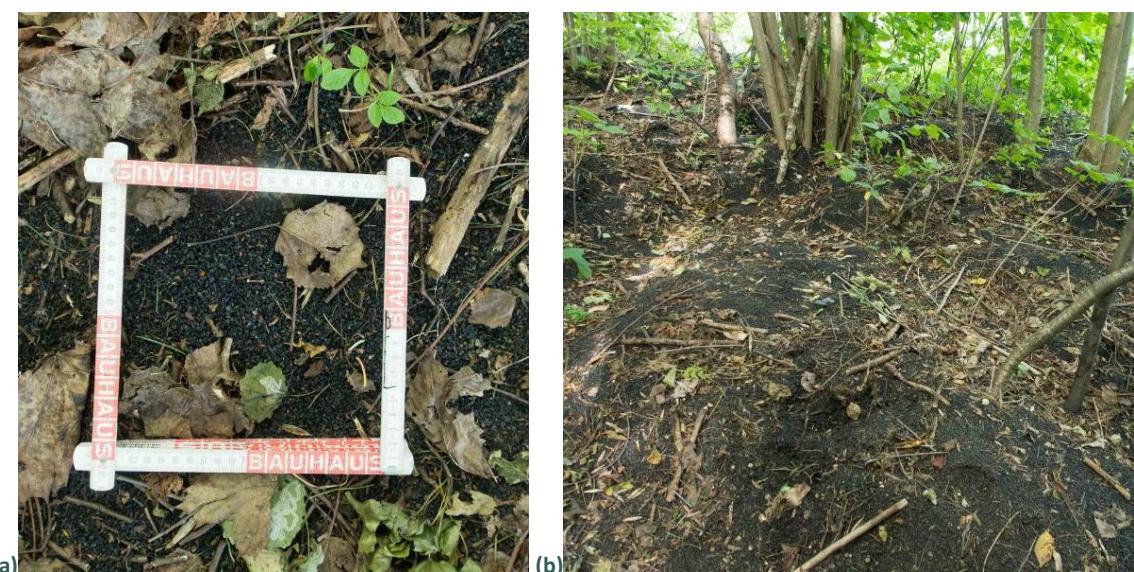
Figure 1. Soil sample N1-1 at Hosle, 13 m away from the artificial turf field (a), the forest floor on the western side of the artificial turf field is covered with large amounts of tire crumb (b).

At Hosle turf field, snow is cleared with a snow blower that throws snow and tire crumb westwards over the western side of the field. We found large amounts of tire crumb in the forest and on the grass-covered area west of the field (up to 15 m from the fence and 5 m above the level of the field), but not on the other sides of the field. Tire crumb found in soil on the western side of the field had no natural leaching pathways and will most likely remain where it is now without spreading towards drains or natural waterways.

Sampling area: 18×18 cm, in the forest located on the west side of the synthetic turf field (Fig. 1)

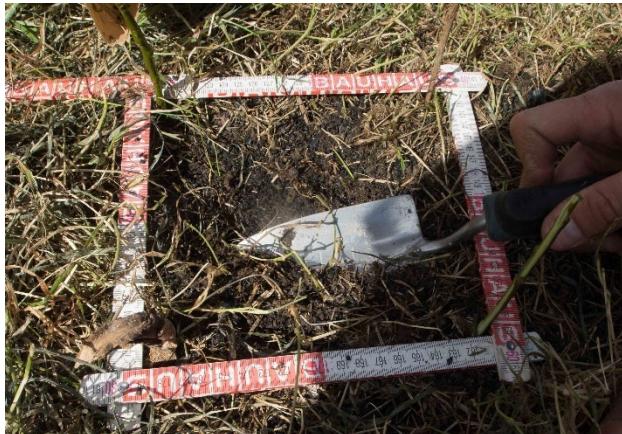
Figure 2. Soil sample N1-2 next to Hosle artificial turf field, on grassy meadow used for temporary storage of used tire crumb.

Sampling area: 18×18 cm, on grassy meadow used for temporary storage of used tire crumb (Fig. 2)

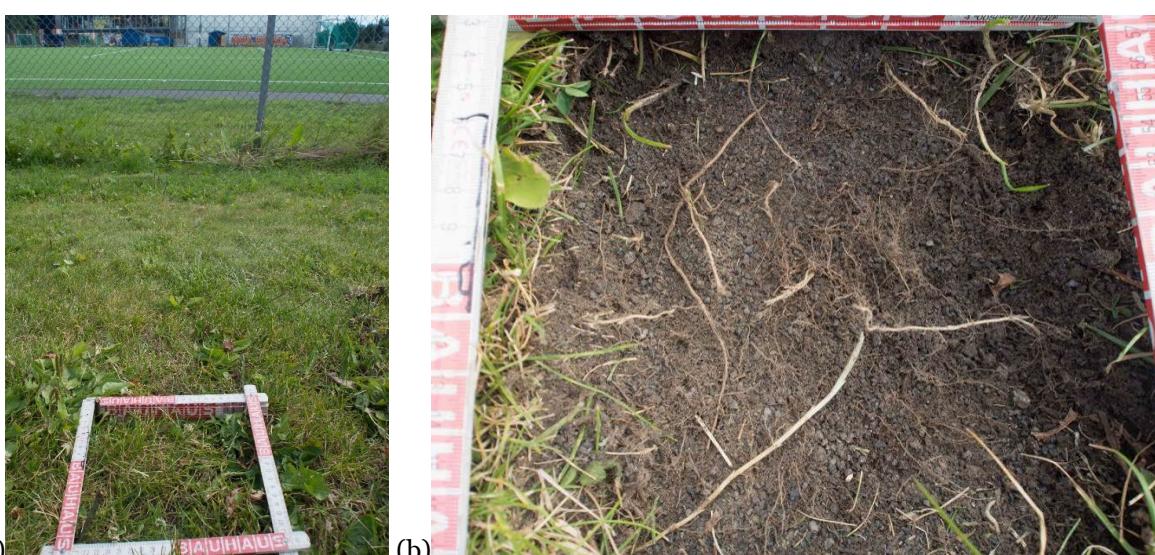
Figure 3. Soil sample N4, 12 m away from Nadderud artificial turf field (a), large amounts of tire crumb are visible in soil under the grass cover (b).

At Nadderud artificial turf field, snow seems to have been cleared without the use of a snow blower, at least in the last years. Tire crumb can be found outside the northern long side of the field, but not along the other sides. Tire crumb present in soil along the northern side has no natural leaching pathways and is likely to remain where it is now without spreading towards drains or natural waterways.

Sampling area: 18×18 cm, grass-covered area outside the turf field (Fig. 3)

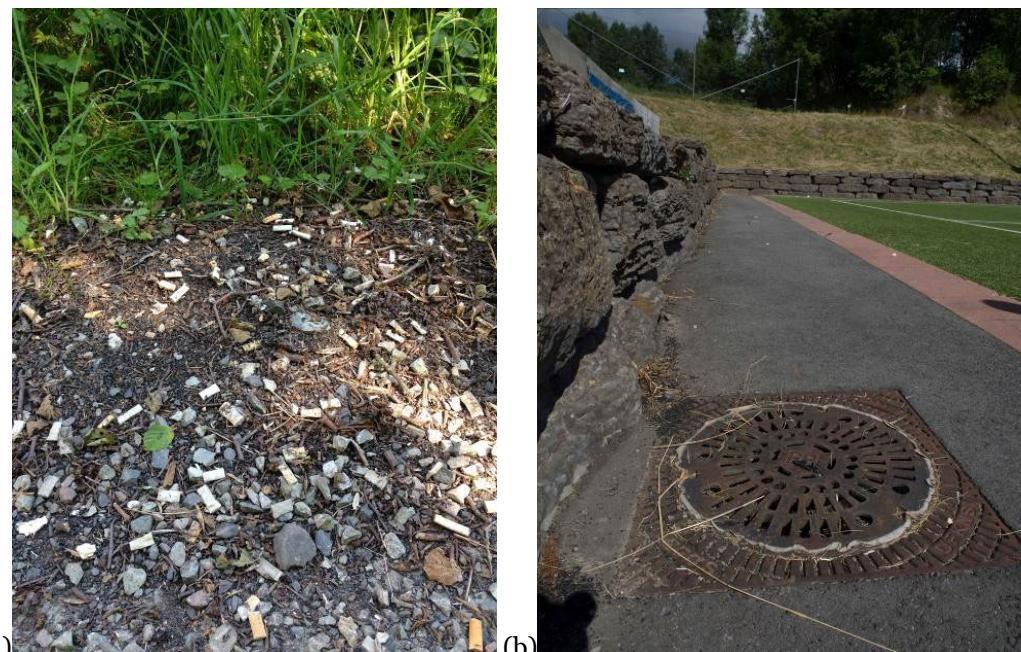
Figure 4. High amounts of tire crumb are visible on the southern footpath between the artificial turf field and the stream Drengsrudbekken (a), drains next to the turf field are lined with geotextile (b).

At Føyka turf field, snow has been cleared for the past 10 years with a snow blower that throws snow and tire crumb outside the long sides of the field, one of which is facing the stream Drengsrudbekken. Large amounts of tire crumb are visible outside the turf field, including the footpath between the field and the stream (Fig. 4a) and in soil all the way down to the stream. Drains on the turf field are equipped with geotextile to prevent leakage of tire crumb down the drain (Fig. 4b), and an effort is now made to collect used tire crumb.

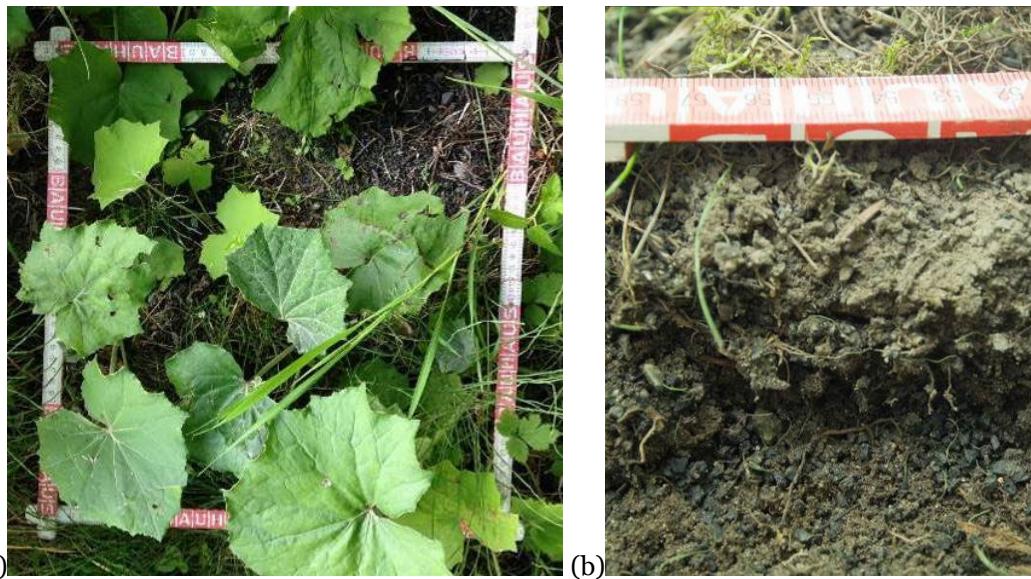
Figure 5. Soil sample X4 close to Føyka artificial turf field, soil is covered with coltsfoot and grass (a), and both tire crumb and artificial grass are visible in between plant roots (b).

There are also visible amounts of tire crumb under the soil surface, down to 6 cm depth (Fig. 5b). The slope (ca. 20 %) between the turf field and the footpath, and then between the footpath and the stream, constitutes a spreading pathway for tire crumb from the turf field to the stream. However, the vegetation present between the footpath and the stream, including trees, shrubs and herbaceous plants, partly prevent tire crumb from being washed further down the slope to the stream. Exceptions to this are several smaller footpaths going down to the stream, where there is no vegetation.

Sampling area: 40×40 cm, in the vegetated area between the southern footpath and the stream Drengsrudbekken (Fig. 5a)

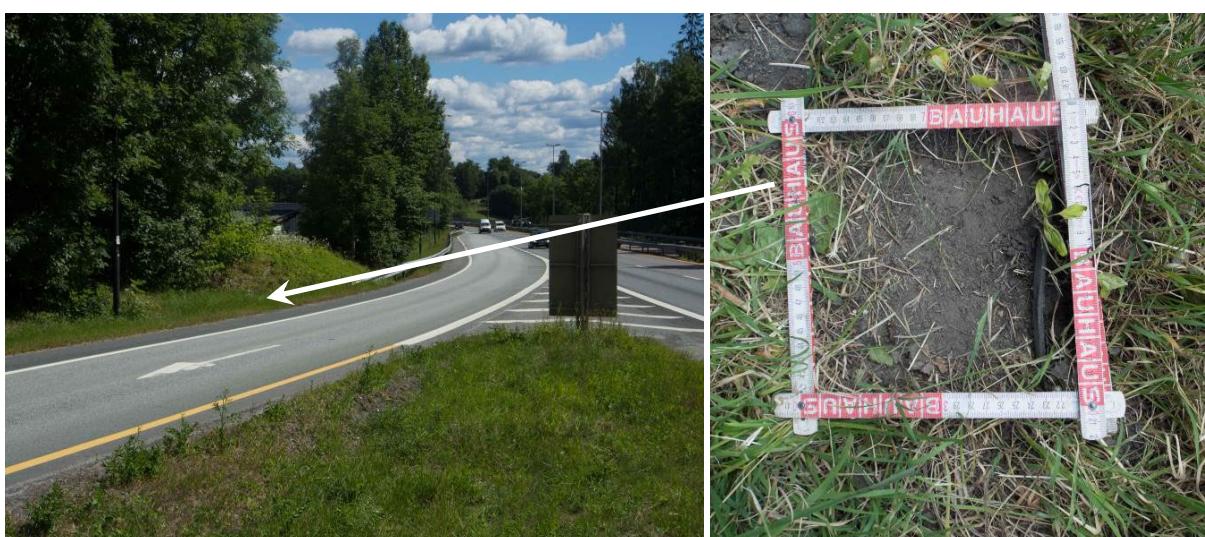
Figure 6. Soil sample X5, along the motorway E18.

Sampling area: 18×18 cm, on the roadside of the motorway E18 (Fig. 6), ca. 170 m south of sampling point X4
