EFFICIENCY OF THE CATHODE PROTECTION IN THE SPORTS CRAFTS, FISHING AND CABOTAGE BOATS

This paper studies the efficiency of sacrificial anodes in nautical engineering, marine and maritime. The anode design, quality manufacturing process and proper installation are critical processes for maximum protection of equipment and vessels.

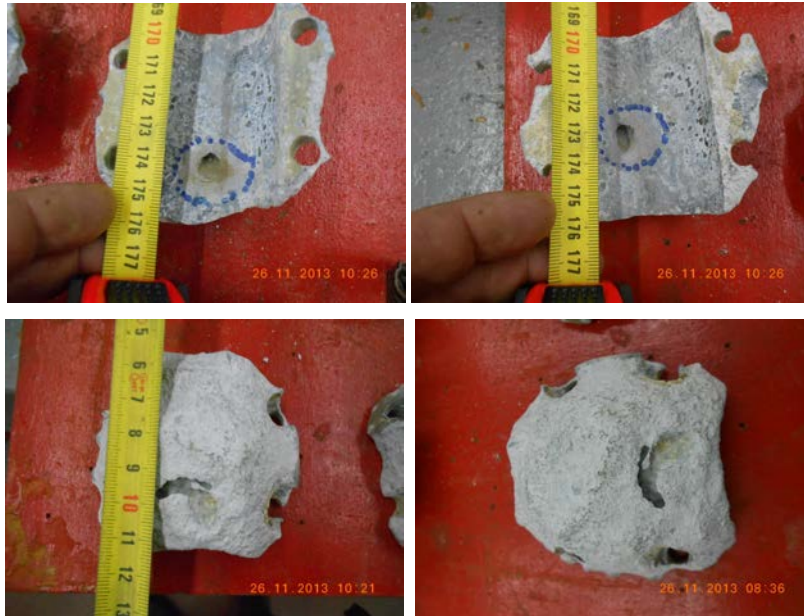
Figure 1 - Zinc sacrificial anode with defects in the internal and external interface

In the majority of the cases, the defects are a result of processes of shrinkage cavity in the casting mold. In other cases, the defects on the surfaces and the detected deformations are a consequence of deformation and alteration of self-casting mold (errors in temperature ranges of manufacture) [3]. The deformations are particularly relevant in special cases, as shown in Figure 1, as in the propeller shaft anodes. The assembly is performed in two halves bolted on the cylindrical surface of the shaft of the boat, very frequent situation in vessels mounted on struts external axes in these cases is observed by simple visual inspection of the contact surface of certain anodes significant losses of the contact surface and consequently loss of protective efficacy in this type of anodes, why manufacturers recommend extreme quality on axis of such anodes or possibly proceed to a grinding surfaces once both halves out of the mold, this correction would significantly improve the effectiveness of these protective elements [1].

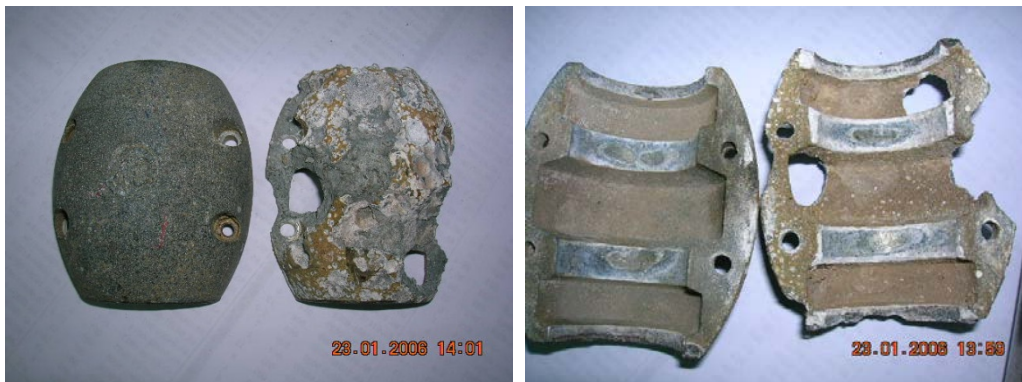
Figure 2 - Zincs defects in the internal contact

The "quality of the contact surface" (see Figure 2) has to be evaluated during installation and especially during the renovation of a sacrificial anode [2]. There are many factors which contribute to "driving difficult", through the contact surface of the anode, in particular, between the anode and the surface to be protected, this is due to the presence of paint and corrosion products from the anode itself and the element on which it is installed.

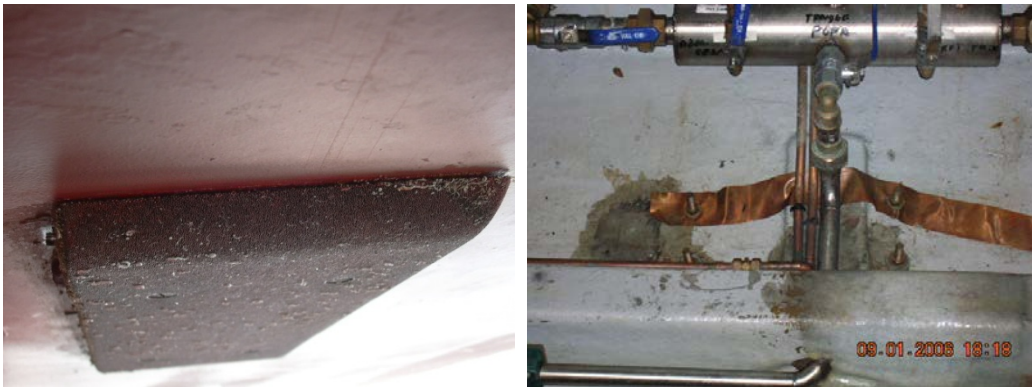
Figure 4 - External porous ground plane

In contemporary electronic equipment, require a good ground. In the case of telephones, this ground is critical to obtain a good range and receiving equipment. The type of wiring and the use of the driver and the relevant section ensure that you get the maximum performance of on-board equipment. As a general rule for boats where the ground connection of telephony equipment and navigation is done in the common ground board connector (see Figure 4). We recommend connecting the ground to this element, are carried out safely. So the water and in his absence, the presence of abnormal levels of moisture and water in the bilge does not affect connections altering the contact [7]. This effect can generate leads through the fluid and cause alterations of the connection and wiring deterioration in moisture absorption (by immersion and / or capillary). To avoid this defect, the connections must be sealed or a porous plate placed at a suitable place.

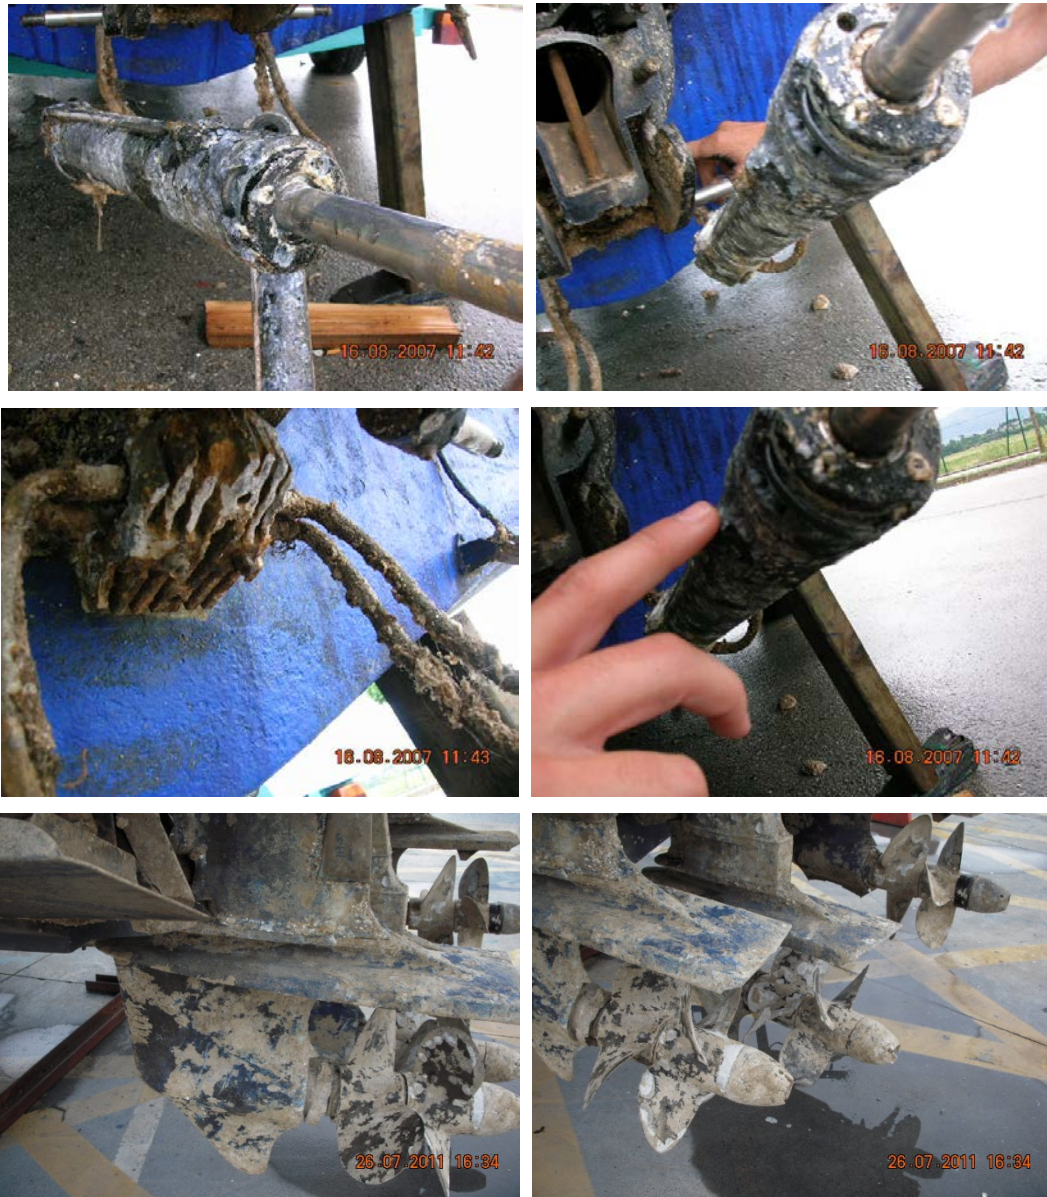
Figure 5 - Serious corrosion in tail propulsion elements (power trim cylinders) and other elements

The result of these wrong decisions in many cases involves the appearance of serious corrosion damage to the equipment and components of the boat or craft [1]. These defects cause the occurrence of faults, with the replacement of components and component parts of the equipment of the boat propellers. Such as the onset of corrosion in queues and outboard propulsion systems as well as external cooling components as shown in Figure 5.

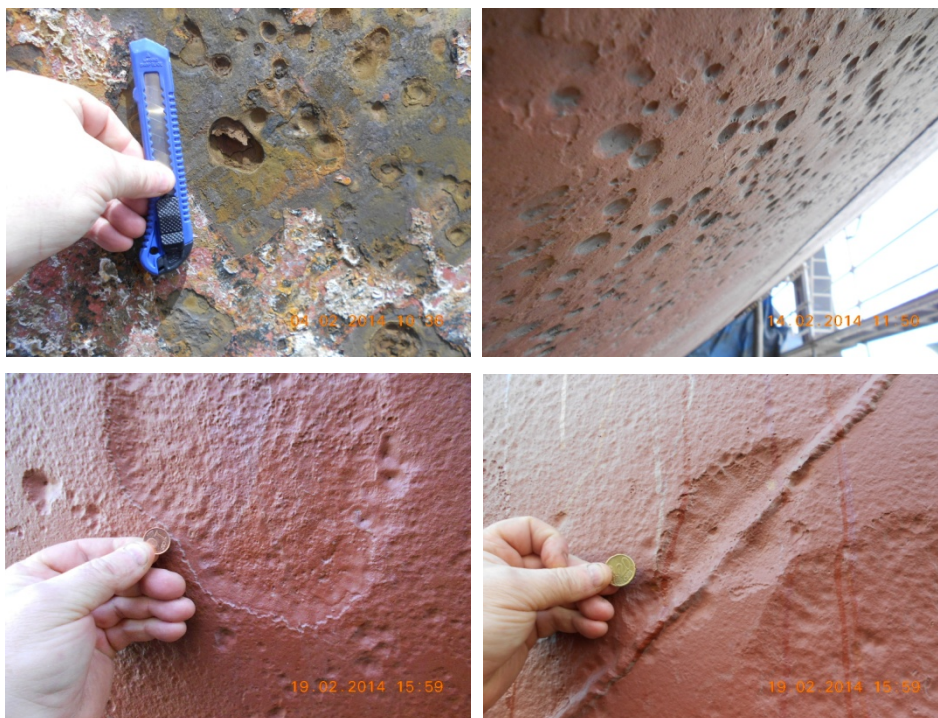
Figure 6 - Effects of severe corrosion

painting is the main factor of the helmet and protective equipment, so that the anodes are willing to protect all small deficiencies that may occur in the progressive deterioration of this protection. Often the protective lining of the helmet and equipment be altered, for very different reasons, the final result being that the protection of hull plating and equipment is altered and diminished. In this case, protection systems act sacrificial anode, but the progression is disrupted and wears quickly, which eventually causes degradation and wear involving the elimination of such protection prematurely (see Figure 6).
