PERFORMANCE GAP? ENERGY, HEALTH AND COMFORT NEEDS IN BUILDINGS

Abstract: Research on performance gap suggests that the actual energy consumption in buildings can be twice as much as expected. Energy models rely on predictive indicators and assumptions that are usually done at design stage, without acknowledging behavioural patterns of actual users. Moreover, in the context of performance gap, it is evident that energy efficiency is overemphasised while other key issues such as health and comfort of occupants, indoor air quality, noise levels etc. have been less stressed and discussed. This paper discusses the performance gap using surveys and physical measurements in a case study building at the University of Cambridge and reports findings of a research workshop with graduate students working on environmental performances of the built environment. The workshop addressed research issues related to energy, comfort and health, used as a method to understand the complexities of and trade-off between different aspects of sustainable buildings. According to the results, it is possible to balance energy, health and comfort needs in building projects. Lessons can be learned from the unive

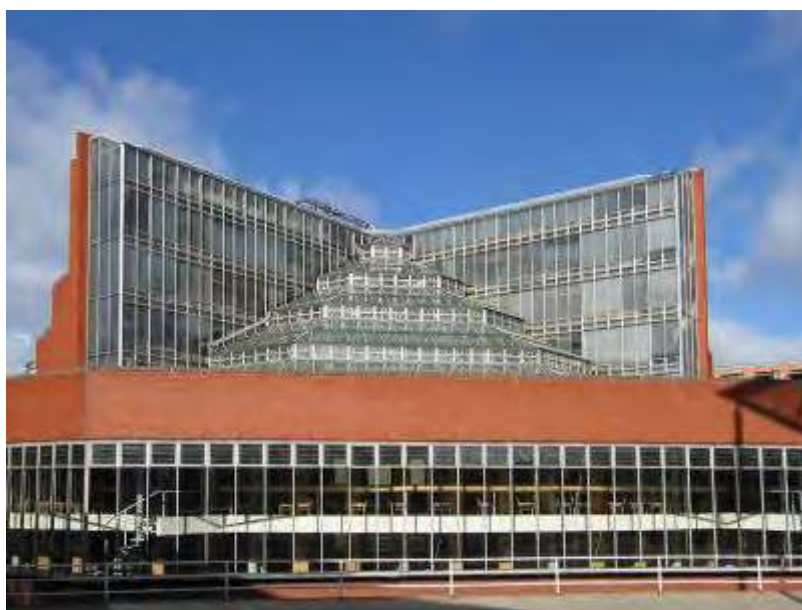
Figure 6: Faculty of History

The selected case study was the Faculty of History in Cambridge (Figure 2). The design of James Stirling was selected based on an architectural competition in 1962. From the beginning, there were concerns about the building's environmental performance 'the building would be subject to solar heat to a fairly large extent' (EMBS files 1963). The building was funded by the Universities Grants Committee (UGC), which meant that the funds had to be spent within a certain time frame and there was pressure to reduce the number of design iterations. The project was well funded; the contract price was £104/m² which amounts to £2440/m² at current prices. The design accommodates the history faculty, with an L-shaped stacked block of 6 levels enclosing a large fan-shaped glazed central space that houses the library. Early in construction, a poor relationship was reported amongst all parties, along with time / cost overruns and leaks were noted during the handover of the building. Due to neighbours' complaints an adjustment and reorientation of the building was made. After two decades of contending with construction and thermal comfort issues, demolition was considered in 1985 but the building was conserved and "grade II" listed in 2000 (Figure 2).

Main reason for poor thermal comfort and high energy use is that 75% of the envelope above the plinth is standard industrial glazing, along with the giant stepped-pyramid skylight of the library (Figure 3). The glazed, double-skin roof in the library was meant to act as a light diffusing layer where the inner layer was obscured to prevent glare and to give shadowless light in the reading area. This was also designed to insulate the cavity between the two skins so that all the louvres in the vertical steps would be closed in winter and opened in the summer to enable ventilation through the stack effect. Artificial light sources in the cavity and the roof provide an 'overhead spectacle'; however, the library space and office spaces are prone to overheating in summer (and draught in

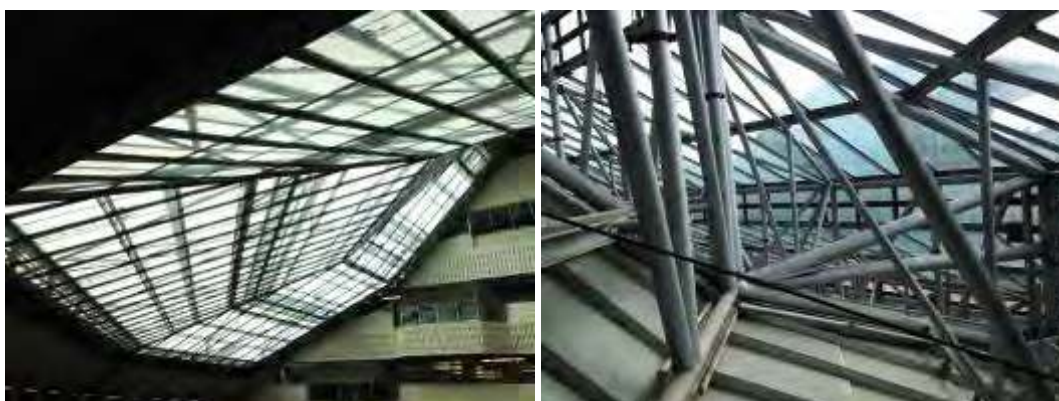
Figure 7: Glazed, double-skin roof of the library

winter). The noisy extract fans in the library were never used and small air-conditioning units have been placed in the administrative corridors. Offices have draughty glass louvres for ventilation, along with secondary glazing and venetian blinds that have been installed in later renovations. It was predicted as early as 1968 that “controls will be fouled up through mismanagement by the humanities-oriented occupants who are below the average in mechanical literacy and competence, while the occupants will take verbal revenge on the architects - whereas revenge should be on UGC and their budgets that are too ‘skimpy’ to permit decent environmental installations or idiot-proof control systems” (Banham 1968).

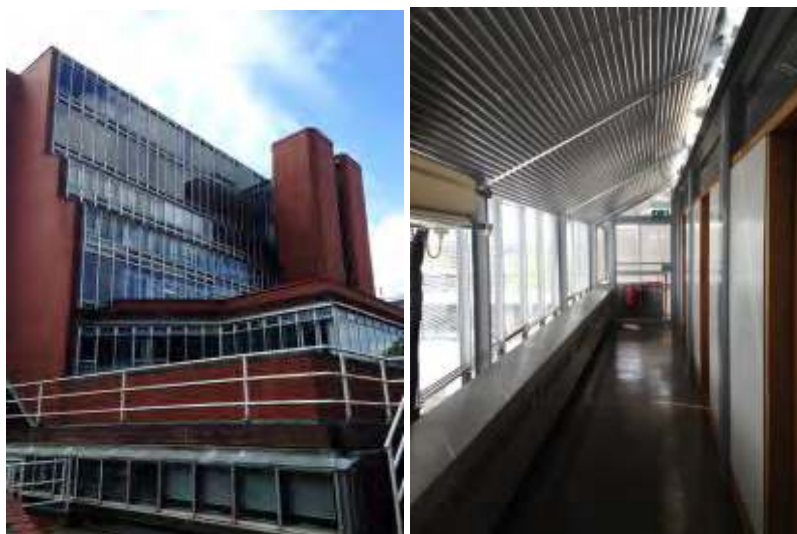
Figure 10: Excessive glazing and solar heat gain contribute to overheating

The situation has been considerably worse in the corridors on the 6th floor (Figure 6) as the temperature has reached nearly 50 °C which is an indicator of severe, and potentially dangerous, thermal comfort conditions for the occupants. Extremely high indoor temperatures in the building necessitated the use of air conditioning units particularly on the higher floors. According to Figure 5, occupants also experience extremely low temperatures (between 10 °C and 15 °C) during winter. Such conditions indicate high heating and cooling requirements in the case study building during both winter and summer. Yet, considering benchmarks, the average electricity consumption of 49.5 kWh/m² is rather low. A possible explanation for this may be the seasonal use of the building by the occupants.

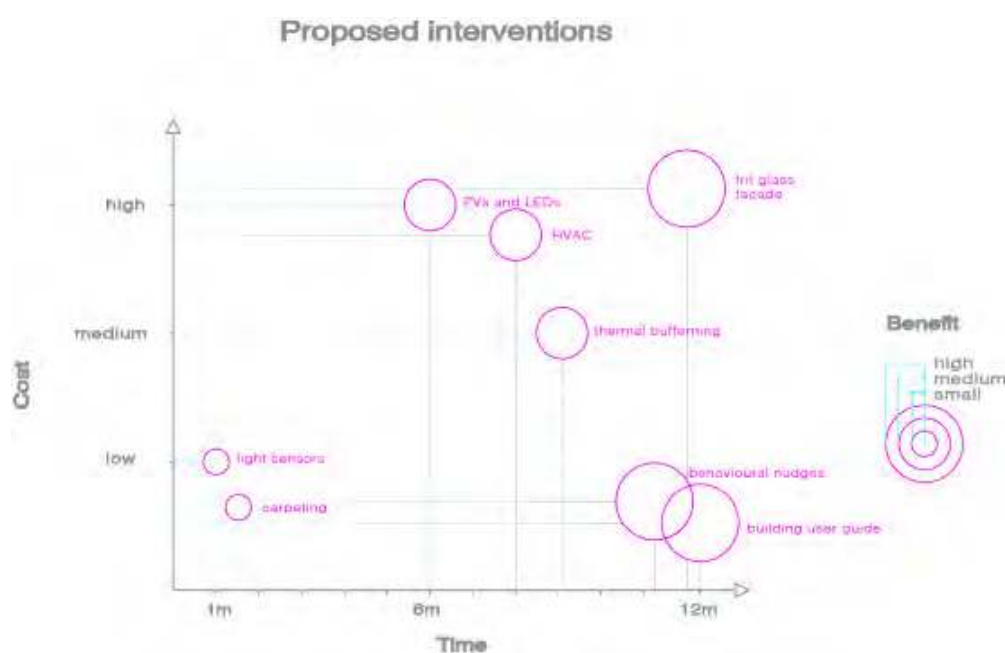
Figure 12: Proposed interventions for the refurbishment of the History Faculty at the University of Cambridge based on the cost, implementation timeframe and benefit

The practical aspects related to the implementation of the proposed interventions (cost, benefit, timeframe) were presented in a comparative graph. The different measures were plotted based on their cost (high, medium, low), the timeframe of their implementation and their impact on energy efficiency and comfort (small, medium, high) (Figure 9).

In terms of comfort and energy efficiency, the replacement of the outer layer of the building's glass envelope with fritted glass and the behavioural nudges were the interventions with a higher expected impact. The new façade intends to give a creative and delicate aesthetic touch, enhancing the identity and popularity of the building however, this is anticipated to be a costly intervention. The interactive 'building wizard' would be less costly but needs constant update and monitoring. The case where the two measures are combined is seen as the optimal intervention in the existing context.
