## VIBRATION ANALYSIS AND DIAGNOSTIC IN A CATAMARAN VESSEL

In this paper the measurement and analysis of vibrations in a catamaran vessel is presented. The analysis was aimed to detect the cause of the structural damage that appears in the vessel during its operation. Cracks appeared in stern tube next to inlet duct and in hull next to sea water discharge pipe.

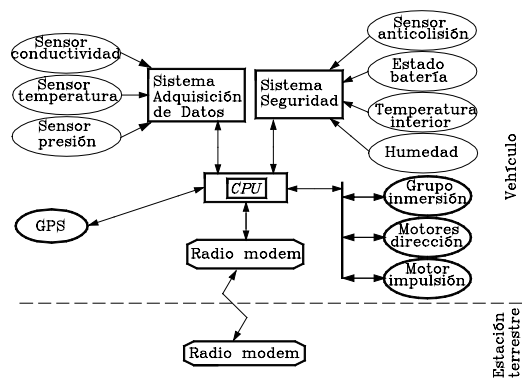
Fig. 3. Diagram of the autonomous control.

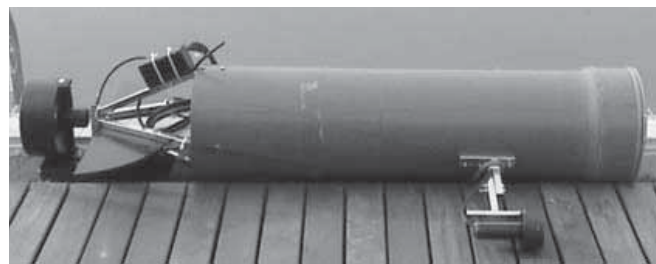
Fig. 4. Constructed vehicle.

Once was verified the correct operation of all vehicle systems, in phase of manual control, we began the field work. The tests were made in a swimming pool of 25m of length, 15m of width and 2 meters of depth. The first time when the vehicle was placed into the water, see figure 4, a perfect balance adjustment was necessary. It was obtained incorporating a ballast in prow of 3.6kg and a push in stern of 1.5kg. This situation allowed the beginning of the immersion and navigation tests. In the navigation test the speed was approximately 1,5m/s with the control of the propulsion motor at 80% of full power. The course variation is obtained very easily using the lateral motors to full power and decreasing the propulsion of the first engine. The operation of immersion was done with complete normality acting on the group motor-cylinder. Navigation in depth was successful, maintaining the course of the vehicle with good stability, direction and depth.

The success of the vehicle test in manual control will accelerate the phase of autonomous control. The result, at this moment, is that we have a robust platform, of dimensions (1885 mm in length and 320 mm of diameter) and weight (76 kg) which is nonexcessive and it

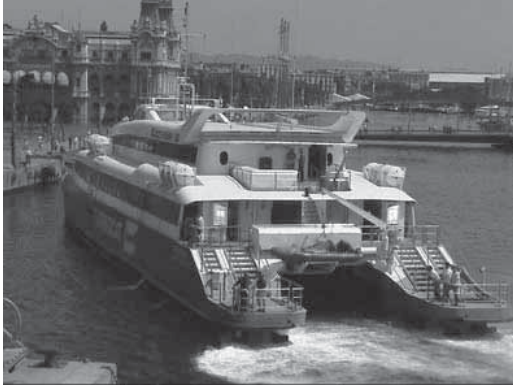
Fig. 1. Picture of the catamaran vessel.

The vessel had four water jet pumps, two on each side, powered by variable speed internal combustion engines. The impeller takes sea water through an inlet duct in the bottom of the vessel and creates an output water jet that propels the unit [1][2]. A deflector behind each jet serves to control the vessel operation.
