# “Almost a model of its kind”: Les Blanchés Banques Camp for German World War I military prisoners

*Harold Mytum, Rob Philpott,  
Gilly Carr, and Nick Saunders*

Complete surface mapping, combined with sample geophysical survey, has enabled a detailed examination of the layout of the Blanchés Banques Camp for German World War I military prisoners. By combining the new survey data with surviving contemporary images, subsequent aerial photographs and an account by the camp designer, Major T. E. Naish, it is possible to understand the decision-making processes in constructing and maintaining the camp, and the constrained world in which the occupants spent several years of the war. This, one of the best-preserved World War I prisoner of war camps in the British Isles, can still be appreciated by walking over the dunes today, and deserves the highest level of protection for the future.

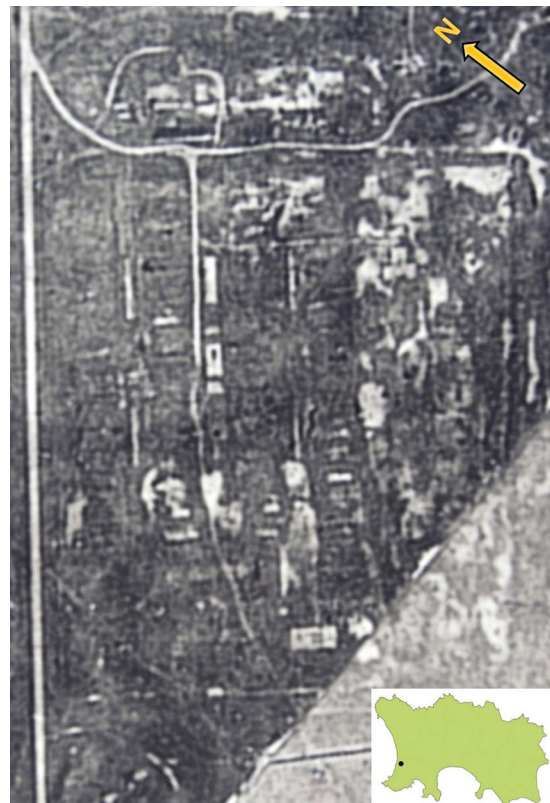
**Figure 1:** 1933 vertical aerial photograph of Les Blanchés Banques Camp, with map showing location on Jersey. Aerial photograph: *Société Jersiaise Photographique Archive*; map: R. Philpott.

The site of the camp lies with an area of sand dunes (Figure 1), designated as a States of Jersey SSI (Site of Special Interest). Part of the site is dominated by tall spiky marram grass, which stabilises the dunes by trapping sand particles, while other areas, notably to the south and north-east, have low vegetation cover, dominated by burnet rose (Figure 2, bottom).

The formation of the dunes has been affected by the presence of the camp (Figures 1; 2, bottom). Three distinct location types could be identified where the camp foundations have had an obvious impact on the development of the dunes. The first is the concrete, or in one case bitumen-coated, floors. They remain largely unencumbered by sand, and only low vegetation has

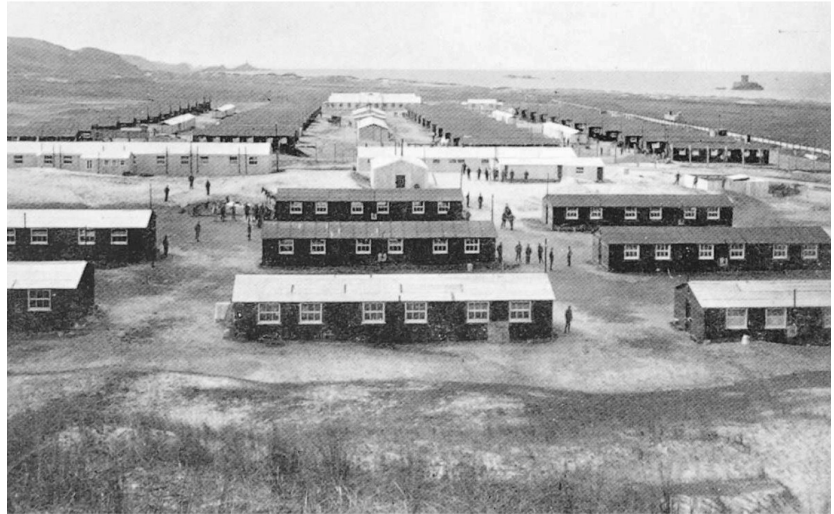
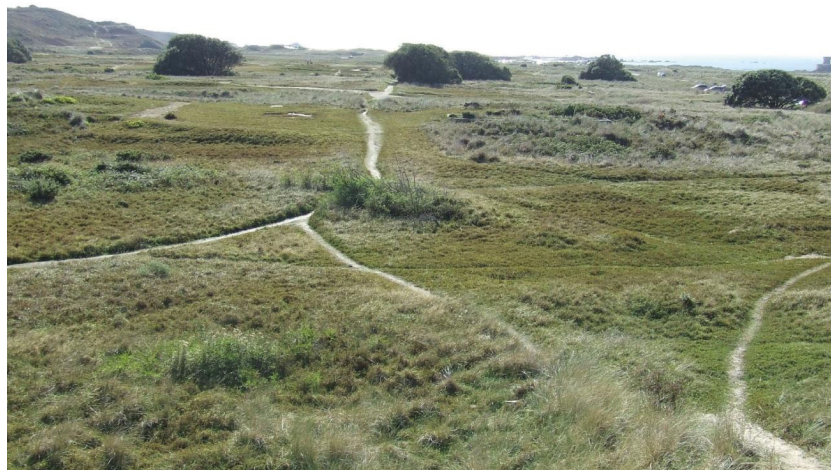
**Figure 2:** General view of the camp from the east.

**Top:** Photograph of the camp in 1915 (Naish 1955).

**Bottom:** 2019 view from same location.

There is some evidence that the dunes were not levelled completely before the camp was constructed. The earliest aerial photograph of the camp taken from the south-east shows the open space of the exercise area/parade ground on a raised terrace slightly higher than the nearest row of barracks.

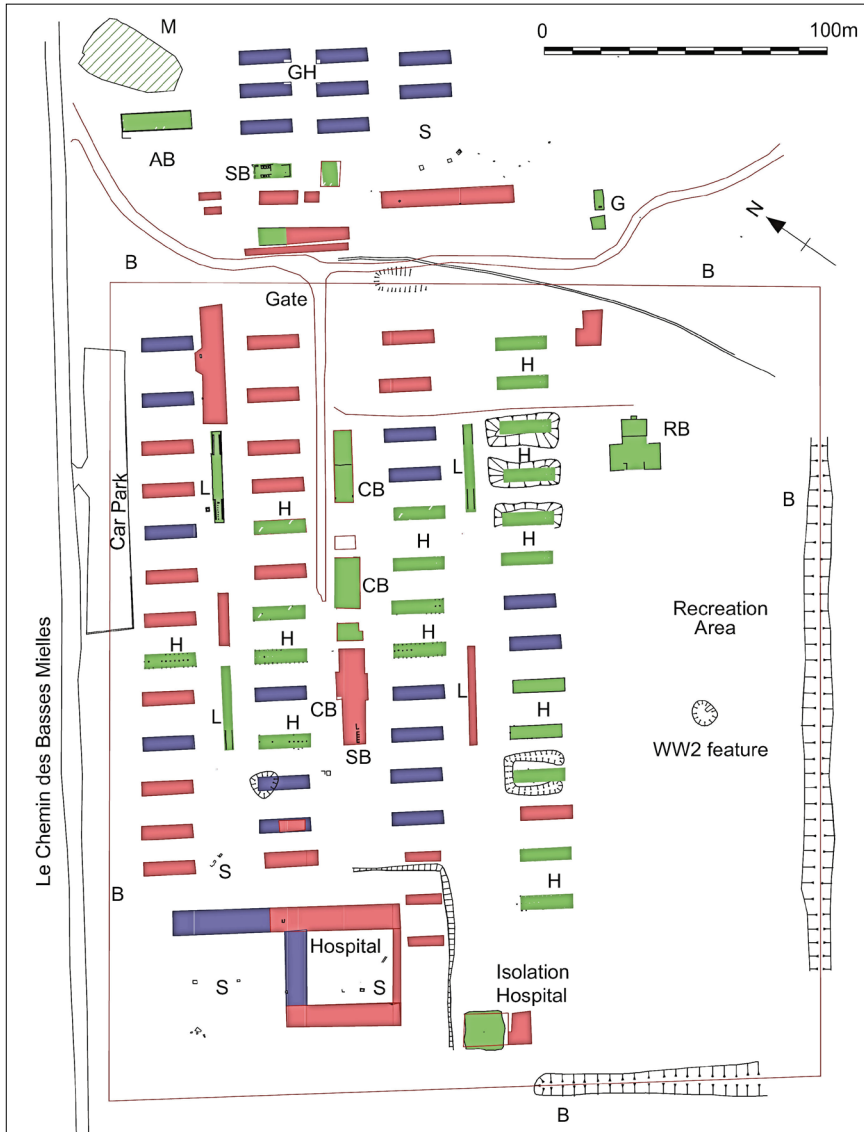
LES BLANCHES BANQUES CAMP

Figure 4: Overall interpretive plan of the Les Blanches Banques Camp.

**Colour key:** Black: features and structures identified on the ground in the TST survey, Grey tone: buildings at least partially identified on the ground, Red: buildings and other features identified from the 1933 aerial photograph, Blue: buildings reconstructed in approximate location from drawings and photographs

**Letter codes:** AB: Administrative Building, B: Boundary, CB: Communal building, G: Electricity generator building, GH: Guards' huts, H: Hut, L: Latrine block, M: Midden/rubbish dump, RB: Recreation building, S: Sump or water tank, SB: Shower block

The fieldwork – combining aerial, surface and geophysical survey – has allowed a reconstruction of a measured camp plan for the first time (Figure

4), and the identification and interpretation of many of the structures that comprised the camp elements for the prisoners and for the guards. The overall extent of the camp has been identified on the ground, and numerous components of the camp have been located. The physical separation of the guards and the prisoners is recognised, with some of the guard buildings on the slightly higher ground to the North-east, enabling better observation. The camp, organised on the lines of a British battalion camp, comprises groups of barrack buildings and an associated latrine block, with central catering and social buildings down the spine of the camp. The recreation area was to the South, with a large open exercise space and a YMCA recreation building that was added on the Eastern part of this open area. The hospital complexes lie at the far South-west.

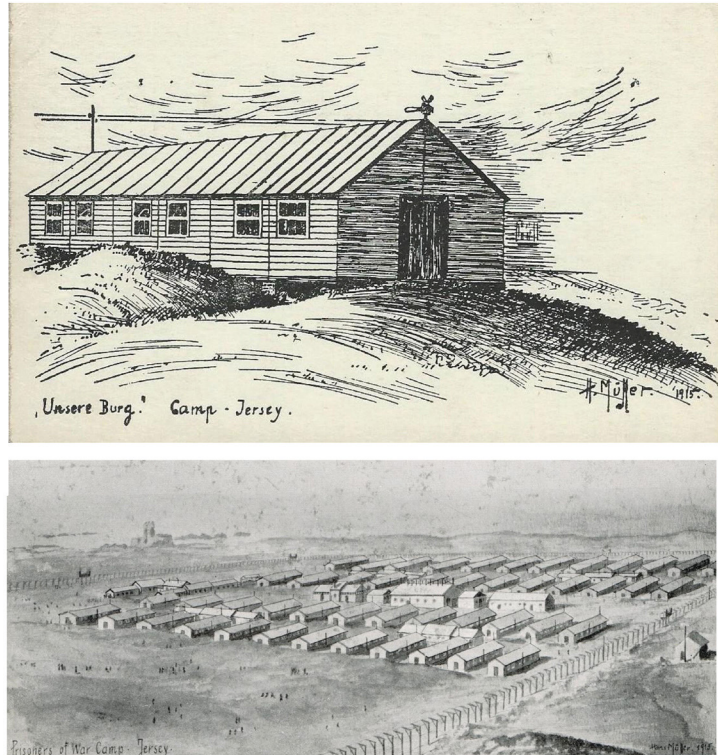
**Figure 5:** Views of the camp by prisoner of war, Hans Müller, 1915.

**Top:** Ink drawing 'Unsere Burg' showing dunes around the raised barrack block. *Mark Lamerton Collections*

**Bottom:** View of the camp with the central communal buildings and hospital buildings to the far left. *Damien Horn Collection.*

The camp hut drawing with the ironic title 'Unsere Burg' [our castle] and signed 'H. Müller 1915' (Fig. 4, top) shows the undulating dunes built up against the wooden wall of the hut. A photograph by Captain Eli Bowers shows the northern side of the camp where the two nearest visible huts are raised well above ground level. The door in the gable end is reached by a flight of six wooden steps. The space around the base of the hut appears to have been built up to leave no void underneath, perhaps to insulate the floors: if such material were left in place after the wooden structures were dismantled with the closure of the camp, this material will have affected dune formation thereafter.

A series of large buildings set along the broad central row between the huts can be seen on contemporary photographs (Figure 5, bottom). These survive as a series of concrete floors laid on the ground surface (e.g. F3, F5). Occasionally the raised lip of the floor was visible, usually with a slot for a timber or asbestos wall but they lack any diagnostic features to enable interpretation. Their location, situated to serve the adjacent blocks of barrack huts, indicates a communal function. Comparison with Armstrong’s plan, which shows that the largest structures are the dining room and cook house, might provide the explanation here. Naish states that barrack huts were used as dining rooms, so there was apparently no dedicated dining hall, so the large buildings may have included the cook house as well as communal drying rooms and ‘wash-ups’.

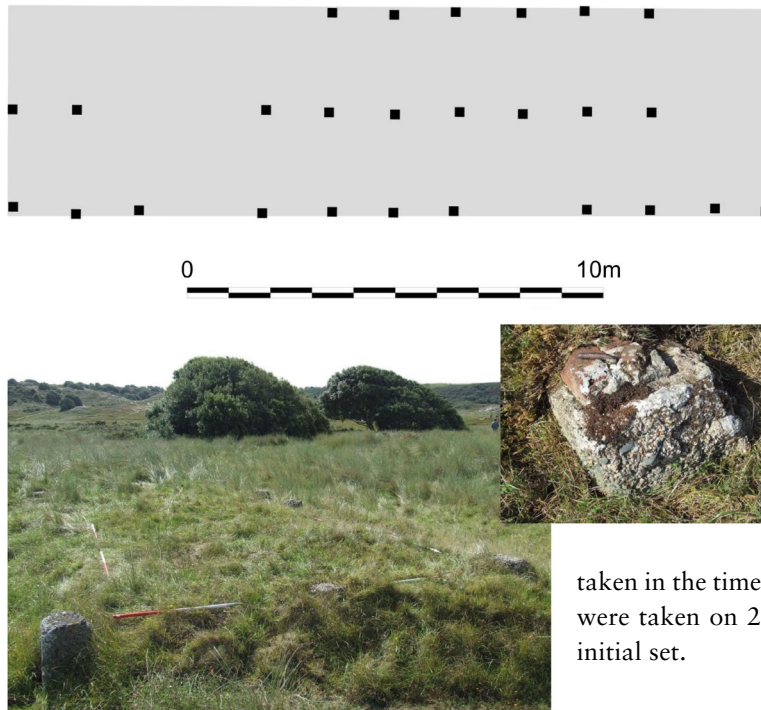
**Figure 6:** Barrack blocks.  
**Top:** Plan of a barrack.  
**Bottom left:** View of a barrack block site.  
**Bottom right:** Concrete pier with brick top.  
 Plan, *R. Philpott*,  
 photographs *H. Mytum*.

alignments of supports (Figure 6). The supports consisted of three parallel rows of low square piers in brick and/or concrete, on which rested the prefabricated floors panels of the barrack huts. The best-preserved groups confirm Naish's observation that there were 39 piers to each hut, arranged in three rows of thirteen: the supports measured 9 inches square (1955, 270).

Some huts lacked surviving supports but were defined instead by elongated deep rectangular hollows within the dune sand. Their regular arrangement and position precisely on the rows of huts indicated that they too marked the location of huts, although the mechanism by which the hollows developed requires further investigation.

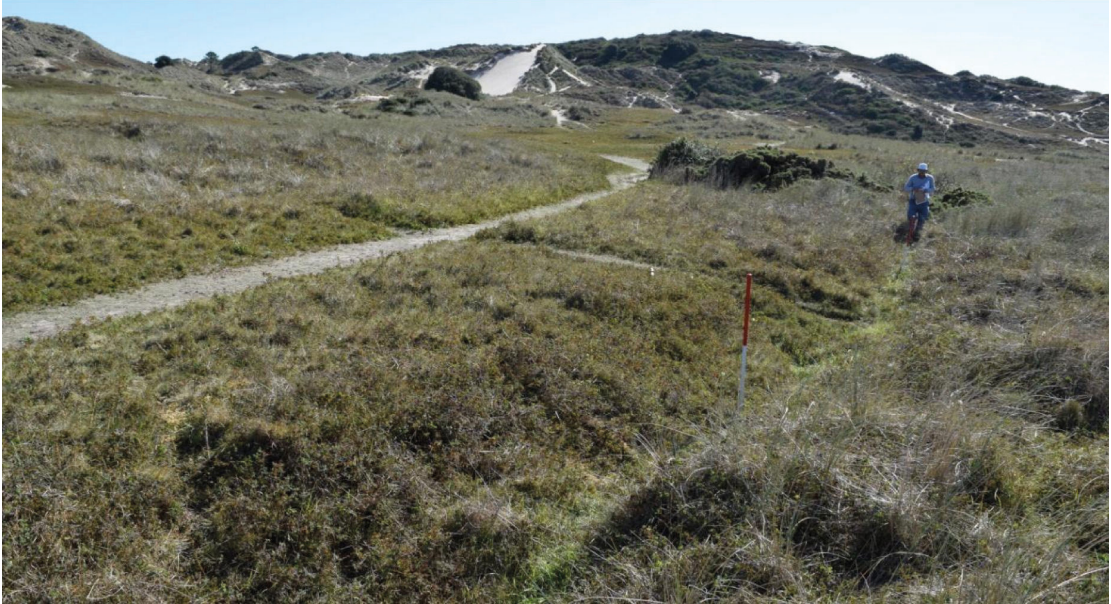
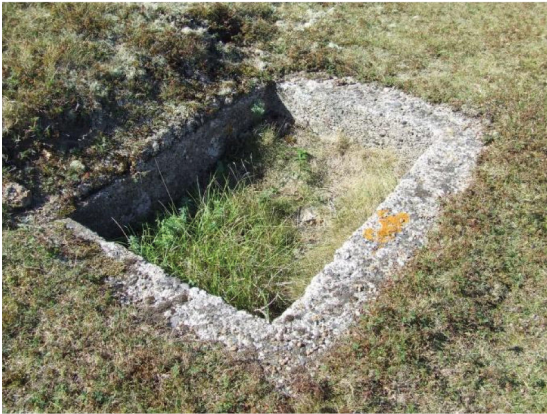
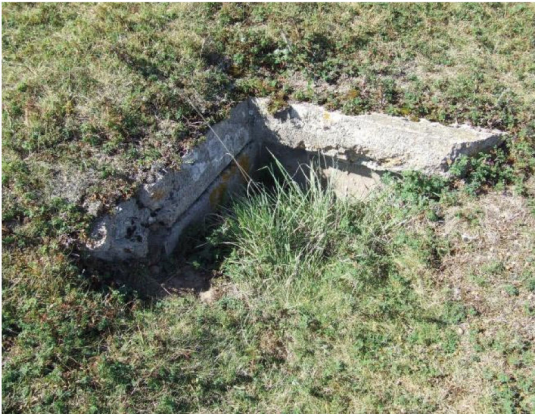
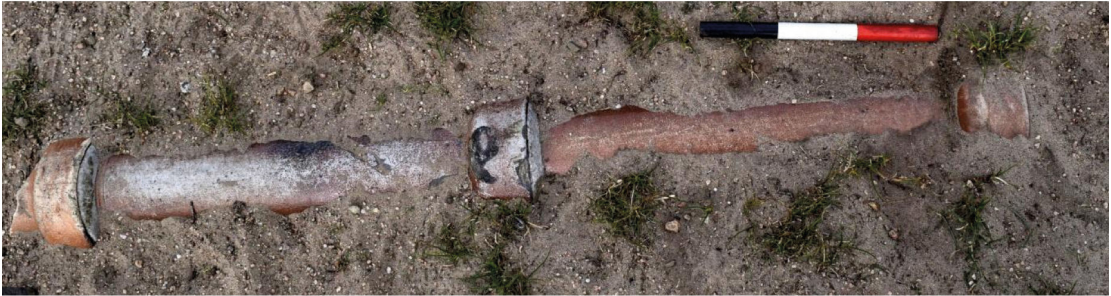
**Figure 8:** Water supply and management.

**Top:** Robbing trench for water main pipe.

**Centre:** different types of sump.

**Bottom:** glazed pipe for subsurface services, exposed by a sand blow.

A deep trench (F62) was identified in the south-eastern part of the site, along the eastern boundary of the camp (Figure 8, top), extending for at least 175m, which appears to have been excavated originally for a water main. The excavated trench is visible on at least one contemporary photograph, where the line of excavated spoil lies just outside the camp boundary. However, the current trench is unlikely to result from the original construction but rather from the removal and recovery of the iron water pipe at the end of the camp’s life. A stretch of the trench was identified on the magnetometer survey in 2019 as a zone of high iron readings, and the pipe may not have been removed along this length.

Several elements of the drainage system were observed in the archaeological survey. Short lengths of brown salt-glazed stoneware drains were visible (Figure 8, bottom), most obviously exposed in the north-western part of the camp on the seaward side of the buildings. The drains are close to, and in one case connected to, rectangular concrete tanks or sumps (Figure 8, centre). There is one obvious line of sumps (F21, F50, F52, F54) which were connected by the sewer pipes. The sumps were originally covered, perhaps with cast iron lids, but these have been removed. The function of the concrete sumps was to provide points in the drainage system which would allow cleaning, removal of blockages and general maintenance.
