Analysis of the invasion of water lilies (*Eichhornia crassipes* (Mart) Solms) in the Cointzio dam, Michoacán, Mexico

Vera-Vargas, Omar R.¹; Prado-Hernández, Jorge V.²; Reyes-López, Delfino³; Pascual-Ramírez, Fermín^{4*}

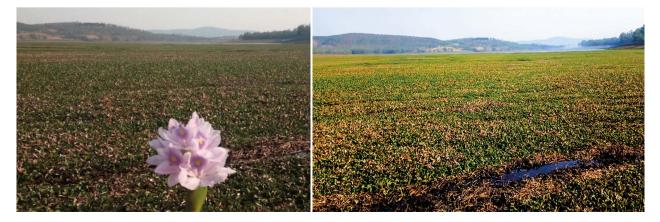
Figure 4. Water lily and invasion overview (Eichhornia crassipes (Mart) Solms) in the Cointzio dam, Michoacán, Mexico.

Although mitigation efforts through the extraction of the lily during the dry season contribute to reduce its impact, it is important to undertake actions that consider the basin as a fundamental work unit. Beyond this, it would be important to analyze the problem of the lily invasion in the reservoir considering the biophysical system with human interactions derived from the analysis of socioecological systems, since water dynamics is a key component in the ecosystems management, and human activities have an effect and are affected by the response of the ecosystem to these interventions (Maass, 2017). Due to this, any action to mitigate the damage caused by the water lily proliferation must be fully agreed with the actors involved in the management process, both internally and externally, throughout the basin and its users (Figure 4).
