Master's Thesis

**Seismic Analysis of Santa Maria
del Mar Church in Barcelona.**

Title of the Msc Dissertation: Seismic Analysis of Santa Maria del mar Church in Barcelona
Supervisor(s): Pere Roca Fabregat
Year: 2008

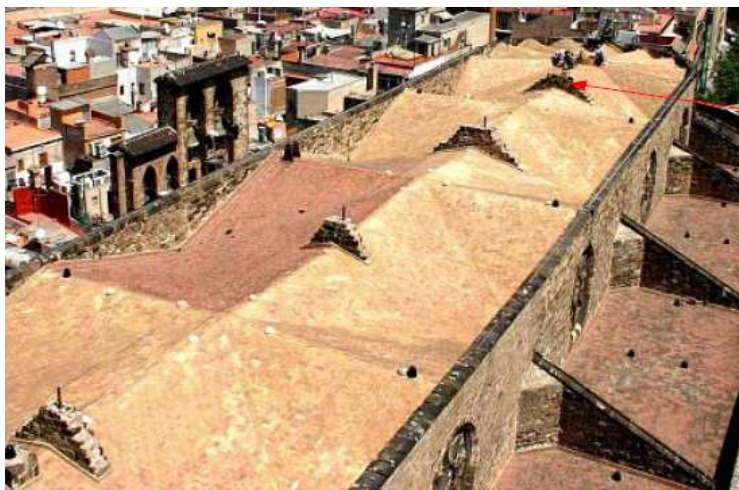
At the last level, the cover of the central nave is done with a tiled surface with different slopes adapted to the vault shape and enabling drainage (figure 2.12). In fact, it is possible to identify the 4 vaults and the vault with palm shape at the head of the church. Another important element is the existence of a triangular wall which is in fact the upper part of the diaphragmatic arch. It is thought that this wall was used in the early times to support the provisional roof of the church.

Figure 2.12 – View of the roof of the central nave

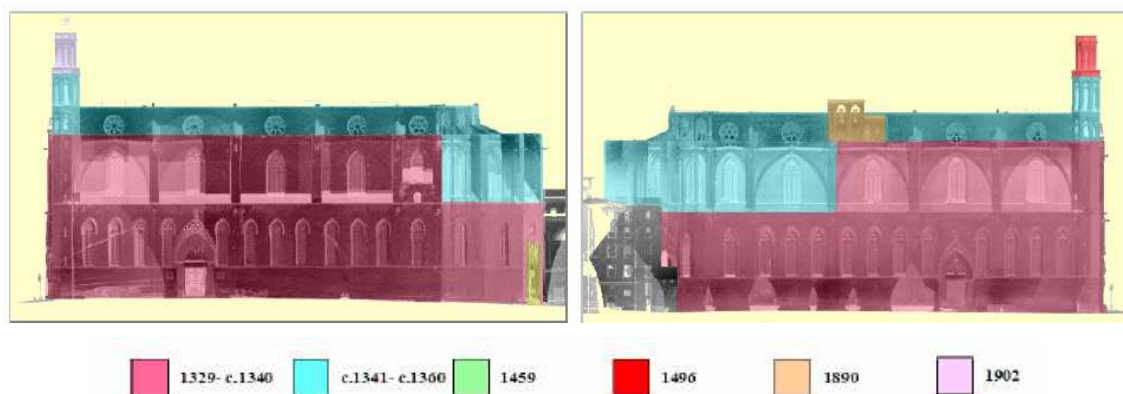
Figure 2.17 – Lateral view of construction phases, according to Vendrell et al. (2007)

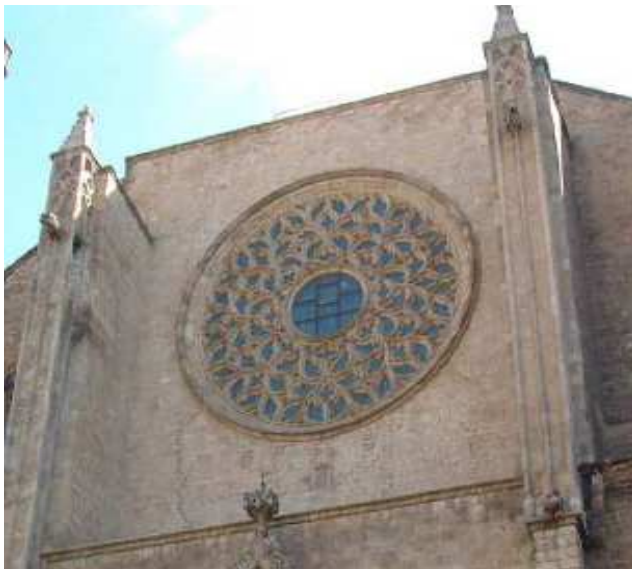
- Earthquake of 1428: it was an important earthquake causing damage to the façade and fall of the rose window (figure 2.18). The damage was however caused probably by a succession of events and not a single one, as between 1427 and 1428 the seismic activity in Barcelona was important. The existing cracks in the façade can be a consequence of these earthquakes (in the beginning of the 20th Century these cracks were described as stable).

Figure 2.18 Current view of the rose window built on 1459 after its collapse in 1428 earthquake

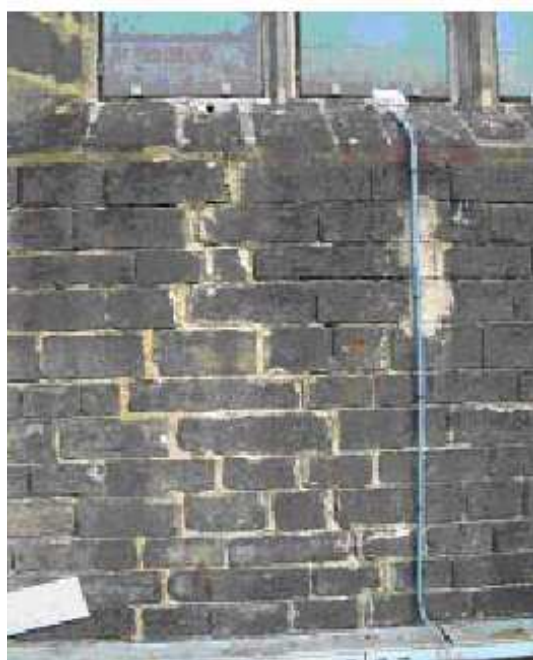
Figure 2.29 – Vertical crack below window

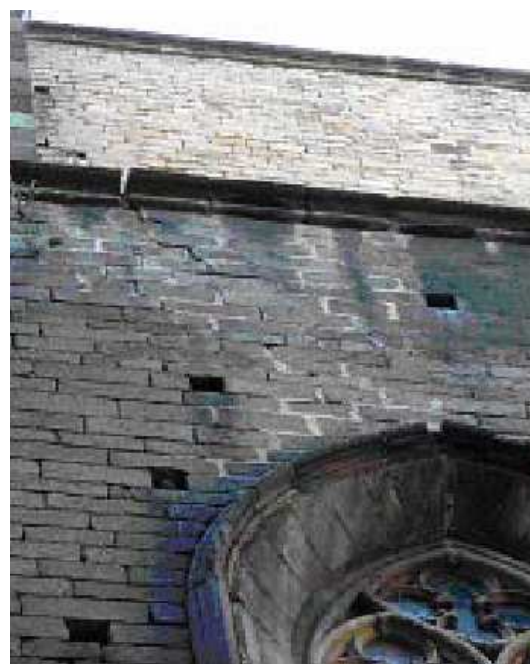
Figure 2.30 – Inclined crack from window towards tower

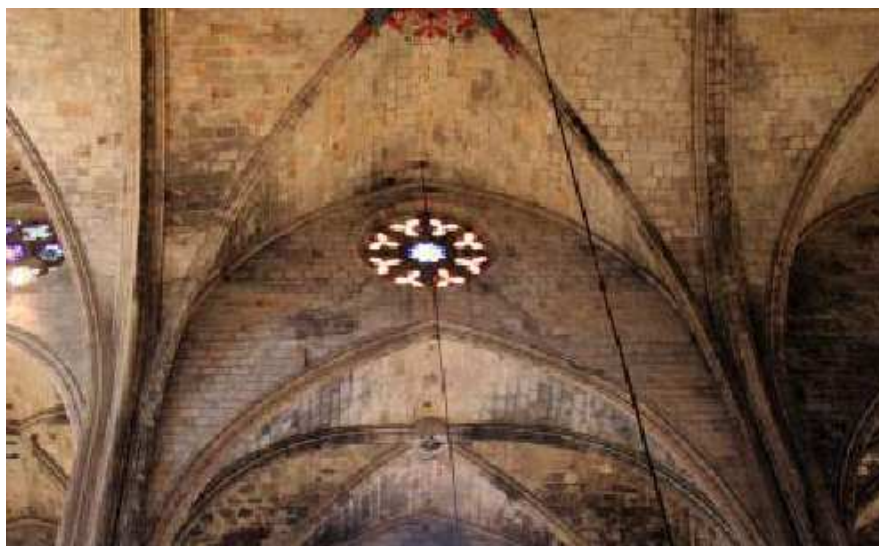
Some cracks are also observed in the upper walls (in the upper perimeter walls and walls of central nave). The most characteristic pattern is the crack starting at the arches and going up inclined to the circle opening, that can be seen both from outside and inside (figure 2.35). It can be caused by the existence of a relieving arch caused by the opening. As a result, the central part wouldn't be loaded.

Figure 2.35 – Crack in the wall of the central nave

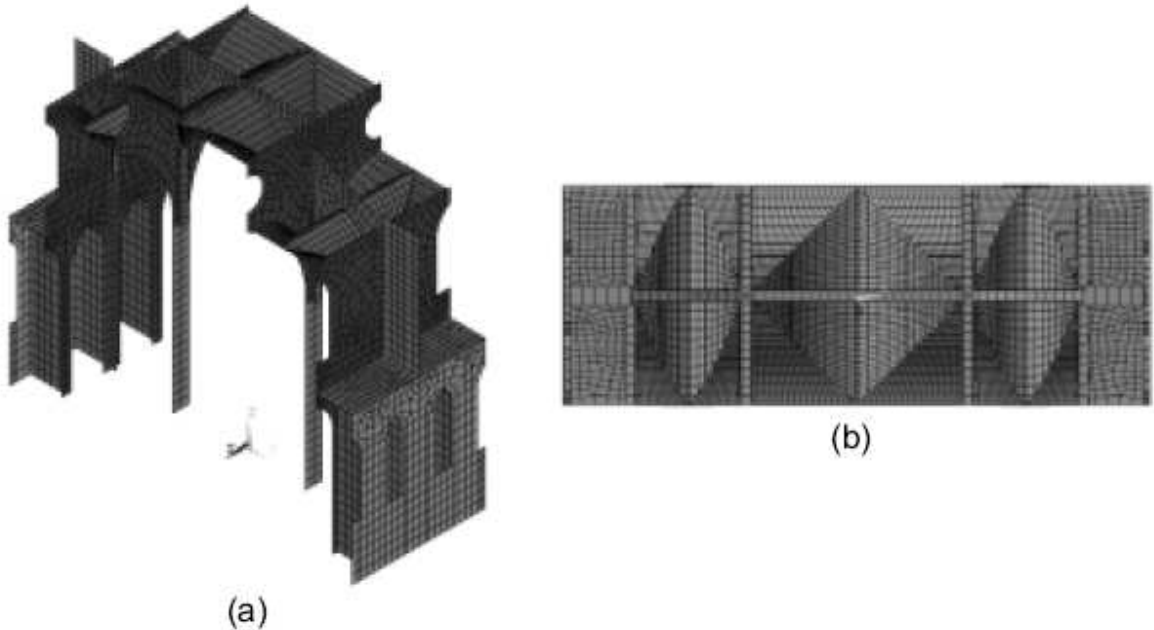
A static nonlinear FEA of a representative 3D model of the central and lateral vaults was carried out (figure 2.40). This model includes half of the vaults at each side of the piers with appropriated boundary conditions. Shell elements are used and a damage constitutive law is considered for masonry. A modal analysis was carried out, obtaining as fundamental period of the structure $T=0.81s$. A pushover analysis was carried out with 3 different models: a) dead load + 0.14g horizontal acceleration, together; b) same analysis with lower E-modulus in the vaults; c) considering load history: first dead load and then incremental horizontal acceleration.

Figure 2.40 - FE model used by Irizarry et al. (2003)

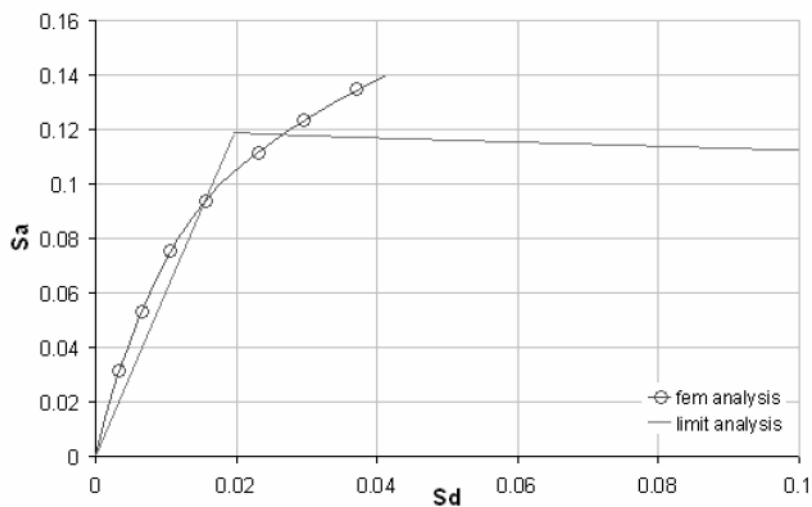
A good correspondence was found between FEA and Limit Analysis capacity curves, even if in one case the evolution is continuous and in the other discrete (figure 2.45).

Figure 2.45 – Comparison between capacity curves obtained by Limit Analysis and FEA (Irizarry, 2004)

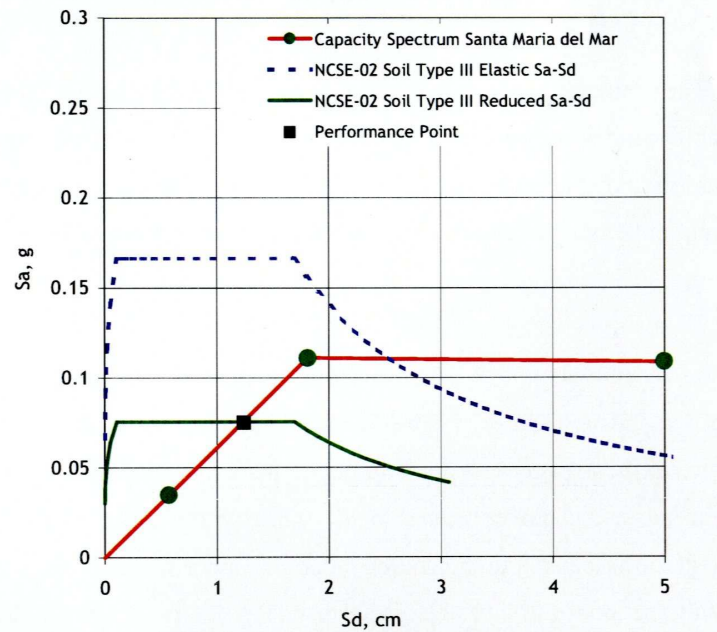
Once defined the capacity curve and the demand spectrum the damage of Sta.Maria del Mar was defined by obtaining the performance point, that is the intesection between the demand and capacity curves. In figures 2.46 to 2.48 this point is found fo the determinstic demand spectra, the probabilistic demand spectra and the demand spectra coming from the Spanish Seismic Code (NCSE-02, 2002). When intersecting out of the linear range a reduction of the demand spectrum has to be done in order to consider the same level of damping.

Figure 2.46 – Performance point considering a demand spectrum from Spanish Seismic Code (Irizarry, 2004)

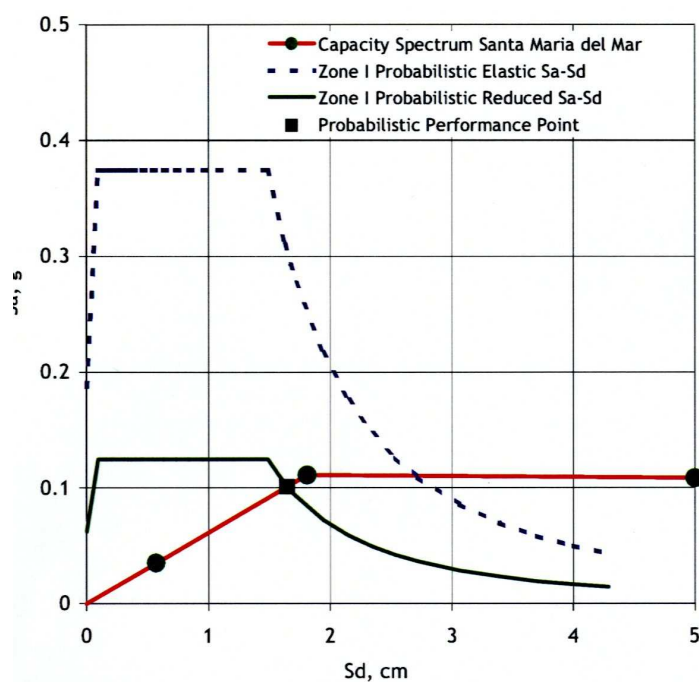
Figure 2.48 – Performance point considering a demand spectrum from probabilistic scenario (Irizarry, 2004)

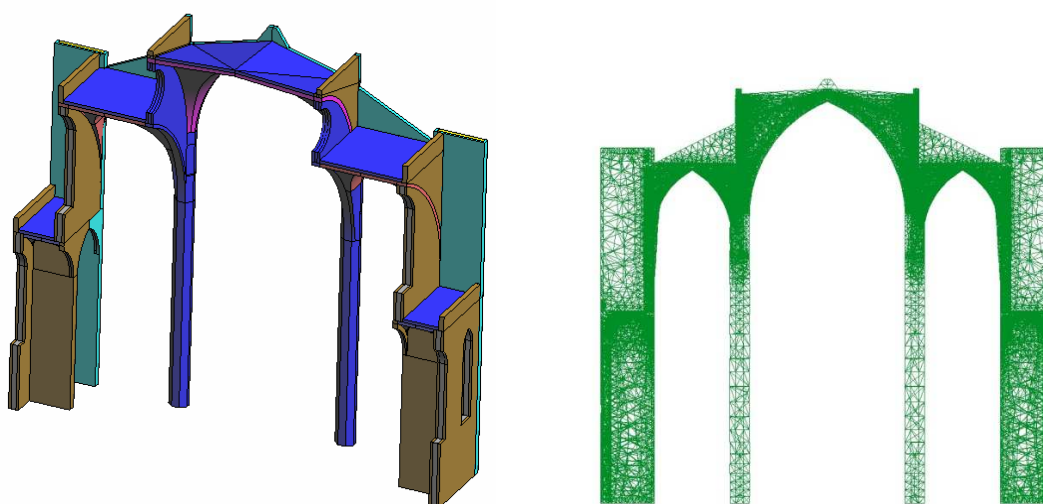
The numerical models were built using the information gathered from the inspection and NDT campaign done in this project: geometry, morphology and mechanical properties of materials. A FE model was built of half of a typical bay, considering appropriate boundary conditions to simulate symmetry (figure 2.49). The elastic properties of model have been validated using the dynamic test results, varying the stiffness of the materials until matching the experimental and numerical fundamental frequency. It was also verified that the stresses in the pier base from the model were similar to the real ones, found out by means of the NDT “holle drilling” test. Nonlinear material properties have been considered to take into account cracking in tension and crushing in compression of masonry. A smeared cracking model (simulating tensile behaviour) combined with a Drucker-Prager plasticity model (simulating compressive behaviour) have been used.

Figure 2.49 - FE model of typical bay: volumetric representation (left) and element discretisation (right) used by Roca (2007)

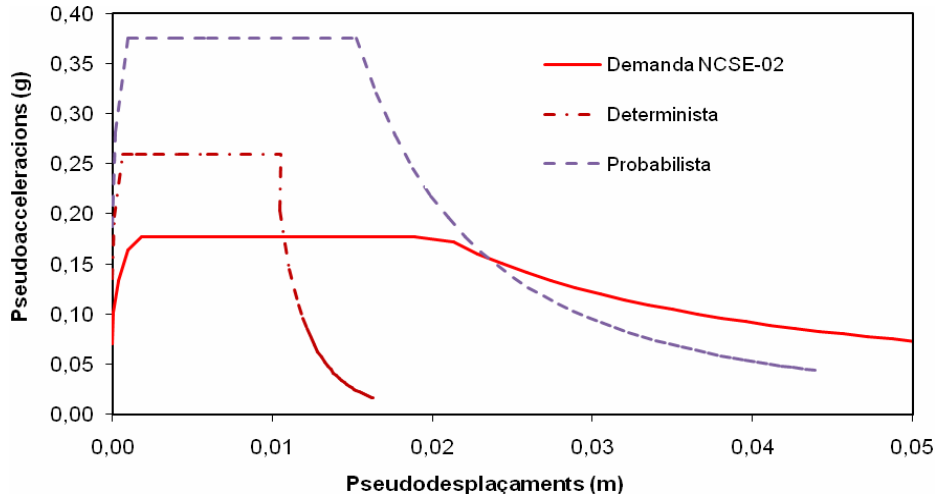
However, our main interest is focused in the seismic analysis carried out. For that purpose the following demand spectra have been considered: the deterministic and probabilistic demand spectra defined by Irizarry (2004) and the one obtained from the Spanish Seismic Code (NCSE-02, 2002). They are plotted in figure 2.50.

Figure 2.50- Demand spectra for the seismic study of Sta. Maria del Mar (Roca, 2007)

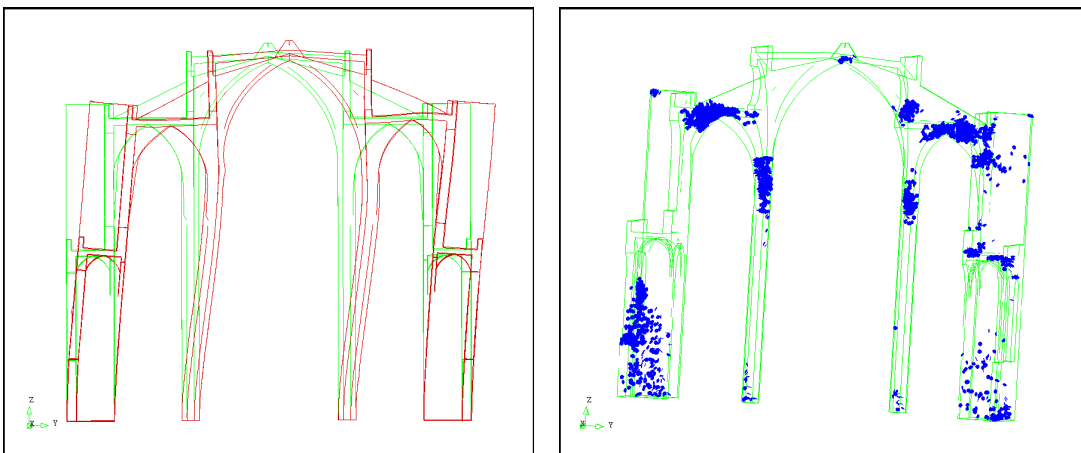
Figure 2.55 – Deformation and damage distribution for pushover in FEA (Roca, 2007)

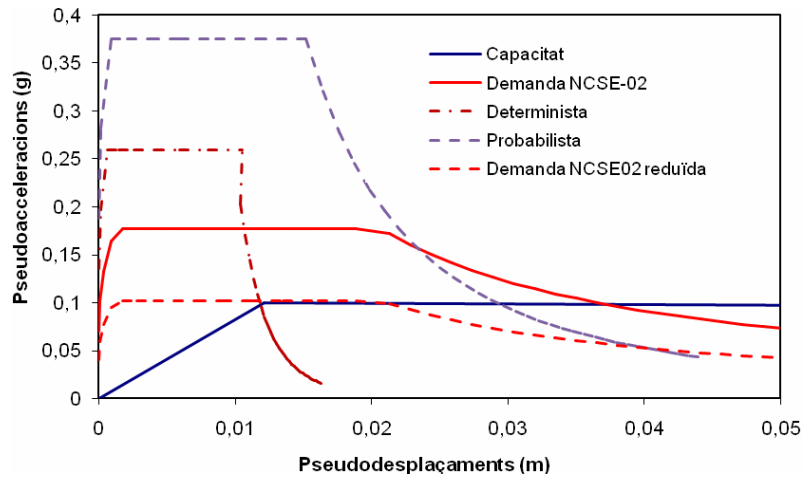
The Capacity Spectrum method was applied with the obtained demand and capacity spectra. Intersecting the capacity and demand curves it is possible to obtain the level of damage expected for an earthquake. The damage is expected to be reduced or moderate as the intersection point is near the elastic limit. Considering ductility, the curves are scaled and the damage is reduced, as shown in the figure 2.56.

Figure 2.56 – Capacity and different demand spectra: deterministic, probabilistic and Seismic code (Roca, 2007)

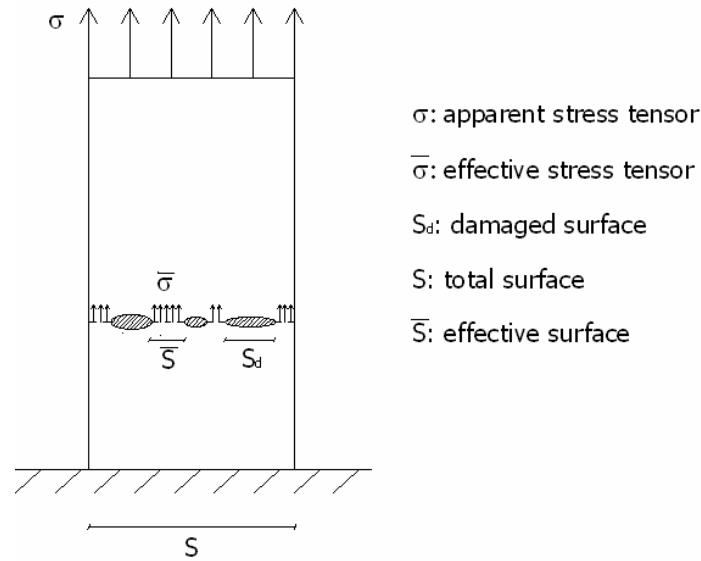
Physically, the material degradation can be interpreted as the result of an initiation of microcracks or microvoids. In this context, the damage variable can be defined as the relation between the ratio of damaged surface and the total surface of the section as shown in figure 3.1

Figure 3.1 – Physical interpretation of damage

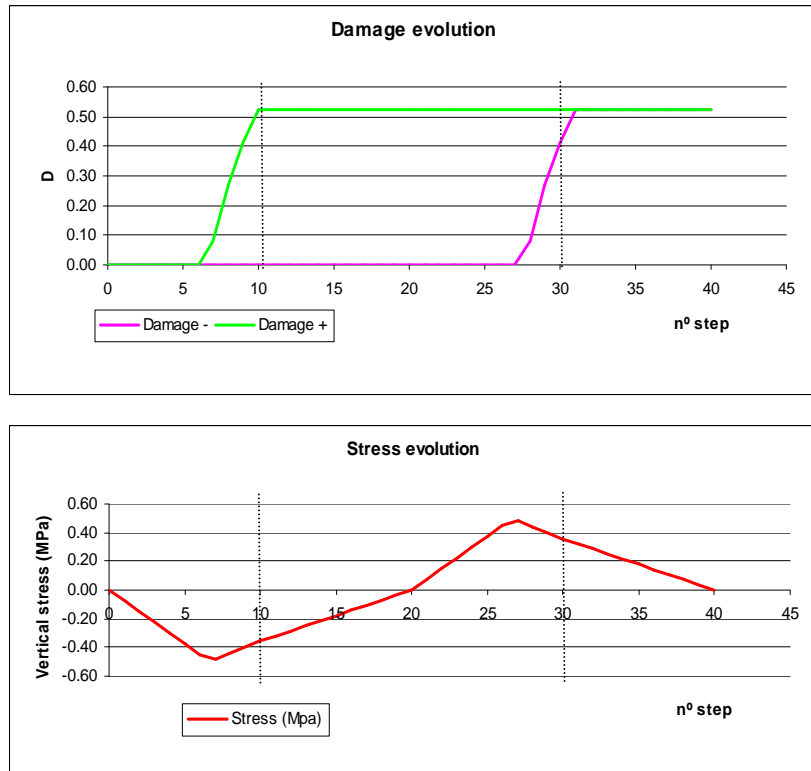
Different values have been given in order to understand and verify the constitutive model, namely the ratio between compression / tension strength and the fracture energy. For the given loading path two different compression / tension strength ratios have been chosen. The results are plotted in figures 3.5 and 3.6.

Figure 3.5 - Damage and vertical stress evolution for Compression / tension strength =1

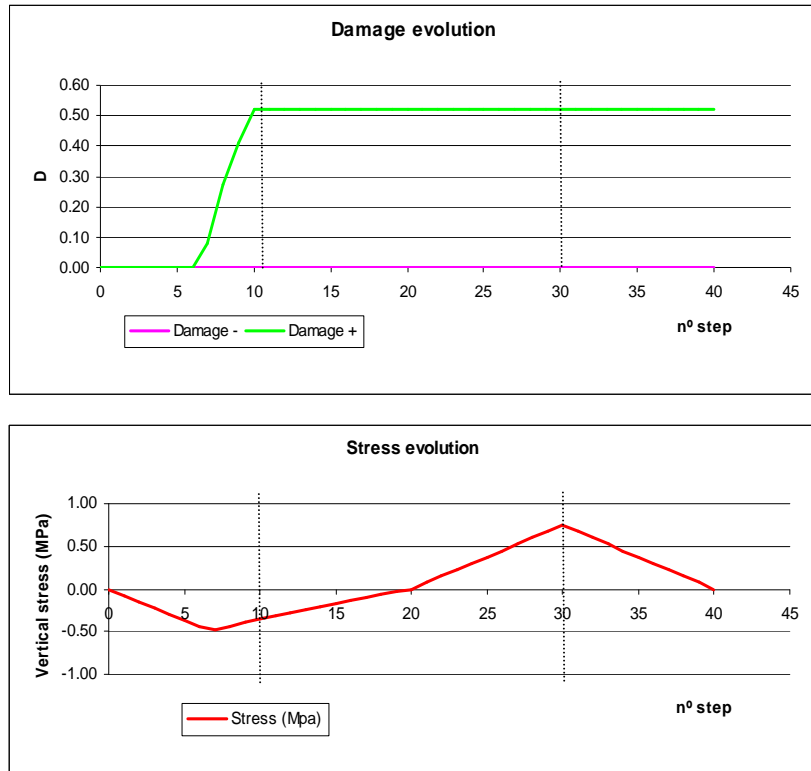
Figure 3.6 - Damage and vertical stress evolution for Compression / tension strength =2

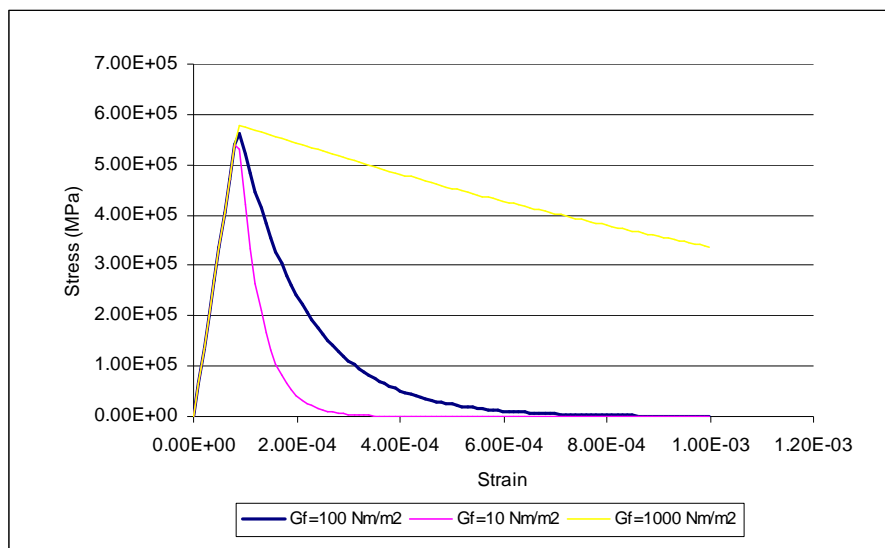
Regarding the fracture energy, it is a parameter defined to control the softening of the material (post-peak behaviour). Different values have been tested obtaining the curves plotted in figure 3.7.

Figure 3.7 Strain-stress diagram for different fracture energy values

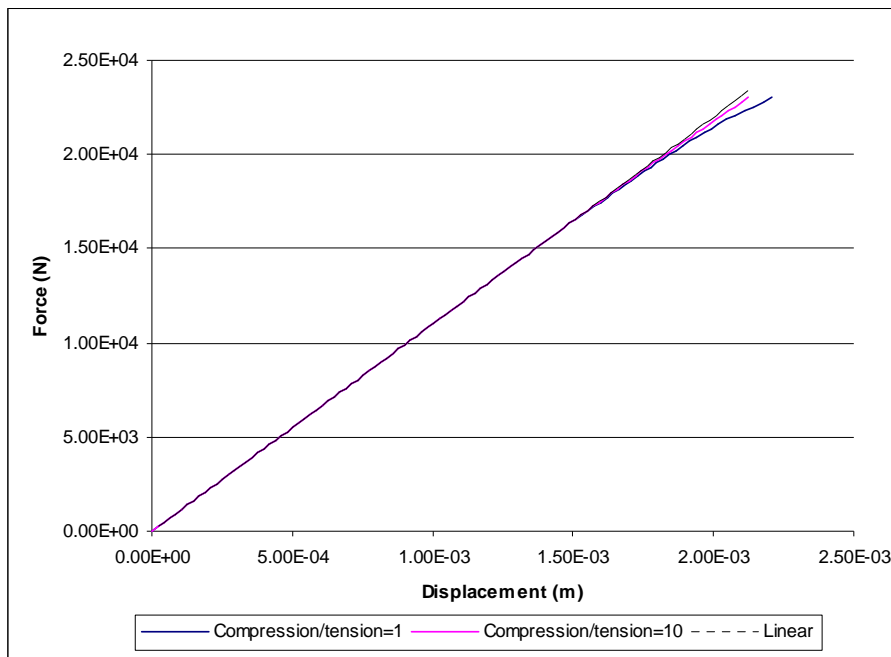
As shown in figures 3.8 and 3.9, considering damage ratio=10 the damage occurs in the base of the section only in the tensile area. This reduces the stiffness of the section with respect to the linear model, reaching higher displacements. For the ratio=1 starts to damage the compression and tension areas of the base, where the bending moment is maximum, more or less at the same level (figures 3.10 and 3.11). This reduces even more the stiffness of the section obtaining higher deformation, as shown in figure 3.12.

Figure 3.12 - Displacement- Force graph for cantilever subjected to horizontal force

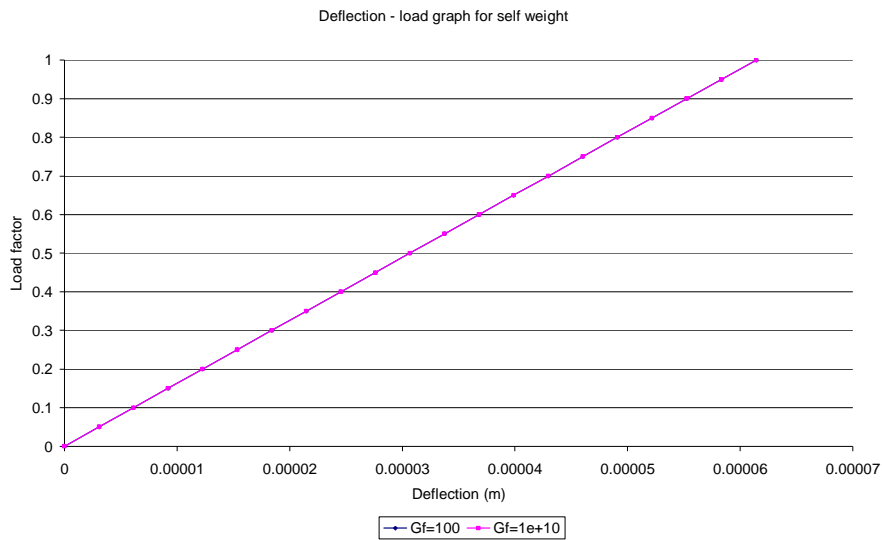
As shown in figure 3.13, the relation deflection-load remains linear while the self-weight is being applied. In both cases the result is the same as the nonlinear range is not reached. As the arch starts to carry the point load at $\frac{1}{4}$ span the load curve becomes non linear (figure 3.14) because the arch starts to be damaged. The result for infinite fracture energy gives a higher strength (Load factor=1.52 against 1.35) because even if damaged the masonry can keep on carrying tension.

Figure 3.13 - Deflection – load factor for self weight

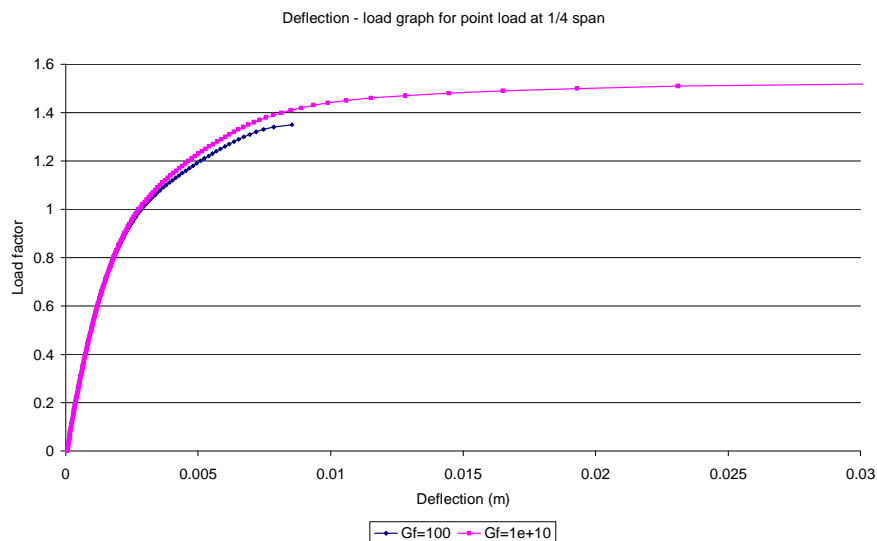
Figure 3.14- Deflection – load factor for $\frac{1}{4}$ span point load

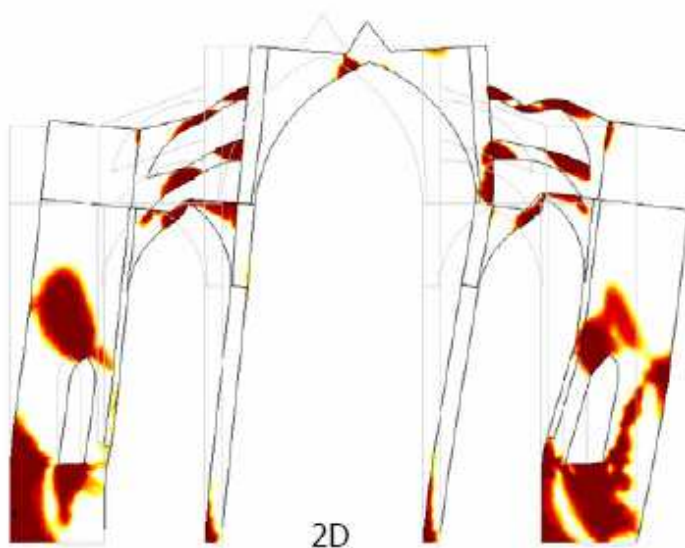
The structure was found to resist around 2 times its self weight, according to both models. The seismic performance of the building is assessed by means of a push-over analysis consisting of the gradual application of a system of lateral equivalent static forces on the structure distributed according to the mass. The continuous damage model predicts failure for a seismic coefficient of 0.10g while the localized damage model a between 0.12g and 0.14g depending on parameters related to the crack formation. The localized cracking model produces a higher failure load factor due to the restrictions that the model imposes to the propagation of damage (as compared in figures 3.25 and 3.26)

Figure 3.25– Collapse mechanism and tensile damage distribution for seismic load using a continuous damage model (Clemente, 2006)

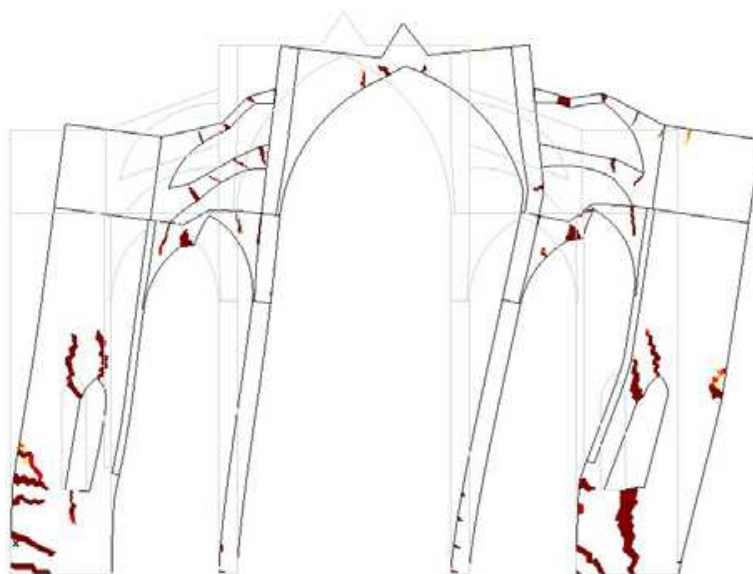
Figure 3.26– Collapse mechanism and tensile damage distribution for seismic load using a localized damage model (Clemente, 2006)

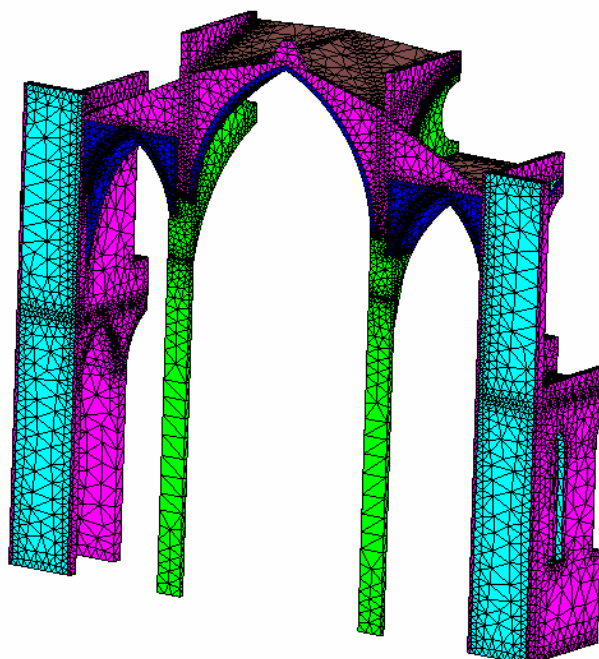
Both the geometry and FE meshing of the typical bay have been imported from the model used by Roca (2007). It consists in a 3 dimension model with 130.453 tetraedrical elements of 4 nodes representing half of the typical bay, introducing the convenient boundary conditions to consider symmetry (figure 4.1). Studying a portion of the building in a seismic analysis is a simplification, but it has been considered sufficiently accurate for the transversal behaviour of the structure. From the experimental modal analysis (Roca, 2007), the bays seemed to have similar dynamic behaviour independently from their position in the church (near the façade or the crossing).

Figure 4.1 - FE model of Santa Maria del Mar

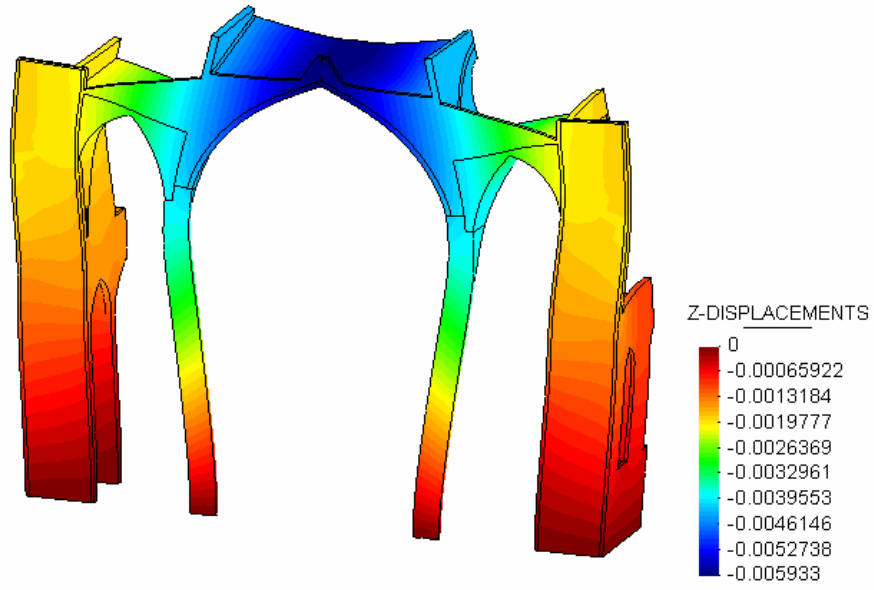
A linear elastic analysis with gravity load and a modal analysis have been carried out to test the model. The first one was done for verification of the model. The obtained results (deformed shape and stress distribution) give realistic values (figure 4.2 to 4.4). The maximum tensions in the vaults (0.65N/mm^2) are a little bit higher than their tensile strength (0.4N/mm^2), but this will be solved with the nonlinear analysis by developing little damage. The maximum deflection (almost 6mm in the key of the central vault) or the maximum vertical stress (3.3 N/mm^2 in the base of the columns), are realistic and assumable values. A nonlinear geometric analysis has been carried out and the obtained values for stresses and displacements are almost identical (difference <0.2%) as the structure is not so slender. As a result, this feature won't be taken into account in following analysis to simplify this analysis.

Figure 4.2 - Vertical displacement under self- weight in m (maximum deflection: 5.9 mm)

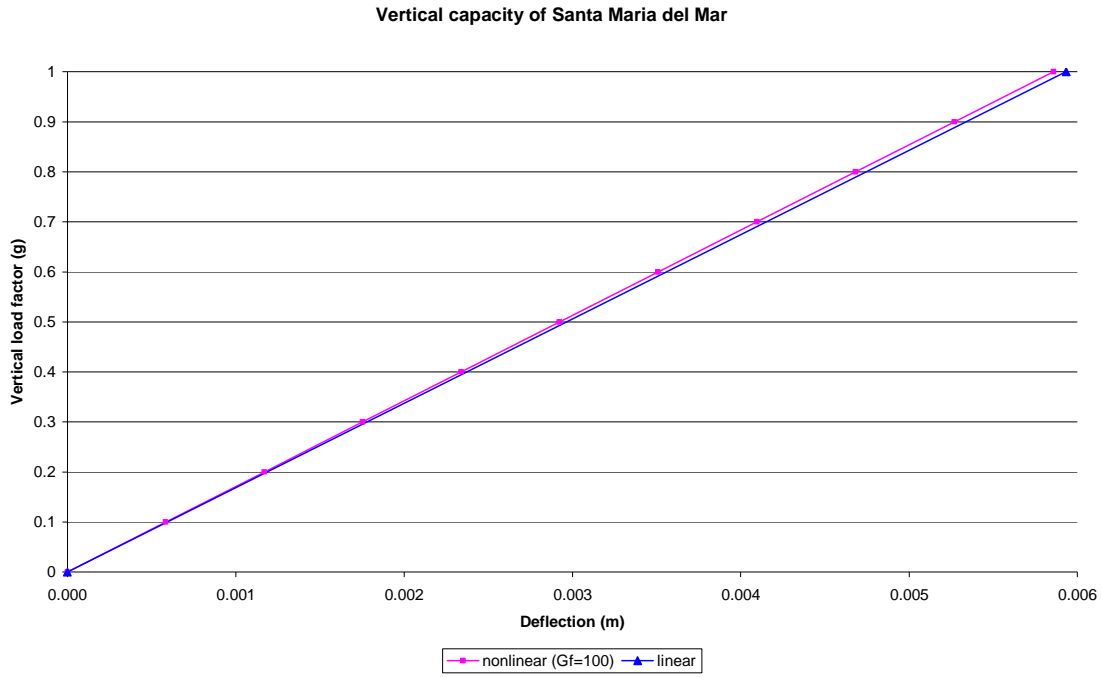
A material nonlinear FE analysis has been done for the gravity load. As shown in figure 4.7 there is a very slight difference between the deflection in a linear and a nonlinear analysis (vertical displacement distribution is shown in figure 4.8). This is due to the slight damage that appears in the corner of the triangular walls above the lateral vaults, as shown in figures 4.9 and 4.10. This damage is caused by the eccentricity of the thrust line, creating tension and cracking.

Figure 4.7 – Deflection in central vault – Load Factor graph

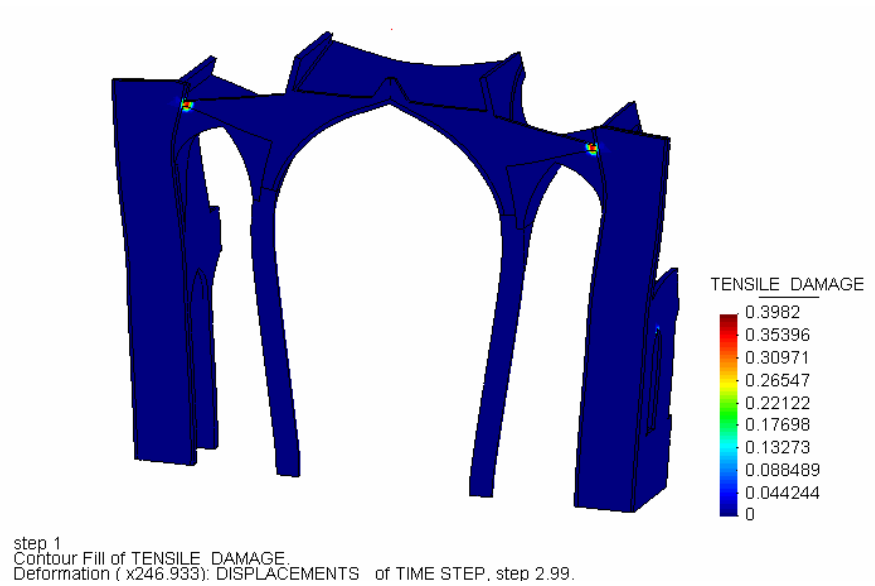
Figure 4.9– Tensile damage distribution due to gravity load

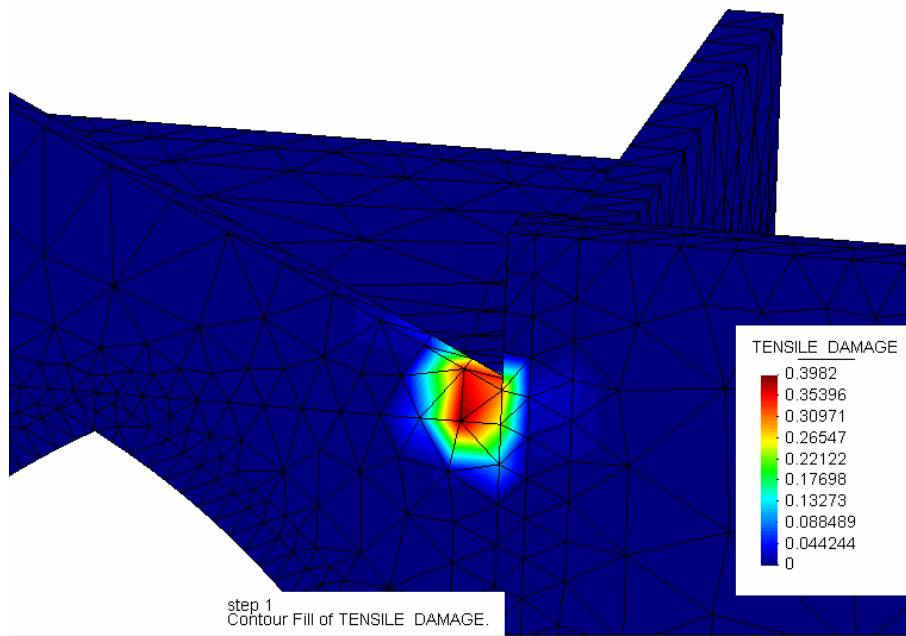
Figure 4.10– Detail of the tensile damage in the triangular wall

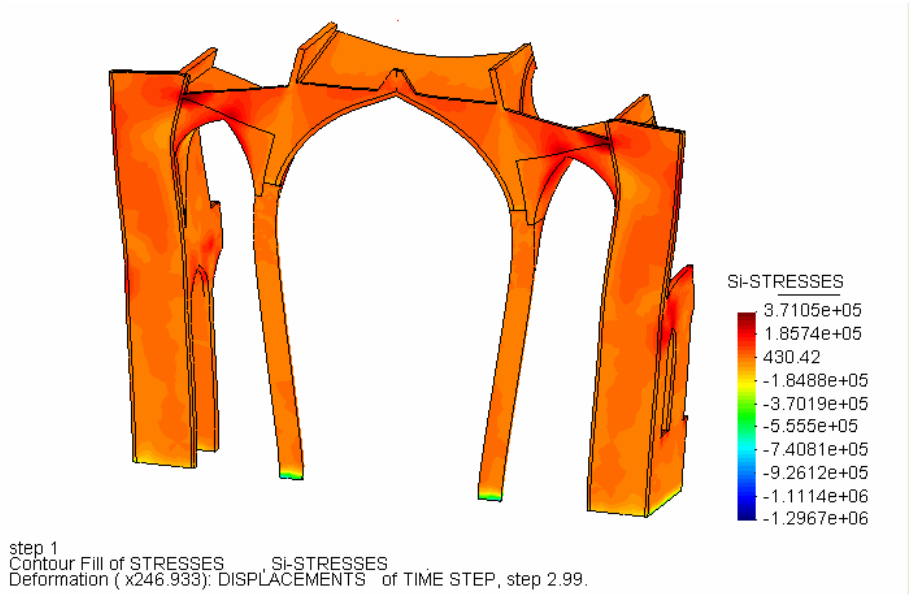
Regarding the stresses, we can observe that the higher tension stresses are concentrated in the damaged areas (figure 4.11). Of course, these stresses are equal or lower than the tensile strength: in the case of the vaults that means 0.4 MPa. The average vertical compression in the base of the piers is 2.8MPa, while the maximum is 3.3MPa (41% of their resistance), as shown in figure 4.12. These values are similar to the stresses measured with the “hole drilling” test: an average of 2.9MPa and a maximum of 3.8MPa (Roca, 2007). No damage is found in compression.

Figure 4.11 – Maximum principal stresses for gravity load in N/m^2 (maximum tensions)

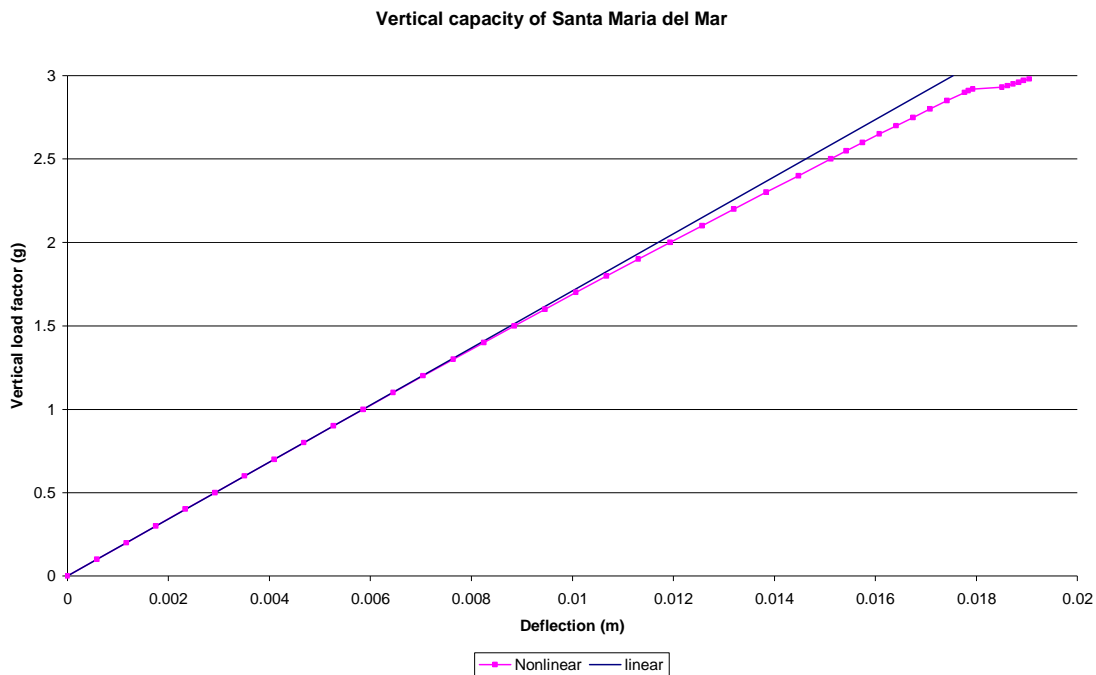
In order to study the safety of the structure, the self-weight has been increased up to collapse. The load factor obtained at the collapse of the structure is not exactly a safety factor as the structure will never be subjected to an extra vertical load with these characteristics. However, it gives a qualitative idea about the safety of the structure. In the case of Santa Maria del Mar Church, the structure would collapse for almost 3 times the self-weight of the structure (figure 4.13). This is quite a big value and it gives an idea of a large safety margin to resist vertical loads. Clemente et al. (2006) obtained a load factor of 2 for Mallorca Cathedral, using a FEA with the same constitutive model. This difference makes sense, as Mallorca cathedral is a more slender construction.

Figure 4.13 – Deflection – Vertical load factor graph up to failure

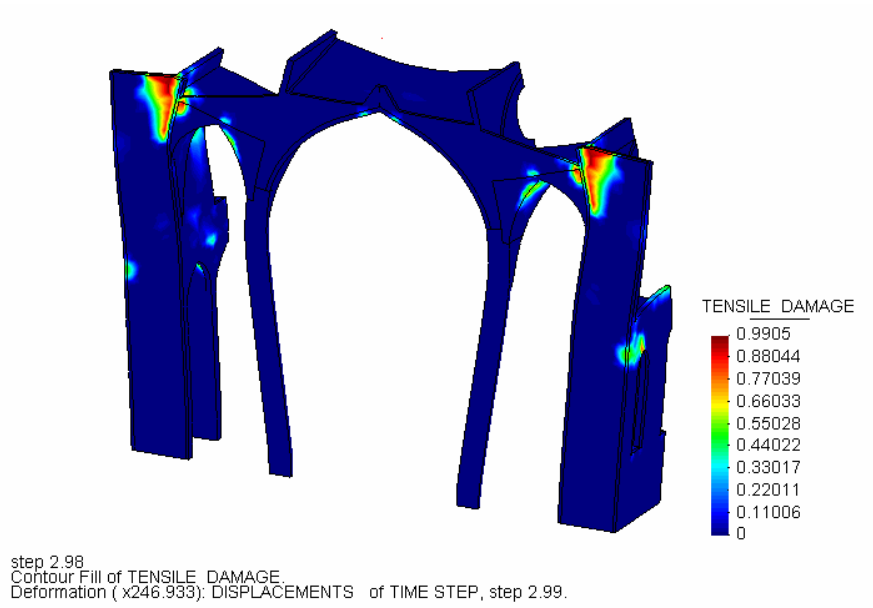
As the load is increased, the structure is damaged in a continuous way but doesn't show a clear trend to plastification. At a load factor next to 3, it was impossible to reach convergence. Just before collapse, the damage distribution is shown in figure 4.14. There is a big damage in tension in the upper side of the lateral vaults. However, there are not enough hinges to develop a collapse mechanism. What in fact leads to collapse is the fragile compressive failure of the piers, before hinges could develop. As presented in figures 4.15 and 4.16 the vertical stresses of the pier have reached the compressive strength (8MPa) in almost the whole base a generating big damage. As it is impossible to redistribute the load, the structure would collapse in a sudden way.

Figure 4.14 – Tensile damage distribution for LF=3

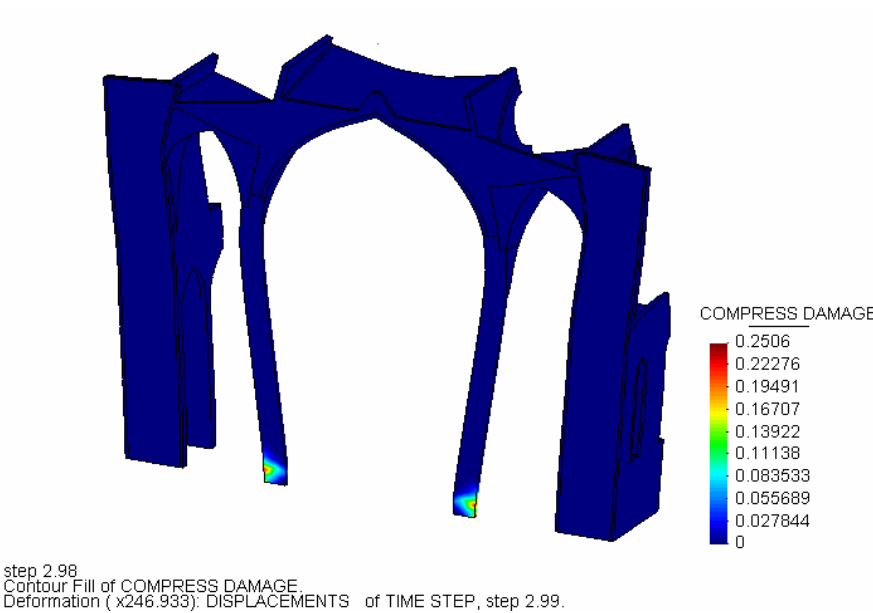
Figure 4.14 – Compressive damage distribution for LF=3

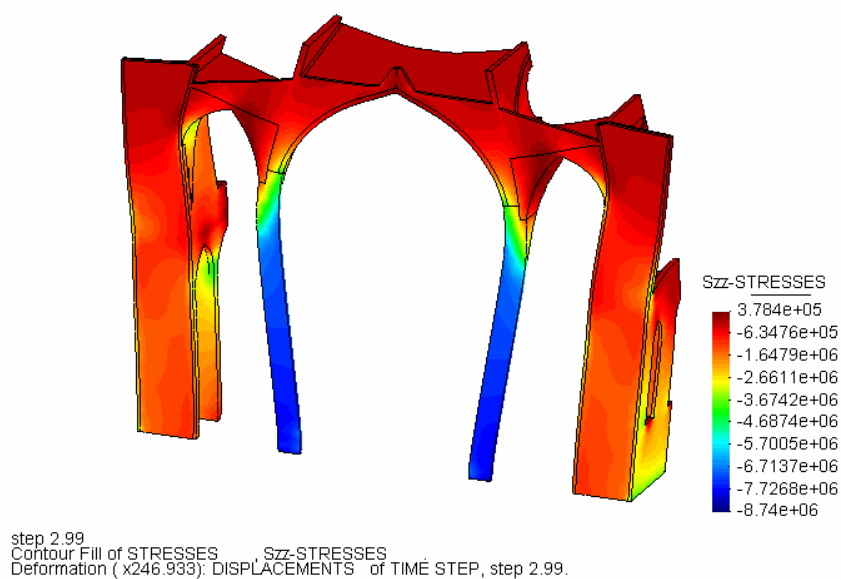
Figure 4.14 – Vertical stresses in in N/m^2 for $\text{LF}=3$

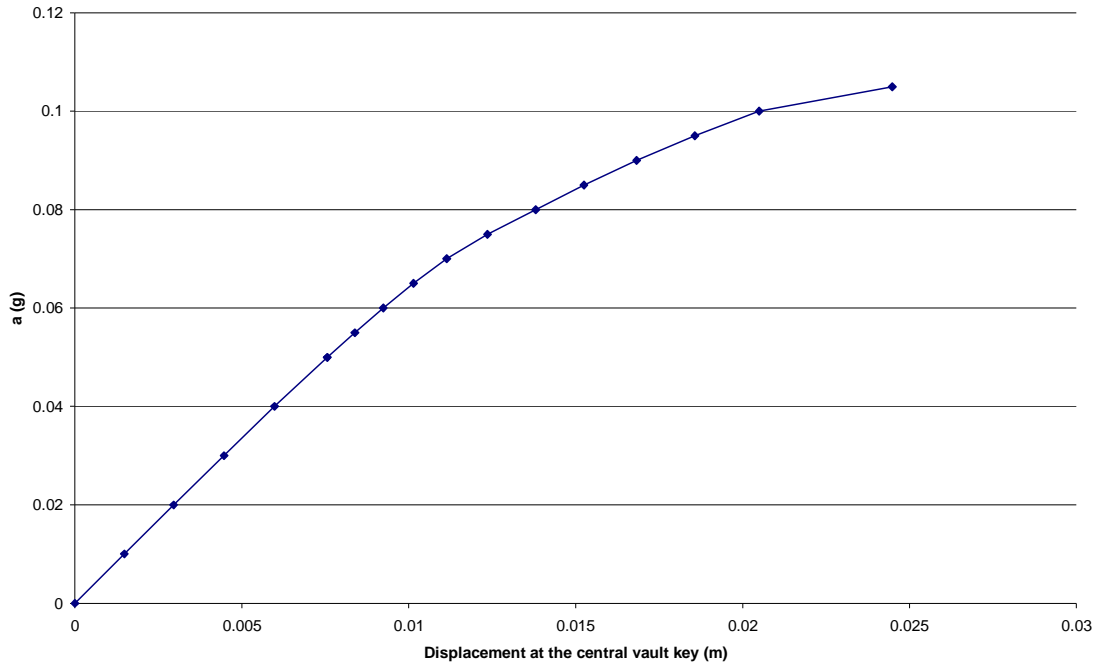
1. For a horizontal load proportional to the mass distribution, the obtained capacity curve is plotted in figure 4.15. Non convergence is reached for 0.105 g. As the curve becomes flat and a peak is expected for a close load. Therefore, collapse is expected for a very close value. As the pushover is load-controlled no information about the post-peak behaviour can be obtained.

Figure 4.15 – Capacity curve for a load distributed according to the mass

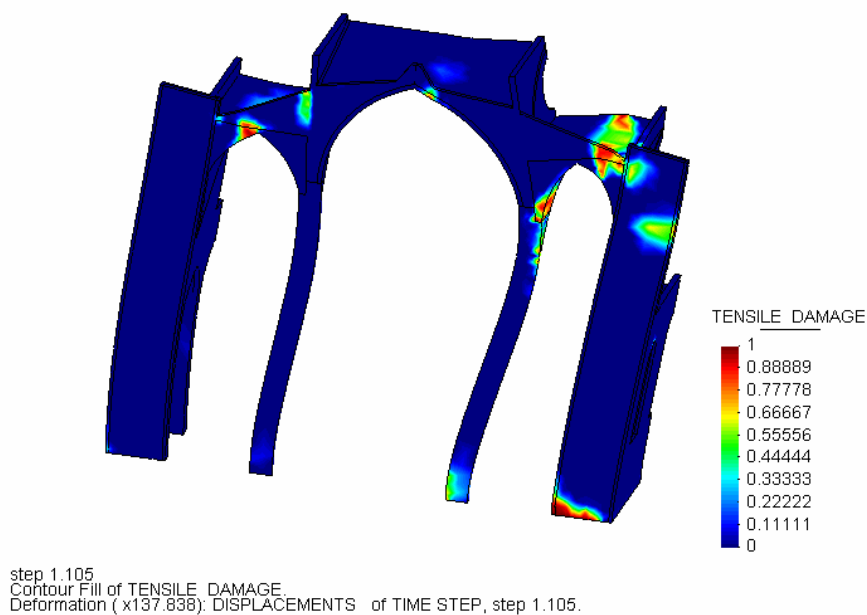
Figure 4.16 – Tensile damage distribution for s=0.105g

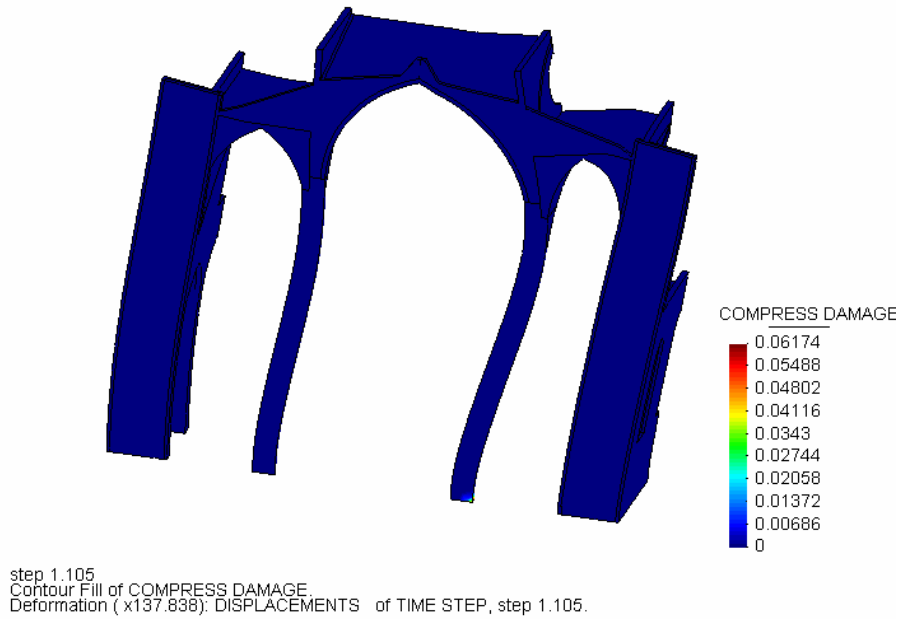
Figure 4.17 – Compressive damage distribution for $s=0.105g$

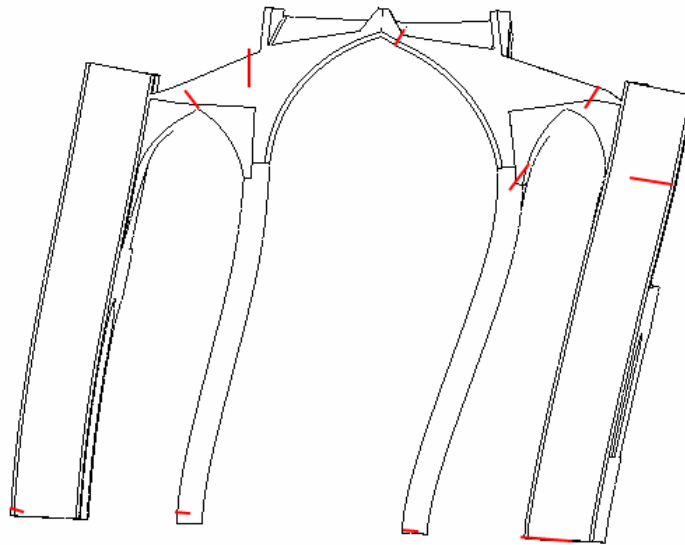
Figure 4.18 –Cracking Pattern
