Master's Thesis

**Seismic Analysis of Santa Maria
del Mar Church in Barcelona.**

Title of the Msc Dissertation: Seismic Analysis of Santa Maria del mar Church in Barcelona
Supervisor(s): Pere Roca Fabregat
Year: 2008

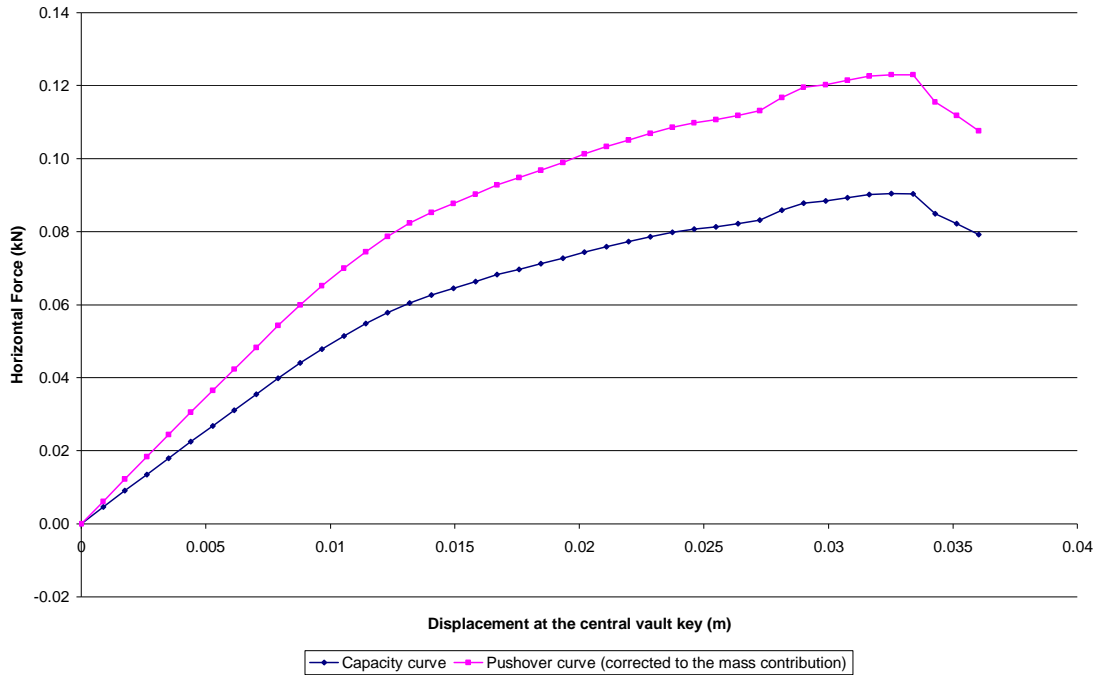
Figure 4.19 – Capacity curve for a load distributed according to the 1st mode

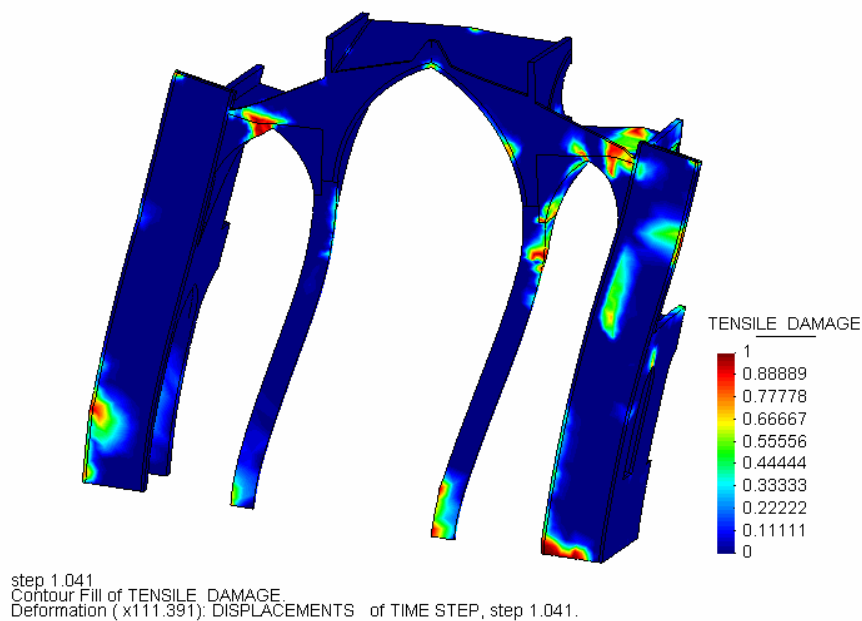
Figure 4.20 – Tensile damage distribution for s=0.12g

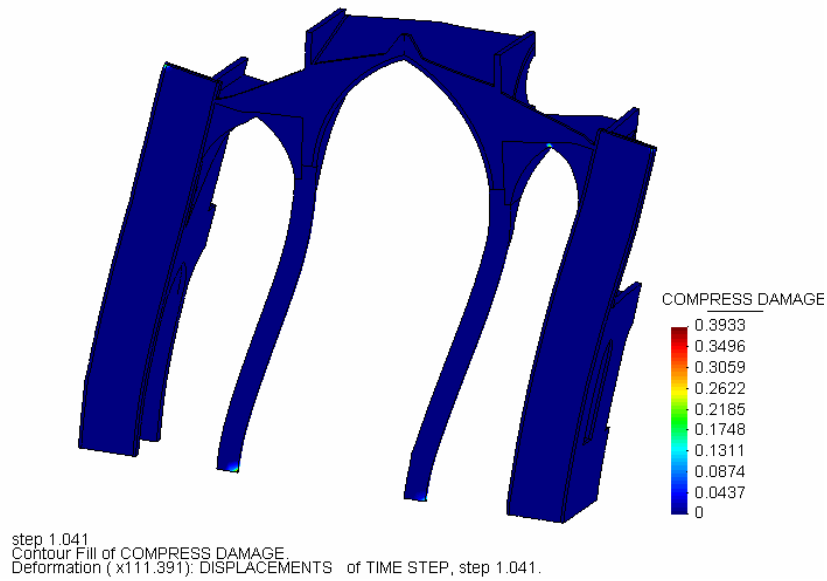
Figure 4.21 – Compressive damage distribution for $s=0.12g$

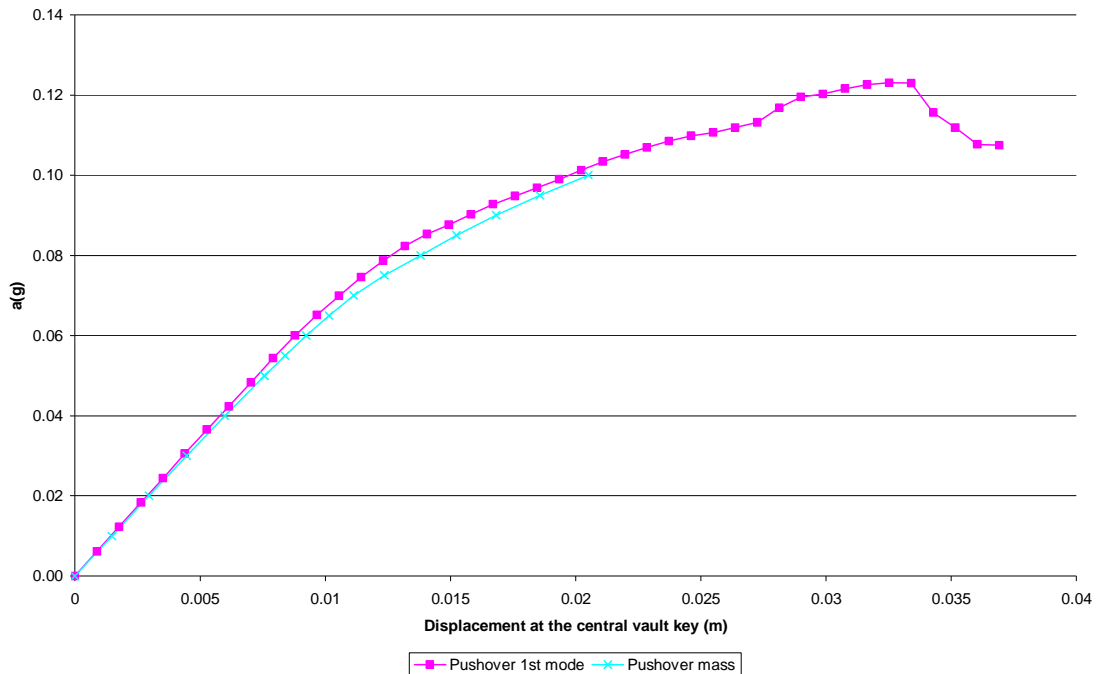
Figure 4.22 – Comparison between capacity curves

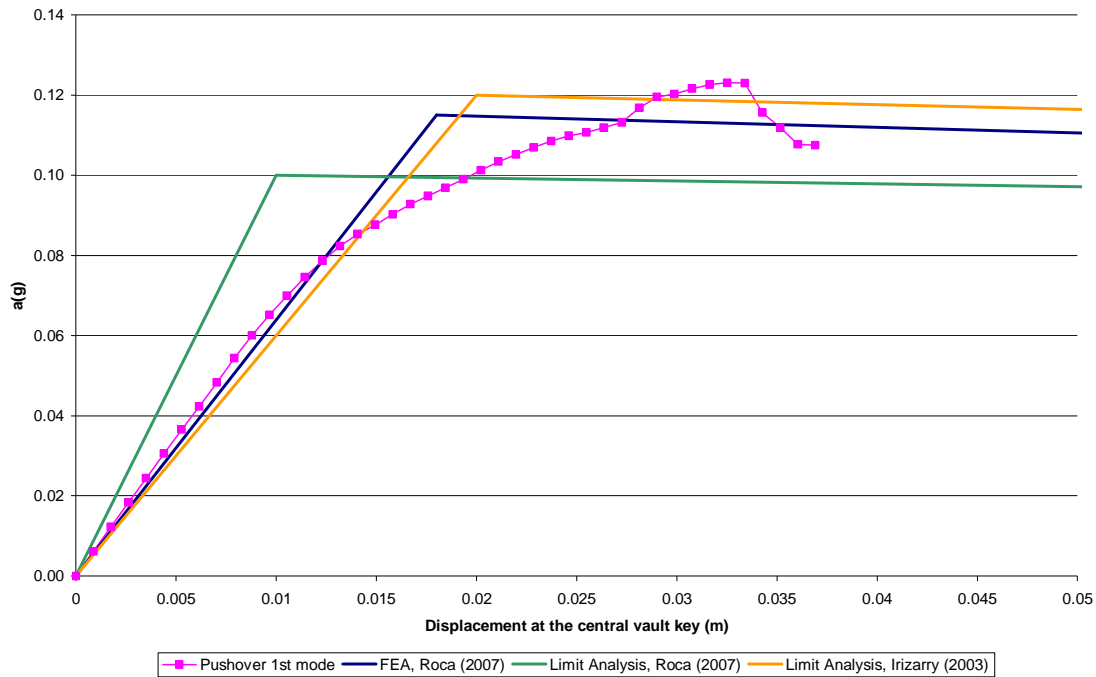
Figure 4.23 – Comparison between capacity curves obtained by different authors

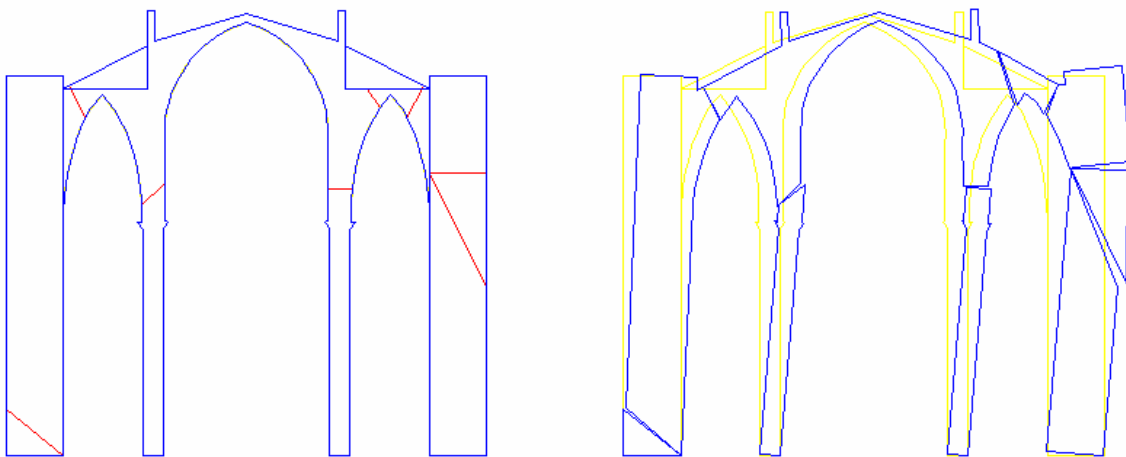
Figure 4.24 – Predicted crack pattern and collapse mechanism

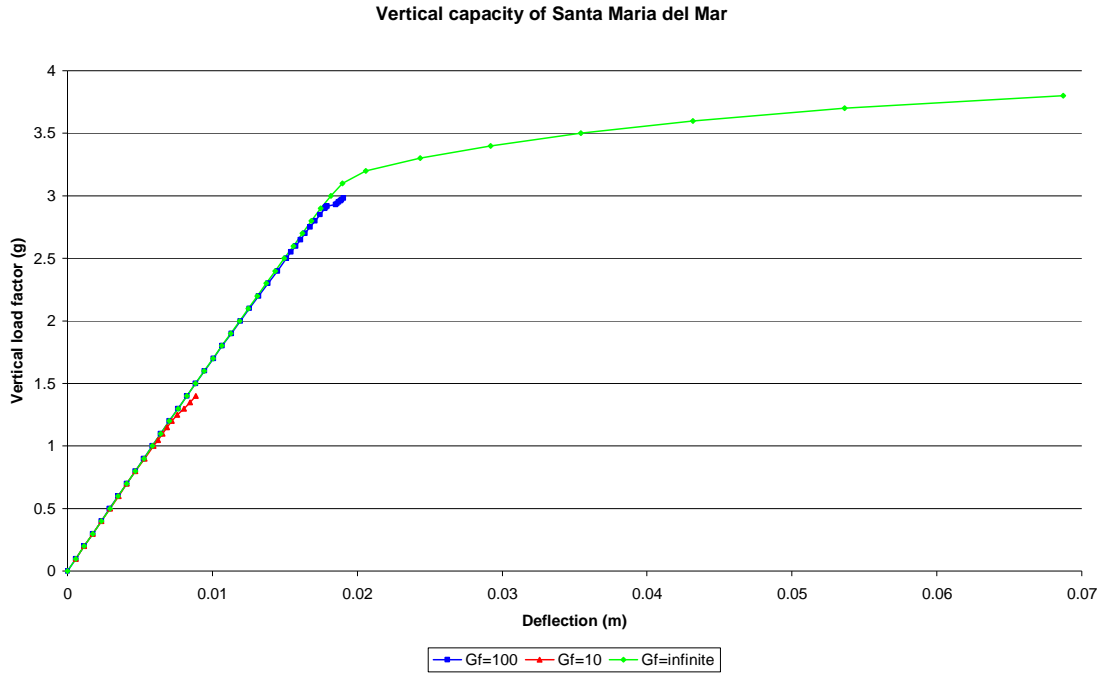
Figure 4.27 – Deflection – vertical load factor plots obtained with different G_f

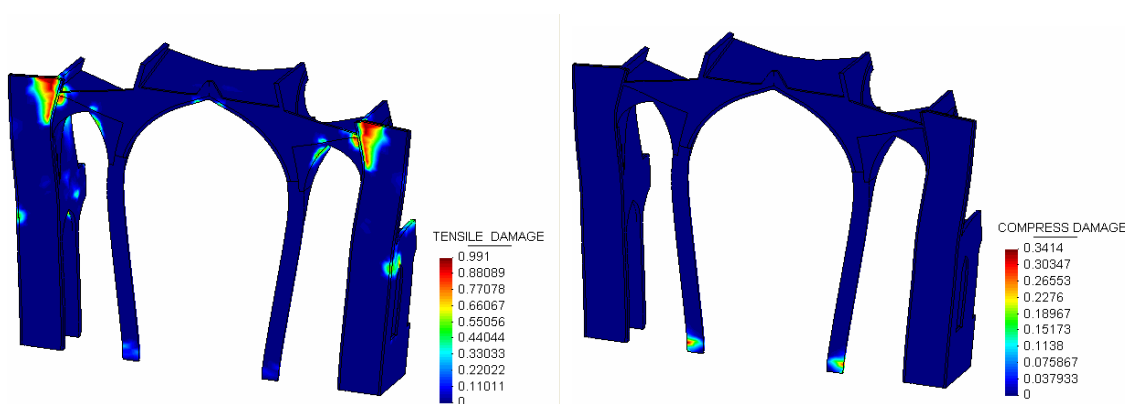
Figure 4.28 – Damage map for $G_f = 0.01\text{Nmm/mm}^2$ at LF=3

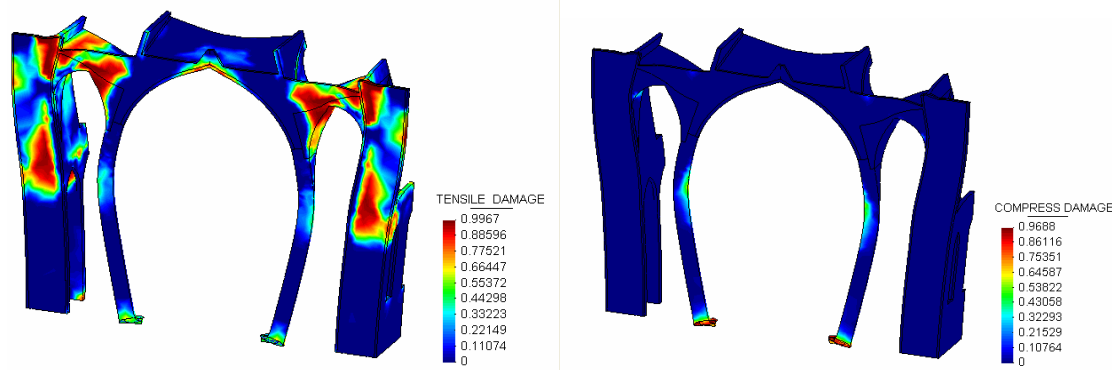
Figure 4.29 – Damage map for infinite G_f at $LF=3.8$

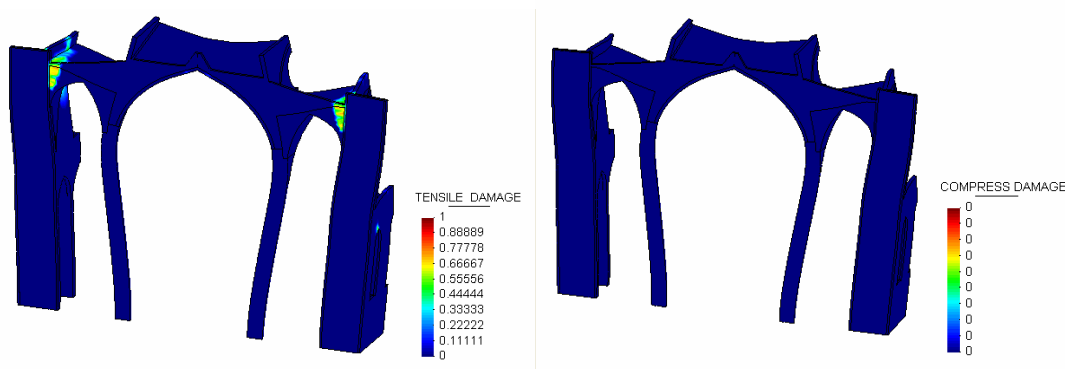
Figure 4.30 – Damage map for $G_f = 0.1 \text{Nmm/mm}^2$ at $LF=1.4$

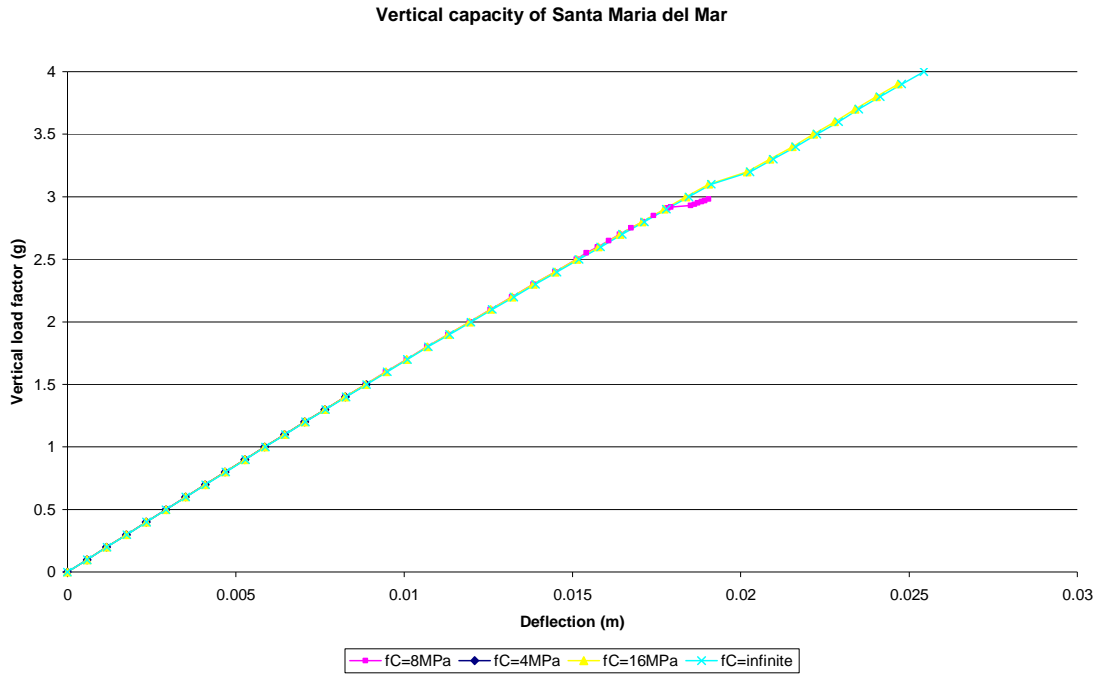
Figure 4.31 – Deflection – vertical load factor plots obtained with different f_c

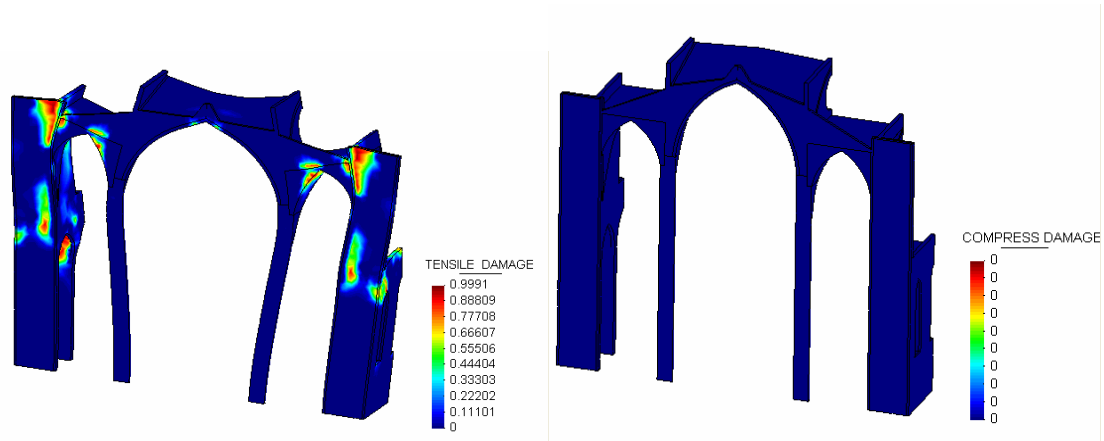
Figure 4.33 – Damage map for infinite f_c

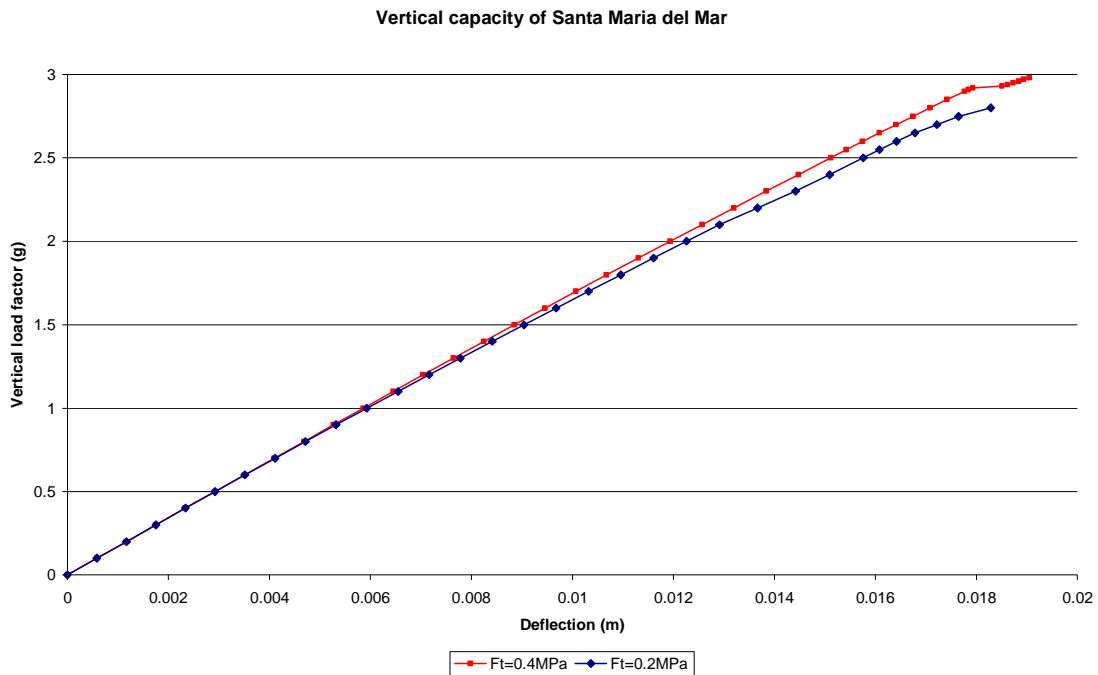
Figure 4.34 – Deflection – vertical load factor plots obtained with different f_t

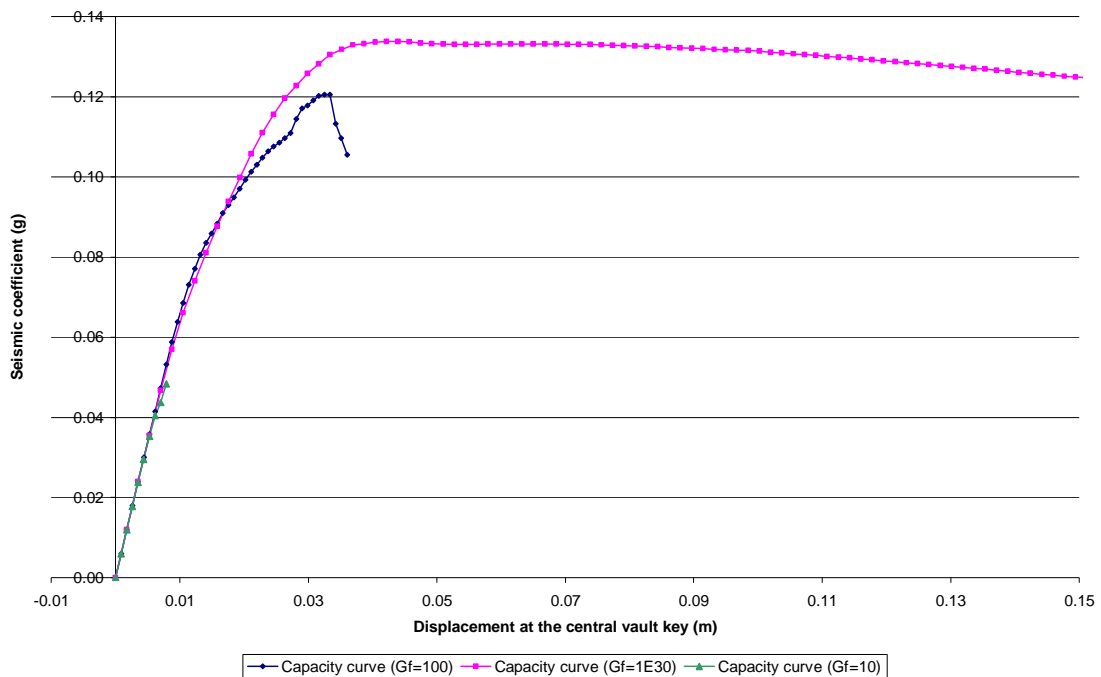
Figure 4.35 – Capacity curve obtained with different G_f

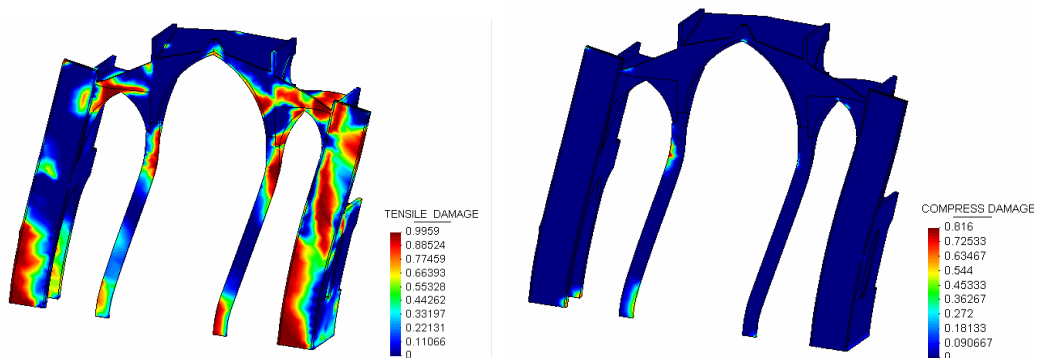
Figure 4.37 – Damage map for $G_f = 0.01 \text{ Nmm/mm}^2$ at $d = 0.15 \text{ m}$

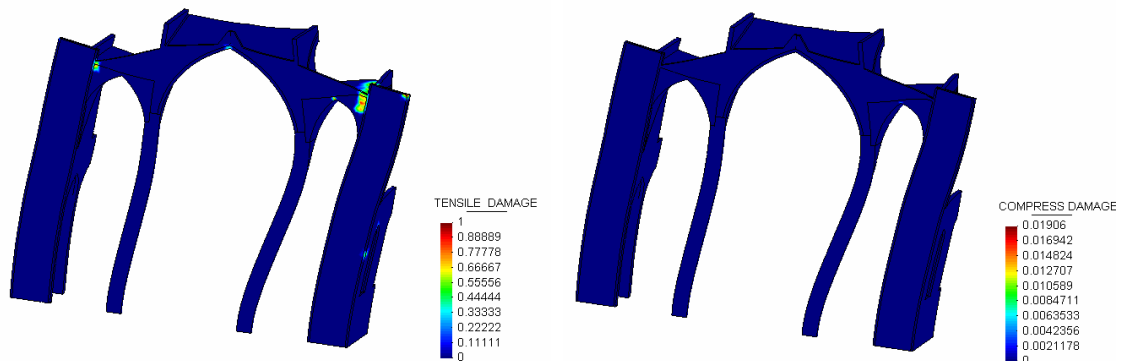
Figure 4.38 – Damage map for $G_f = 0.1 \text{ Nmm/mm}^2$ at $d = 0.008 \text{ m}$

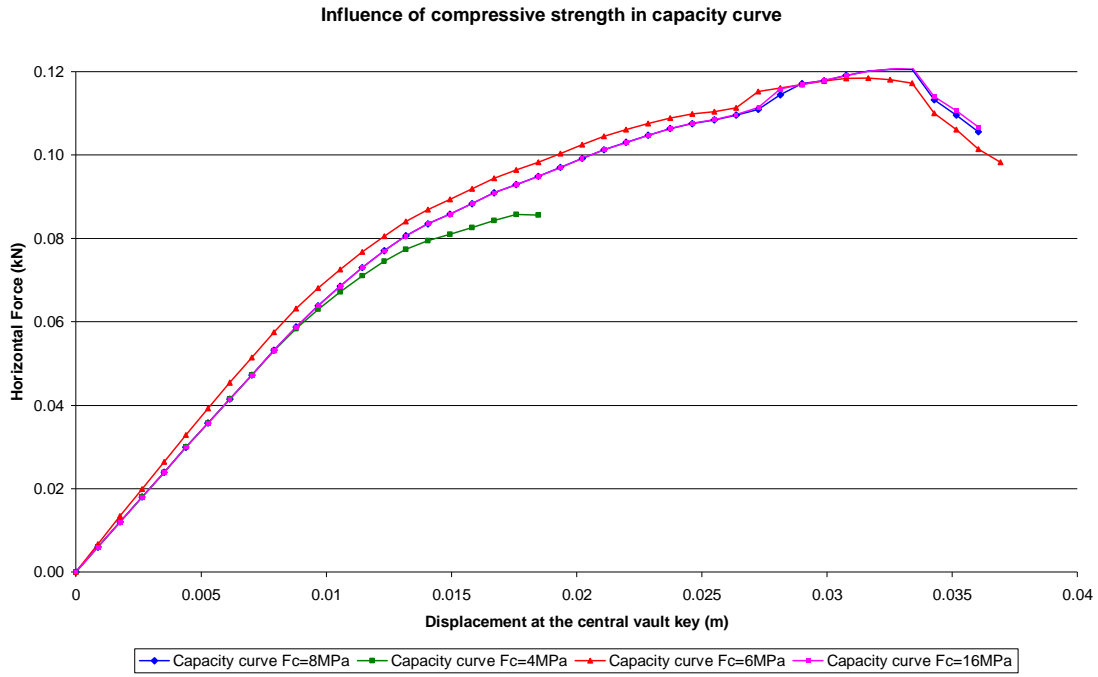
Figure 4.39 – Capacity curve obtained with different f_c

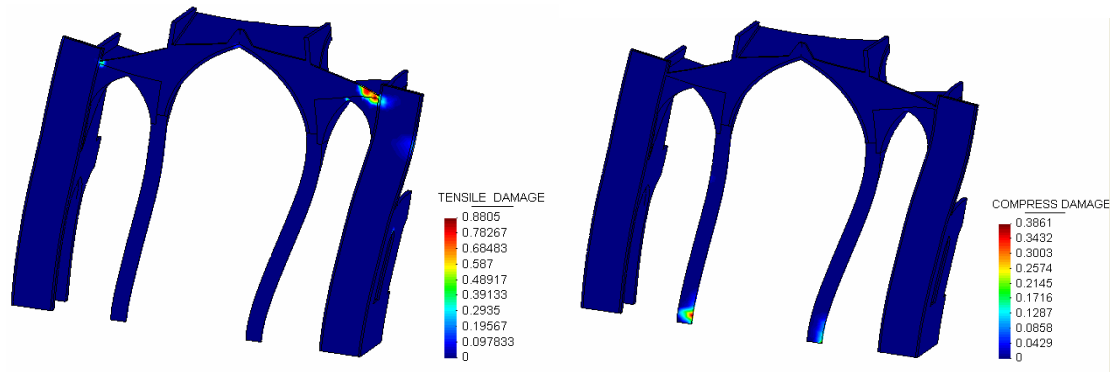
Figure 4.41 – Damage map for $f_c = 3\text{MPa}$ at $s=0.04g$

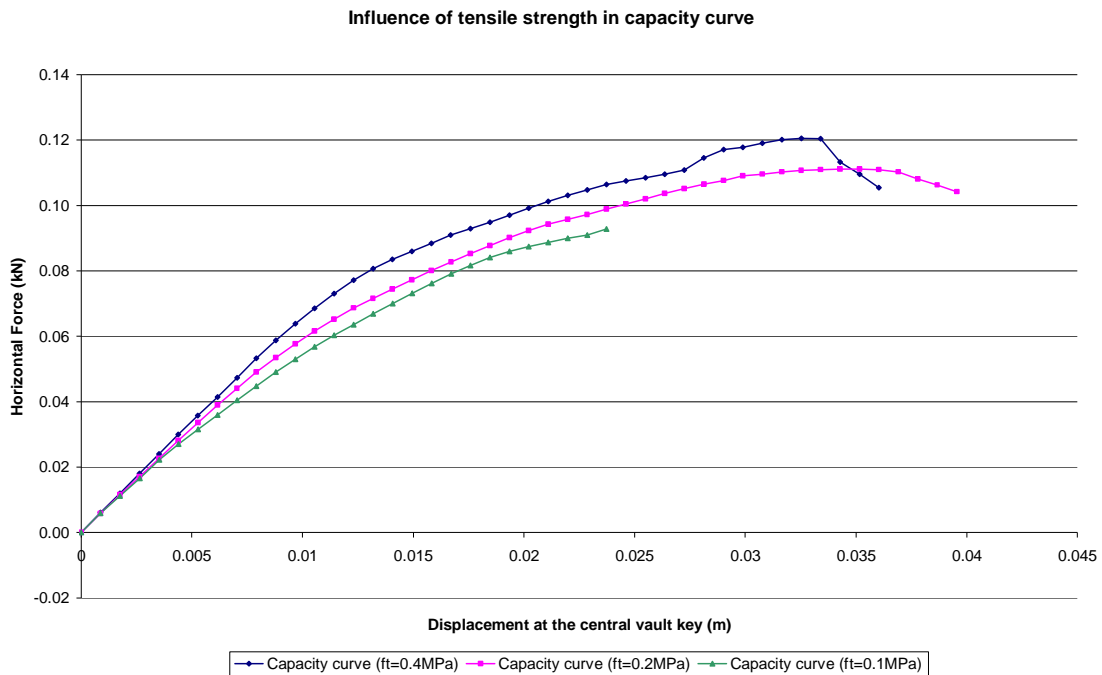
Figure 4.42 – Capacity curve obtained with different f_t

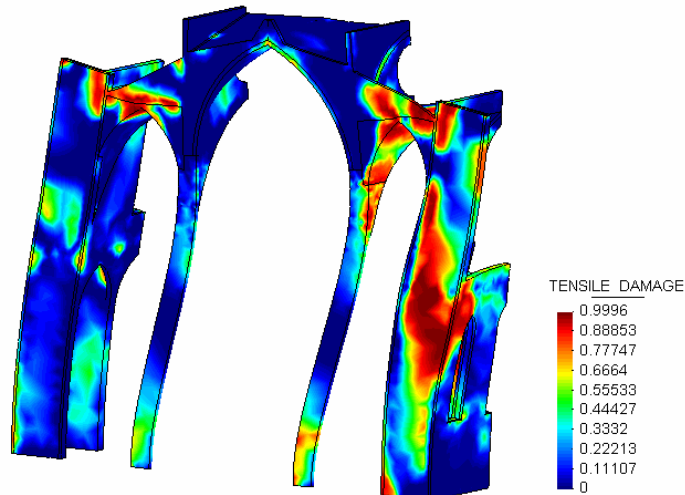
Figure 4.43 – Damage map for $f_t = 0.1\text{MPa}$ at $s=0.09g$

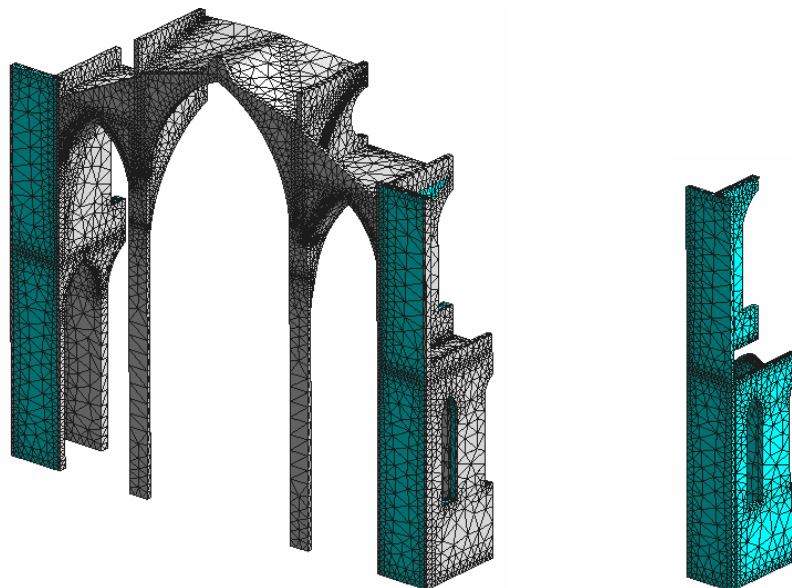
Figure 4.44 – Injected volume (buttress infill)

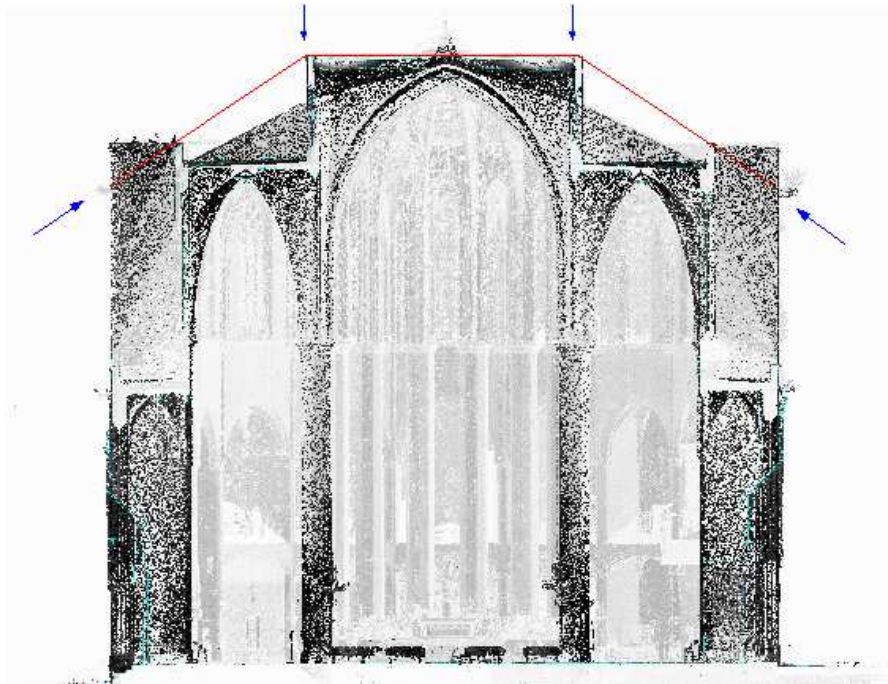
Figure 4.45 – Prestressing cables and equivalent forces

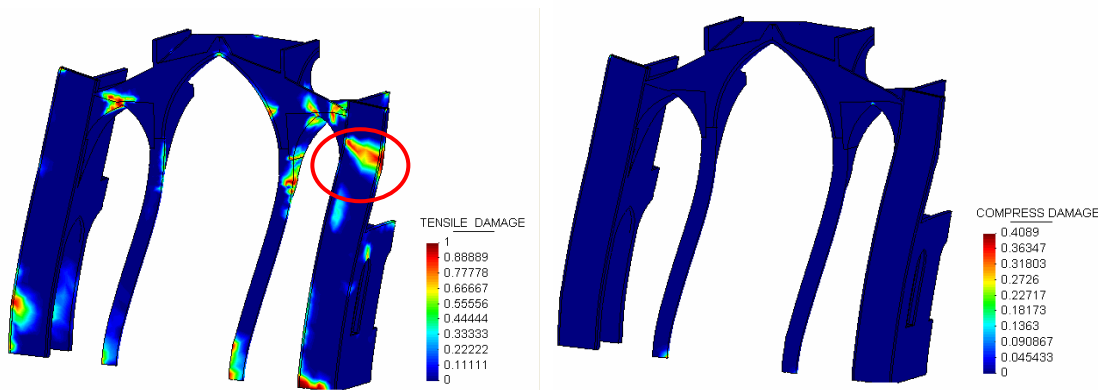
Figure 4.49– Damage map for prestressed section

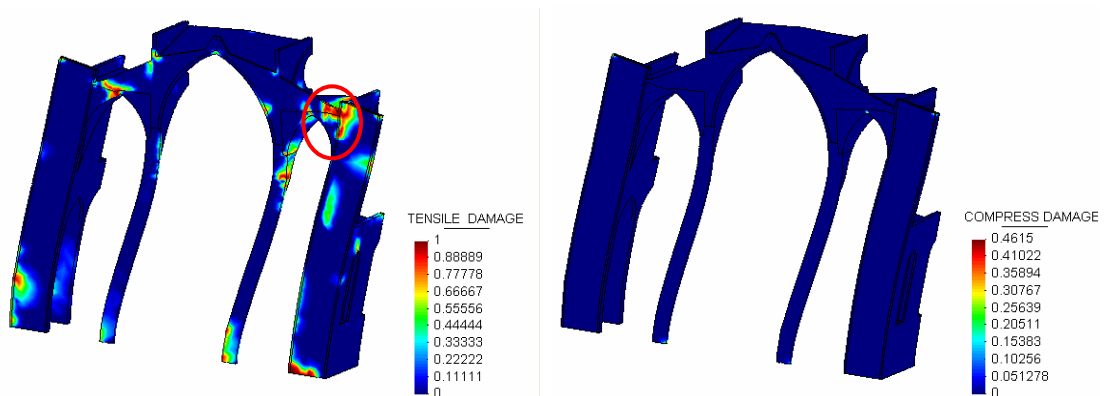
Figure 4.50 – Damage map for section strengthened with tie

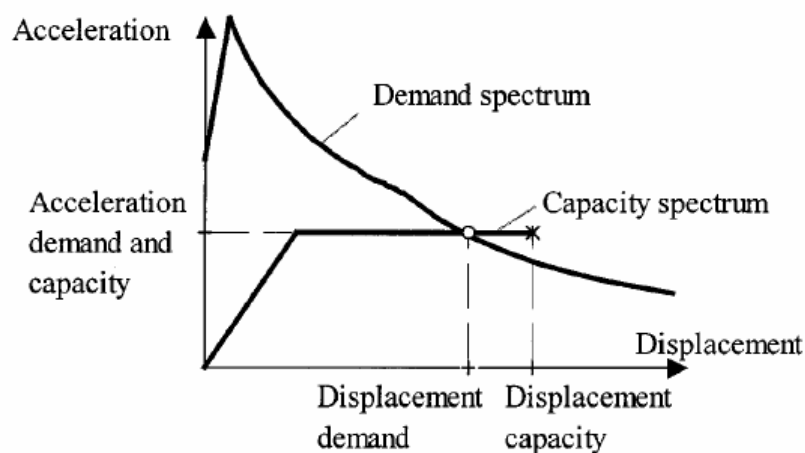
Figure 5.1- Capacity spectrum method, Fajfar (1999)

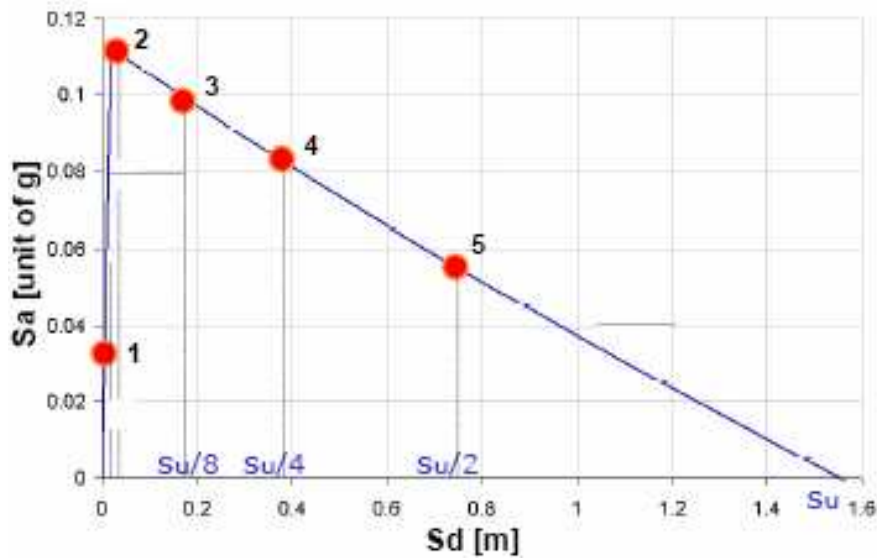
Figure 5.2 – Damage thresholds used by Irizarry (2004) for Santa Maria del Mar Church

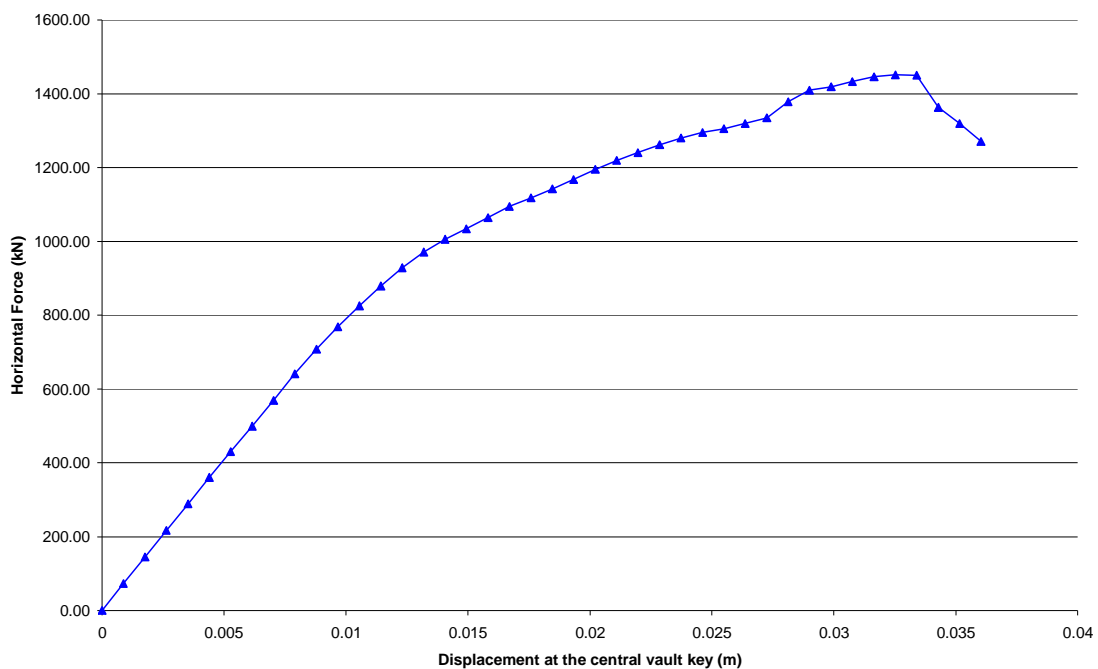
Figure 5.3 – Capacity curve of Santa Maria del Mar obtained with FEA

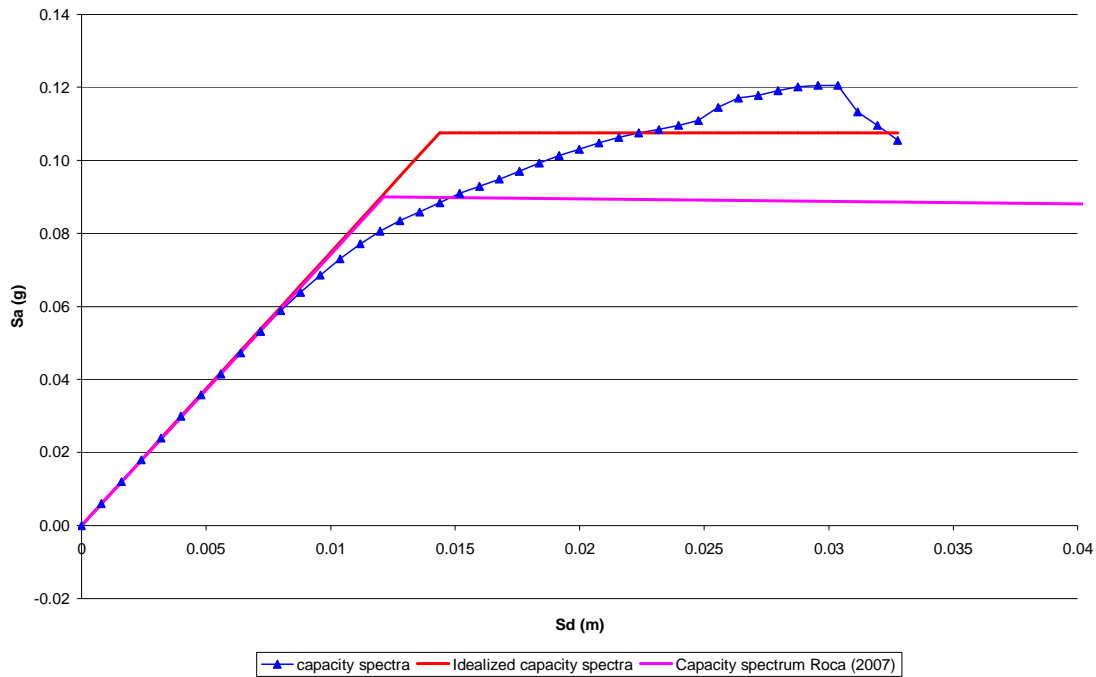
Figure 5.4 – Capacity spectrum of Santa Maria del Mar (obtained with FEA and simplified)

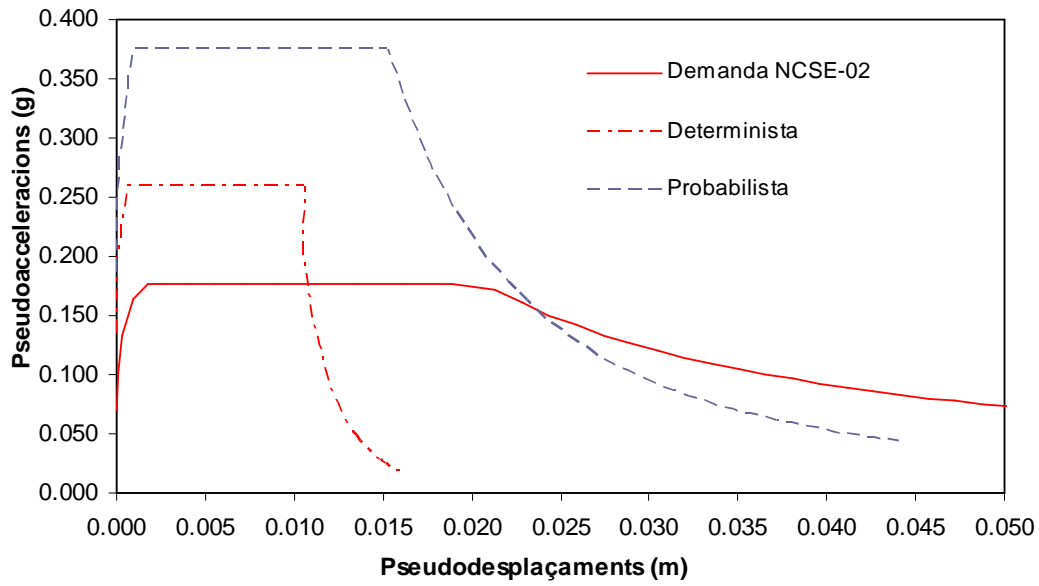
Figure 5.5 – Elastic demand spectra for Santa Maria del Mar location (Roca, 2007)

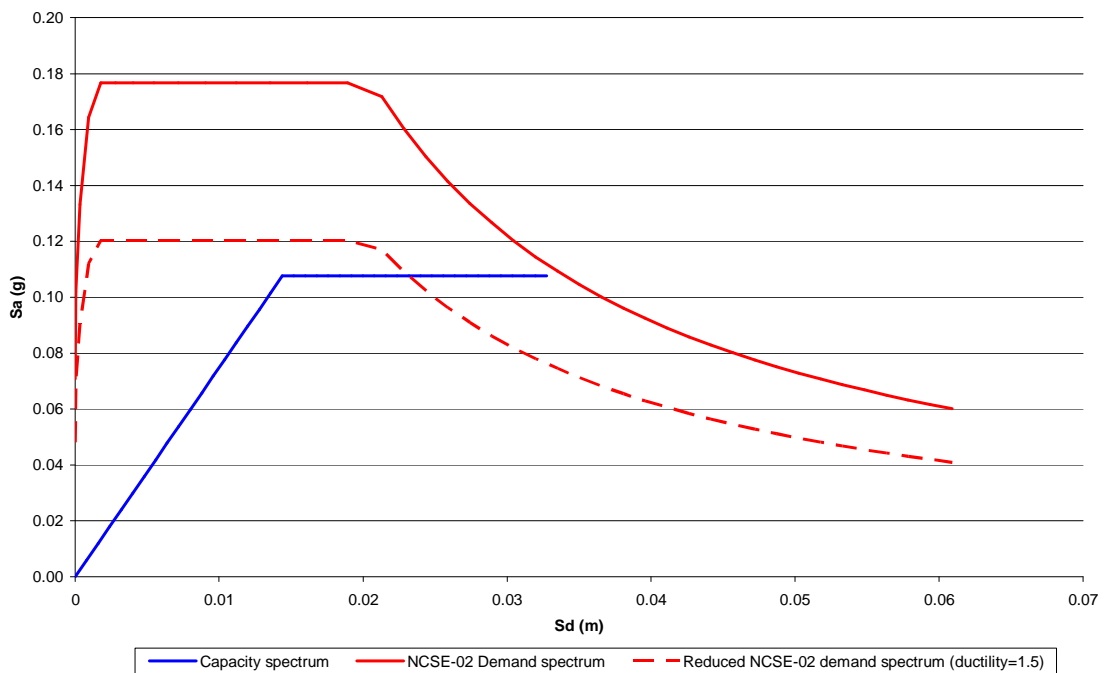
Figure 5.6 – Performance point for NCSE-02 demand spectrum

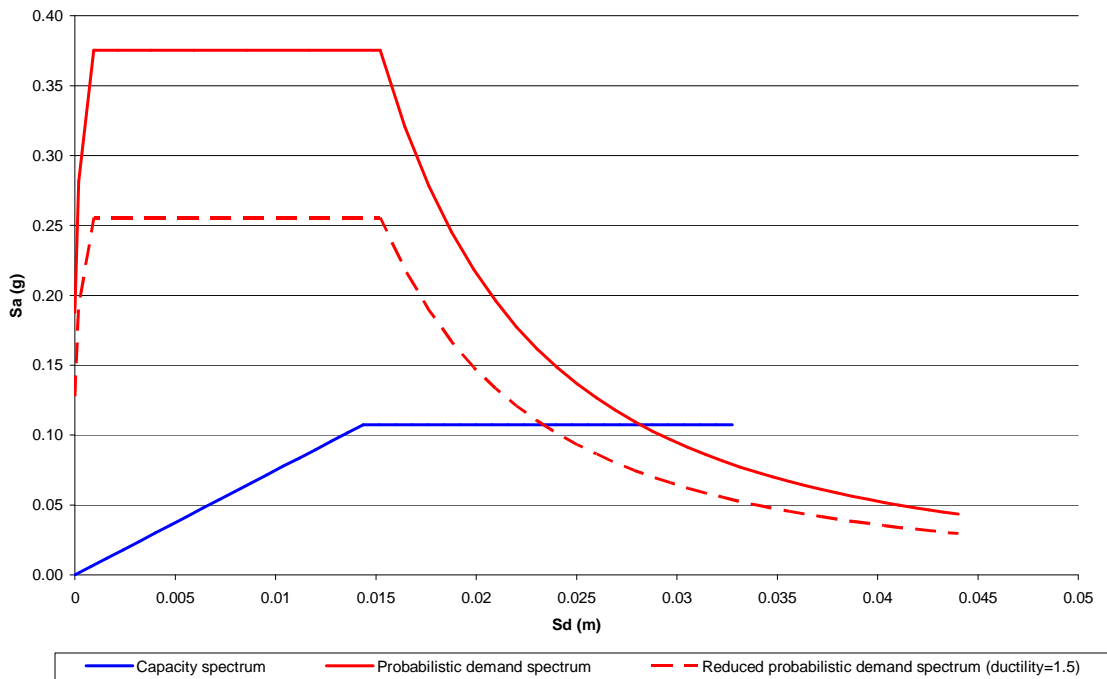
Figure 5.8 – Performance point for probabilistic demand spectrum
