Title of the Msc Dissertation: Inventory of Repair and Strengthening Methods with Iron and Steel

Year: 2009

University: Technical University of Catalonia

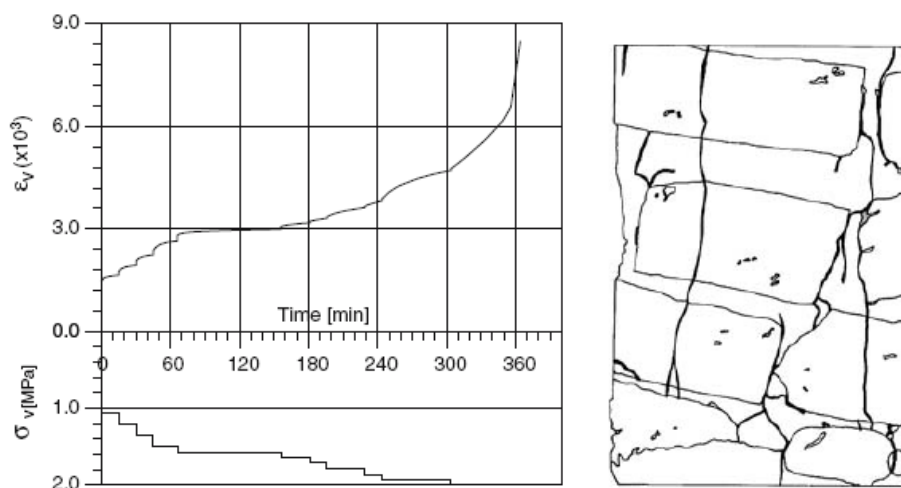
Figure 5.2.5.1 Typical timestress/ strain behavior of overstressed masonry: phases of primary, secondary and tertiary creep (corresponding to triggering of uncontrollable collapse), due to slow load steps reproduced in laboratory on masonry prisms (Polytechnic of Milan)[29]

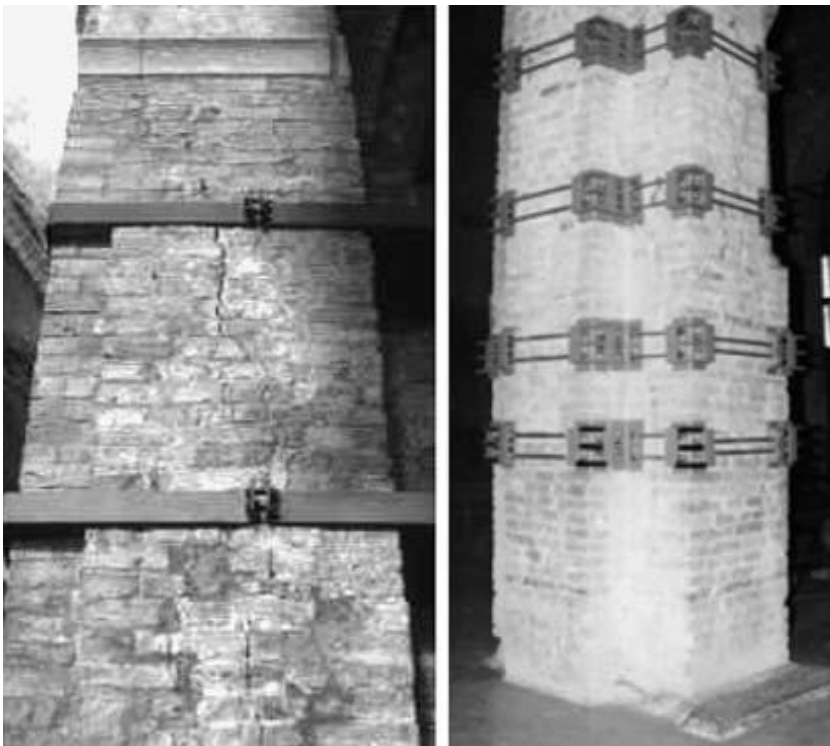
Figure 5.2.5.11 Church of S. Sofia in Padova: provisional measures on cracked pillars

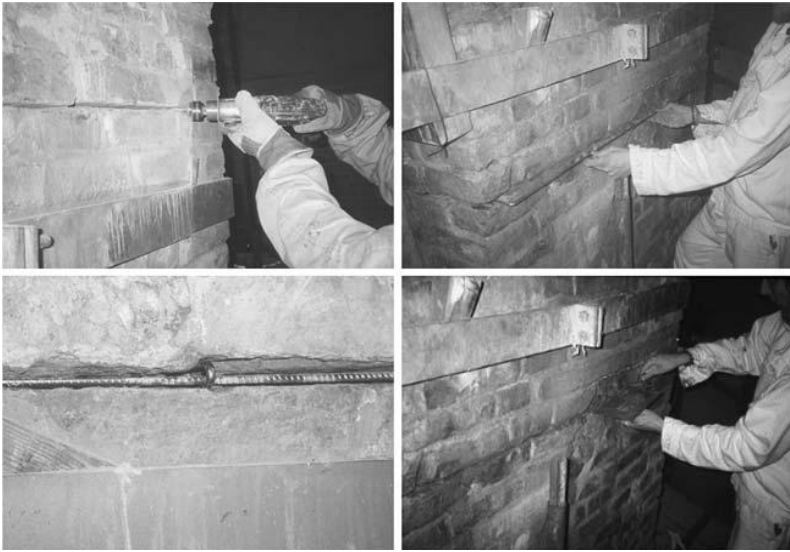
Figure 5.2.5.12 Phases of excavation, positioning, pinning and repointing of a damaged pillar (reinforcing rings were then removed)

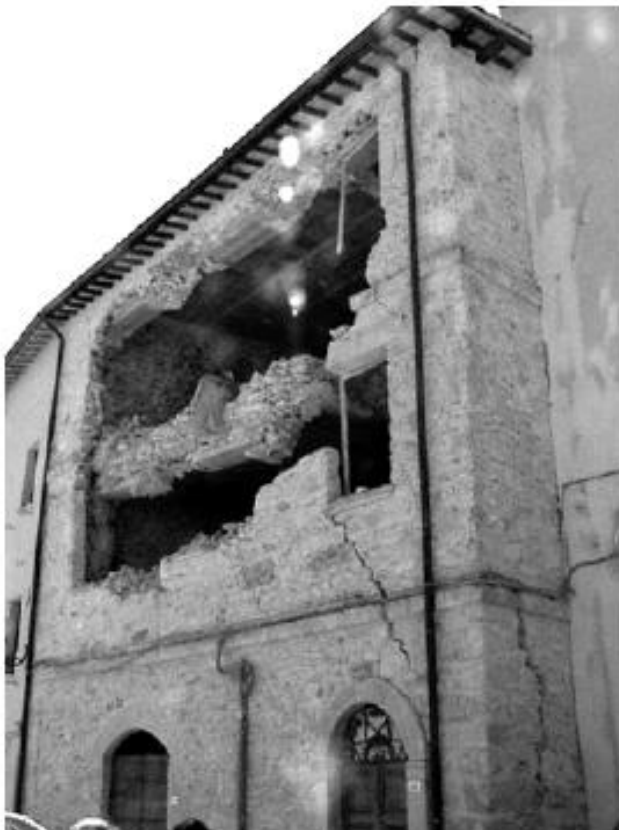
Figure 5.2.6.1 Damages after Umbria earthquake to a building repaired by introduction of concrete tie beams.

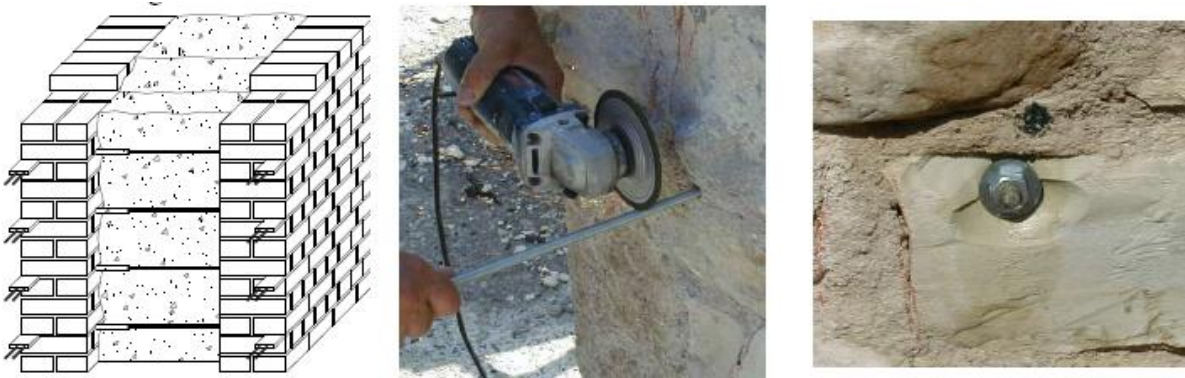
Figure 5.2.6.7 . Strengthening solution for pier walls: a) restoring of mortar joints and installation of steel bars, b) transversal bars bolted through washer.

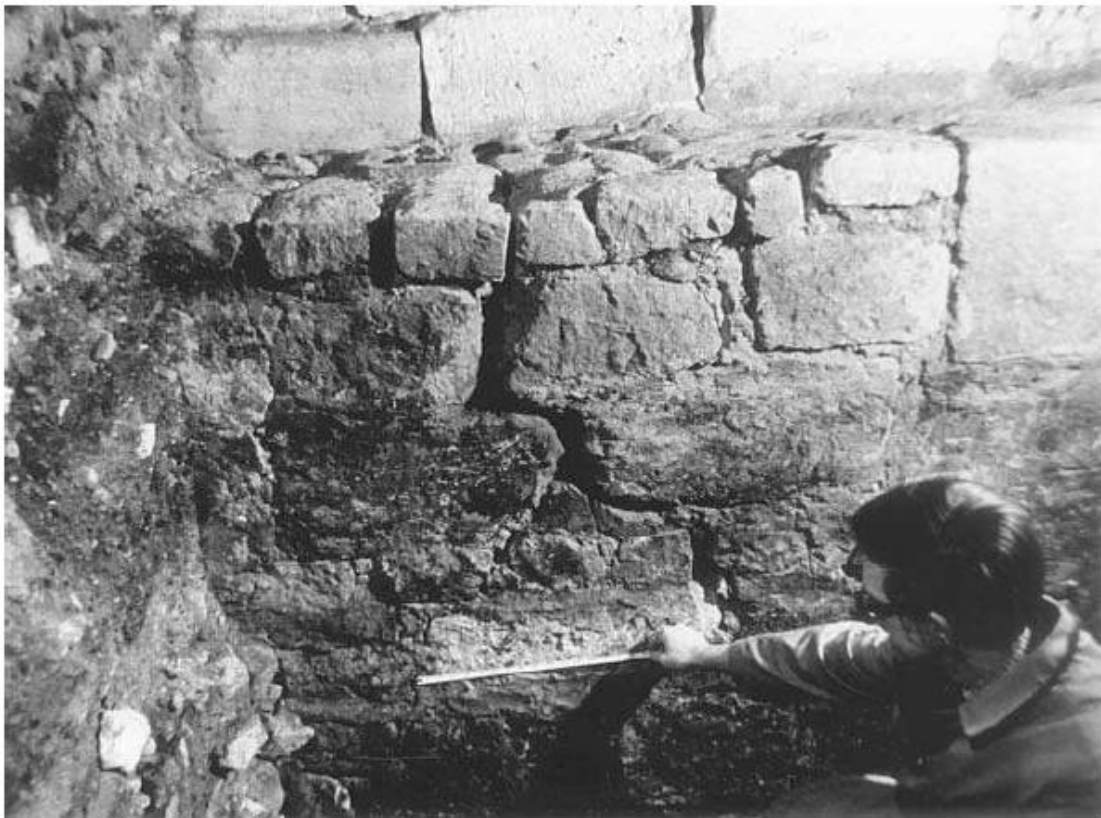
York Minster exploratory excavation 1967: The imposition in the fifteenth century of the 16 000 tons Central Tower on the eleventh-century foundations, intended for a much less heavy crossing, caused differential settlement which distorted and cracked the foundation masonry.

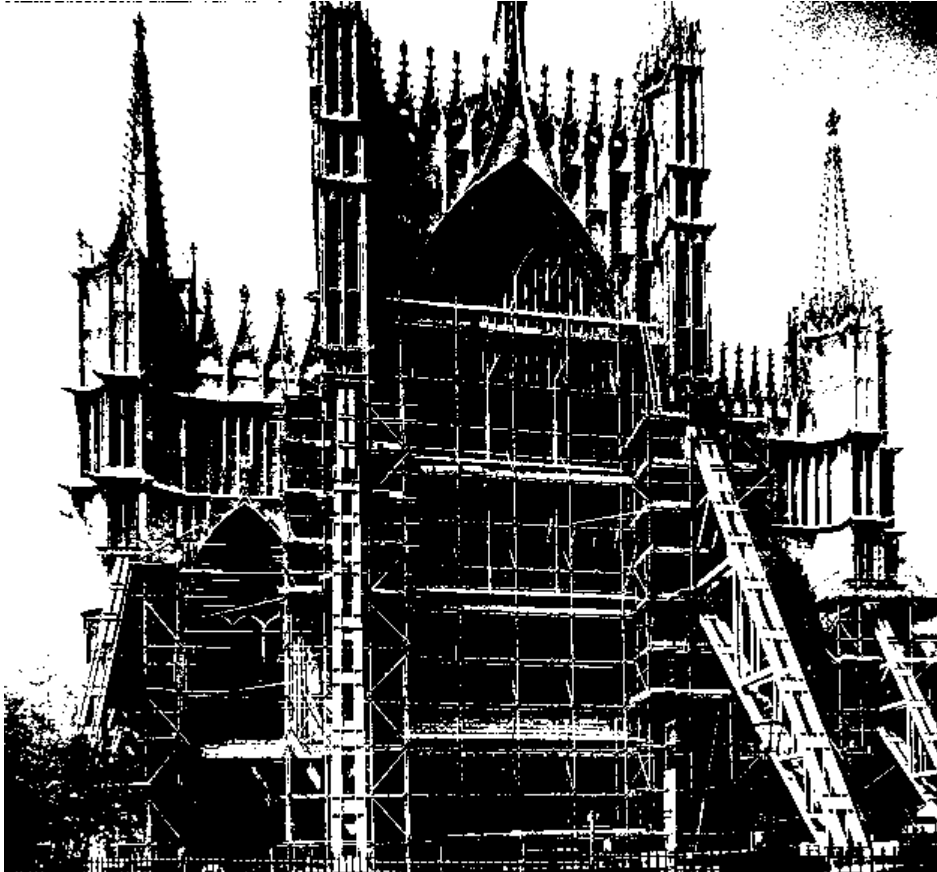
Figure 5.3.6.1 Shoring, east end, York Minster, England

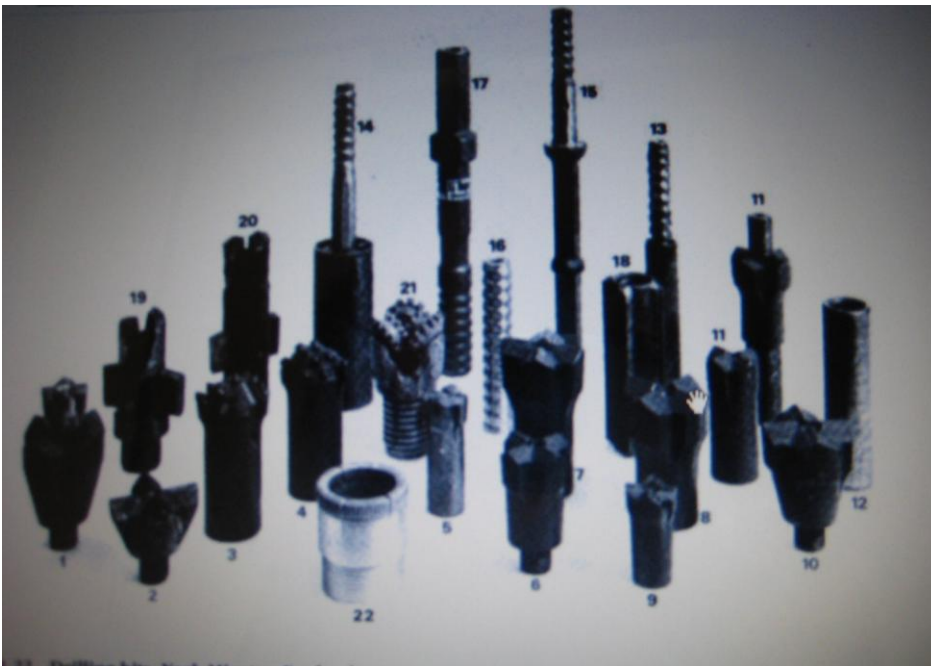
Figure 5.3.7.1 Drilling bits, York Minster, England (Courtesy: Shepherd Building Group Ltd)

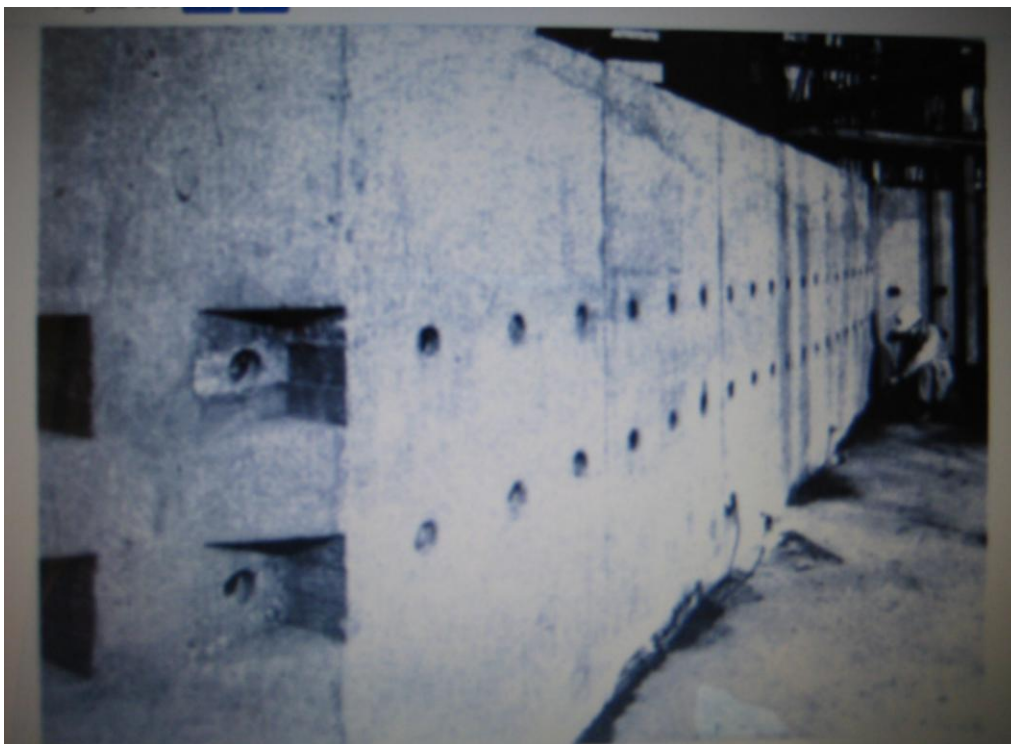
Figure 5.3.7.2. Enlarged foundations, central tower, York Minster, England

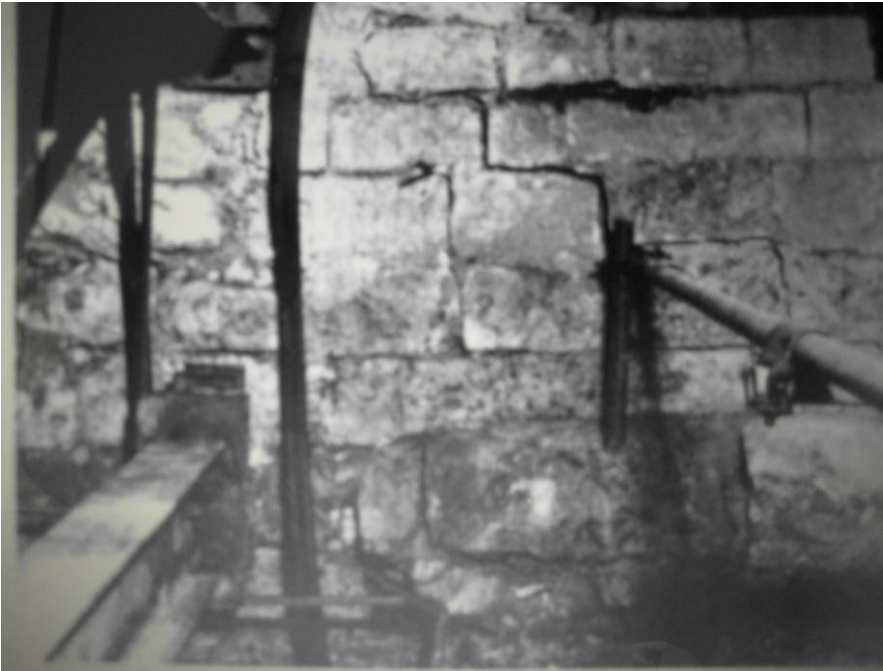
Figure 6.9.4 North-east pier foundation, York Minster, England

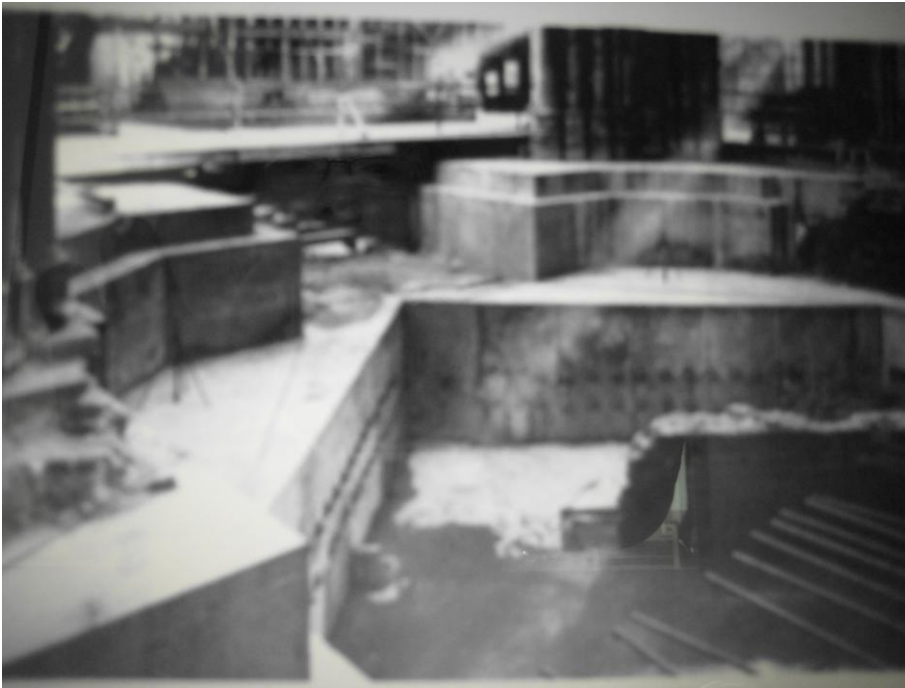
Figure 6.9.5 *Enlarged foundations, central tower, York Minster, England (Courtesy of Shepherd Building Group, Ltd)*

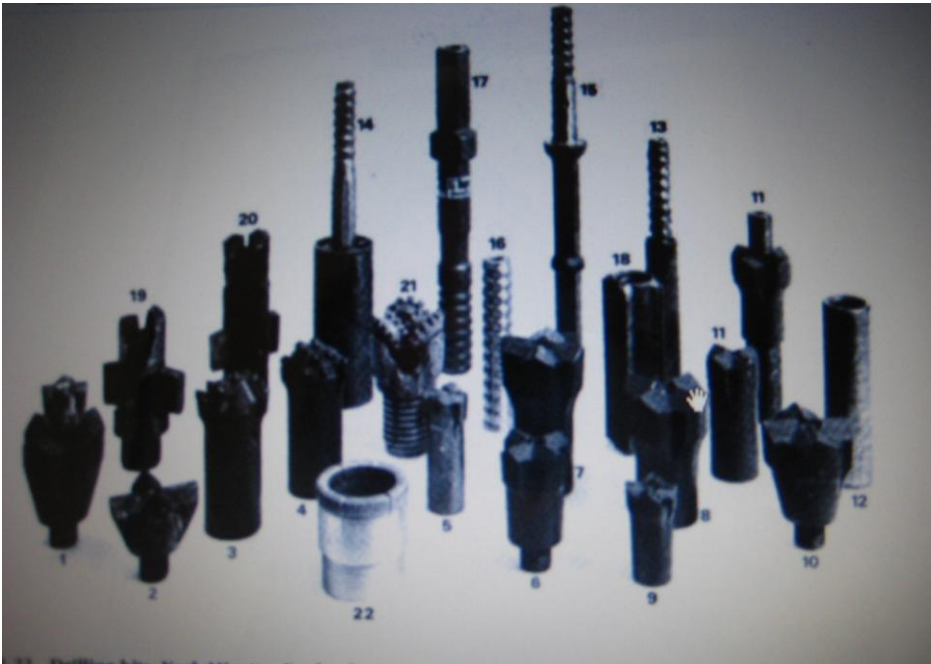
Figure 6.9.7 Drilling bits, York Minster, England (Courtesy: Shepherd Building Group Ltd)

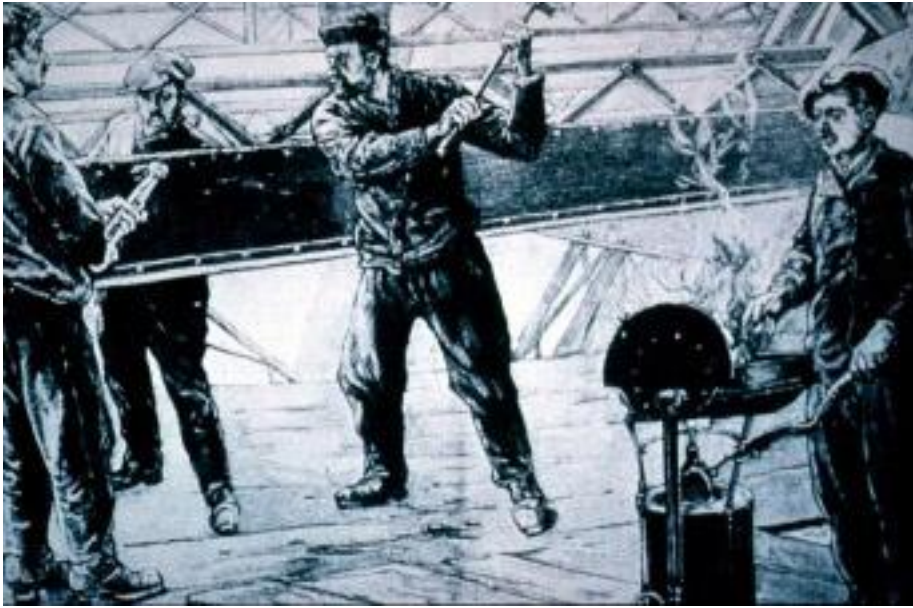
Figure I.5 *The change from cast iron, with elements that fitted together, to wrought iron, joined by rivets, had a significant effect on the appearance of joints.*
