SMART STRUCTURES

Economic Feasibility Study

FINAL REPORT

EUROPEAN PROJECT SEMESTER
UNIVERSITAT POLITÈCNICA de CATALUNYA
Vilanova i la Geltrú

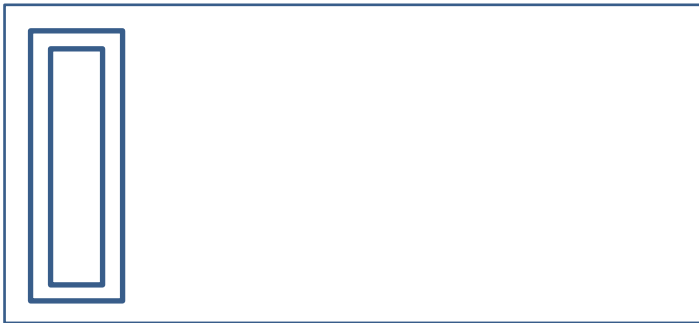
Figure 4: Continuous Footing

The second type is called continuous footing and it is characterized by large feet on which are the main walls based. The slab is placed under the ground with part of the wall as can be seen in Figure 4. The Sant Antoni church has most likely this type of foundation made out of stones.

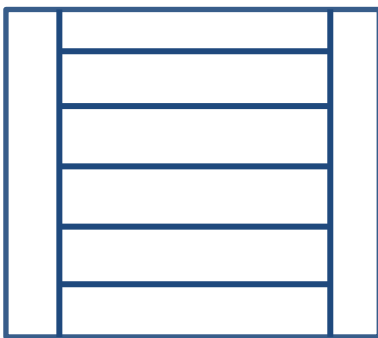
Figure 8: One-way floor

The one-way floor consist of two beams with several different beams between them, this creates rectangle compartments. These are not likely to be filled with Ferro concrete. The flooring is made out of concrete. This type of concrete is used in the Sant Antoni church.

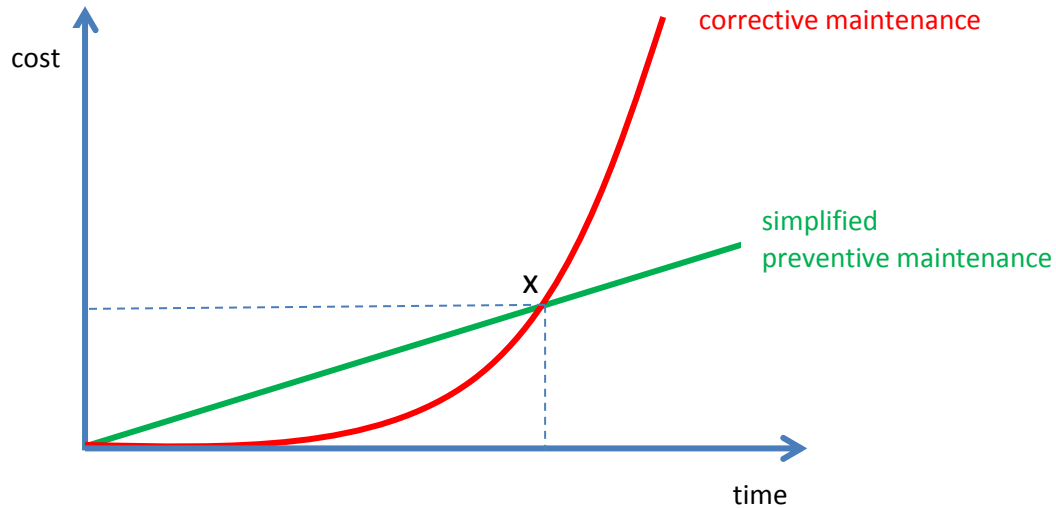
Figure 11: Corrective and preventive maintenance

In Figure 11 you can see the corrective maintenance starts in the beginning as a very cost saving way of maintenance. However after a certain amount of time, when pathologies in the structure are formed at a point that it has to be repaired the costs are jumping. The red line in the graph shows this exponential growth.

Point X in the figure is the point that has to be reached for the preventive maintenance to be profitable. In reality preventive maintenance is an investment that has been in certain intervals, that is why the real graph can be compared to stairs and not to a line. The demonstration of this simplification is demonstrated in Figure 12 below.

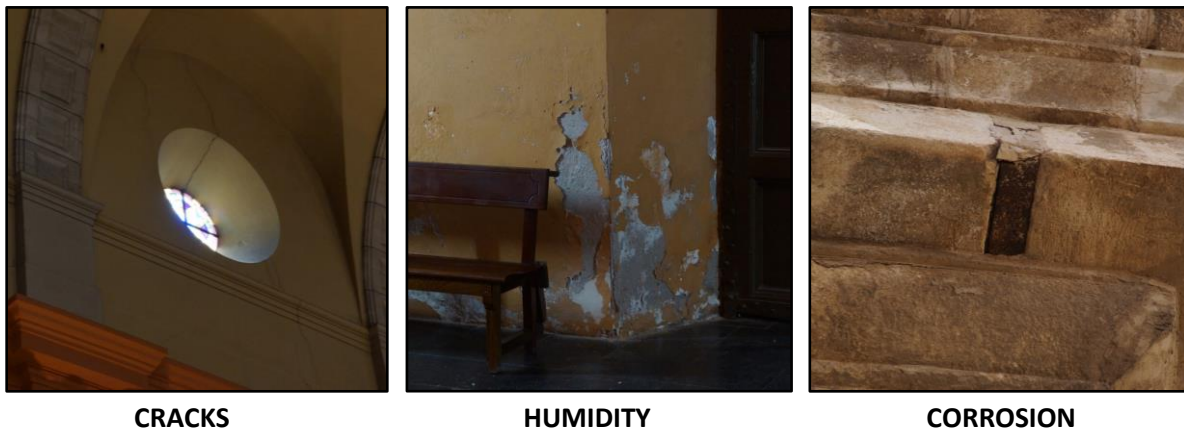
Figure 17: Pathologies in the Sant Antoni Church

Cracks, humidity and corrosion are the most common pathologies in the church.

The humidity problems are in 2 stages. The one that can be seen in the middle of Figure 17 is capillarity humidity that seeps in from the bottom. It goes up the wall and might cause mould on the wall and the wood used in the structure. The other form of humidity comes from leaks. This might have an origin in the cracks that can be seen in the church.

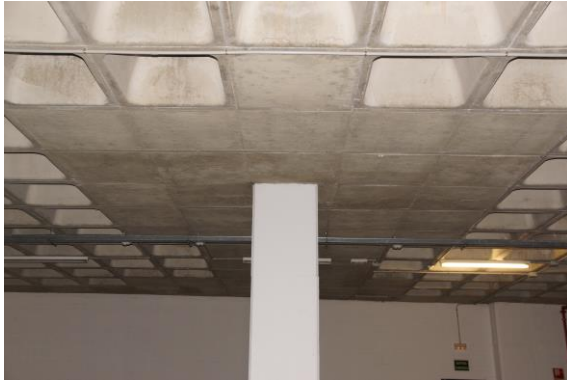
Figure 18: Pillar with two-way flooring

On Friday the 17 April 2015 before our weekly meeting we had an inspection of the Neàpolis building. The building is around 8 years old and was build out of ferro concrete and has single-footing foundation. The vertical structure consists only of pillars and the flooring is two-ways. Where the two-way flooring is mostly hollow, next to the pillars the flooring is filled with ferro concrete for support and strength.

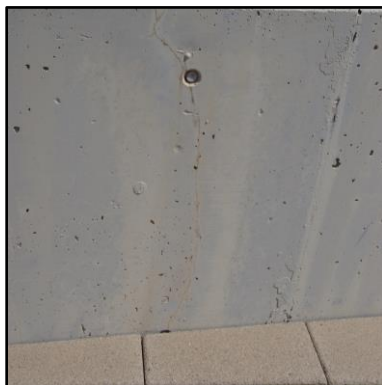
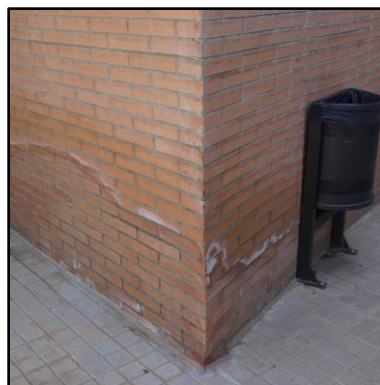
Figure 19: Pathologies in the Neàpolis Building

During the inspection of the Neàpolis building no major pathologies were found, however there were some small examples of the capillarity humidity and cracks. The structure of the building is fairly bear, which makes the way the building was constructed easy to spot.

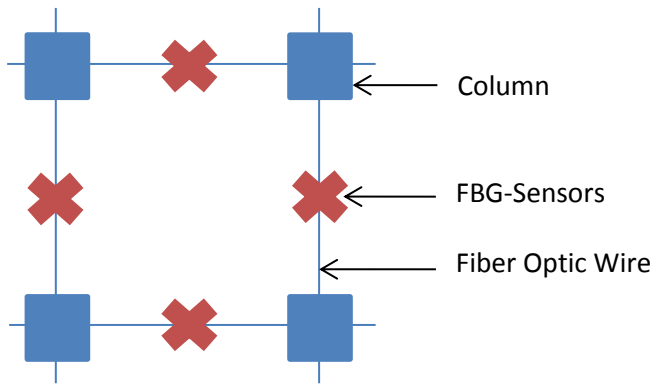
Figure 26: Scheme for sensors with bending

From this figure the scheme for the positions of FBG-Sensors in the Neàpolis building is derivable. It is demonstrated in the next figure.

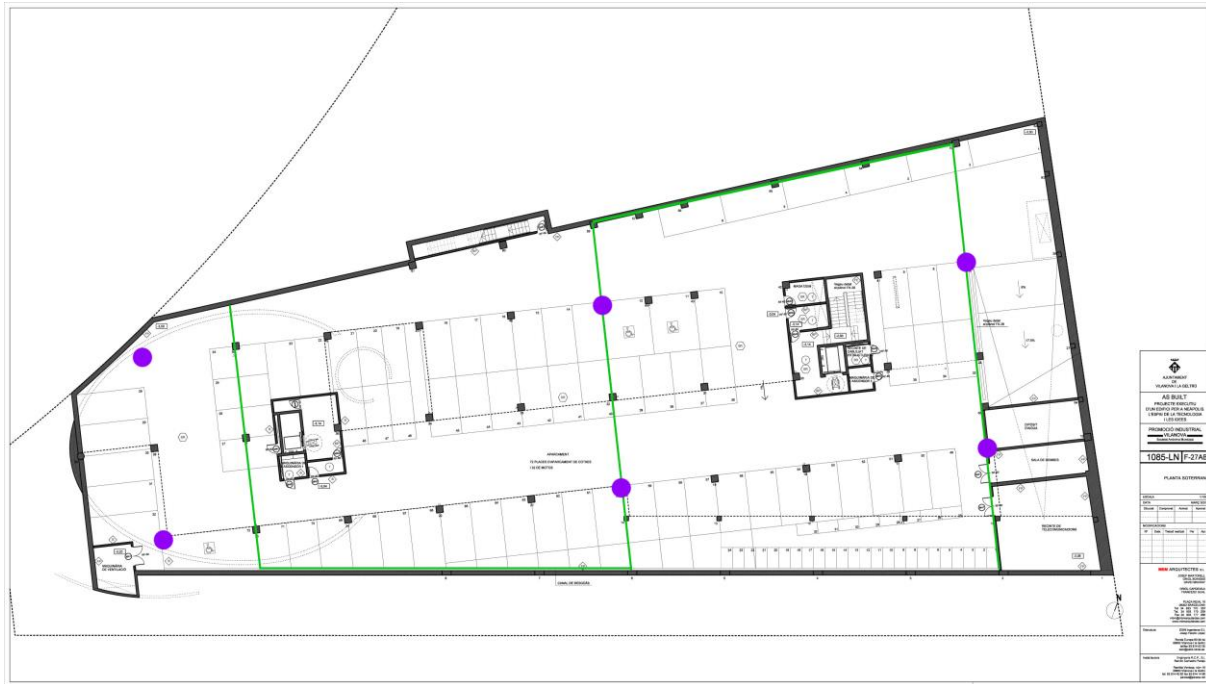
Figure 27: Low-Intensity-Concept for the Neàpolis Building

The first concept is made for parts of buildings with low strain and fewer changes in the structure. The low intensity concept includes an arrangement of 3 Fiber Optic wires in the ceiling. The wires are placed, with the same distance, on the beginning, in the middle and in the end of the floor to measure the structure on different parts with different forces by using fewer sensors. In the Neàpolis building are altogether 14 Sensors planned for the low intensity concept, as you can find below.

The first line of Fiber Optic sensors will be installed in the first row of columns on the right side. Here are 5 columns, this results that there are 5 Sensors and 14,5 m of wire in the beginning of the floor.

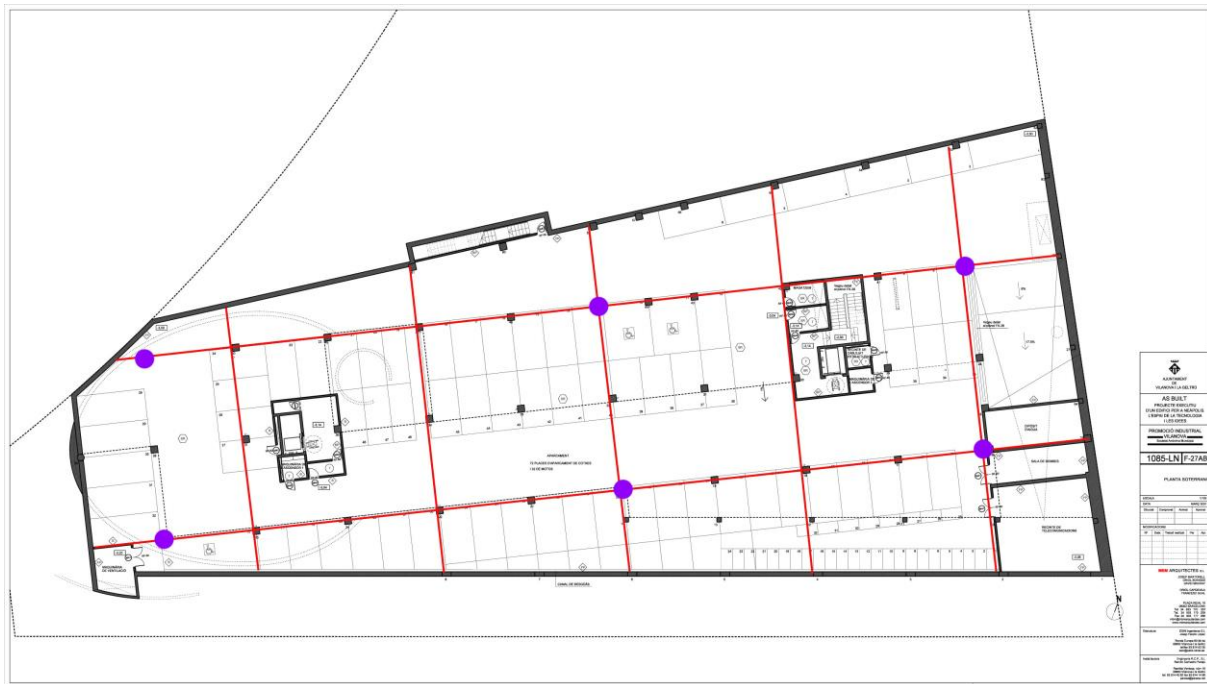
Figure 29: High-Intensity-Concept for the Neàpolis Building

The last concept is the high intensity and it is able to measure the changes in a great area of the ceiling. The placement of Fiber Optic sensors starts in the first row of columns on the right side. From this point every second row is provided with wires and sensors, as well as in the medium intensity concept. The concept is pictured in Figure 29.

It is not necessary to place sensors in every row. The differences of environmental influences between these distances are very low. According to the number of sensors and the length of required wires are the same as in the medium intensity concept. A length of 58,8 m wire and 23 sensors are planned.

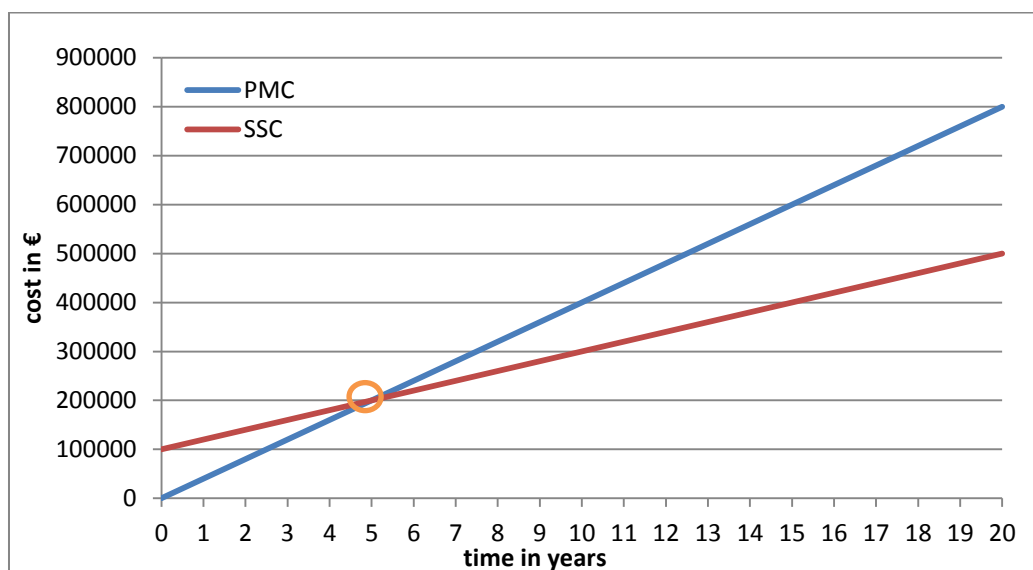
Figure 33: Break-Even-Point of the Sant Antoni Church

The following graph verifies the calculation from getting a benefit after using a Smart Structure system for 5 years.

According to the graphs in Figure 33, we can see that the preventive maintenance with a Smart Structure system is less expensive than the preventive maintenance without Smart Structure system. The break-even-point is around 5 years.

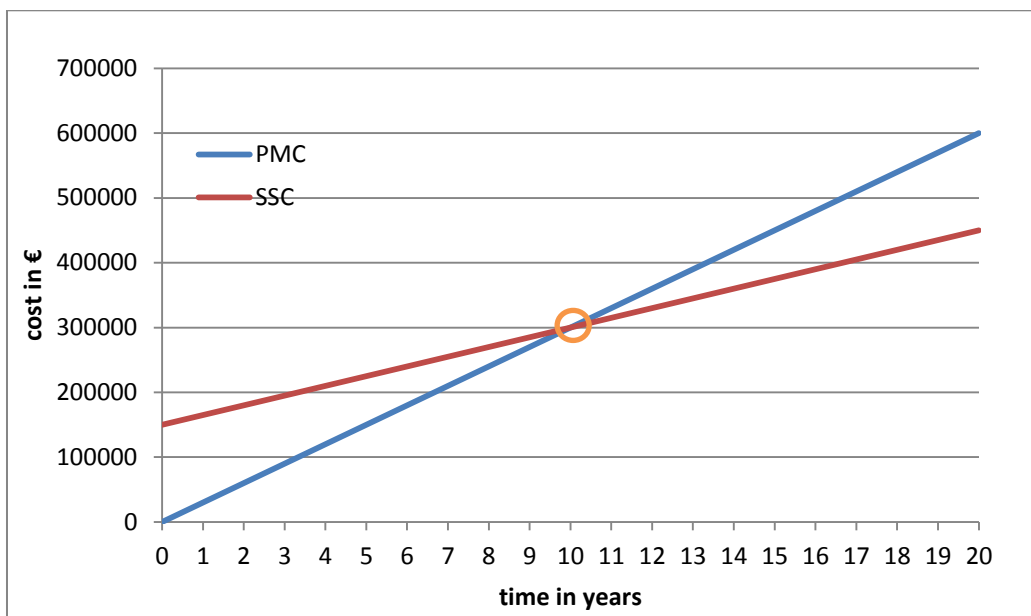
Figure 34: Break-Even-Point of the Neàpolis building

The Figure 34 is demonstrating the graphs of the Smart Structure costs and the preventive maintenance cost without sensors. They cross at about 10 years and that is the point where the investor gets benefits.

In comparison to the Sant Antoni church the Neàpolis building needs a longer time to get the investment of the Smart Structure system back. That is because the building is by contrast to the church much younger and has not a lot of pathologies. The whole system gets really interesting, if a building needs a lot of maintenance like the Sant Antoni church. Because only if money is invested in the preservation of a building, it is possible to get benefits. And the more it has to be invested in the health of a structure, the more can the Smart Structure system save and the faster the invest will be returned.
