Title: Contact damage resistance of TiN-coated hardmetals: Beneficial effects associated with substrate grinding

# Contact damage resistance of TiN-coated hardmetals: Beneficial effects associated with substrate grinding

Contact loading is a common service condition for coated hardmetal tools and components. Substrate grinding represents a key step within the manufacturing chain of these coated systems. Within this context, the influence of surface integrity changes caused by abrasive grinding of the hardmetal substrate, prior to coating, is evaluated with respect to contact damage resistance. Three different substrate surface finish conditions are studied: ground (G), mirror-like polished (P) and ground plus heat-treated (GTT). Tests are conducted by means of spherical indentation under increasing monotonic load and the contact damage resistance is assessed. Substrate grinding enhances resistance against both crack nucleation at the coating surface and subsequent propagation into the hardmetal substrate. Hence, crack emergence and damage evolution is effectively delayed for the coated G condition, as compared to the reference P one. The observed system response is discussed on t

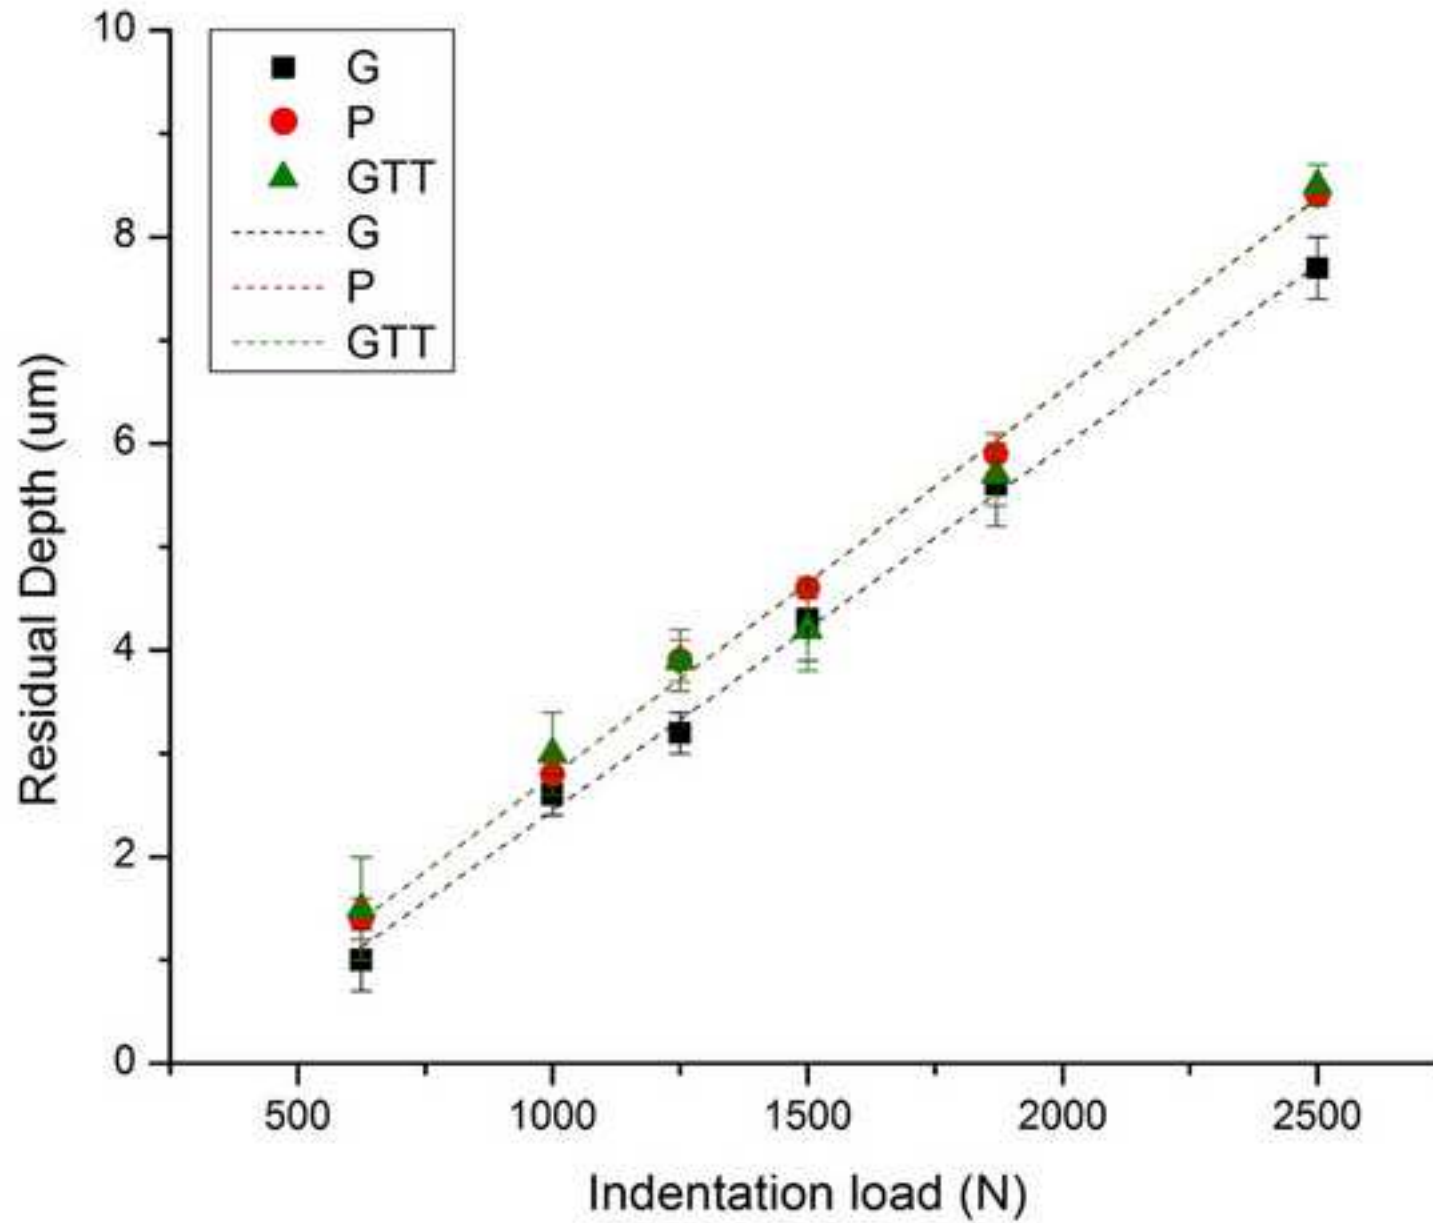
Figure 3  
[Click here to download high resolution image](#)

throughout the used load range. Residual depths associated with indentation imprints are shown in **Figure 3** for the three conditions studied. It is clear that irreversible deformation gets more pronounced as indentation load is increased. Within the experimental scatter, clear differences as a function of substrate surface finish are not observed. However, a trend towards smaller residual depths is discerned for the coated G condition, particularly at the higher applied indentation load.

**(Authors)** **R3** is right about the possibility of plotting contact pressure versus deformation curves. Indeed, experimental data for plotting it are given in **Figure 3**. However, we found that relative (slight) differences among studied conditions (G, P and GTT) were shown clearer by **Figure 3** than by plotting pressure-deformation curves.

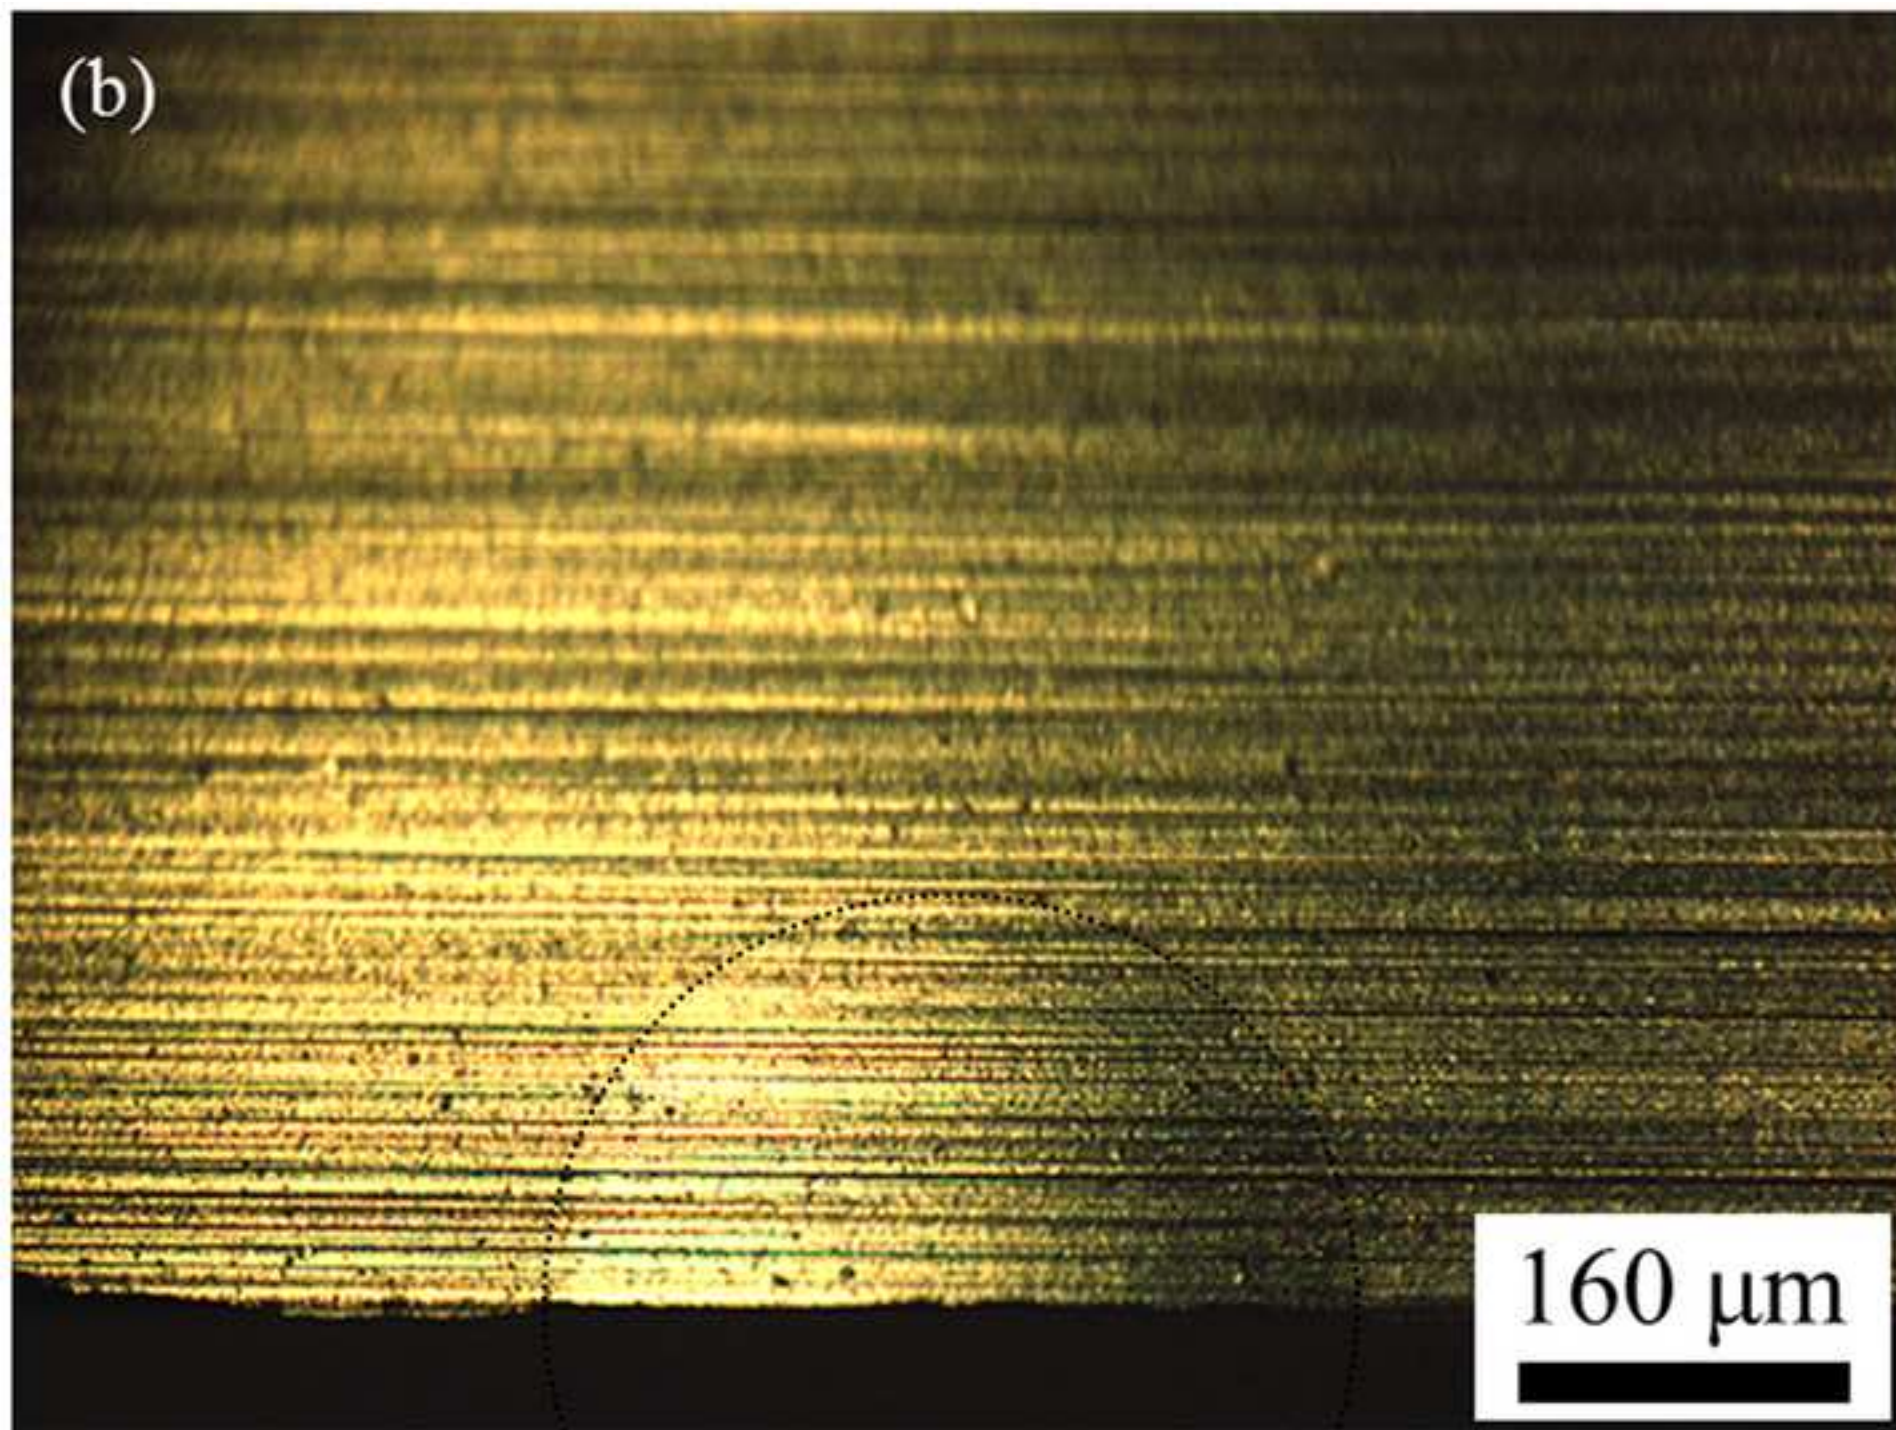
Figure 9a  
[Click here to download high resolution image](#)

**Fig. 9.** Surface CLSM micrographs of failures sites from Hertzian indentation at 2500 N in bars broken for the investigated coated systems: (a) coated P condition - failure origin at surface ring crack; and (b) coated G condition - fracture path going through the inner contact orthogonally (i.e. following grinding-induced grooves). **The residual imprints of spherical contact are underlined by dashed lines.**

**(Authors)** – We disagree with R2 on this issue. Although assessment of substrate grinding effects on damage tolerance of coated systems exposed to contact loads was not the main objective of the work, Figure 9 is helpful for as a starting point to understand and discern the different interactions among propagating contact-induced cracks, remnant compressive stress fields, surface texture features (nicely highlighted in Figure 9), and pre-existing grinding-induced microcracks. In this regard, it must be emphasized that we have not attempted to yield higher relevance of this issue than the one stated, recalling further research for deeper understanding. The fact that all other reviewers did not do any specific comment on Figure 9 will support our viewpoint.

Finally, the interaction among propagating contact-induced cracks, a remnant compressive stress field, surface texture features and pre-existing grinding-induced microcracks at the subsurface deserves an additional analysis. As it is observed in **Figure 7a**, damage scenario resulting from the referred interaction seems to be less localized (and thus critical) than those observed for the P condition. In general terms, it may be described as distributed and oriented, departing from the straight and longitudinal crack path exhibited by the through-thickness fissures nucleated at the surface. Indeed, it somehow resembles the damage scenario resulting after contact loading of structural ceramics with heterogeneous microstructures, which has been validated as an optimal microstructure tailoring strategy for improving damage tolerance of these materials [37]. Based on this assumption, a simple damage tolerance investigation was made for the G and P coated systems. It consisted of bend testing to failure coated specimens previously indented. **Figure 9** shows surface CLSM micrographs of failures from Hertzian indentation sites in bars broken for these two coated systems. As expected, in both cases ruptures are associated with indentation-induced damage. However, interaction between extrinsic damage and failure path are different. While rupture in the coated P system is characterized by surface traces of the fracture going along previously identified surface ring (**Figure 9a**), fracture for the coated G condition traverses the inner contact orthogonally (i.e. following grinding-induced grooves) (**Figure 9b**). As extrinsically induced damage is maximum (regarding depth and localization) in the contour periphery, these findings would point out a beneficial effect of grinding-induced changes (i.e. distributed damage, surface texture and residual stresses) with respect to effective damage tolerance of the coated hardmetals studied. Nevertheless, the findings presented here
