Landslides (2015) 12:193–204
 DOI 10.1007/s10346-014-0548-z
 Received: 31 January 2014
 Accepted: 18 December 2014
 Published online: 13 January 2015
 © Springer-Verlag Berlin Heidelberg 2015

Landslide hazard, monitoring and conservation strategy for the safeguard of Vardzia Byzantine monastery complex, Georgia

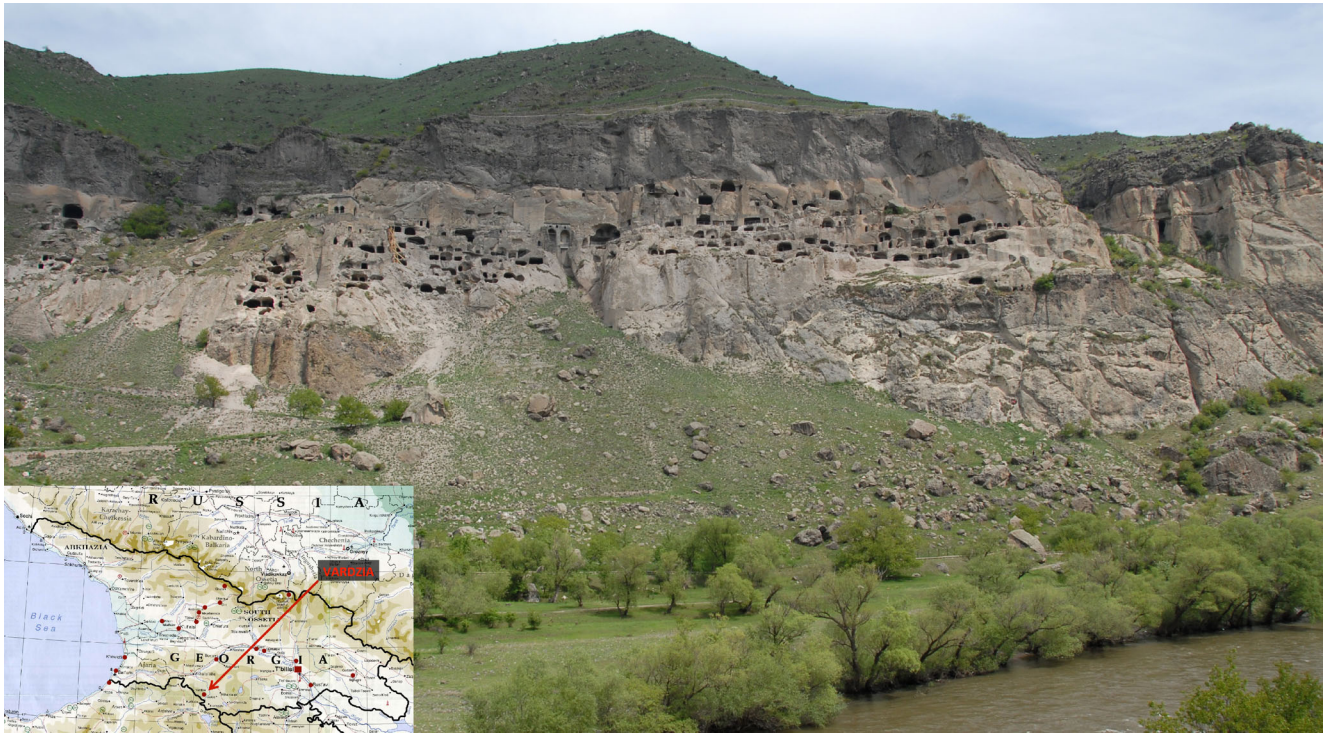
Fig. 1 The rock-cut city of Vardzia (Georgia)

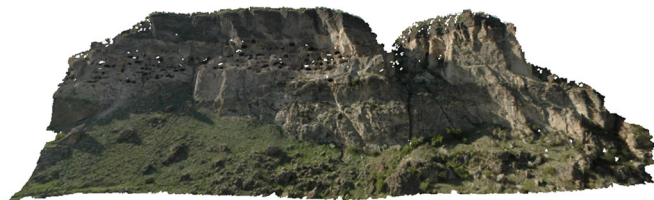
Fig. 2 Textured 3D model of the cave monastery of Vardzia from TLS techniques

Surveying activities at the Vardzia site were performed using a topographical Riegl Z210i laser scanner both for measuring the 3D coordinates of the models and acquiring the RGB information linked to the point clouds. Ten TLS scans were acquired, in order to exactly reconstruct the topography of the site (Fig. 2), from two different scan positions by applying the multi-scanning technique (Baldo et al. 2009). Average spatial resolution ranges from 10×10 cm up to some meters, depending on the distance between the laser and the object. Purpose-built targets were used to link the scans together and to build up a high-resolution 3D model of the cave monastery. The final model consists of a point cloud made of about 8,000,000 points from which a DTM with a 1×1 m cell size has been derived.

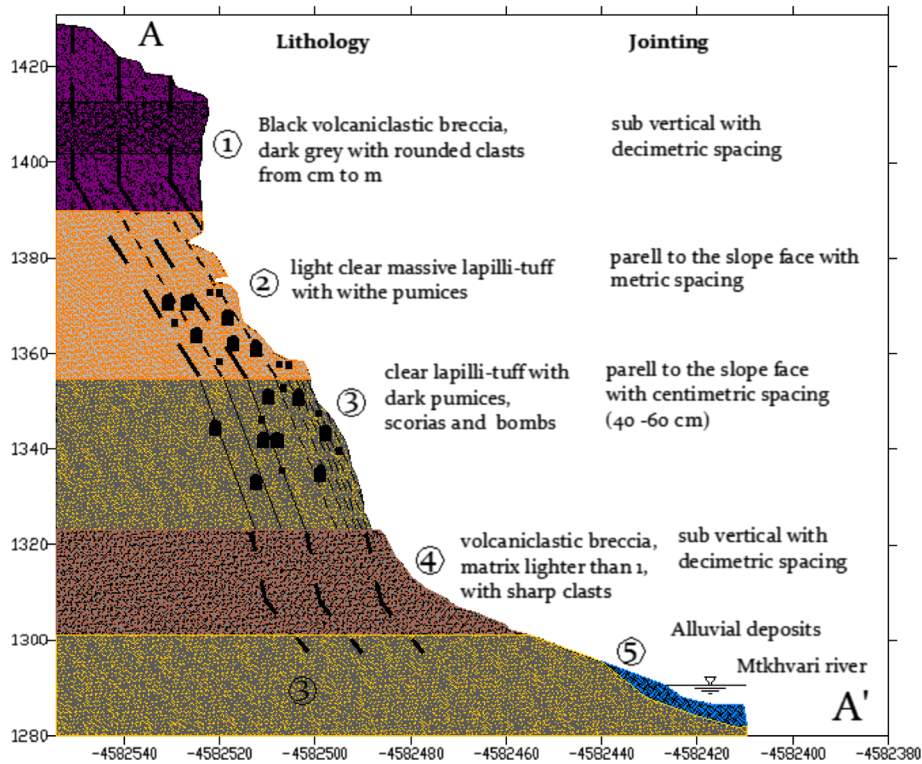
Fig. 4 Litostratigraphic cross section of the Vardzia rocky cliff

A representative lithologic cross section of the slope has been accomplished during the last field mission (Fig. 4). The entire

Following the general scheme of the cross section defined in Fig. 4 and with the aim to provide a preliminary assessment according to slope failure type and processes affecting the entire rocky cliff (from top to bottom), most failures can be classified into various categories (Cruden 1991; Cruden and Varnes 1996), depending on the combination of the main joint sets and the geomechanical and geo-structural conditions of the different layers. The only exception is the large roto-translational rock slide, potentially affecting both layers 1, 2, and 3. With reference to the different levels of Fig. 4, the main rock slope failures can be classified as follows and displayed in Fig. 6.

2. In the upper black volcanoclastic breccia (level 1 in Fig. 4), there are mainly rock fall of clasts, detaching from the matrix. Tourists are the most exposed to these phenomena. Occasionally, topple or wedge failure can be recognized, often due to the lack of support of the underlying layer, frequently affected by planar sliding.

3. In the light clear massive lapilli-tuff (level 2 in Fig. 4), the main rock slope failure are mainly due to wedge failure and rock falling and high- and low-angle planar rock sliding along the main discontinuities.

4. In the clear lapilli-tuff with dark pumices, scorias, and bombs (level 3 in Fig. 4), the main observed and potential rock slope failures are planar sliding along the main structural settings and topples.

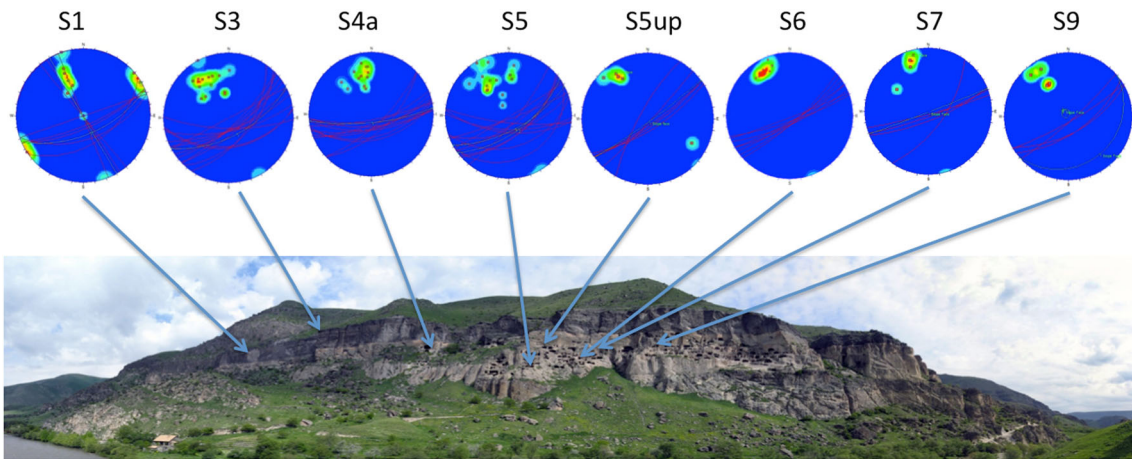
Fig. 5 Stereoplots of joint dip measurements from the Vardzia monastery area (*left*) and global kinematic analyses (*right*): **a** direct toppling (0.42 % of total planes), **b** flexural toppling (no critical planes), **c** planar sliding (32.88% of total planes), and **d** wedge failure (44.59 % of total planes)

Vardzia monastery slope promoted different types of discontinuities in the volcanoclastic igneous rocks (Mitchell and Westaway 1999). This is due to the stress-strain behavior (e.g., lateral unloading due to valley erosion coupled with tectonic stress and cooling of the pyroclastics falls) and to the typical petrographical and physical properties of the soft rocks (e.g., chemical and mineralogical composition, grain size, shape, thickness, homogeneity, porosity, permeability, type of cement). The presence of brittle volcanic and pyroclastic rocks in the area, as a general rule, promotes blocky rock masses due to high frequency of discontinuities of various origins (Gamkrelidze 1986). A geomechanical characterization of discontinuities has been done along the entire study area in order to describe the structural setting of the area and recognize eventual master joints. Rock weathering, slope degradation, and instability in the area are the result of different structural combinations of the main joint sets (Spizzichino et al. 2009). Our analyses, although only a preliminary and not exhaustive discontinuity survey was performed over the whole area, allowed to characterize some relevant slope sector in terms of discontinuity orientation. All collected data have been analyzed (DIPS® Rocscience software). The rock mass strength has been observed to depend on the density, nature, and extent of fracture and rock strength (i.e., lower within the black volcanic breccia, higher within whitish tuff and lapilli tuff). The stereoplots of Fig. 5 show that the major joint systems are steeply dipping (70°) towards SE (dip direction 140°–165°). A preliminary kinematic analysis focused on the identification of possible instability modes has been performed for sliding (planar, wedge) and toppling (direct and flexural) phenomena. The main results are also shown in the stereoplots of Fig. 5.

and its visitors. Listric joints develop parallel to the slope face and define potentially unstable rock blocks of different shapes and magnitudes (Figs. 5 and 6). Most of the joints display dip angles greater than 60°, which are kinematically unstable. Failure is initially prevented because the listric joints are not fully persistent and their continuity is reduced by the presence of rock bridges (Fig. 10). Rock bridges separating joint segments and fractures provide an effective cohesion to the joint, and the rock block cannot fall or slide until the bridge fails. Evaluating the strength of the rock bridges is fundamental for the assessment of the hazard potential and associated risk. The rock mass is assumed to fail in shear and tension while provides a strength component proportional to the fraction of the failure plane that is still intact (Jennings 1970). The importance of rock bridges on the stability of rock slopes has been addressed among others by Einstein et al. (1983) and Nichol et al. (2002).

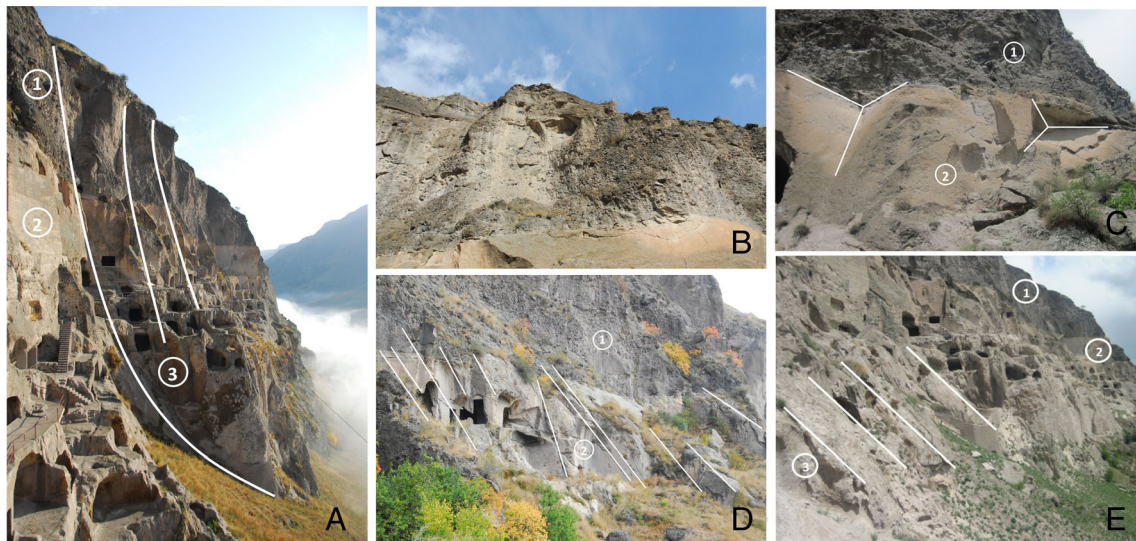
Fig. 6 Slope failure type and processes affecting the rocky cliff of Vardzia. a Large roto-translational rock slide involving both layers 1, 2, and 3. b Rock fall scarp in the upper part of layer 1. c Wedge failure at the contact between layer 1 (on top) and layer 2. d High- and low-angle potential planar rock slide. e High- and low-angle potential planar rock slide

- a) Large roto-translational rock slide affecting layers 1, 2, and 3 (Fig. 6a)
- b) Rock fall, topple, or wedge failure often due to the lack of support of the underlying layer frequently affected by planar sliding (Fig. 6b)

- d) Wedge failure and rock falling (Fig. 6c)

- e) High- and low-angle planar rock sliding along the main discontinuities (Fig. 6d)

- f) Planar sliding along the main structural settings (Fig. 6e)
g) Rock fall and topples

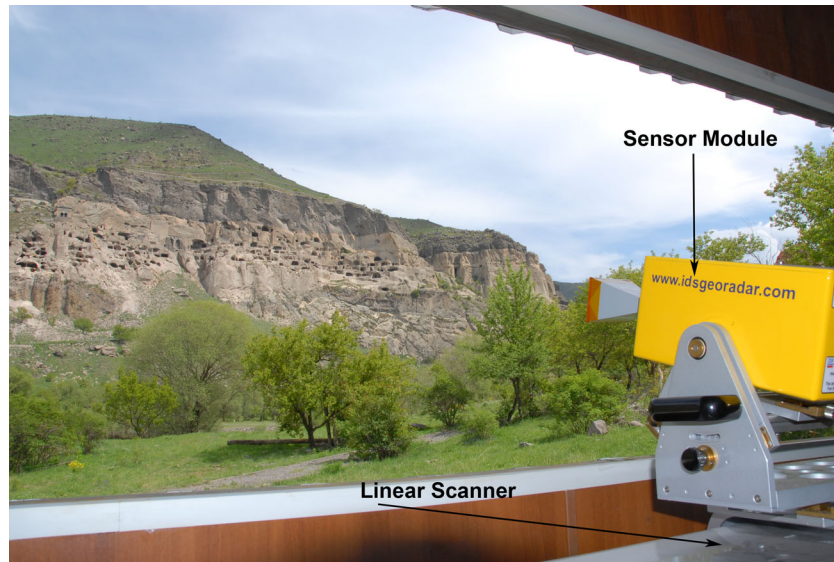
Fig. 7 IBIS-L radar monitoring system HW description and application in Vardzia

The radar system is a stepped-frequency continuous wave (SF-CW) coherent radar with SAR and interferometric capabilities. The acquisition station has been realized with the valuable support of the NACHPG and the pre-acquisition and start up activities have been finalized and calibrated during the last field mission. The above mentioned technique (SF-CW) allows the resolution of the scenario along range direction independently from the distance (range resolution up to 0.75 m). The SAR technique also allows the

Micro-tremors at such points on the slope as identified as moved by the radar scanning system shown in Fig. 7 could provide dynamic characteristics of the point. Amplitudes and loci of micro-tremors as well as frequency characteristics like predominant period of vibration are useful index to analyze stability trend of these trends.

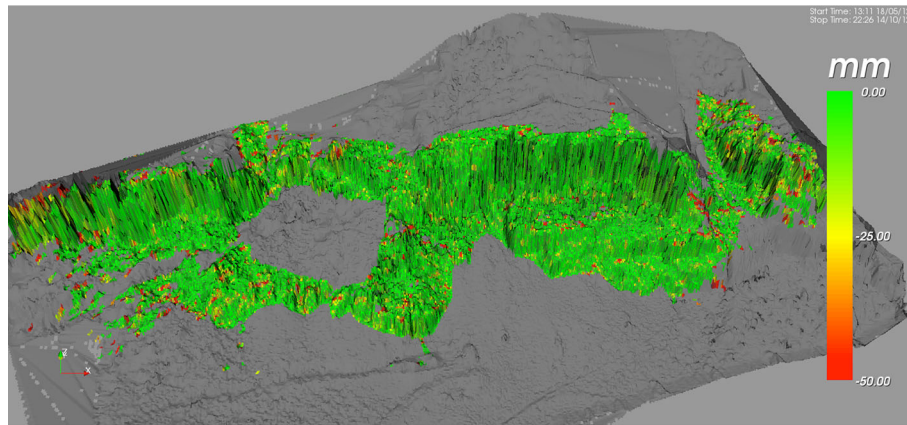
Fig. 8 NAverage velocity and displacements map for the period May to October 2012

After the first 6 months of monitoring, the preliminary results are quite stable and comfortable. With the exception of some individual control points (mainly due to noise factors related to vegetation), the investigated area is stable and under control (Fig. 8).

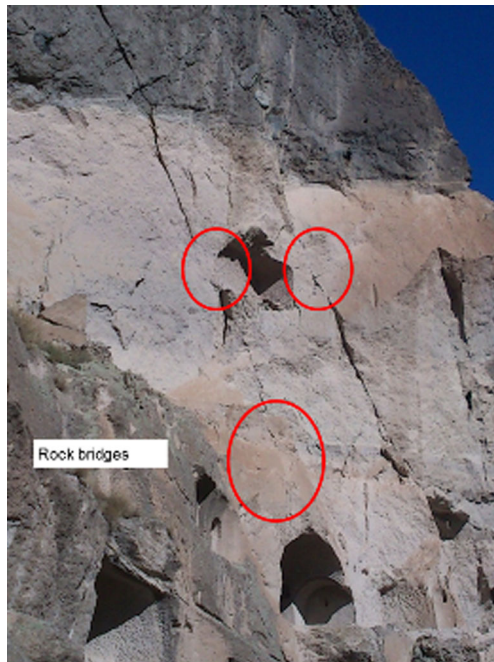
Fig. 10 Rock bridges in joints affecting massive lapilli tuff (layer 2 of Fig. 4)

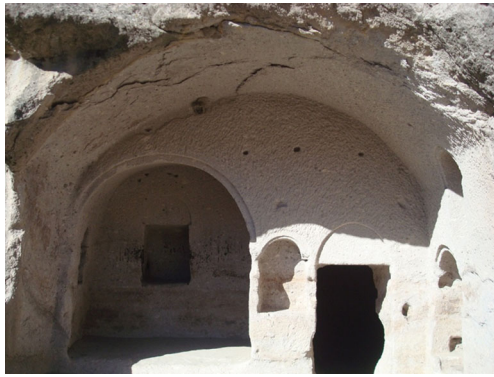
Fig. 11 Spalling of the rock surface in the roof of the room, controlled by rock weathering and stress degradation
