Title	Experimental MR imaging of zirconia ceramic joint implants at 1.5 and 3 T
Author(s)	Kamishima, T.; Kitamura, N.; Amemiya, M.; Ishizaka, K.; Kato, F.; Yasuda, K.; Shirato, H.; Terae, S.
Citation	Clinical Radiology, 65(5), 387-390 <a href="https://doi.org/10.1016/j.crad.2009.12.007">https://doi.org/10.1016/j.crad.2009.12.007</a>
Issue Date	2010-05
Doc URL	<a href="http://hdl.handle.net/2115/43103">http://hdl.handle.net/2115/43103</a>
Type	article (author version)
File Information	CR65-5_387-390.pdf

**Experimental MR imaging of zirconia ceramic joint implants at 1.5T and 3 T**

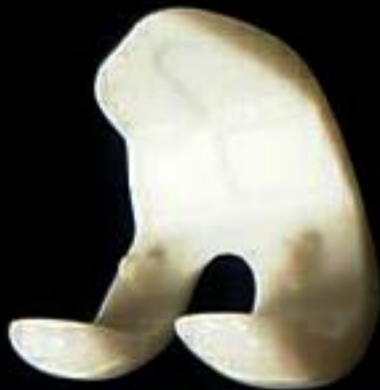
Figure 1 Photograph of an oxidized zirconium implant.

Two femoral implants for artificial knee joints of the same shape, one made of cobalt-chrome and the other of zirconia ceramic (LFA®-III, JMM, Osaka, Japan), were placed in 2 separate columnar acrylic phantoms (300 mm × 300 mm × 150 mm) filled with agar. Each implant was placed in the middle of the phantom (Figure 1).

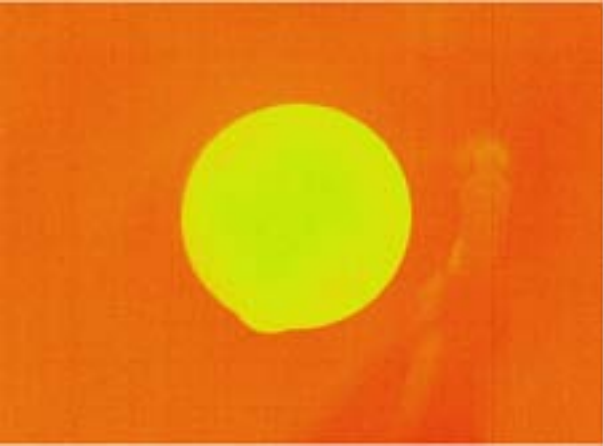
Figure 4 Thermography taken before and immediately after scanning oxidized zirconium implant with 3-T MR system. Change of color from yellowish to greenish indicates that the temperature decreases after the scan. Circular areas for figures of

pre-scanning (4a) and post-scanning (4b) represent the thermographical image taken from above.
