Uniaxial tension-compression fatigue behavior and fiber bridging degradation of strain hardening fiber reinforced cementitious composites

Takashi Matsumoto<sup>a\*</sup>, Kavalin Wangsiripaisal<sup>b</sup>, Toshiro Hayashikawa<sup>a</sup>, Xingwen He<sup>a</sup>

<sup>a</sup> Division of Built Environment, Graduate School of Engineering, Hokkaido University, Sapporo, 060-8628, Japan

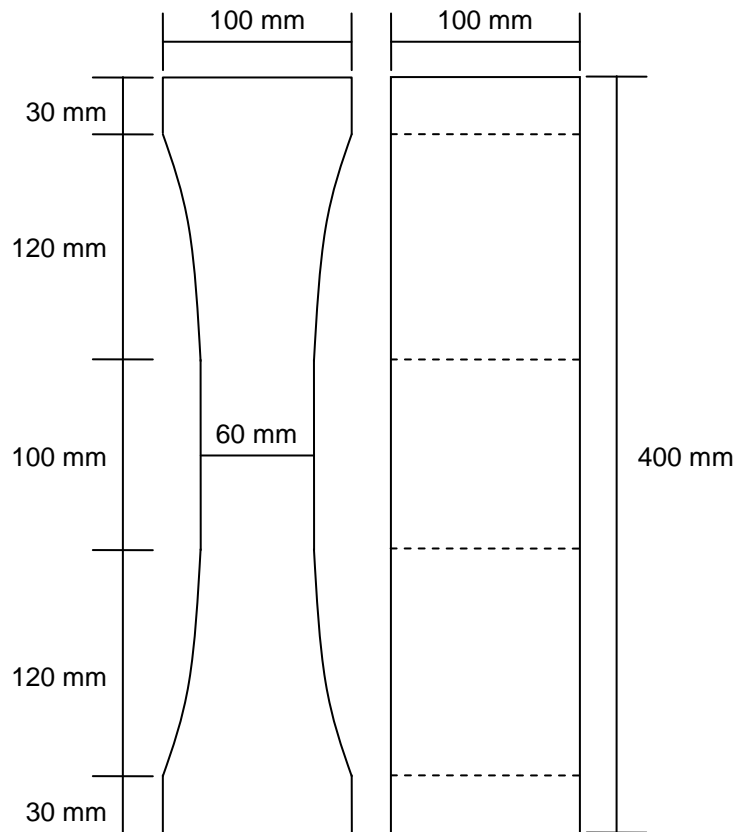
Specimen dimensions are shown in Fig. 1. The specimen dimensions are designed in order to control the initiation of cracks in a specific area and to eliminate the overall failure of a specimen at or near the grip. Namely, the cross sectional area is gradually reduced from 100 mm square at both ends to 100 mm by 60 mm at the center, and it is constant over the central 100 mm length. Within this constant cross sectional zone, multiple cracks are intended to initiate and grow. At both ends, the cross sectional area is also constant in order to have bonding to loading grips. The total length of a specimen is 400 mm.

**Fig. 1. Shape and dimensions of specimens.**

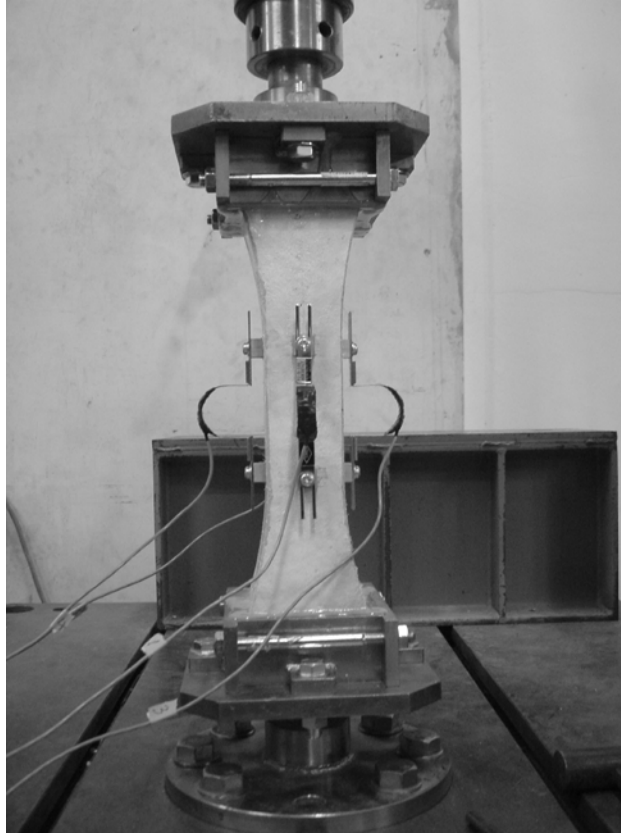
For data acquisition, four strain gauges were carefully attached with accurate alignment on the four side surfaces (Fig. 2). These gauges have 100 mm of gauge length, therefore they have enough length to cover the central constant cross sectional zone. These gauges were attached in order to measure the tensile and compressive strain over the central zone and to control the static and fatigue loading sequences under displacement control. In addition to the four strain gauges, load and stroke displacement were also obtained from the 200 kN capacity feed back controlled loading machine.

**Fig. 2. Experimental set-up. Strain gauge is attached on each of side surfaces.**

Before the experimental setup, specimens were painted with a white color spray paint so that cracks could be identified and observed easily. Then, epoxy adhesive was used for bonding the ends of a specimen to upper and lower loading grip. The loading grip has four side plates with height of 50 mm in order to have enough stress-transferred area. Moreover, the plates are designed to have grooves so that mechanical bond works as well. Two to three hours were needed to gain enough bond strength between the grips and the specimen.

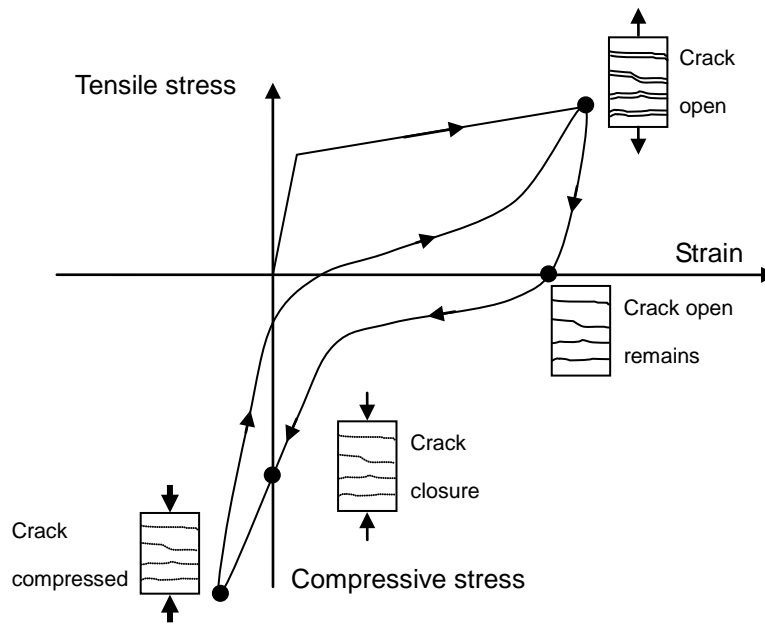
The former strain level of 0 % means that overall the specimens are not in compression, but it means that cracks are enforced to close fully (Fig. 3). As can be exemplified from visible cracks of unloaded fiber composite specimens (Matsumoto and Li [22], Wu et al. [23]), the cracks of unloaded specimens always have some remaining opening. This is because, even at overall zero load level, pulled-out fibers still remain in the crack and resist against the crack closure. Therefore, the maximum compressive strain level of 0 % means that there is no space between crack surfaces and that fibers have to be pushed back into matrix or to be buckled between crack surfaces. The latter strain level of 0.05 % is more severe than the former (Fig. 3). Not only fibers go back into matrix or buckle and crack surfaces are in

Tension-compression fatigue loading was applied as follows (see also Fig. 3). First, a specimen was loaded in tension under displacement control at the rate of 0.005 mm/sec. After reaching the maximum tensile strain level, the specimen was unloaded, and further loaded into the maximum compressive strain level at the same rate of displacement control. From this point on, cyclic fatigue loading was applied at the frequency of 1 Hz under the constant displacement amplitude between the corresponding maximum tensile and compressive strain. Load and the average of four gauges were recorded. The cyclic loading was applied with a sinusoidal wave, and it was stopped when the load decrease ceased or the number of cycles reached 2,000 cycles.

**Fig. 3. Tension-compression loading sequence and crack behaviors.**

Fig. 3. Tension-compression loading sequence and crack behaviors.

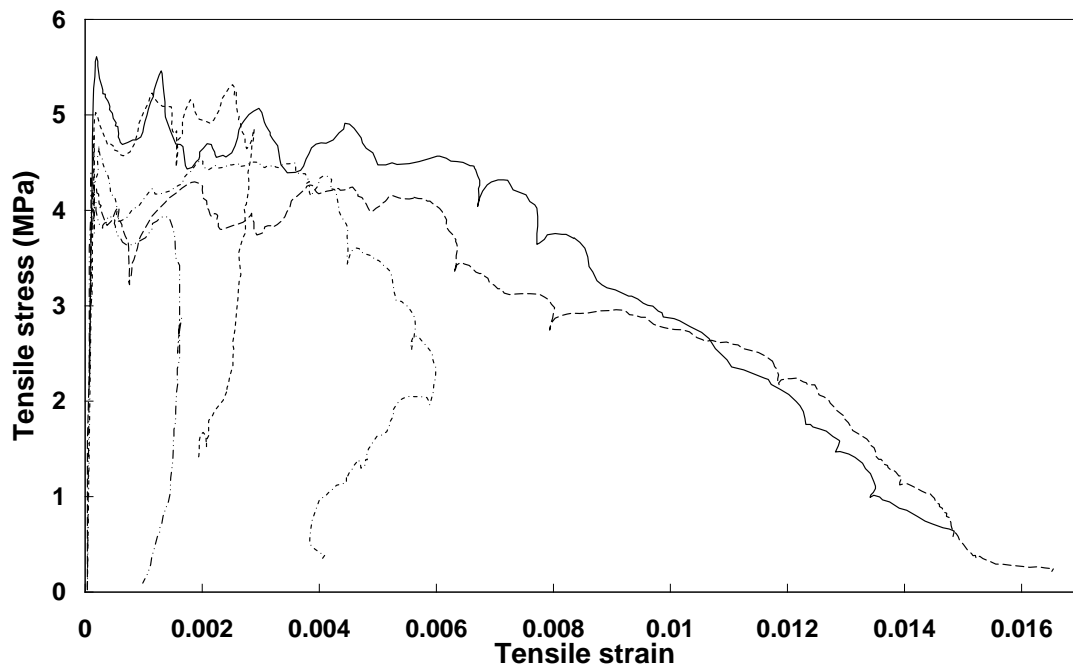
The obtained tensile stress-strain relations of Mix A are shown in Fig. 4, and those of Mix B in Fig. 5.

Tensile stress was observed to linearly increase with tensile strain, until first cracking took place.

Several load drops were observed, although they were recovered. These load drops were associated with

multiple crack occurrences during strain hardening. Finally, one of the cracks became localized, and

overall strain softening was observed. Since the final localization took place outside the gauge length in

a few specimens, those stress-strain curves exhibit unloading towards the origin. This explains the

variability of specimens shown in Figs. 4 and 5. Actually, multiple cracks were observed for all the

Fig. 4. Tensile behaviors of Mix A specimens.

The average tensile strength of Mix A is 4.98 MPa, and Mix B 4.83 MPa. The average tensile strain capacity measured at the first cracking stress level of Mix A is 0.414 %, and Mix B 0.375 %.

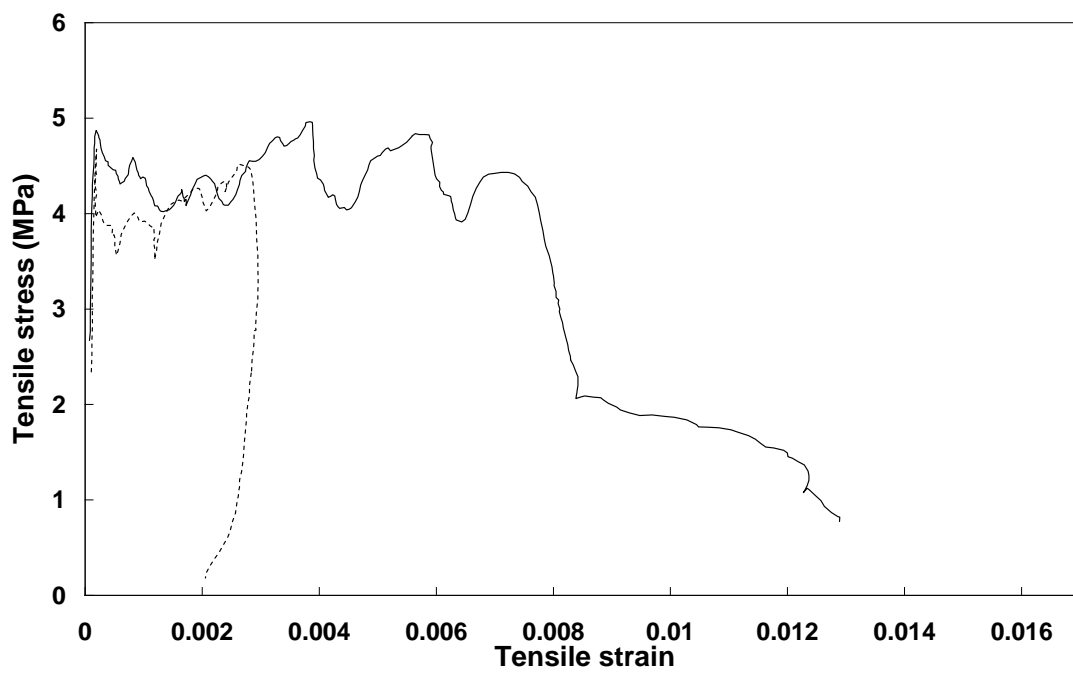
**Fig. 5. Tensile behaviors of Mix B specimens.**

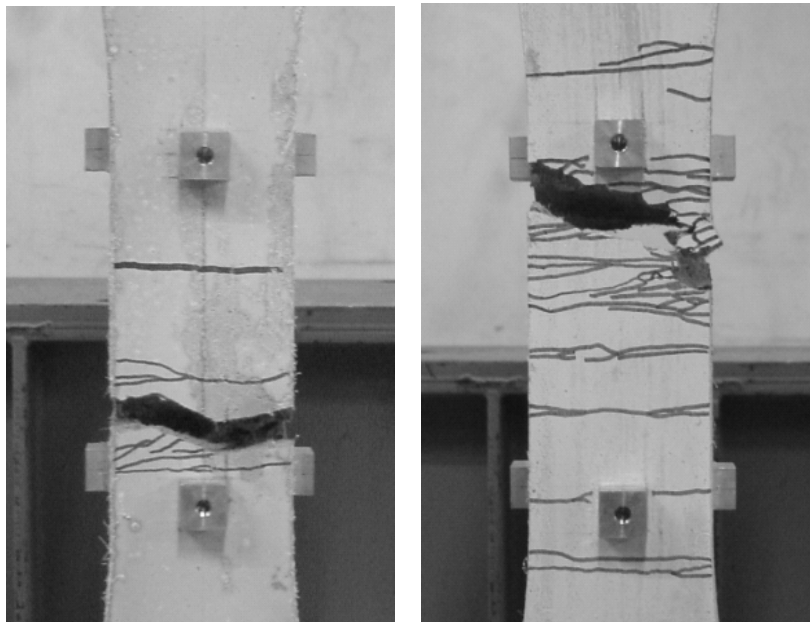
Fig. 6 shows the multiple cracks of Mix A and B, and it shows that these multiple cracks are mostly formed within the central zone. Mix B with light weight aggregates formed more cracks compared to Mix A, supporting the lowering effect of matrix fracture toughness by the light weight aggregates.

**Fig. 6. Multiple cracks of Mix A (left) and Mix B (right). Cracks are visualized with markings.**

Fig. 6. Multiple cracks of Mix A (left) and Mix B (right). Cracks are visualized with markings.

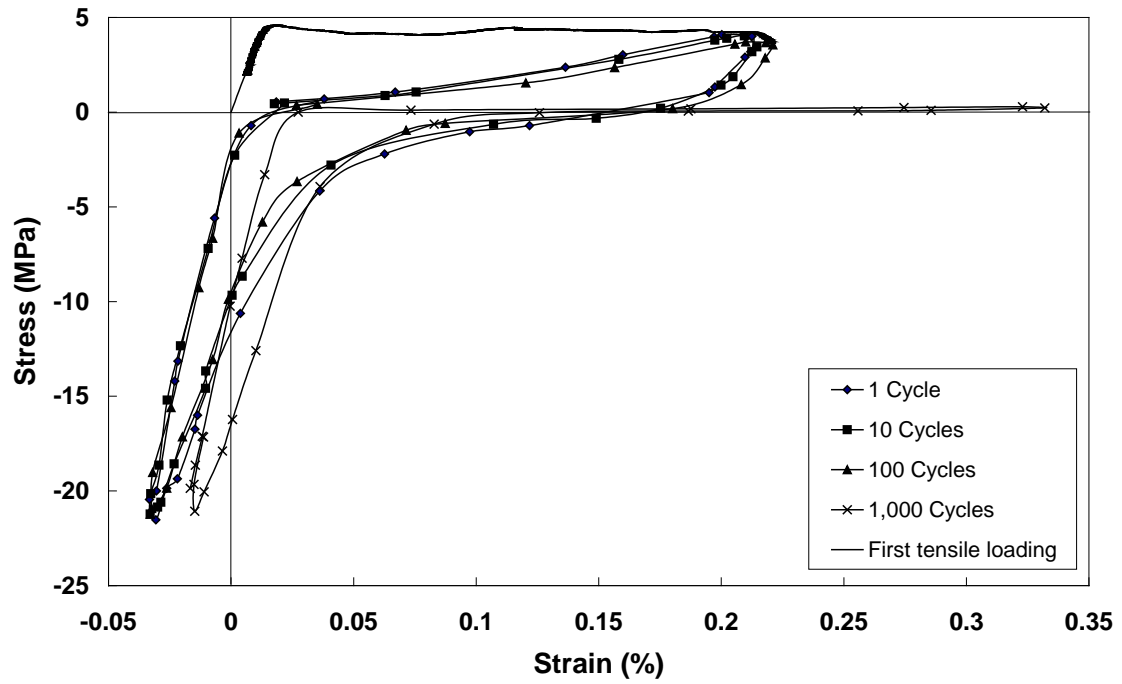
Fig. 7 shows the hysteresis curves of a Case 1 specimen under tension-compression fatigue. The curves are the stress-strain behavior at first tensile loading, 1, 10, 100, and 1,000 cycles. From 1 to 100 cycles, the shapes of curves do not change significantly, and the maximum tensile and compressive stress on the curves decrease slightly. From 100 to 1,000 cycles, the curves change significantly. At 1,000 cycles, the tensile stress is nearly zero, meaning that a crack opens up with no tensile stress transmitted across the crack. The hysteresis curves imply that the bridging stress across the crack has degraded

quickly between 100 and 1,000 cycles.

Fig. 7 Hysteresis curves during tension-compression fatigue of a Case 1 specimen.

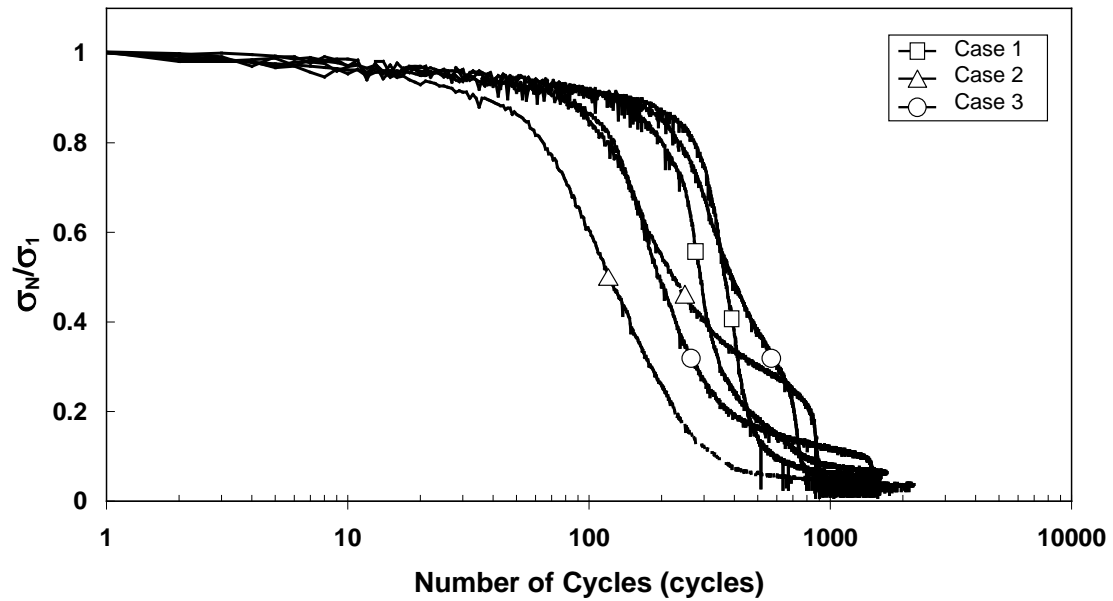
**Fig. 8 Bridging stress degradation curves during tension-compression fatigue.**

In order to observe the bridging stress degradation, the tensile stress corresponding to the preset maximum tensile strain was recorded with the number of cycles. In Fig. 8, the ratio of the tensile stress at the current number of cycles,  $\sigma_N$ , to that at 1 cycle,  $\sigma_1$ , is plotted with the number of cycles for all the specimens. Fig. 8 shows that there are three stages in the bridging stress degradation curves. First, from 1 to 100 cycles, bridging stress gradually decreases roughly to 90 %. Second, from 100 to 1,000 cycles, the bridging stress sharply decreases roughly to 10 %. Some specimens suffer from severe damage, and those specimens exhibit a decrease nearly to 0 %. Finally, after the sharp decrease, the bridging stress decreases gradually again. The tests were terminated, if the final decrease is negligible and the number of cycles is above 1,000 cycles.

The differences among the experimental cases can be seen at the onset of the second stage and during the second stage.

For Case 1 and 2 of Mix A, Case 1 enters the second stage slightly later than Case 2, but Case 1 decays quickly with sharper gradients. This behavior was partially contrary to expectations. It was expected that Case 1 started to decay earlier and decayed quickly, since Case 1 was subjected to more severe loading conditions as explained in section 2.3. At this moment, the reason why Case 1 started to decay later than Case 2 is not clear.

Case 3 of Mix B started to decay earlier than Case 1, but later than Case 2. Also, Case 3 decays less quickly than Case 1, but more than Case 2. When compared to Case 1 under the same loading conditions, Case 3 exhibited more multiple cracks. The increased number of multiple cracks may contribute to the distribution of damages, and the gradient of the second decline stage in Case 3 might be achieved. The reason why Case 3 started to decay earlier than Case 1 is not clear at this moment.

Although there are not enough specimens to discuss the differences among the three cases, all the three cases show that the major bridging stress degradation takes place before 1,000 cycles and that the bridging stress degrades nearly to 10 %. It can be said that the bridging stress degradation under tension-compression fatigue is significantly severe, and that its degradation life on the order of  $10^3$  cycles is quite short compared to engineering design life on the order of  $10^6$  cycles.

Fig. 8 Bridging stress degradation curves during tension-compression fatigue.

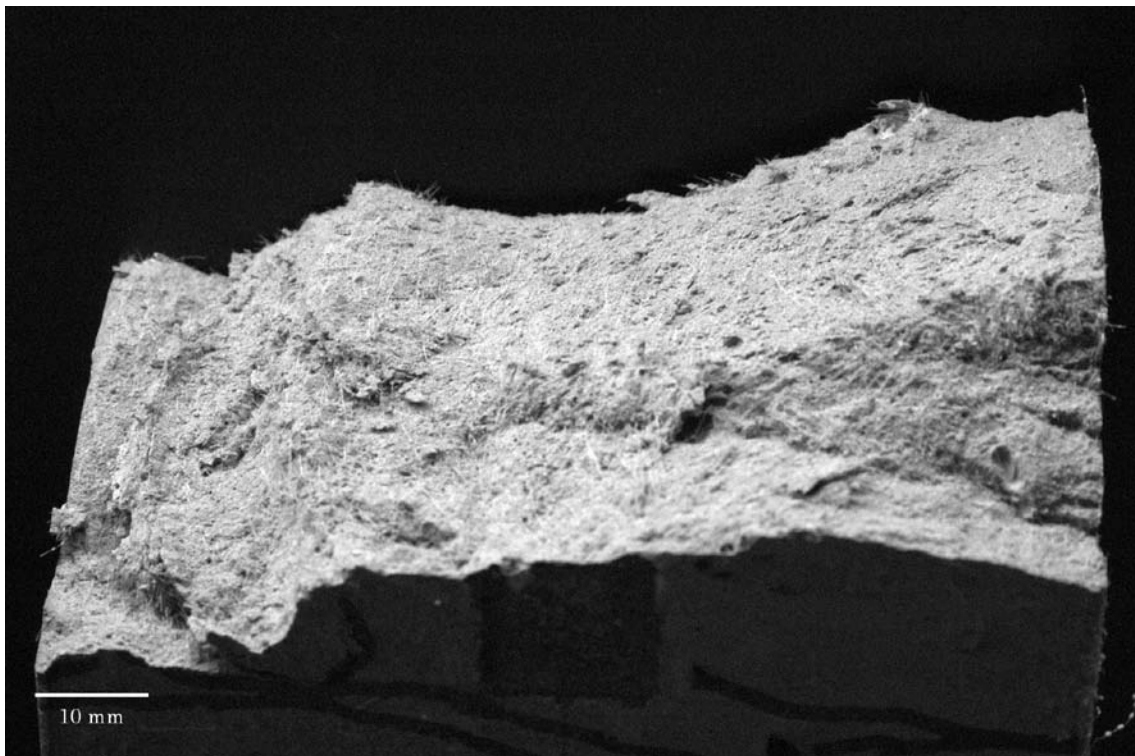
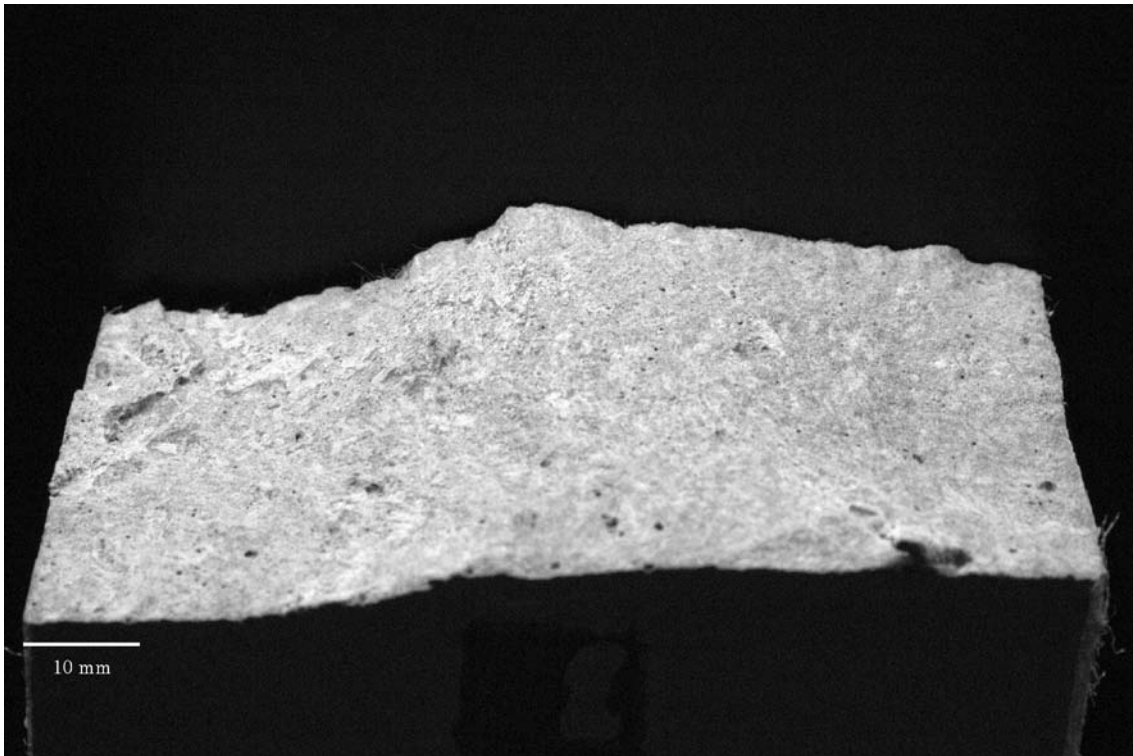
Fig. 9 shows the typical failure surfaces of a static specimen and a tension-compression fatigue (Case 1) specimen. Both specimens are made of Mix A. When the static specimen is compared to the fatigue specimen, it is clearly seen that the failure surface is rougher and that more fibers are protruded on the surface. Also, it was observed that cement powder accumulated on the failure surface of the fatigue specimen. The reason could be as follows. The failure surface in the fatigue specimen was made smooth, after the surface was subjected to cyclic contact and wear during tension-compression fatigue. At the same time, the fibers were damaged between the surfaces, and those fibers were worn out to short protrusion length. For further understanding of fiber damages, it is necessary to observe the fibers in situ under tension-compression fatigue, and detailed image analysis is required to examine the fiber failure mode.

**Fig. 9 Failure surface of a static tensile specimen with protruded fibers (up) and a tension-compression fatigue (Case 1) specimen without protruded fibers (down).**

Fig. 9 and Fig. 10 exemplify the severity of tension-compression fatigue for bridging fibers. The early bridging stress degradation before 1,000 cycles obviously results from the severe damages to bridging fibers.

Fig. 9 Failure surface of a static tensile specimen with protruded fibers (up) and a tension-compression fatigue (Case 1) specimen without protruded fibers (down).

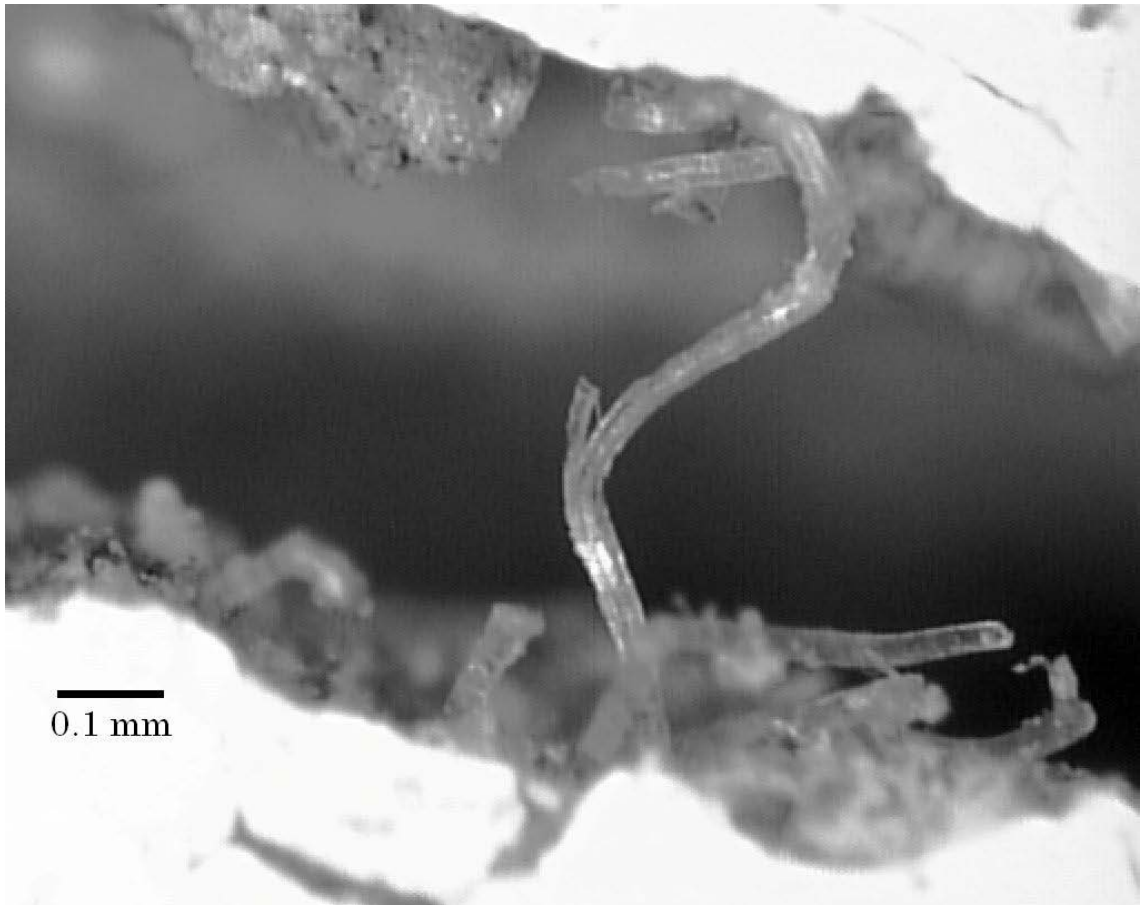
Fig. 10 is a microscopic image of a crack. In the figure, a fiber is buckled, and other fibers are short-protruded on the surface. It is considered that some fibers are buckled between the crack surfaces under tension-compression fatigue, and that this buckling may lead to the rupture of fibers. Yielding is also possible for the rupture of fibers. In either case, it is considered that these ruptured fibers were worn out to the short protrusion length observed on the surface.

**Fig. 10 Buckling of a fiber and short protrusion of fibers.**

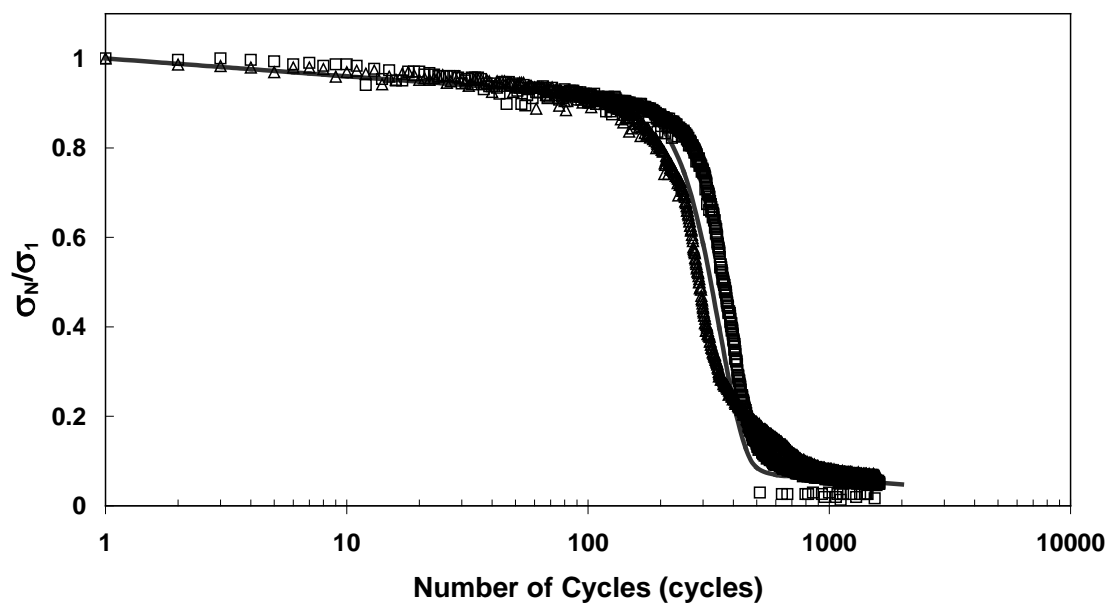
Fitting curves are obtained for the three cases of bridging stress degradation, and they are shown in Fig.

11, 12, and 13, respectively. The fitting curves are given by the following equation:

Table 4 shows the parameters of the fitting curves. The shape parameter,  $m$ , of Case 1 is 25, while those of Case 2 and 3 are lower: 9 and 12, respectively. The shape parameter describes the gradient of the second decline stage of a bridging degradation curve. The larger the shape parameter is, the steeper the gradient becomes. Hence, with a large shape parameter like Case 1, the second decline stage can be narrowed down or well-defined. On the other hand, with a small shape parameter like Case 2 and 3, it has some range in two orders of magnitude. Regarding the scale parameter,  $\log N_0$ , it is noted that, when  $N$  is equal to  $N_0$ ,  $w(N)$  becomes  $1/e = 0.37$ , according to Weibull distribution. Namely,  $N_0$  points the number of cycles for the second decline stage.

**Fig. 11** Fitting curve and bridging stress degradation curves of Case 1.

Fig. 11 Fitting curve and bridging stress degradation curves of Case 1.

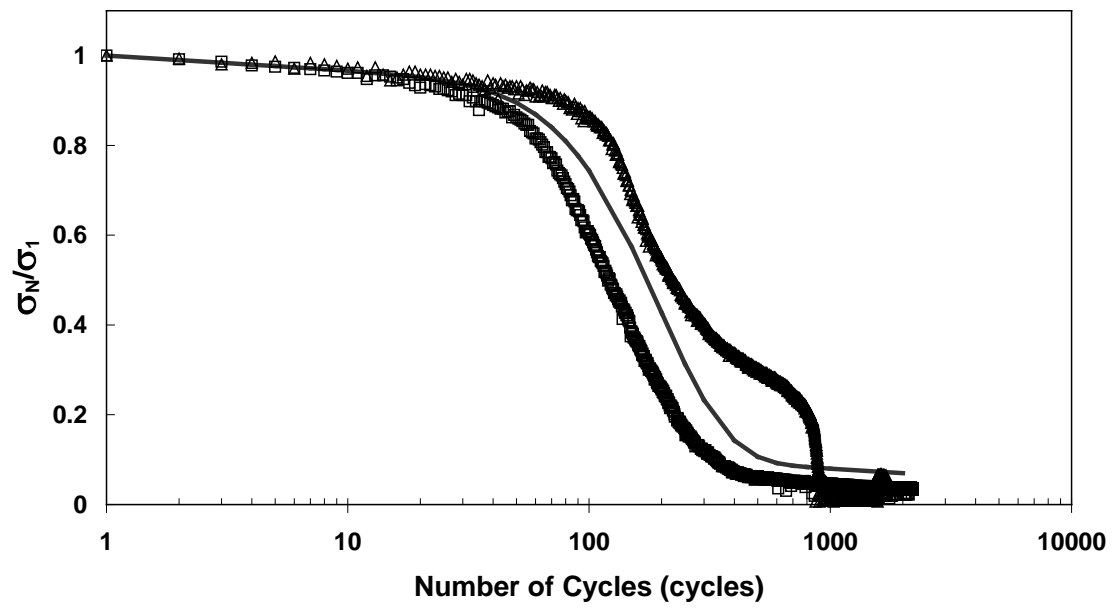
Fig. 12 Fitting curve and bridging stress degradation curves of Case 2.

Fig. 12 Fitting curve and bridging stress degradation curves of Case 2.

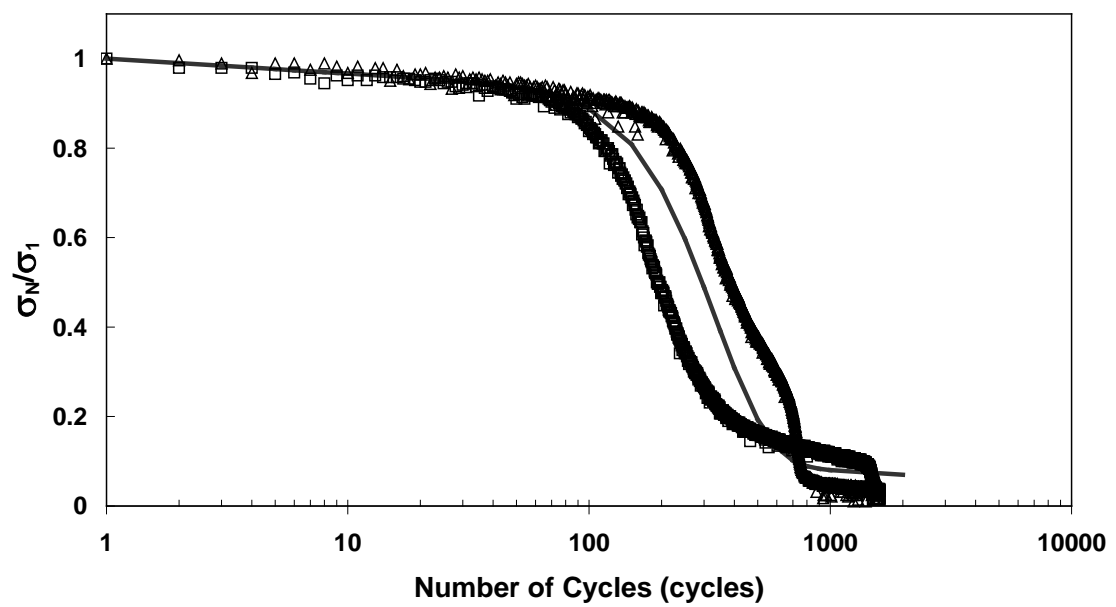
Fig. 13 Fitting curve and bridging stress degradation curves of Case 3.

Fig. 13 Fitting curve and bridging stress degradation curves of Case 3.

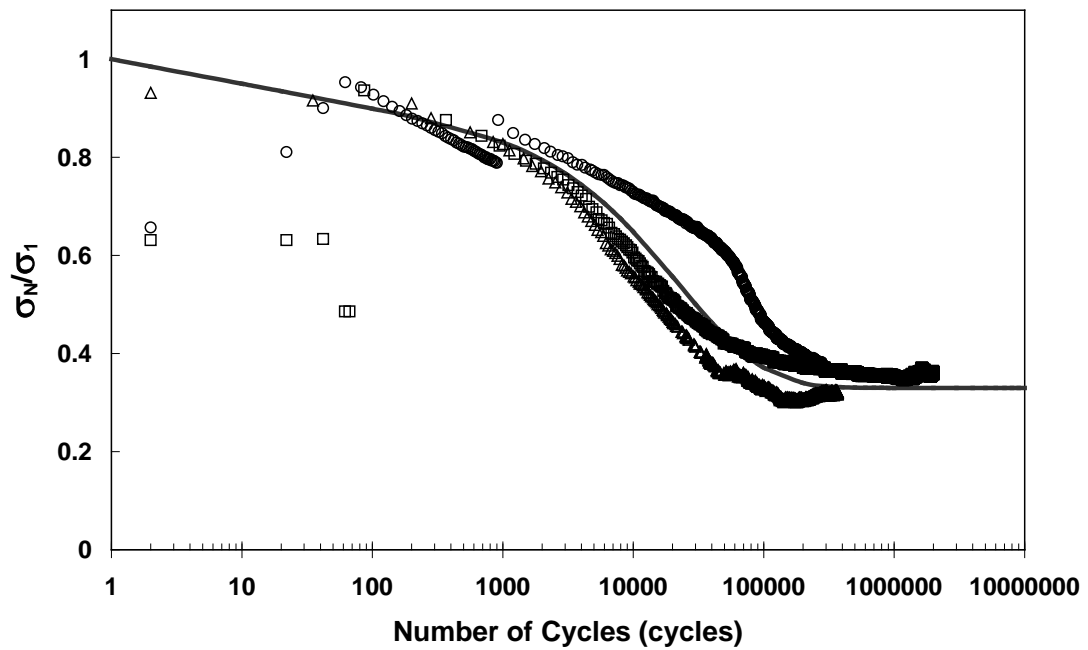
Fig. 14, 15, and 16 show the resulting bridging stress degradation curves under tensile fatigue for the maximum strain level of 0.1, 0.15, and 0.2 %, respectively. The curves have similar behaviors to those presented in the current study. In the same manner, the curves can be divided into three stages.

Fig. 14, 15, and 16 also show the fitting curves obtained in the same way as explained in section 3.3, and Table 5 presents the parameters. The shape parameter,  $m$ , is smaller, meaning that the second decline stage has more range. The scale parameter,  $\log N_0$ , is larger, showing that the number of cycles for the second decline stage is larger. The gradient of the initial slope,  $a_1$ , is slightly steeper, although the loading condition is less severe in the cited study. This is probably because of the lack of measurement points from 1 to 1,000 cycles or the difference in matrix compositions. On the other hand, the gradient of the final slope,  $a_2$ , is set to be zero, based on the behaviors of the degradation curves. Finally, the intercept,  $b_2$ , is larger than that of the current study. This implies that, in the tensile fatigue condition, there are more fibers loaded below fatigue limit.

**Fig. 14 Fitting curve and bridging stress degradation curves during tensile fatigue with maximum tensile strain of 0.1 %.**

Fig. 14 Fitting curve and bridging stress degradation curves during tensile fatigue with maximum tensile strain of 0.1 %.

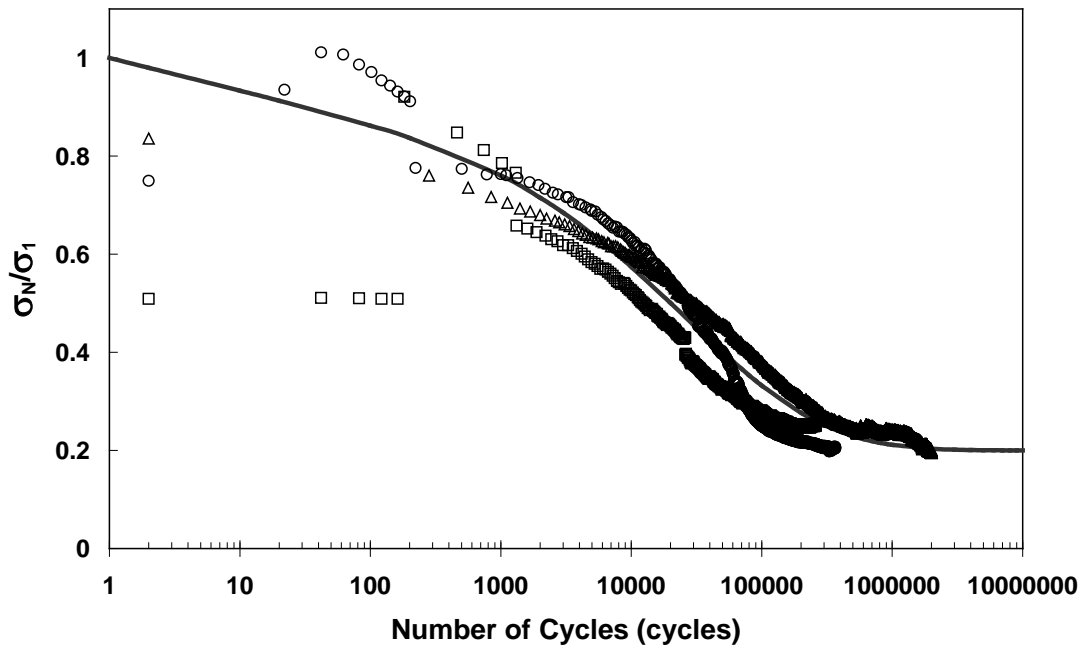
Fig. 15 Fitting curve and bridging stress degradation curves during tensile fatigue with maximum tensile strain of 0.15 %.

Fig. 15 Fitting curve and bridging stress degradation curves during tensile fatigue with maximum

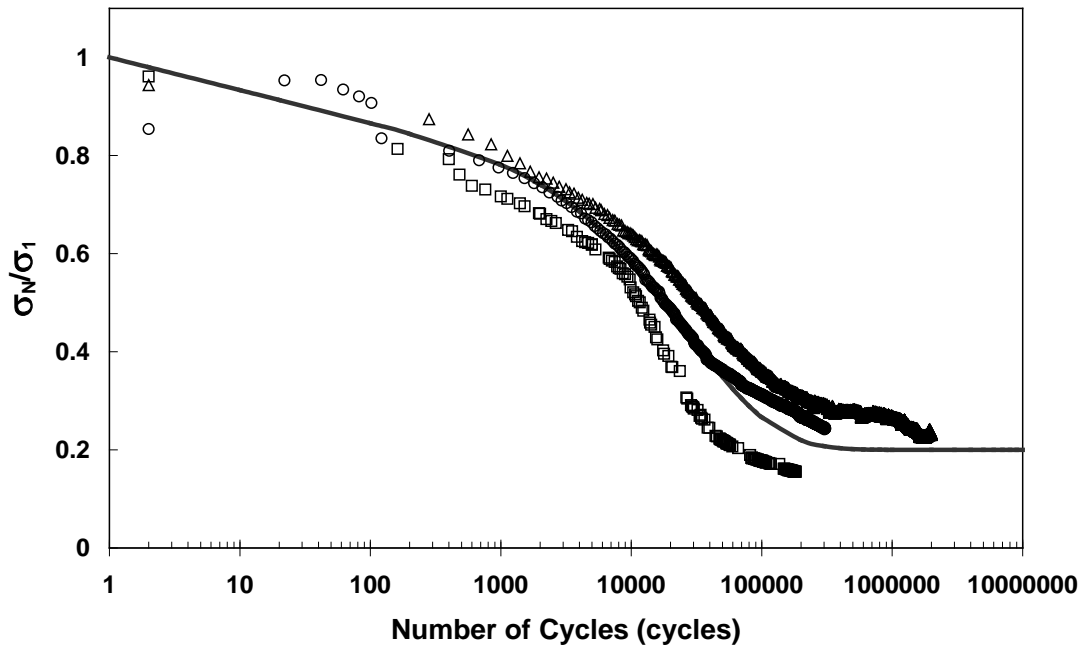
Fig. 16 Fitting curve and bridging stress degradation curves during tensile fatigue with

**maximum tensile strain of 0.2 %.**

Fig. 16 Fitting curve and bridging stress degradation curves during tensile fatigue with maximum
