Surface Cracking on $\Sigma 3$, $\Sigma 9$ CSL and Random Grain Boundaries in Helium Implanted 316L

Austenitic Stainless Steel

Abstract

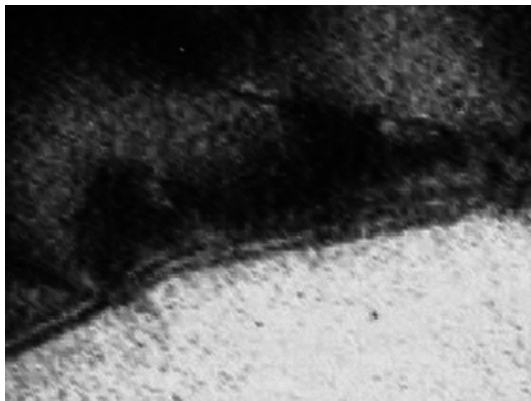
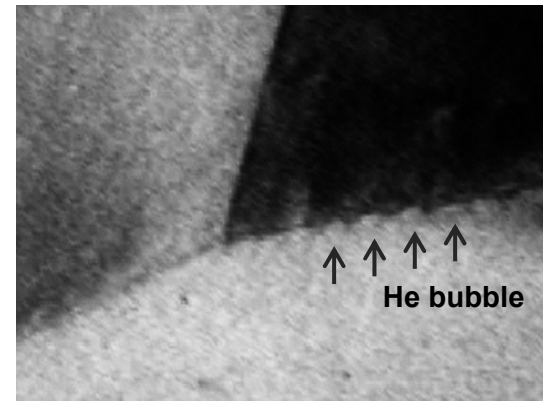
Fig.2 Behavior of helium bubble nucleation and growth on a random grain boundary during *in-situ* annealing in the MBHVEM up to 923 K.

Fig. 2 shows the helium bubble formation behavior in helium ion implanted 316L steel during the *in-situ* heating experiment in the MBHVEM. Before heating, no helium bubbles were seen at the random grain boundary, twin boundary or in the matrix. When the sample temperature reached 773 K, tiny helium bubbles (~10 nm) formed exclusively at the random grain boundary. The bubbles grew slowly upon further heating of the sample to 873 K. Finally, upon heating to 923 K, the bubbles coalesced forming a channel of helium gas along the random grain boundary. No helium bubbles were seen at the twin boundary during this heating experiment.

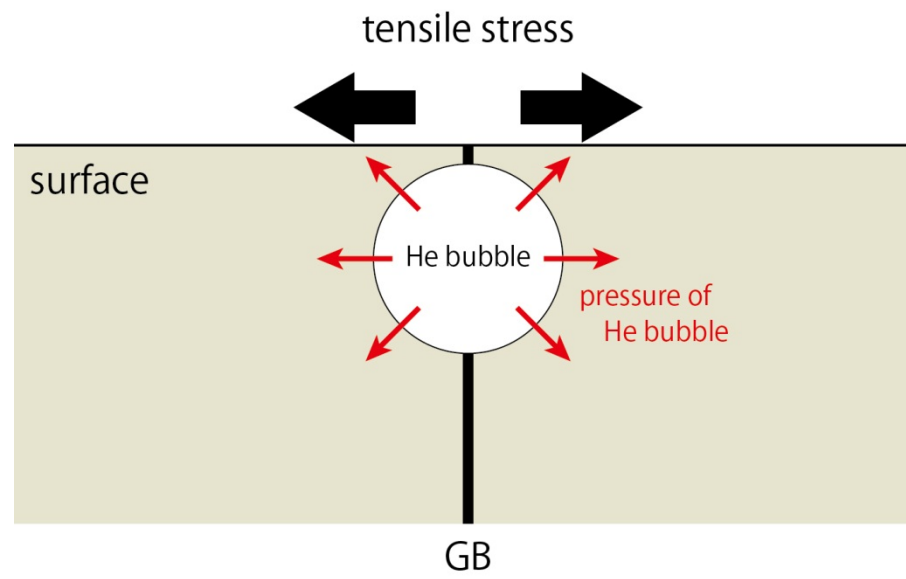
Fig.8 Schematic illustration of the generation of surface stress caused by helium bubble overpressure formed on the grain boundary near the surface.

After annealing of the helium ion implanted 316L stainless steel in the MBHVEM, surface cracking occurred along the random boundary and some CSL boundaries. This is due to the formation and rupture of helium bubbles at the grain boundaries. Helium cracking is known to occur during welding of stainless steel containing helium atoms. In the heat-up period of welding, helium bubbles nucleate at grain boundaries and grow by thermal vacancy absorption because of helium gas overpressure in the bubbles [26]. In the cooling period, the helium bubbles continuously grow by stress-induced vacancy absorption [26] due to the tensile stress associated with the solidification of the melting zone. When the tensile stress exceeds the fracture stress of the grain boundary decorated

by the helium bubbles, surface cracking occurs. It was observed that many helium bubbles nucleated and grew at the grain boundaries during *in-situ* annealing in the MBHVEM, analogous to the heat-up process during welding. However, in our experiment, the cooling rate of the sample was about 10 K/s, which is much slower than that during welding. Furthermore, there was no melting zone near the grain boundaries, hence the effect of external tensile stress can be neglected. As shown in Fig. 1, the distribution of implanted helium atoms is limited to a depth of 300 nm from the surface, resulting in helium bubbles only being nucleated at grain boundaries near the surface. When the helium bubbles grow through the absorption of both thermal vacancies and helium atoms, tensile stress is applied near the surface due to the helium gas overpressure in the bubbles (see Fig. 8). We believe that the surface cracking occurred during the annealing period in the MBHVEM (not during the cooling period) and the surface does not affect the nucleation of helium bubbles at the grain boundaries.
