# STUDY ON FALL PROTECTION FOR ASSEMBLING AND DISMANTLING WORKS OF SYSTEM SCAFFOLDS

K. OHDO\*, S. TAKANASHI, Y. HINO, and H. TAKAHASHI

*Construction Safety Research Group, National Institute of Occupational Safety and Health, Japan*

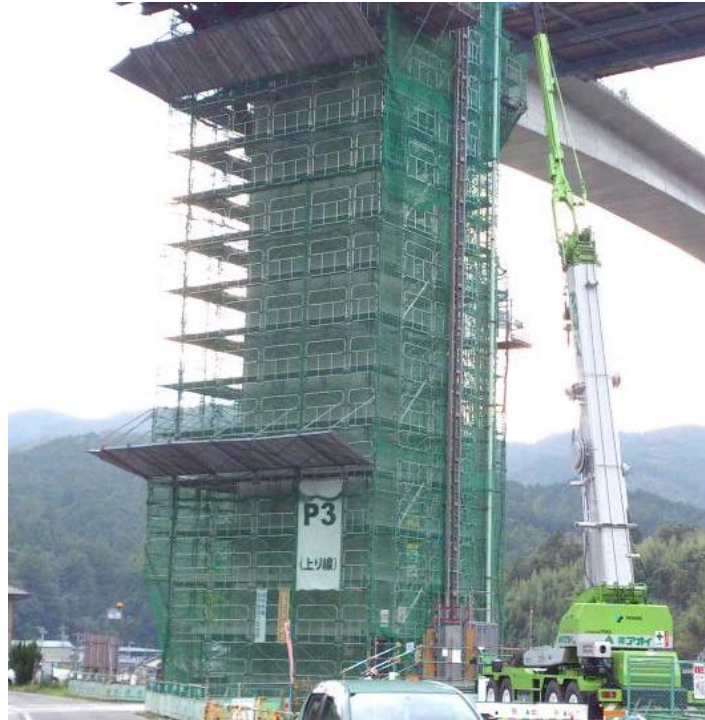
**Figure 1: Prefabricated scaffolds assembled by Advanced Guardrail Installation Method.**

In order to examine further countermeasures to reduce such falls, the Ministry of Health, Labour and Welfare, Japan (MHLW) established a committee at the authors' institute to evaluate various construction methods according to present safety guidelines. From the results and the discussion, the Guideline for Advanced Guardrail Installation Method was amended (Ministry of Health, Labour and Welfare, Japan 2009).

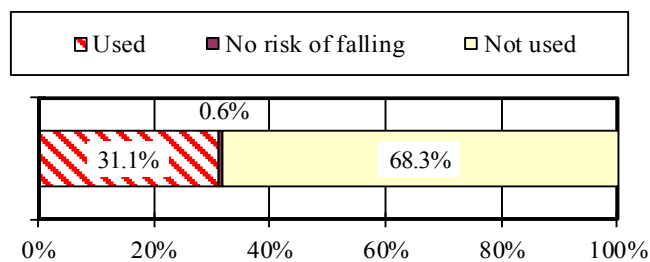
**Figure 2: The use rate of Advanced Guardrail Installation Method.**

However, it was discovered that this method is not widely used. The MHLW investigated the use rate of this method on 4,892 construction sites. The result is shown in Figure 2. Only 31% of construction sites used this method, and it was found that the use of the method was not widespread, especially for system scaffolds due to a low working property of the methods. Therefore, in this study, other assembling and dismantling method for system scaffolds were examined for the safety work. Finally, the assembling work of the system scaffolds was performed to examine whether the method was practicable.

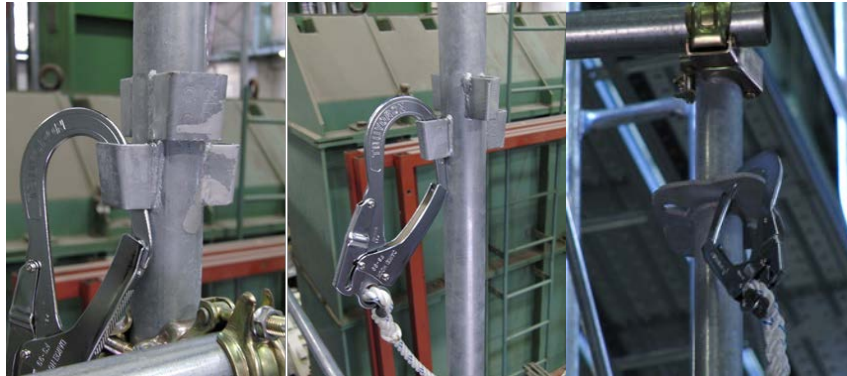
**Figure 3: Typical wedge pockets and the hook of the safety harness (Left: Type A, Center: Type B , Right: Type C).**

In this study, typical system scaffolds by wedge connections in Japan were selected to examine the safety assembling and dismantling method for prevention the fall from the scaffolds. Then, it was decided that wedge pockets were used for connecting the hook of the safety harness to the scaffolds for fall prevention. Three types of the system scaffolds in Japan were selected in this study. Figure 3 show the typical wedge pockets of the selected system scaffolds and the hook of the safety harness connected to the wedge pockets.

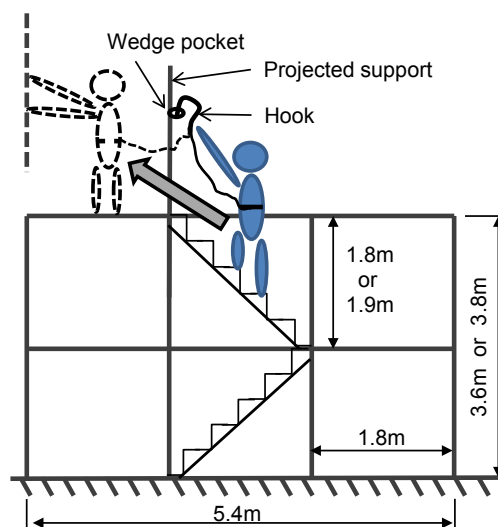
**Figure 4: 2 stories and 3 bays scaffolds.**

When workers use the safety harness on the scaffolds, the horizontal stability of the scaffolds must be confirmed. In Japan, the ties, which connect the scaffolds to the building wall, shall be installed within 5m (vertical)  $\times$  5.5m (horizontal) to keep the horizontal stability of the scaffolds by Occupational Safety and Health Regulation (Ministry of Health, Labour and Welfare, Japan 1972). For the case of typical system scaffolds selected in this study, the height of 1 story is 1.8m or 1.9m, and the width of 1 bay is 1.8m. From these reasons, the ties are assumed to be installed within 2 stories (3.6m or 3.8m)  $\times$  3 bays (5.4m) for the selected scaffolds. Therefore, the height and width of the scaffolds were decided to be this maximum tie spacing, as shown in Figure 4.

In the experiment, the safety of the fall protection by the safety harness during the assembling or dismantling works above the 2nd story of the scaffolds was examined. A support with wedge pockets was projected above the 2nd story as shown in Figure 4, because it is recommended that the hook should be connected above the ring of lanyard to reduce the damage of falling workers (National Institute of Industrial Safety 2004). Then, the strength of the wedge pocket projected above the 2nd story of the scaffolds must be also confirmed.

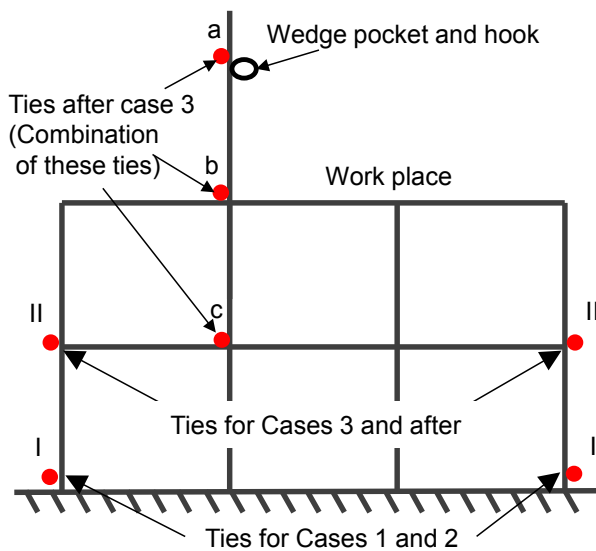
Figure 5: Configurations of ties.

The horizontal stability of the scaffolds and the strength of the wedge pocket were confirmed by fall experiments using a human dummy. Figures 5-6 show the structure of the scaffolds in the experiments, and Table 1 shows the experimental cases. Configurations of ties were changed to confirm the stability of the scaffolds and the strength of the wedge pocket in various conditions, as shown in Figures 5-6 and Table 1. The experiment in Figure 6 was performed for confirming the strength of the guardrail.

Table 2 shows the results of the experiment. In the cases 1 and 2, the ties were installed at the points of I in Figure 5, which is 2 stories down from the work place. The horizontal displacement of the scaffolds exceeded 300mm, when the human dummy was dropped in these cases. Then, it seemed that the scaffolds were unstable by the video observation of the experiments.

In the case 3, the ties were installed at the points of II in Figure 5, which is 1 story down from the work place, and the horizontal displacement of the scaffolds was also observed after the experiment. From the result of the experiment, it was found that the horizontal displacement did not exceeded 300mm, and it seemed that the scaffolds were stable by the video observation. Therefore, in the experiments after the case 3, the ties were installed at the points of II, as shown in Figure 5.

In the cases that the ties were installed at the points of a and b in Figure 5, it was assumed that the impact load concentrated on the wedge pocket by the fall of the human dummy. In the cases that the ties were installed at the point of c in Figure 5, it was assumed that the moment concentrated on the bottom of the projected support by the fall of the human dummy. The experiments were carried out in consideration of these configurations of ties to confirm the strength of the scaffolds' members.

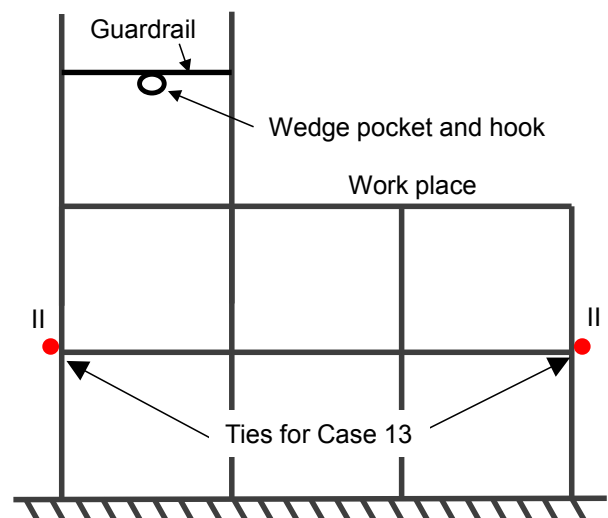
Figure 6: Configurations of ties (Case 13).

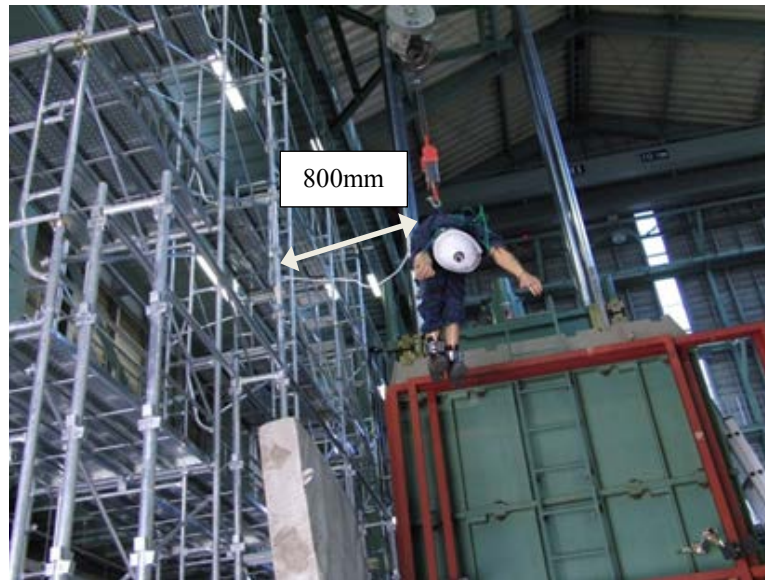
**Figure 7: Experimental method for drop of human dummy.**

In the experiment, the human dummy, of which weight was 980N was dropped from the same height of the hook of the harness, and the distance between the hook and the human dummy was set to be 800mm as shown in Figure 7. This experimental method was the same way as the fall test by Advanced and Secured Handrail (Japanese Industrial Standards 2006). After the experiments, it was observed the horizontal displacement of the scaffolds and the damage of the wedge pocket, support, guardrail and the hook.

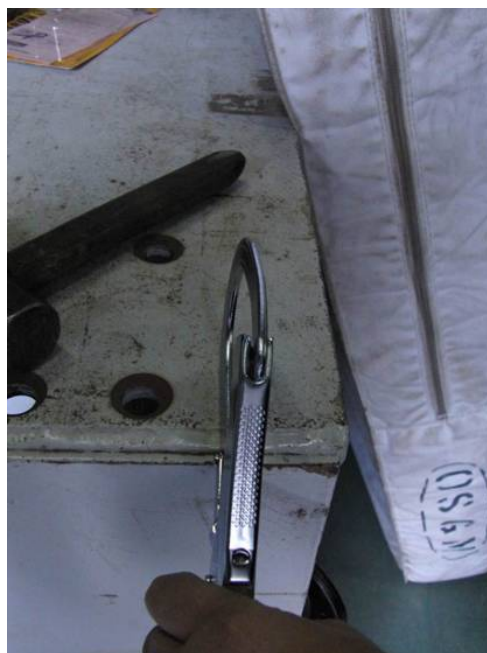
**Figure 8: Slight curved hook by the fall experiment.**

In a series of these experiments, there were no damage or only a slight damage in the wedge pocket, support, guardrail or the hook, as shown in Table 2 and Figure 8. Therefore, in the case when the ties were installed within 1 story from the work place, it was confirmed that the assembling and dismantling works of the system scaffolds could be performed safe, concerning the stability of the scaffolds and the strength of the scaffolds' members.

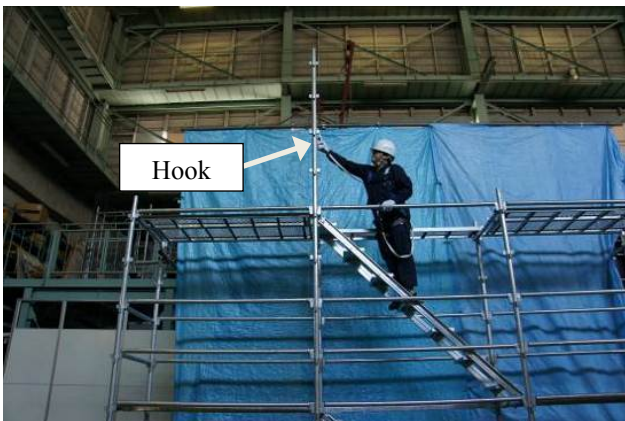
**Figure 9: The worker who tried climbing the stairs to the next platform.**

First, the worker tried climbing the stairs to the next platform. Then, the hook of the harness could be hung to the wedge pocket with previously projected support, as shown in Figure 9, because it is recommended that the hook should be hung above the ring of lanyard (above the waist) to reduce the damage of falling workers by the Recommendations for Use of Safety Belts (National Institute of Industrial Safety 2004). After climbing to the next platform, the worker tried setting other supports, as shown in Figure 10. Then, the worker could be performed with using the harness.

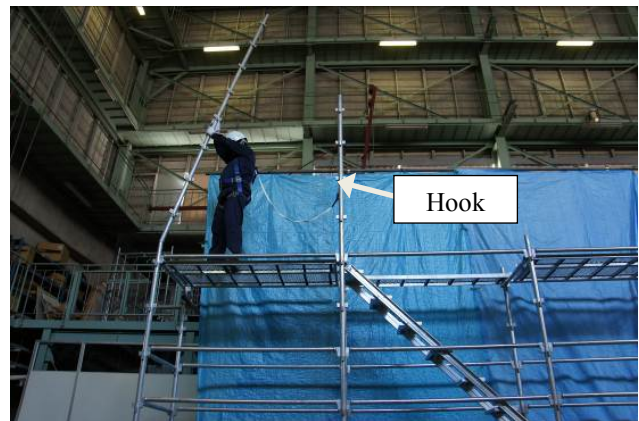
**Figure 10: The worker who tried setting other supports.**

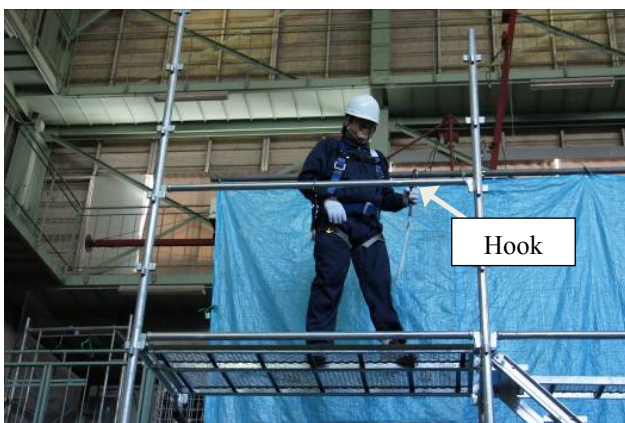
**Figure 11: The worker who tried setting the guardrail between the supports.**

Next, the worker tried setting the guardrail between the supports, and then the worker could hang the hook of the harness to the guardrail, as shown in Figure 11. After this work stage, the worker could assemble the scaffolds on the next platform with hanging the hook of the harness to the guardrails at all times, as shown in Figure 12. The dismantling work of the scaffolds could be also performed in the reverse order of the assembling work.

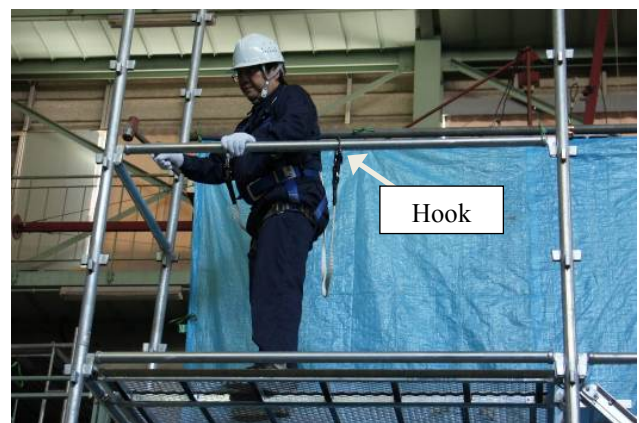
**Figure 12: The worker who tried setting other members with hanging the hook of the harness to the guardrail.**
