LOW-CYCLE FATIGUE FAILURE MECHANISM OF WIND TURBINE FOUNDATION DUE TO VIBRATION OF UPPER STRUCTURE

K. YONETSU^{1*}, C. FUJIYAMA^{2†}

ABSTRACT

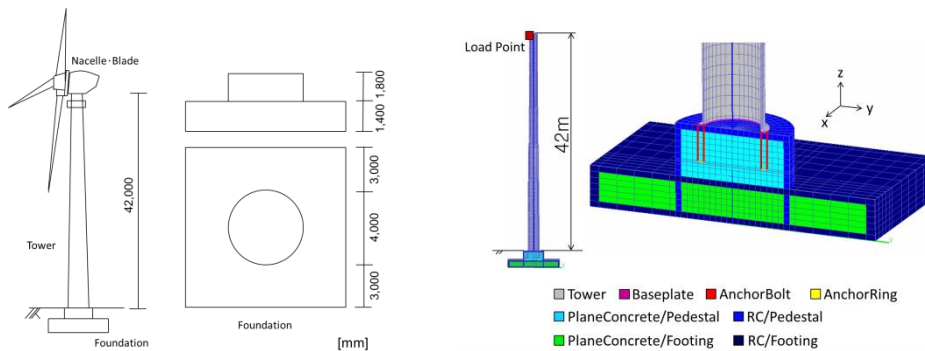
Figure 1: Schematic and model for analysis

Fig. 1 shows a schematic of targeting wind turbine and its model for-analysis. Hub height of the model is 42 m. The tower and foundation are connected by 88 anchor bolts and an anchor ring. Because of symmetry, only half of the wind turbine is needed to be modeled. The model is made primarily from solid elements. Only the anchor bolts are modeled by line elements, with particular tension strains representing torque. To account for bond and friction between steel and concrete, interface elements are used between tower and foundation (Yasojima and Sakamoto 2012).

Concrete strength of the pedestal and footing are 28.6 N/mm^2 and 29.3 N/mm^2 , respectively. Yielding strength of the tower and anchor bolts are 400.0 N/mm^2 and 931.6 N/mm^2 , respectively. The total dead weight of nacelle and blades are applied as a 650 kN axial force on the tower. The torque tightening the tower and foundation is $2.12 \text{ kN}\cdot\text{m}$.

The bottom of the model was fully restrained in the vertical. The X-axis was restrained in a symmetrical cross section. In this study, it is assumed that the influence of elasticity of the ground can be ignored.

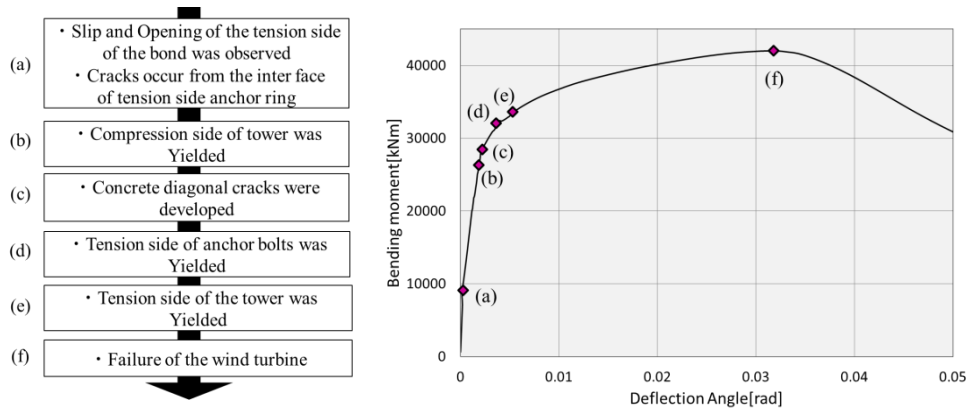
Figure 2: Failure process for static analysis

Fig. 2 shows the result of the static analysis in this study. The cone-shaped failure from the anchor ring was confirmed from principal strain contour and deformation. This means that the behavior of the anchor bolt affects the failure of the wind turbine. The failure process observed can be broken

down into steps (a) to (f), which are represented in the diagram of bending moment versus deflection angle of the bottom of the tower. The results agree with past research.

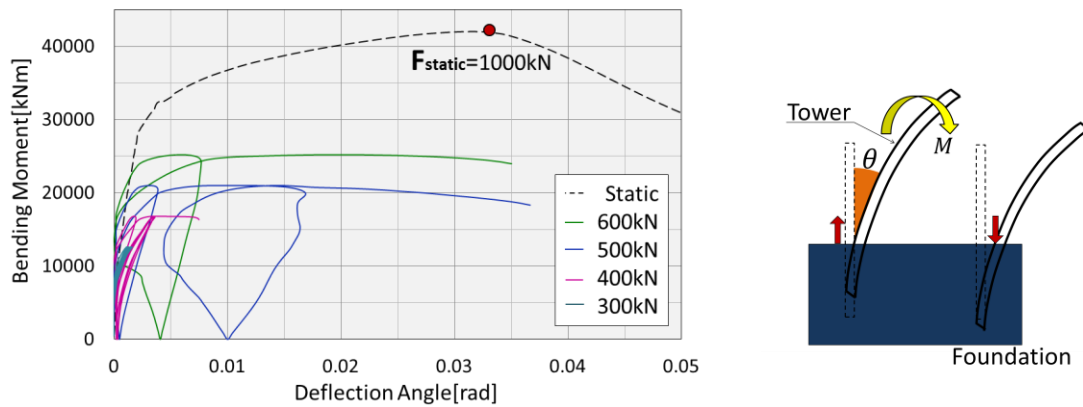
Figure 3: Relation of the bending moment to the deflection angle

Fig. 3 shows the relation of the bending moment to deflection angle of the tower at the bottom. The deflection angle of the tower at applied tension side was adopted as an indicator. The deflection angle at an amplitude of 300 kN overwrote the same path during the whole load history, although deflection angles at amplitudes 400 kN, 500 N and 600 kN increased rapidly after particular load cycles. In other words, repetition of a load whose amplitude is over 40% of the ultimate load F_{static} could cause failure of the wind turbine.

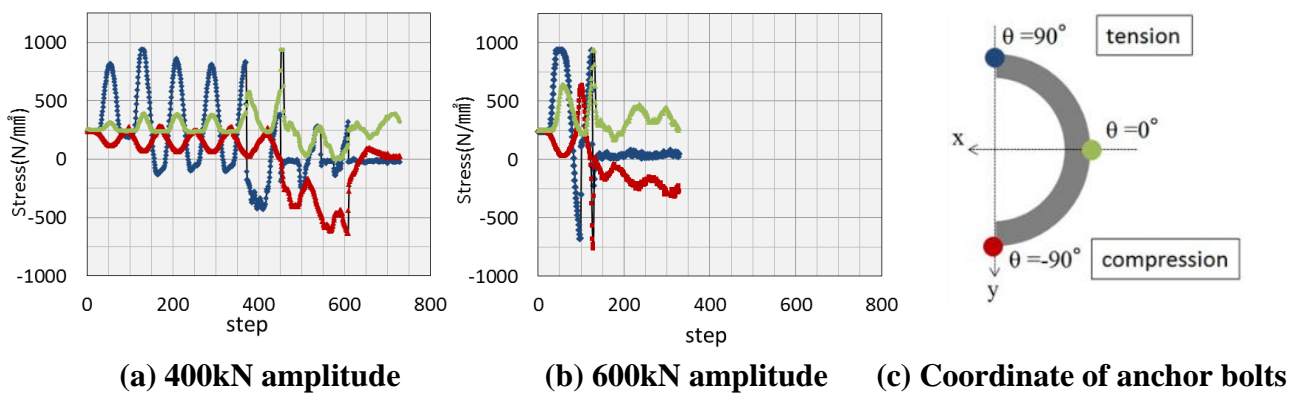
Figure 4: Stress of the anchor

Yielding of anchor bolts due to dynamic load was guessed by the relation of stress-step. In order to simplify the description, the location of an anchor bolt was defined using polar coordinates. The anchor bolt in the neutral area was defined as $\theta = 0$ degrees. As well, tension side of the anchor bolt and compression side of the anchor bolt were defined as $\theta = 90$ degrees and $\theta = -90$ degrees, respectively (Fig. 4(c)).

The stress of anchor bolts at amplitudes 400 kN and 600 kN are shown in Fig. 4(a) and (b). For 400 kN, the order of yielding of the anchor bolts was 90 degrees, 0 degrees, -90 degrees (Fig. 4(a)). The anchor bolts yielded from tension side to compression side. On the contrary, for 600 kN, anchor yield of focused three anchor bolts coincided at the first loading.

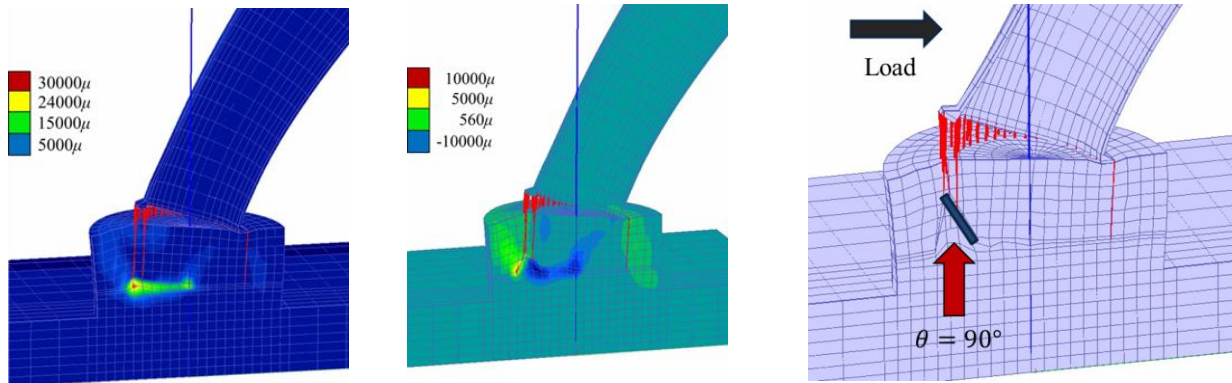
Figure 5: Strain contour and deformation of foundation for 400 kN at failure

The mechanism of failure was revealed in detail by strain contour and deformation of the foundation. First, failure mode at amplitude 400 kN was studied. Fig. 5(a) shows the contour of the principal strain and 10 times magnified deformation at the failure. The predominant strain areas were cone-shaped from the tip of the anchor ring to the top surface of the pedestal. The cone-shaped failure can be observed from the contour of shear strains shown in Fig. 5(b) as well. Fig. 5(c) shows

a 10 times magnified deformation of the foundation. At cycle number 28, the anchor ring at $\theta = 90$ degrees looked like it was being pulled out. At cycle number 290, the anchor ring at $\theta = -90$ degrees was pushed out. This behavior of the anchor ring could be due to the concrete fracture which was simulated by advanced dynamic analysis. We define this failure process as Mode I.

(a) Principal strain contour (b) Shear strain contour (c) Magnified deformation (disp. x50)

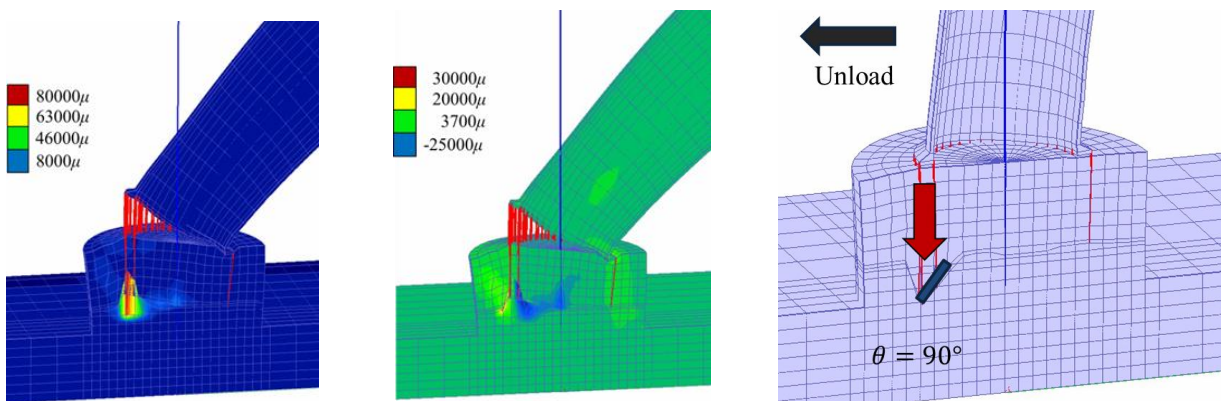
Figure 6: Strain contour and deformation of foundation for 600kN at failure

Second, load amplitude 600 kN was studied. Cone-shaped failure similar to that of 400 kN was not clearly observed from principal strain contour, though it could be inferred from shear strain contour (Fig. 6(a), 6(b)). At 50 times magnified, just before the failure, at the first loading, the anchor ring at $\theta = 90$ degrees looked like it was being pushed out, as shown in Fig. 6(c). During the following loading, the anchor ring at $\theta = 90$ degrees was pulled out and the anchor ring at $\theta = -90$ degrees was pushed out. This behavior of the anchor ring was caused by concrete fracture due to the dynamic load of tension and compression alternating. We define this failure process as Mode II.

(a) Principal strain contour (b) Shear strain contour (c) Magnified deformation (disp. x50)

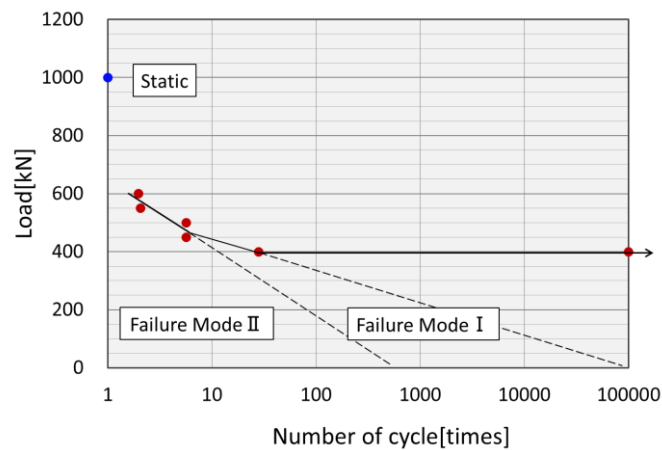
Figure 7: Load – Number of cycle

The relation of load amplitude and number of cycles at failure are shown in Fig. 7. The area was separated into two that correspond to failure modes I and II. In dynamic and static load, the

relevance of the relation of the load and failure mode was not confirmed. Failure occurred in low-cycle fatigue at less than 100 cycles. However, with amplitude less than 400 kN, no number of cycles resulted in a collapse of the wind turbine. This suggests that wind turbine collapse during low-cycle fatigue requires a minimum threshold amplitude.
