Degradation Effects in sc-Si PV Modules Subjected to Natural and Induced Ageing after Several Years of Field Operation

Abstract

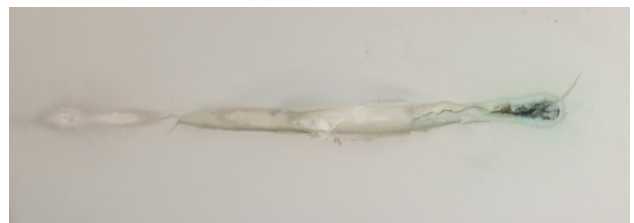
Other degradation effects observed in cells exhibited to only natural ageing processes during the 18 years of field operation include degradation of the AR coating (Fig. 3(a)) and degradation of the interface between the cell and the encapsulant. The latter is usually located between the fingers and close to the busbars as displayed in a worse case in Fig.3(b). Some of the cells subjected to induced shading effects exhibit more severe degradation linked to corrosion of fingers, busbars and contacts (see for eg. Fig.4(a) and 4(b)), which is associated with degradation of the encapsulant [1]. Furthermore, damage in the back sealing of the module was observed, including tear in the Tedlar, bubble, humidity ingress further causing corrosion of the cell metallization, as seen in a severe case in Fig.5.

Fig. 5: Damage in the back sealing surface behind the busbar; tear, blister, humidity ingress are visible.

The thermographic image of the cell exhibiting severe damage in the back sealing surface at the location of the busbar (see Fig. 5) is displayed in Fig.10. The IR image has been captured at the back side of module I4. A hotspot with extremely high temperature reaching 170°C degrees is identified located on the busbar. The tear and blister are also visible having lower temperatures. It may be observed that the temperature of the remaining part of the cell as moving away from the busbar remains as low as that of the average temperature of the module. Such high temperatures are detrimental for the health of the cell, causing degradation in the encapsulant and a chain of chemical reactions leading to further degradation of the cell and module.
