LEAP Research Report
No. 54

A synthesis of historical environmental changes to Brooklands Lagoon/Te Riu o Te Aika Kawa, Canterbury

February 2021

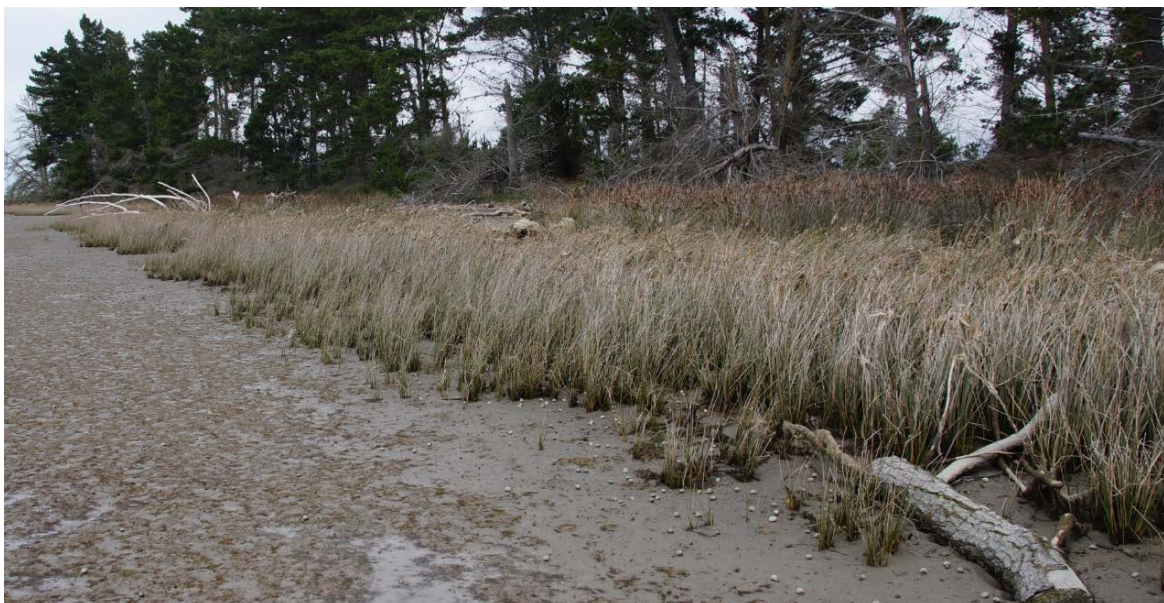
Plate 1: Saltmarsh vegetation at Brooklands Lagoon. Photo: Jazmynn Hodder-Swain

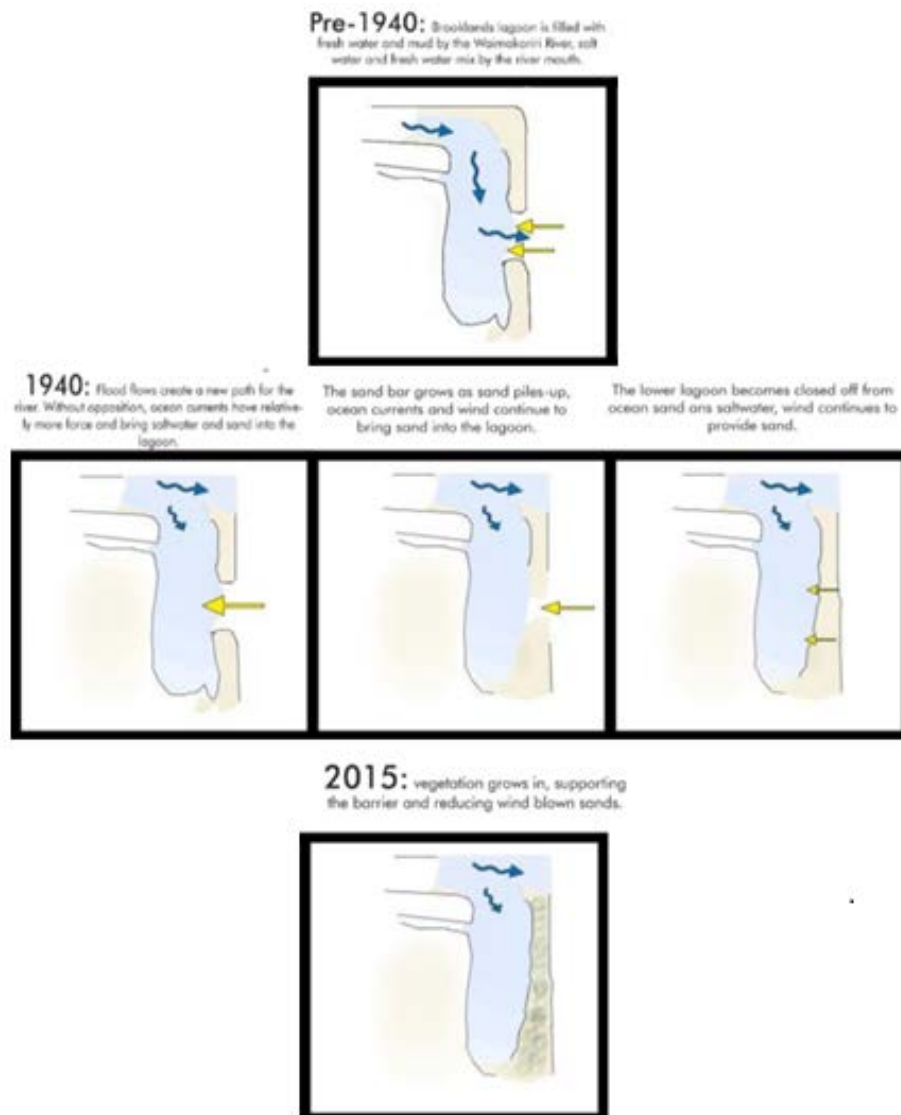
Figure 1: An annotated diagram of the summarised history of Brooklands Lagoon (Used with permission and adapted from Schlam & Reid, 2015).

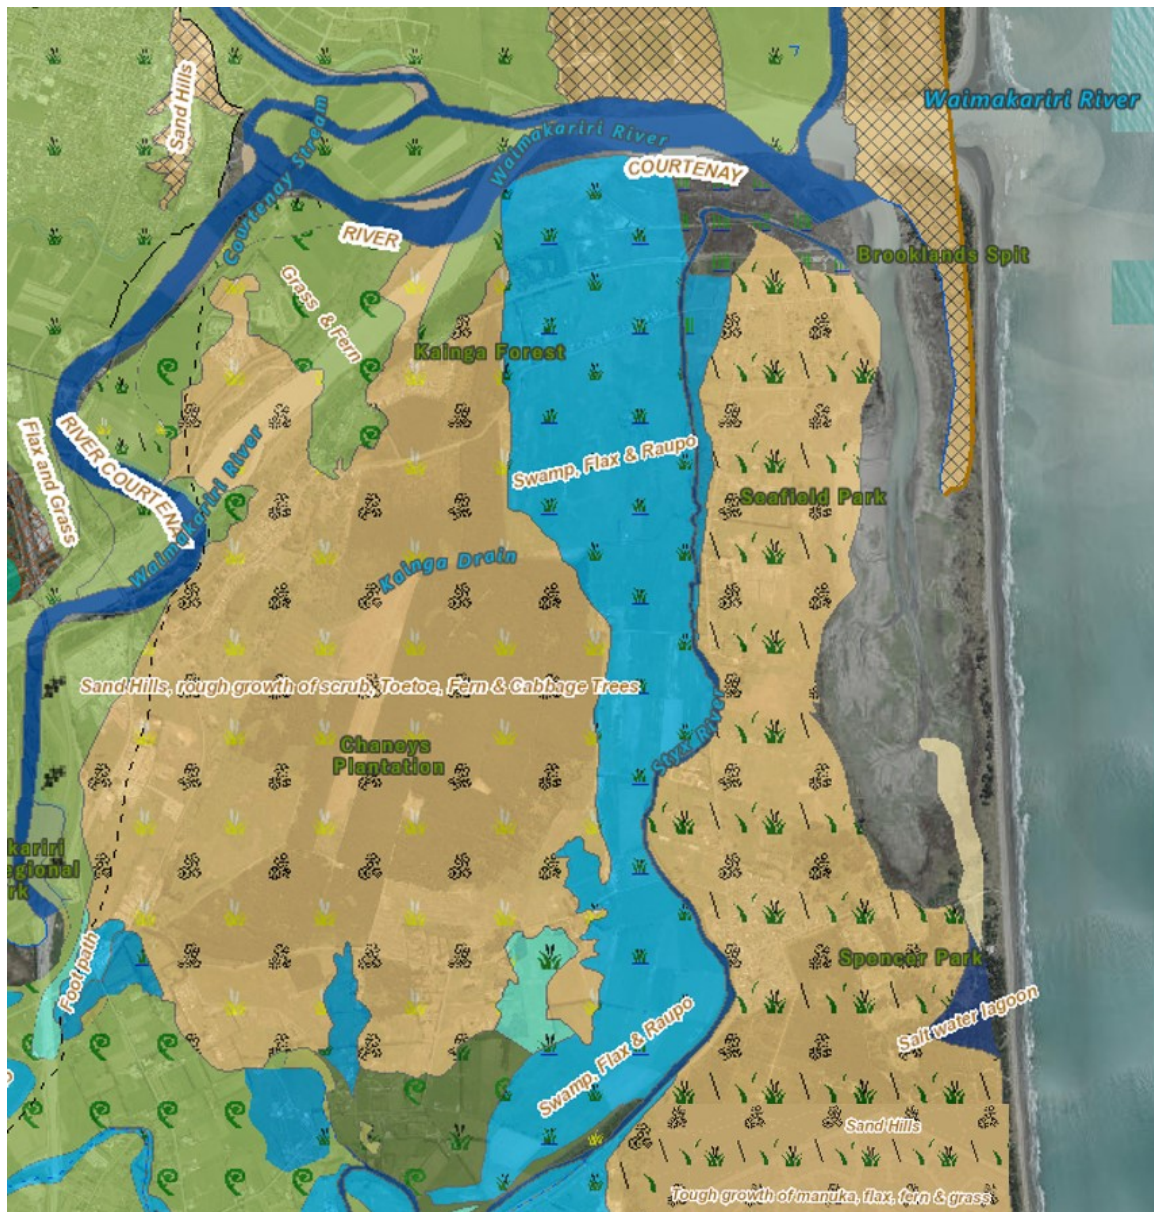
Figure 7: Overlay of land cover on 19th Century Black Maps, approx. c.1856 (Taken from Canterbury Maps).

Historically, the area around the river mouth was an important site for mahinga kai for Ngāi Tahu, with an array of fish, shellfish and plants being gathered seasonally and according to tikanga Māori (Mahaanui Kurataiao Ltd, 2013). As well as being a mahinga kai source of its own, it was an access point to the Pūharakekenui / Styx River catchment "and the fishing grounds of Te Tai o Mahaanui (Eldon & Kelly, 1985; Tau et al., 1990, as cited in Orchard et al. 2012, p. 1). The area was once part of an extensive wetland ecosystem prior to intensive colonial settlement (Figure 7).

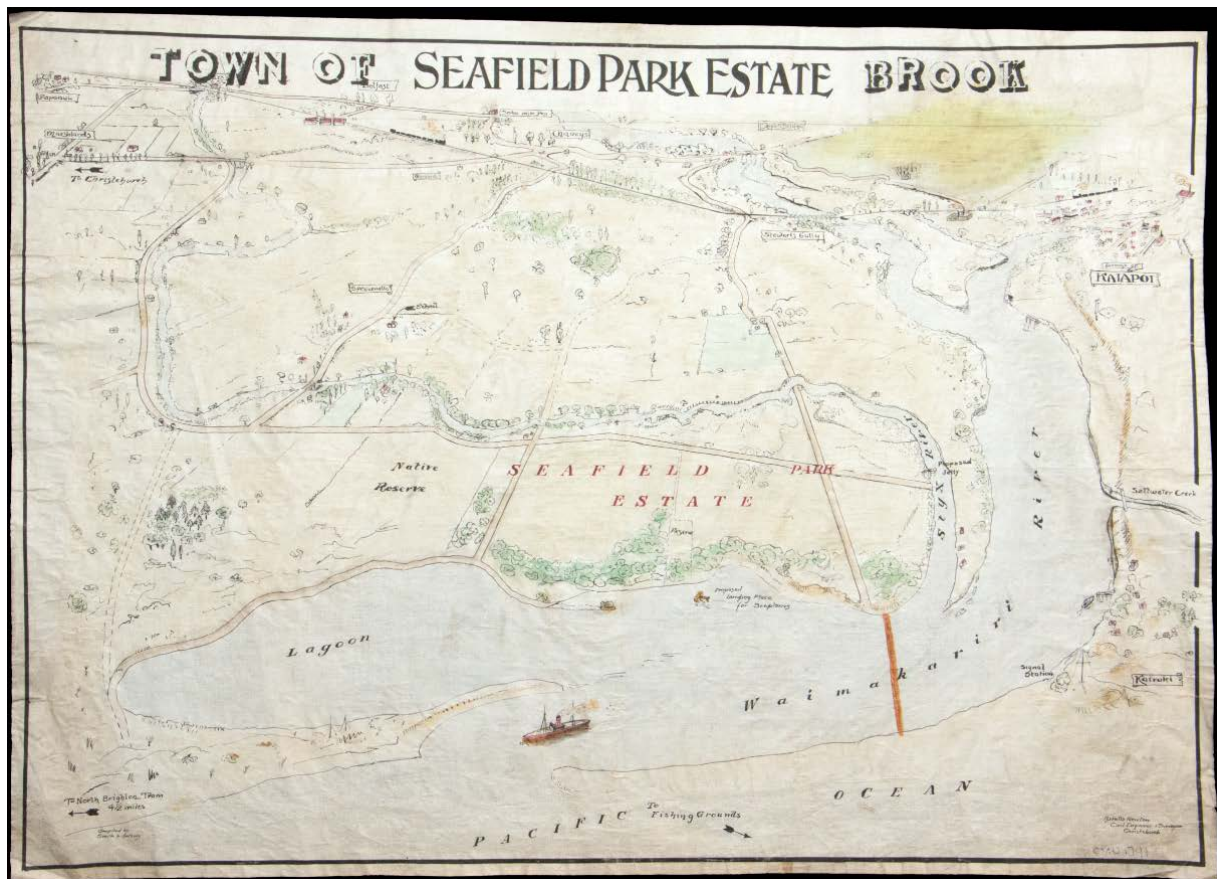
Plate 4: Town of Seafield Park Estate, Town of Brook Map, showing Mouth of Waimakariri River and Brooklands Lagoon with proposed landing place for sea planes. Diagrammatic by Smith and Anthony, A Wells Civil Engineer, Christchurch. Canterbury Museum CMU1791.²

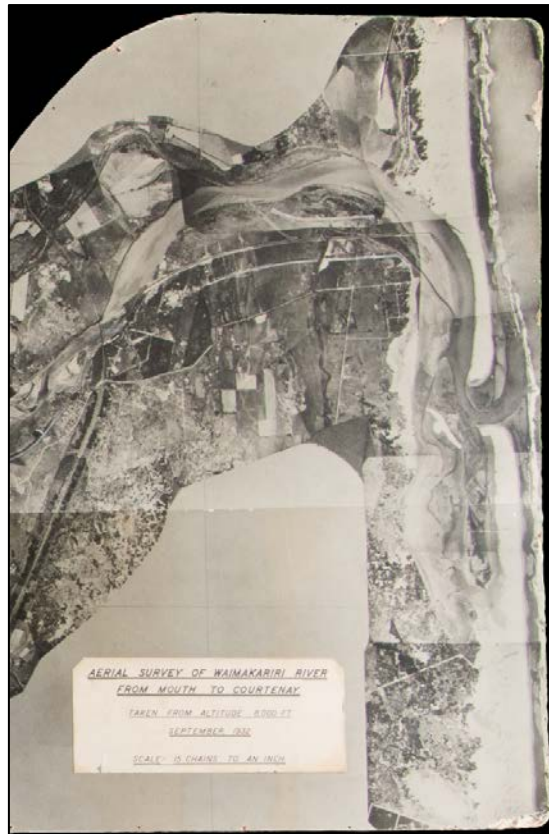
Figure 7: Cropped from: Aerial survey of Waimakariri River from mouth to Courtenay taken from altitude 8000ft, September 1932. Canterbury Museum Vernon ID 653029

The earliest aerial imagery of Brooklands Lagoon was found to be from 1932 and it is clear that the Waimakariri River mouth exited through a long northern and southern spit, as shown in Figure 10. In 1934, the first tidal gates were installed by the North Canterbury Catchment Board to ensure that the Waimakariri River flood waters would not enter the Styx River (Hicks & Duncan, 1993).

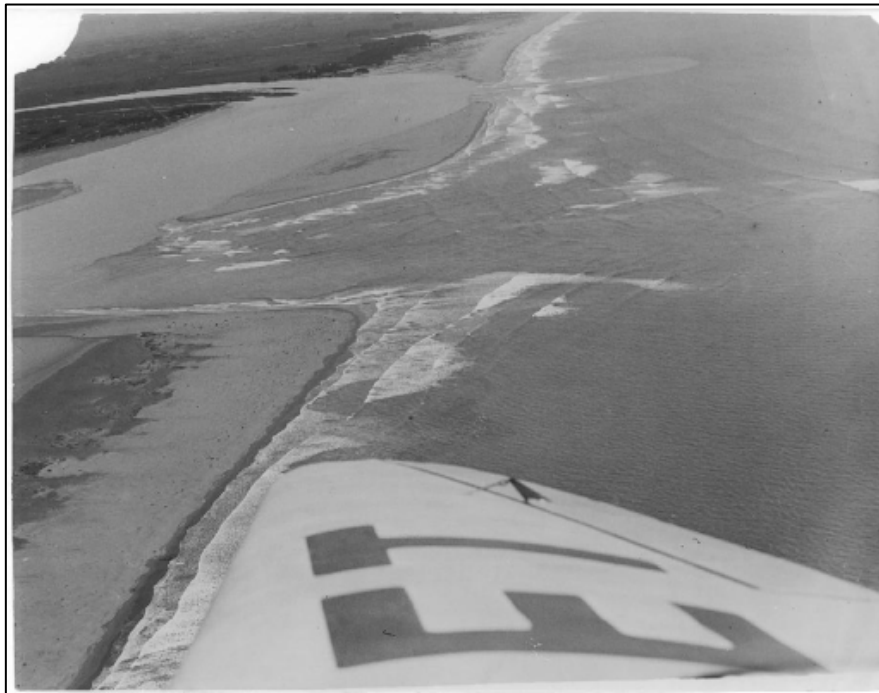
Figure 8: Storms occurring in 1936 as well as the works carried out in the early 1930s led to the Waimakariri River mouth having two exits to sea (From Environment Canterbury Regional Council, n.d.-a).

In October 1936, a storm led to the Waimakariri River reaching its highest recorded flood level which resulted in part of the northern sandspit of the Waimakariri River mouth being partially washed away (National Institute of Water and Atmospheric Research, n.d.-c). This is shown in Figure 11.

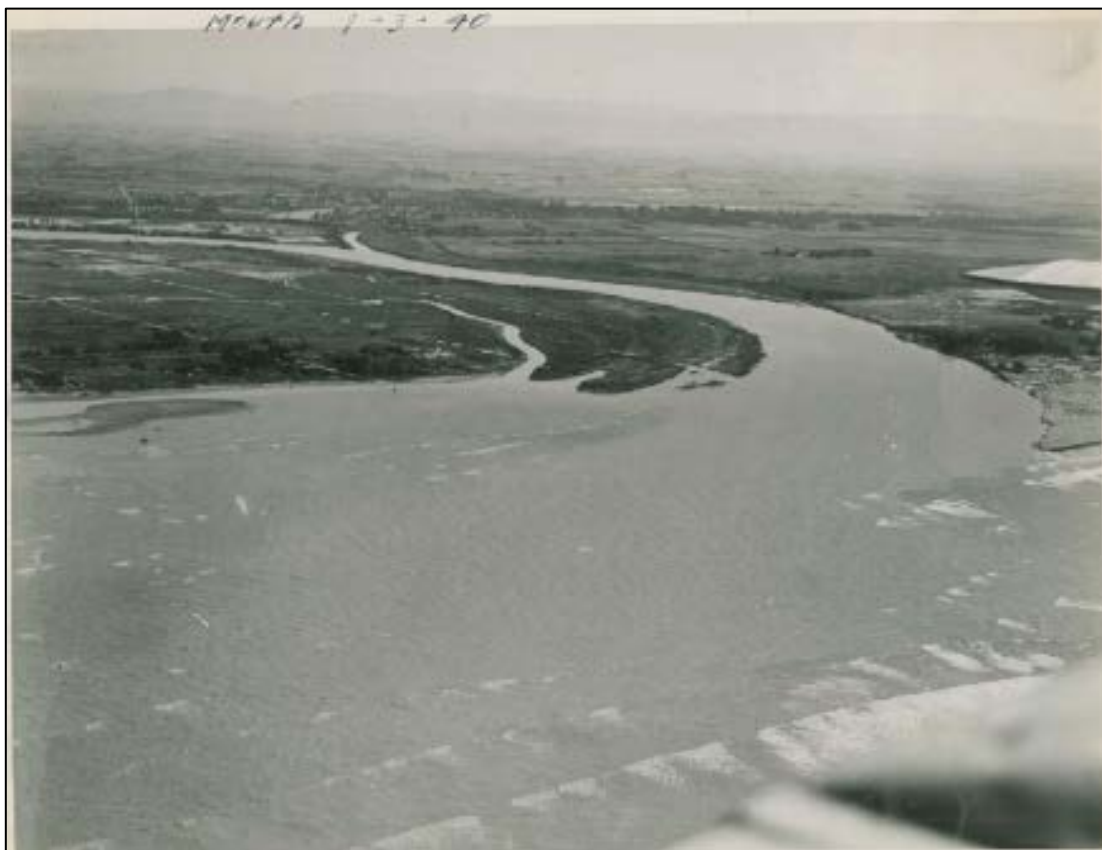
Figure 9: The spit was entirely flooded during this 1940 flood (From Environment Canterbury Regional Council, 1940).

Following heavy rain in the Southern Alps on the 28th and 29th of February 1940, a significant flood occurred in the Waimakariri River (National Institute of Water and Atmospheric Research, n.d.-b). The river was bank to bank and burst through stopbanks at some points, damaging bridges and washing away houses (National Institute of Water and Atmospheric Research, n.d.-b). It was recorded as having “a peak discharge of 176,000 cusecs (4984 cumecs) at the traffic bridge” and reaching “a velocity of 15 ft per second (16.5km/hr)” (National Institute of Water and Atmospheric Research, n.d.-b). The effects of this large flood on Brooklands Lagoon can be seen in Figure 12.

This flood ultimately ended up shifting the Waimakariri River mouth approximately 3 kilometres north to where it flows to the sea today, and was helped along this path by the excavation work that had been carried out in the early 1930s (Boyle, 2011; Worner, 2009). Prior to this flood, “the current Brooklands Spit area was a broad expansion of water and shifting sand bars with little vegetation” (Boyle, 2016, as cited in Todd et al., 2017). However, this was not the channel that had been created via stabilisation works in the early 1930s (Worner, 2009). The moving of the river mouth to its current position changed Brooklands Lagoon “from an active part of the lower river course to a tidal backwater” (Cooper, n.d., as cited in Boyle, 2011, p. 6).

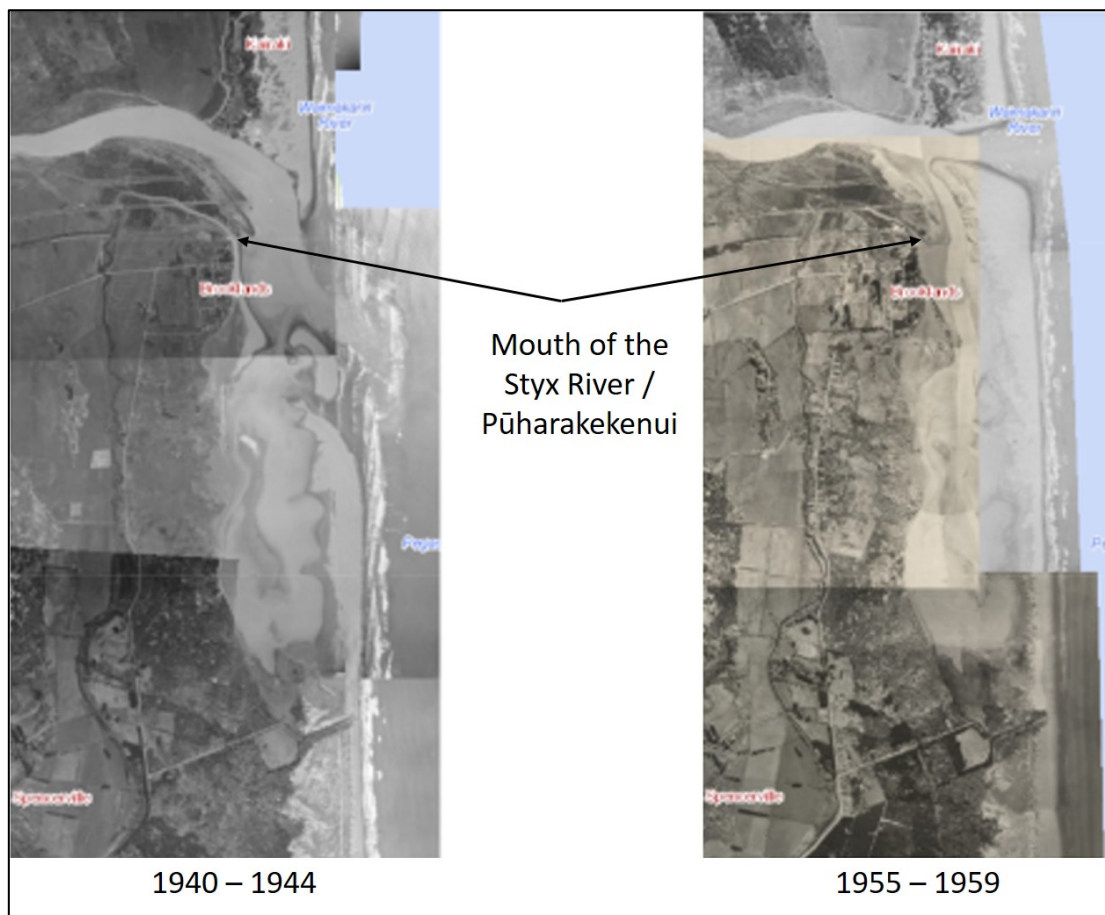
Figure 10: Showing the difference in the Northern and Southern sandbars from 1940 to 1959 (Adapted from Land Information New Zealand, Statistics New Zealand & Environment Canterbury Regional Council, n.d.; Land Information New Zealand, Statistics New Zealand, New Zealand Aerial Mapping et al., n.d.)

From 1940 to 1959, the elongation and stabilisation of Brooklands Lagoon spit occurred due to natural geomorphological processes as shown in Figure 13. In the 1940 – 1944 image, the Pūharakekenui/Styx River exited directly into the ocean, and had a shifting sandbar. However, in the 1955 – 1959 image, the mouth of Pūharakekenui exited into Brooklands Lagoon, which had a long southern spit and the northern spit had eroded.

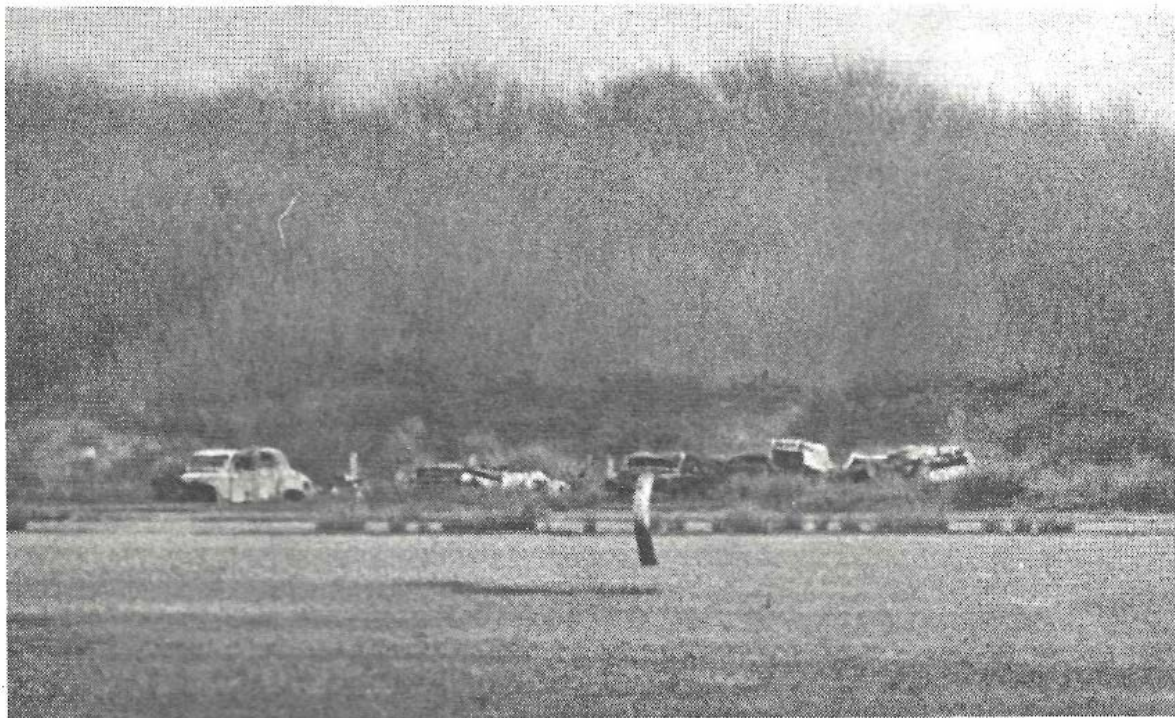
Figure 11: Plate 8 from Knox & Bolton (1978, p. 108) shows car bodies on the western bank of the Lagoon.

Issue	Effect
Effluent Discharges	Heavy metal and biological contamination Nutrient over enrichment
Lagoon infilling and sedimentation	Shallowing from 4ft deep in 1938 to approximately 1ft deep in 1978 Change in sediment composition Increase in mudflats Changes in vegetation distribution and species richness
Recreational/Human activities	Dumping of waste (e.g., Figure 15), Disturbance to species. Deterioration of water quality

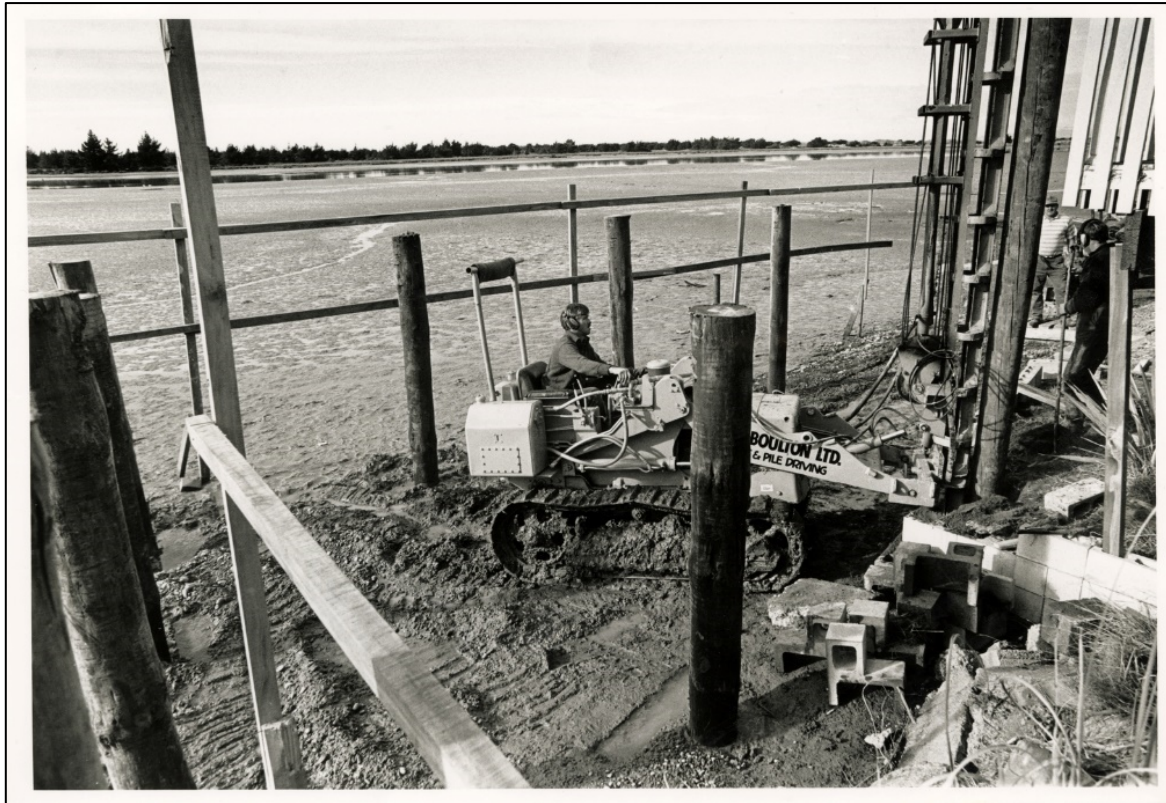
Plate 6: An extension was added to the Blue Lagoon restaurant in 1990, with the building extending into Brooklands Lagoon (From Christchurch Star, 1990).

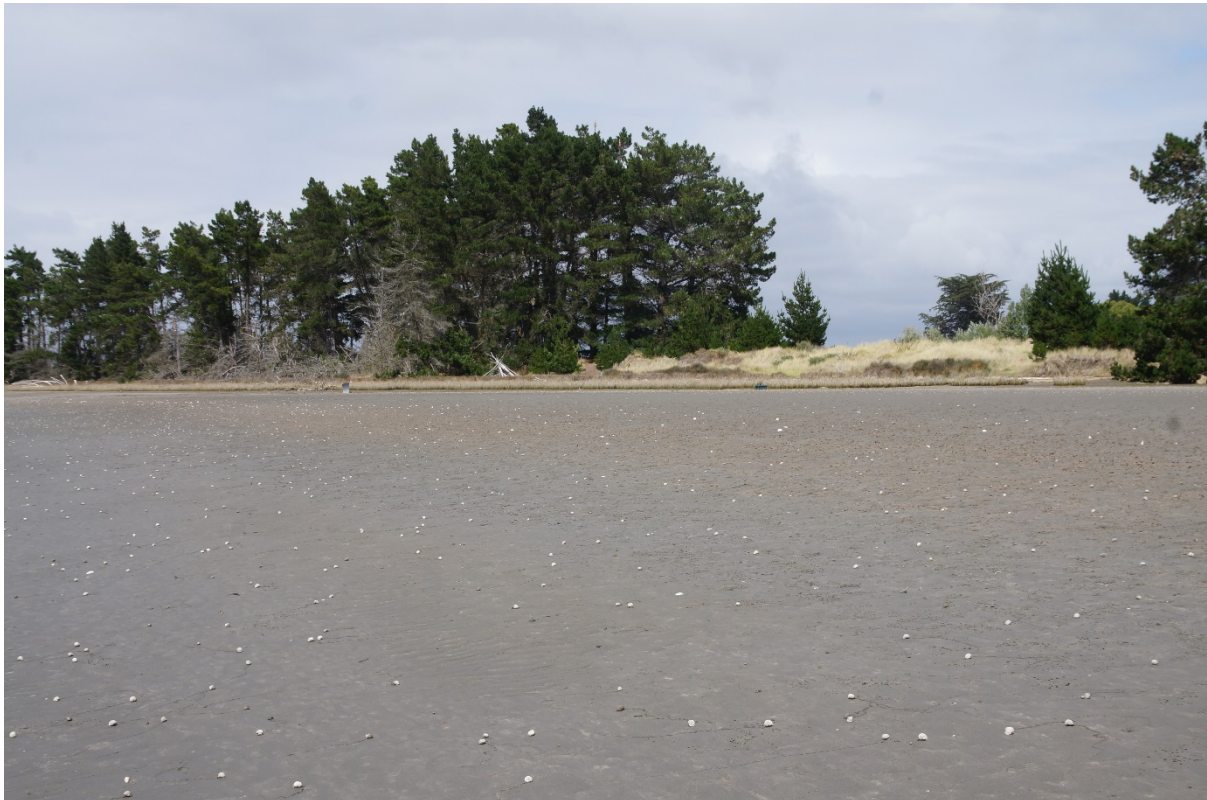
Plate 7: Pine and marram grass on eastern side of the estuary. Photo: J. Hodder-Swain.

- The sandspit of the lagoon was eroding. This was attributed to *Pinus radiata* filtering windblown sand, meaning that sand that had eroded away could not be replaced.

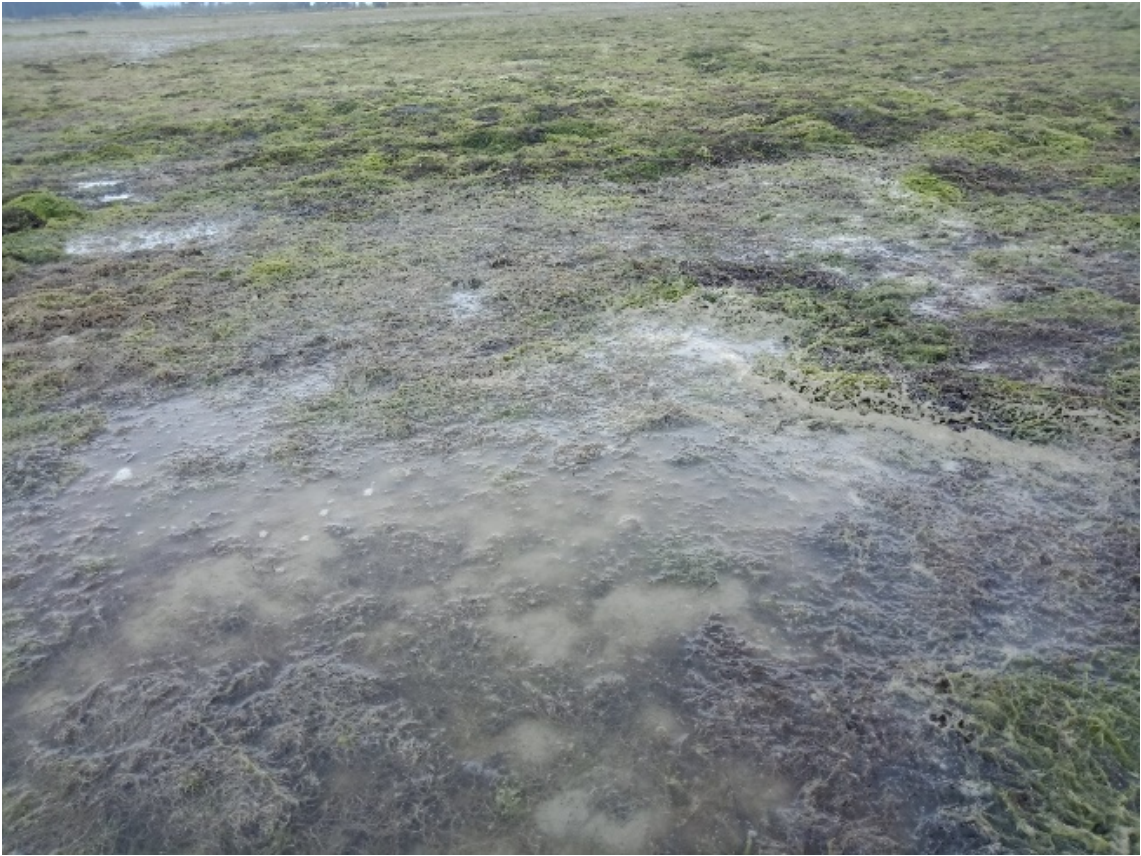
Figure 14: A mat of nuisance macroalgae present at low tide in Brooklands Lagoon, reflecting the effects of excessive nutrients combined with warm temperatures. Photo: J. Hodder-Swain.

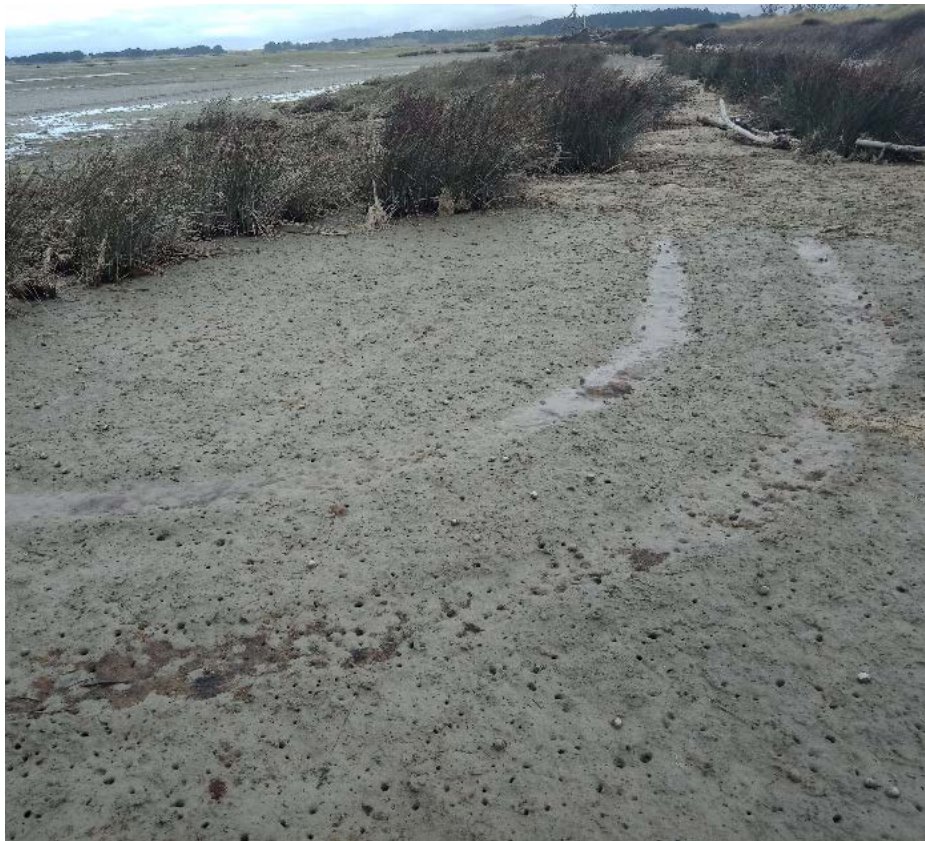
Figure 15: Tyre marks present in Te Riu o Te Aika Kawa. January 2021. Photo: J. Hodder-Swain.
