CoA Memo. No. 96

THE COLLEGE OF AERONAUTICS

DEPARTMENT OF MATERIALS

FINAL REPORT OF GRIT BLASTING AND METAL SPRAYING
TRIALS CARRIED OUT AT H.M. DOCKYARD, DEVONPORT

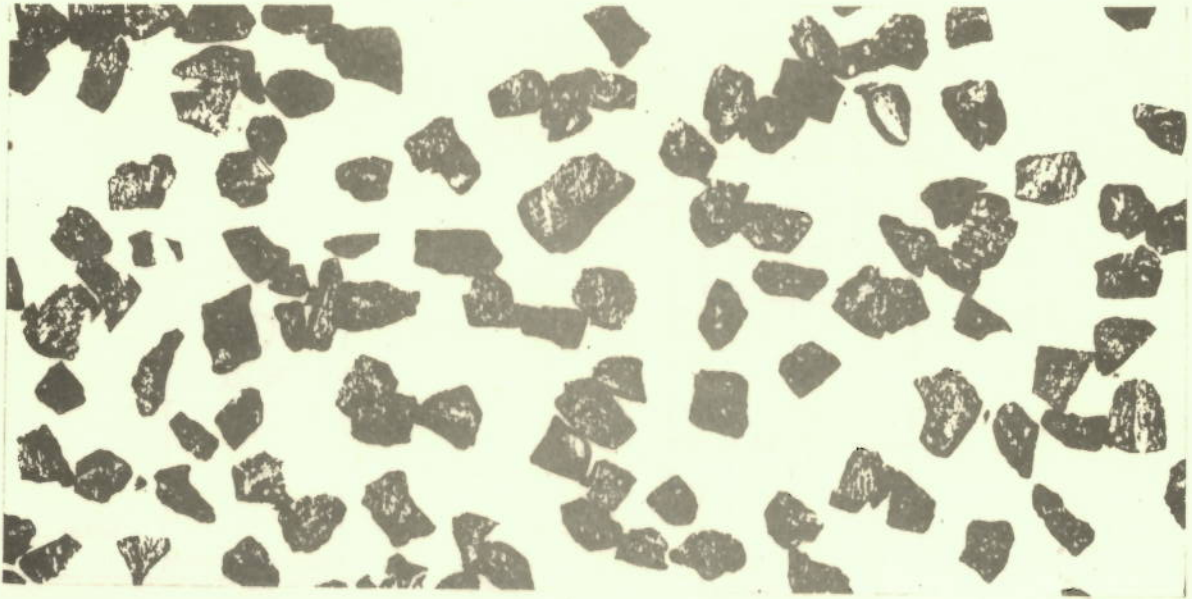
FIG.2. NEW G24 GRIT USED IN M.G.HOUSE x 5

Grit quality is shown in Figs. 2 - 8. Comparison of new G 24 grit with a sample taken after preparing 19 test plates indicate that the grit quality was unaffected. The grit condition after 2, 4 and 6 days is shown in Figs. 4 - 6. Unfortunately the extent to which the grit was used over this period was not recorded; some blunting of the grit is evident but, on the whole, the condition has remained good. The new G 39 grit used on the ships hull is shown in Fig. 7 and may be compared with used G 39 grit taken from the same location.

The levels of bond strength obtained with aluminium coatings agree with those obtained in previous work despite a considerable variation in coating thickness. The effect of coating thickness has not been investigated in work at Cranfield but thicker coatings are generally agreed to have lower bond strengths. In the present tests, coating thickness varied between 0.005 inch and 0.019 inch, and no relation between strength and coating thickness could be observed. The grit used for blasting was adequate (Fig. 1) and showed no signs of breakdown (Fig. 2).

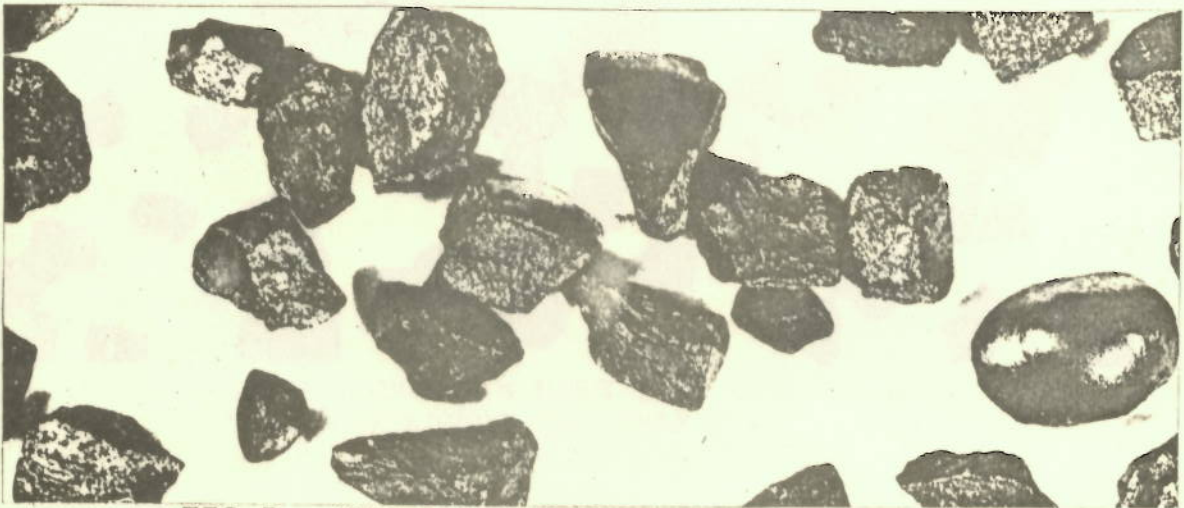
FIG. 7. NEW G39 GRIT USED FOR BLASTING OF SHIP'S HULL

The work on the ship's hull indicated that the blasting operators were capable of working to satisfactory standards. The use of G 39 grit is fairly widespread in the industry, on the grounds that the grit soon breaks down to a smaller size. This breakdown is shown by comparing Figs. 7 and 8; the used G 39 grit contains a quantity of sharp angular particles but rounded and blunted particles are also evident.
