RESEARCH ON FORMING QUALITY OF POLY-WEDGE PULLEY SPINNING

As an important power transmission part, pulleys are widely used in automobile industry, agricultural machinery, pumps and machines. A near-net forming process for six-wedge belt pulleys manufacturing was put forward. For this purpose, the required tooth shape and size can be formed directly by spinning without machining. The whole manufacturing procedures include blanking, drawing and spinning. The spinning procedure includes five processes, performing, drumming, thickening, toothing and finishing. The forming defects occurred during each forming processes of poly-wedge pulley spinning, such as the drumming failure, flanged opening-end, folded side-wall, insufficient bottom size, flashed opening-end, cutting-off bottom, are introduced, and the factors influencing the defects are analyzed. The corresponding preventive measures are put forward.

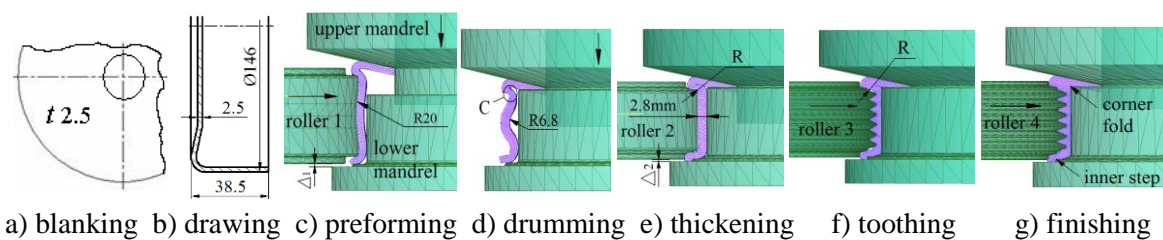
Figure 2: Manufacturing procedures of the poly-wedge pulley.

a) blanking

b) drawing

c) preforming

d) drumming

e) thickening

f) tothing

g) finishing

The five spinning processes are as follows (see Figure 2) (Xia et al. 2009):

(1) Preforming: Feeding the performing roller 1 along the radial direction together with the upper mandrel downward along the axial direction, the side wall of the cup-shaped blank obtained by deep drawing was formed to the shallow drum-shaped workpiece, the radius of the shallow drum-shaped arc was R20 (as shown in Figure 2c);

(2) Drumming: Moving the upper mandrel downward individually until the bottom of the preformed shallow drum-shaped workpiece contacted with the lower mandrel tightly, the side wall of the shallow drum-shaped blank obtained by preforming was further formed as the deep drum-shaped blank, the radius of the deep drum-shaped arc was R6.8 (as shown in Figure 2d);

(3) Thickening: Feeding the thickening roller 2 along the radial direction until the deep drum-shaped side wall was pressed to the flatness, the wall thickness was 2.8 mm after thickening (as shown in Figure 2e).

(4) Tothing: Feeding the tothing roller 3 along the radial direction to form the tooth preliminarily (as shown in Figure 2f).

(5) Finishing: Feeding the finishing roller 4 along the radial direction to shape the tooth accurately (as shown in Figure 2g).

Flanging at opening end The defect is shown in Figure 3b). The reason for the defect is that the setting height of roller 1 is unreasonable. To prevent the metal flowing from the gap Δ_1 between the roller 1 and the surface of the lower mandrel (as shown in Figure 2c), the designed gap Δ_1 should be less than 0.2, the 8% of workpiece thickness. If the gap Δ_1 is greater than the designed one, under the press of the radial feed of roller 1, the material flows easily from the gap Δ_1 , and results in an unstable deformation of opening end and flanging defect when the upper mandrel moves downward during drumming process.

Insufficient bottom size and flash at opening end The defects are shown in Figure 4b). The reason for the defects is that the setting height of thickening roller 2 is unreasonable. The gap Δ_2 between the roller 2 and the lower mandrel is greater than the designed one, Δ_2 should be less than 0.2mm, the 8% of workpiece thickness (as shown in Figure 2e).

The defects of bottom cutting-off may occur during both thickening and tothing processes (as shown in Figure 6). The reason for the defect is that the roundness radius R of roller 2 or roller 3 is too small (as shown in Figure 2e and Figure 2f). Because the thickness reduction at the position C (as shown in Figure 2d) is large during preforming, the bottom cutting-off occurs easily during thickening or tothing. The problem could be solved well by increasing the roundness radius R from 1 mm to 2 mm. Experimental results showed that roundness radius R should be greater than 0.8 times of the side wall thickness of cup-shaped drawn workpiece.

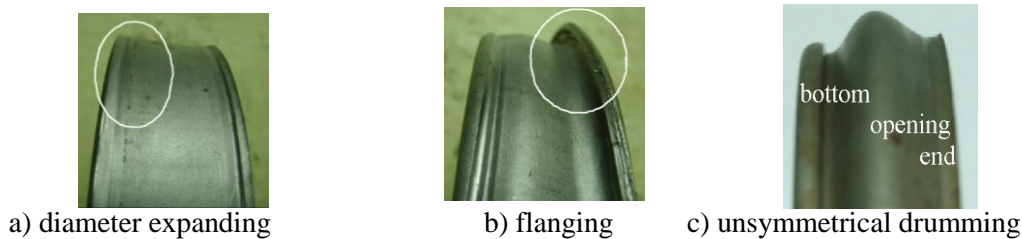
Figure 3: Defects during drumming process

The defects occurred during drumming process are mainly diameter expanding at bottom portion, flanging at opening end of workpiece and unsymmetrical drumming (as shown in Figure 3). These defects are actually caused by the previous preforming process. During the preforming process, a desired curvature is obtained by feeding the performing roller 1 along the radial direction together with the upper mandrel downward along the axial direction (as shown in Figure 2c), and the predetermined shallow drum-shaped arc occurs at the side wall of the cup-shaped blank due to the axial pressing of upper mandrel and radial feeding of performing roller 1 (as shown in Figure 2d).

Diameter expanding at workpiece bottom The defect is shown in Figure 3a). The reason for the defect is that the radial feed of roller 1 is too small, the radial feed of roller 1 should be at least 2 times of workpiece thickness, i.e. 4.8~5 mm $((146-2 \times (2.55 \sim 2.75) - 130.9) / 2)$, where the outer diameter of cup-shaped workpiece $\varnothing 146$ is determined by the maximum outer diameter of part $\varnothing 144.86$ plus the machining allowance 2×0.5 ; 2.55~2.75 is variation range of maximum thickness of side wall of cup-shaped workpiece; $\varnothing 130.9$ is the inner diameter of part). If the radial feed of roller 1 is less than 4.8 mm, shallower drum-shaped workpiece will be obtained after performing, drumming deformation at the center portion of cup-shaped workpiece occurs difficultly due to the supporting rigidity of the side wall being strong enough; therefore, diameter expanding occurs at the workpiece bottom because of buckling.

Unsymmetrical drumming The defect is shown in Figure 3c). The reason for the defect is that the distribution of the side wall thickness of the cup-shaped workpiece obtained by deep drawing is

uneven. The thickness reduces gradually from the opening end to the bottom along the side wall of the cup-shaped workpiece (Luo et al. 2010), hence the drum tends to occur at the bottom during drumming.

The main measures to prevent the above defects are as follows: (1) Selecting a reasonable height to set the roller 1, decreasing the gap Δ_1 between the roller 1 and lower mandrel as small as possible on condition that the roller 1 doesn't contact with the lower mandrel, i.e. $\Delta_1=0\sim 0.2\text{mm}$. (2) Controlling the radial feed of roller 1 until the arc surface of roller 1 just contact with the side wall of workpiece, i.e. radial feed=4.8~5mm. (3) Controlling the thickness deviation of the side wall of the cup-shaped workpiece obtained by deep drawing strictly, the maximum thickness deviation should less than 7%.

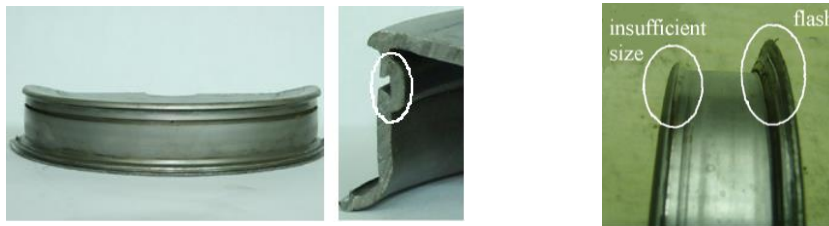
Figure 4: defects during thickening

The defects occurred during thickening process are mainly side wall folding, insufficient bottom size and flash at opening end (as shown in Figure 4).

(a) side wall folding

(b) insufficient size and flash

Side wall folding The defect is shown in Figure 4a), a swallowtail annular trough occurs on the side wall of workpiece during thickening. The reason for the defect is the unsymmetrical drum during drumming process (as shown in Figure 3c). Because the drum tends to occur at the workpiece bottom and the wall thickness near the bottom is thinner than another portion, the material flows more easily to the bottom than to the opening end of workpiece. Meanwhile, a large resistance force exists at the bottom arc portion, under the action of the pressing forces from both the bottom and opening end directions, the local accumulated material is extruded, which results in the swallowtail annular folding.

The radial extrusion occurs on the corner portion A of workpiece (as shown in Figure 1) under the pressing of roller 2, which results in the material flows towards the workpiece center and results in the insufficient bottom diameter. On the other hand, the material at the opening end flows easily towards the workpiece edge from the gap Δ_2 , which results in the flash at the opening end of workpiece.

To prevent the above defects, a suitable setting height of roller 2 should be guaranteed. The gap Δ_2 between the roller 2 and the lower mandrel should be as smaller as possible under the condition that the roller 2 doesn't contact with the surface of lower mandrel, i.e. $\Delta_2=0\sim 0.2\text{mm}$. Figure 5 shows a qualified thickening workpiece.

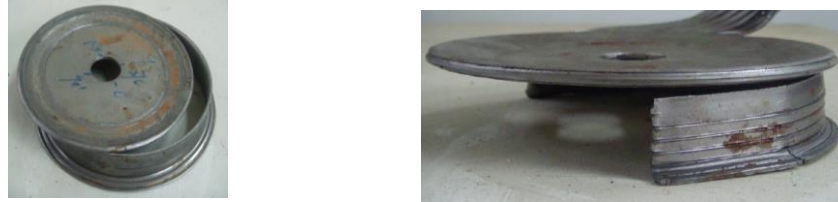
Figure 6: Bottom cutting-off

(a) bottom cutting-off during thickening (b) bottom cutting-off during tothing

(3) The defects of bottom cutting-off may occur during both thickening and tothing. The defects can be prevented by increasing the roundness radius R of thickening and tothing rollers properly, the roundness radius R should be greater than 0.8 times of the side wall thickness of cup-shaped drawn workpiece.
