# Scour Damage to Vermont Bridges and Scour Monitoring

TRC Report 15-002

June 2015

UVM Transportation Research Center Report 15-002

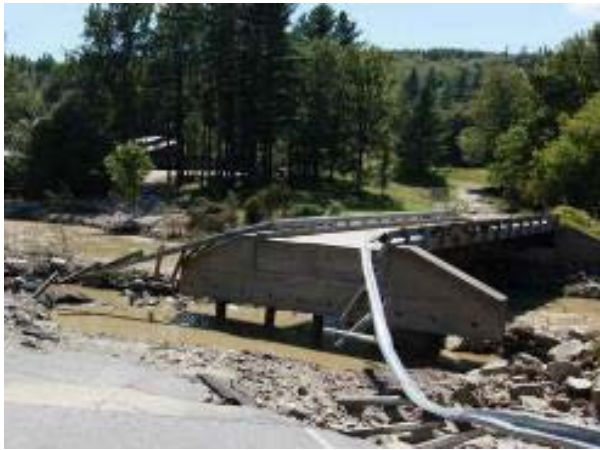
(a) Scour behind an abutment of a bridge in Ludlow, VT (source: Burlington Free Press)

Regionally, the aftermath of recent flooding following Tropical Storm Irene is evident in the example photographs shown in Figure 1.1. Tropical storm Irene had unprecedented impacts on transportation infrastructure in numerous regions of the New England states and the state of New York. In Vermont alone, over 300 bridges and over 900 culverts were damaged. Damages from scour and erosion (Figure 1.1) were extensive. Climate data show that Vermont is experiencing more extreme events, and that this trend is predicted to continue with more significant floods and major flooding (Frumhoff et al., 2007; Stager and Thill, 2010; Betts, 2011) demanding more resilient approaches to scour and erosion mitigation.

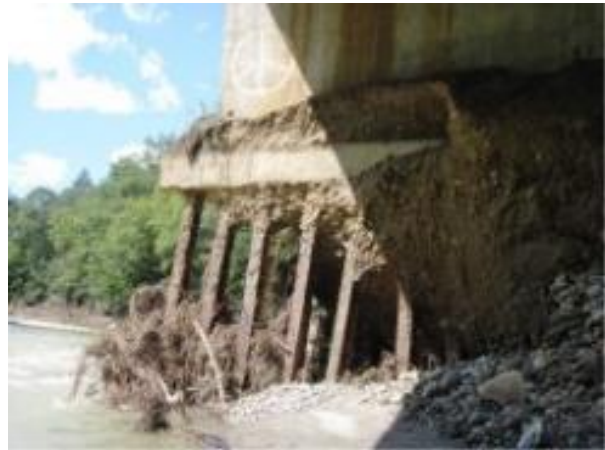
(b) Abutment scour in Dummerston, VT (Source: VAOT)

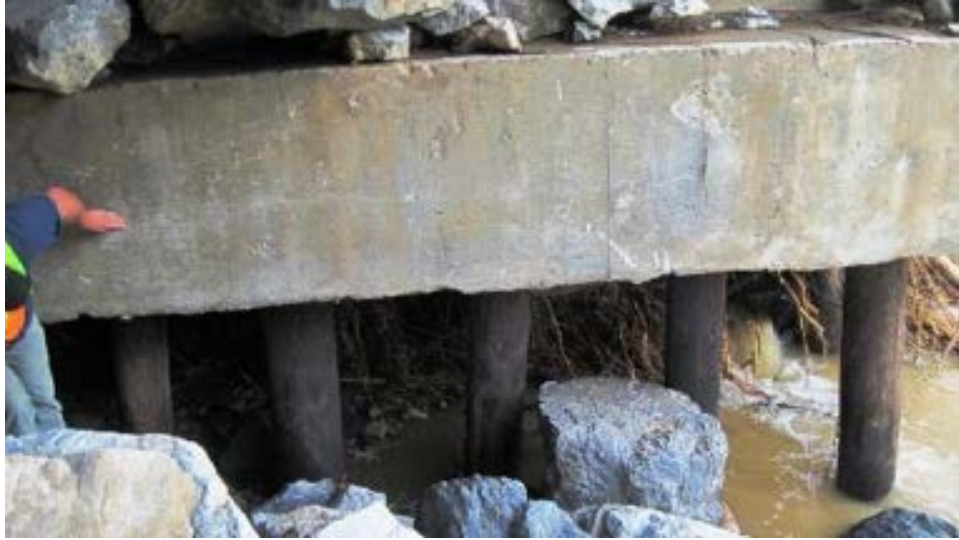
*(a) Clarendon US7-B96 Bridge: scour beneath the foundation, exposing several feet of wooden piles*

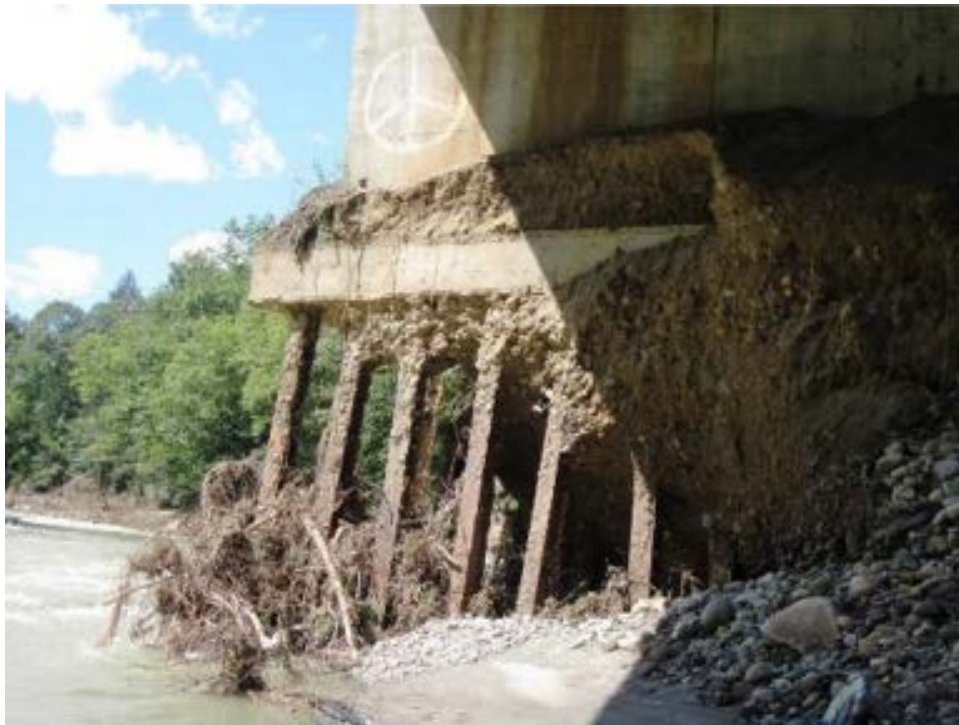
*(b) Dummerston VT30-B9 Bridge: scour beneath the concrete spread footing, with settlement resulting in the cracking of the foundation.*

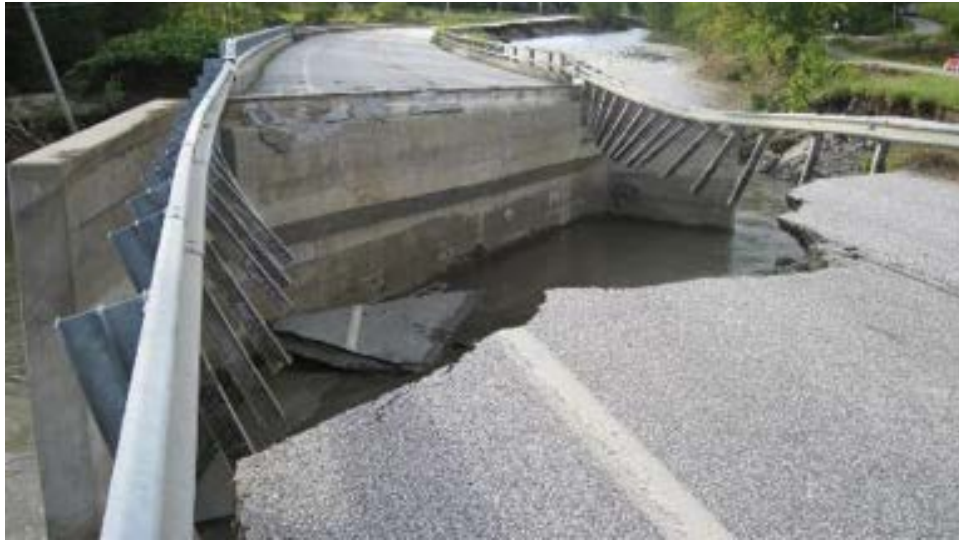
*(a) Braintree VT112A-B6 Bridge: erosion behind the wing-walled abutment, with complete loss of the bridge approach*

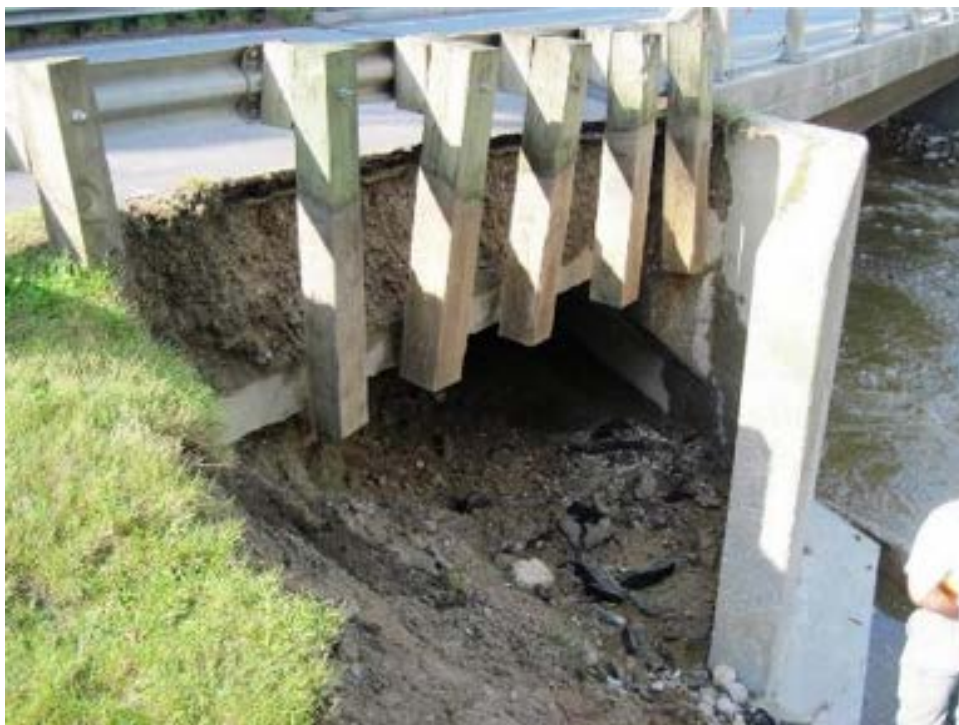
*(b) Jamaica VT30-B40 Bridge: flanking behind the abutment undermining the approach slab*

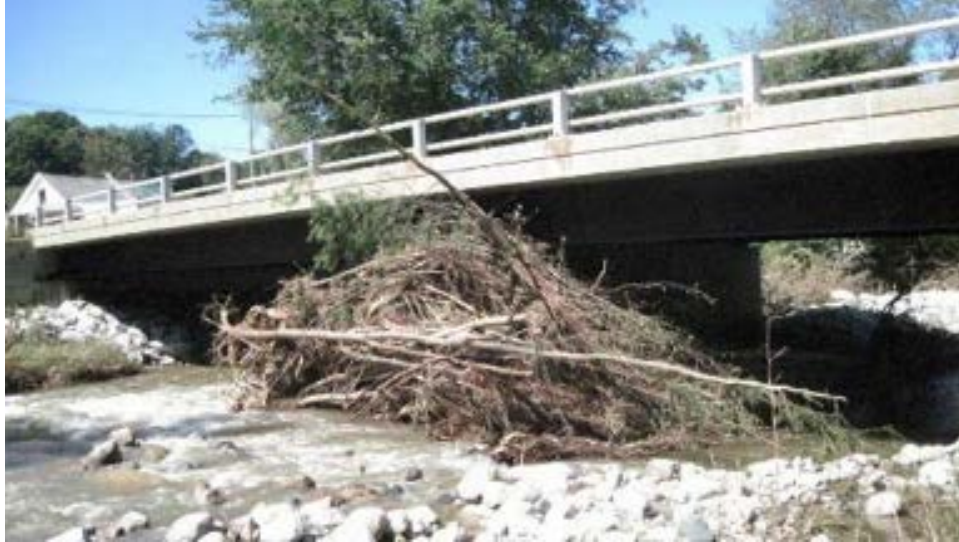
*(a) Wallingford VT140-B10 Bridge: debris buildup on a pier, reducing the flow area*

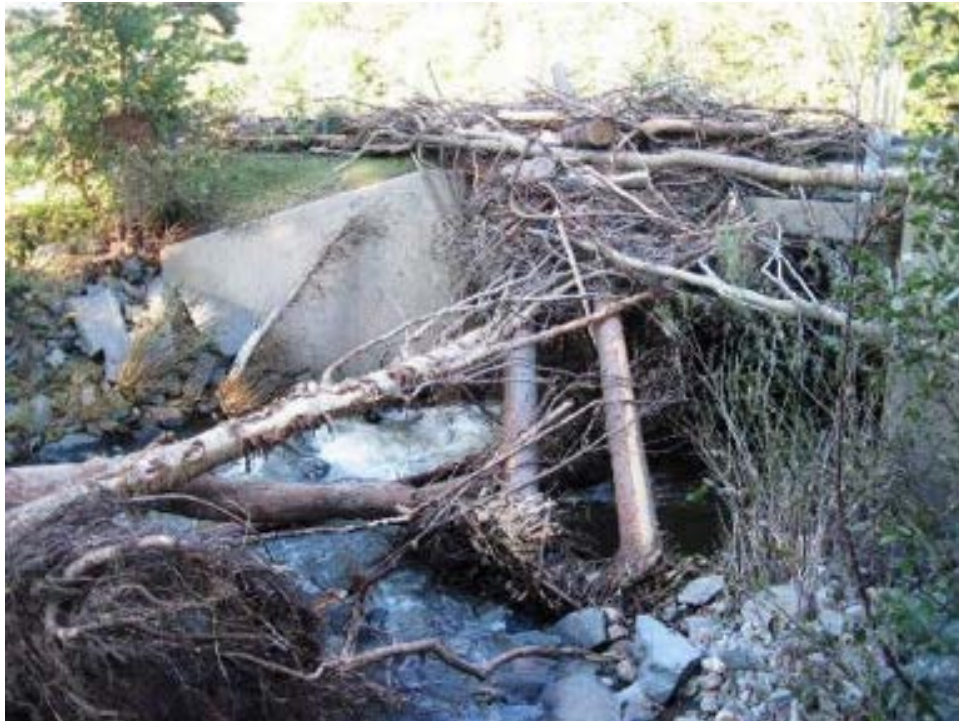
*(b) Wilmington VT100-B53 Bridge: obstructions at a small single span resulting in blockage and overtopping*

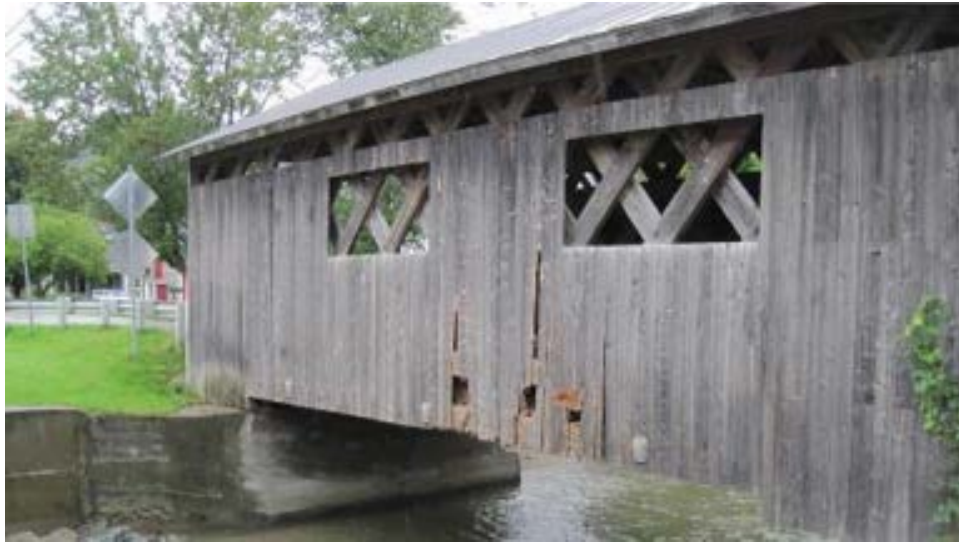
*(a) Montgomery C2001-B5 Bridge: damage to the sideboards of a covered bridge*

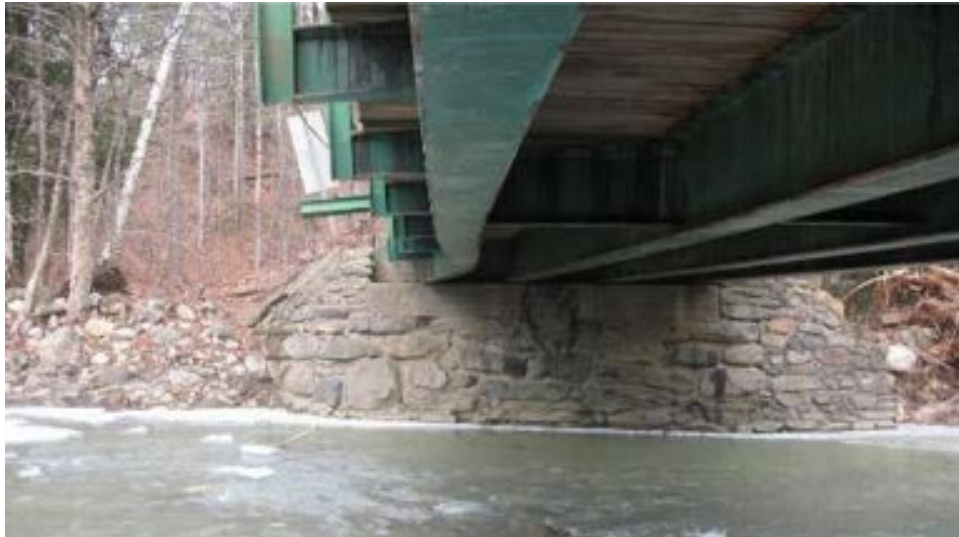
*(b) Marlboro C3014-B23 Bridge: damage to the main beam of the bridge from debris impact*

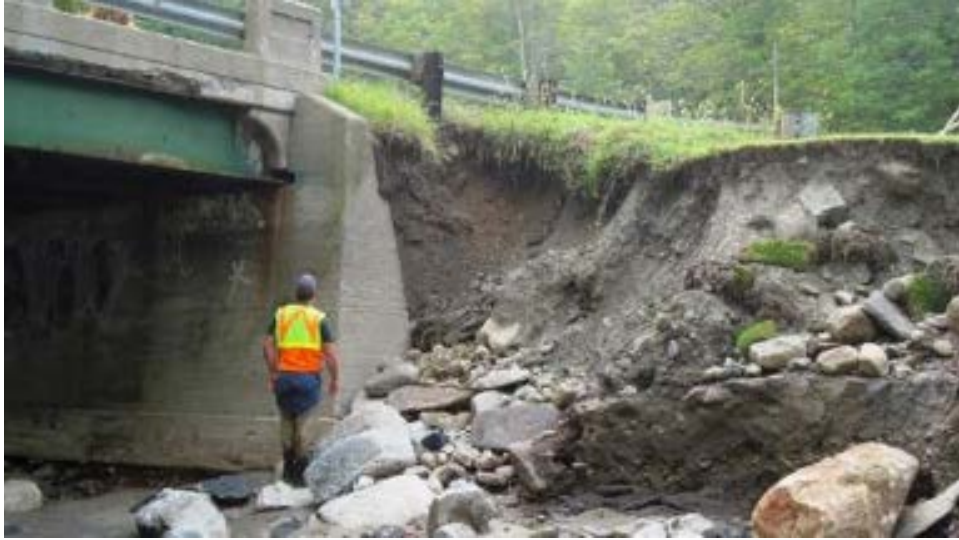
*(a) Wardsboro VT100-B68 Bridge: flanking erosion behind the abutment, and minor scour to the footing*

The type of bridge damage was further categorized by the authors into 3 levels: major, moderate and minor (examples provided in Figures 2.6-2.8). Minor damage is damage that can be repaired using basic construction equipment and practices without requiring any engineering analysis. Examples include backfilling the approach, or adding replacement riprap. Bridge damage is categorized as moderate when the bridge has become unstable and requires engineered repairs. This would include scour beneath foundations or physical damage to bridge members.

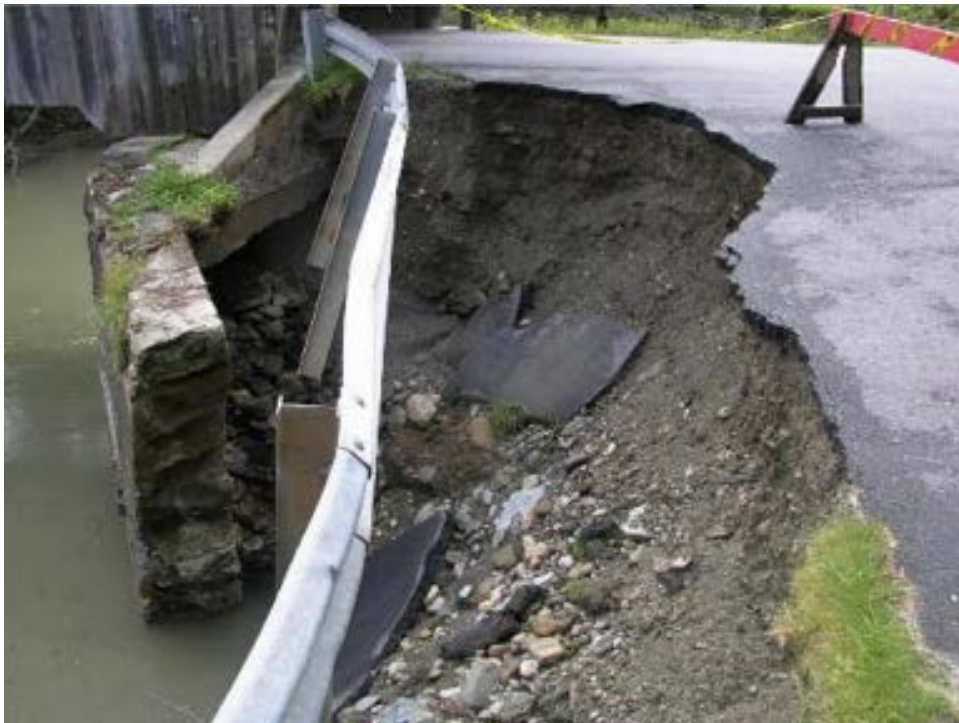
*(b) Warren FAS188-B6 Bridge: Channel erosion and flanking behind the wingwall, with scour hole at the toe*

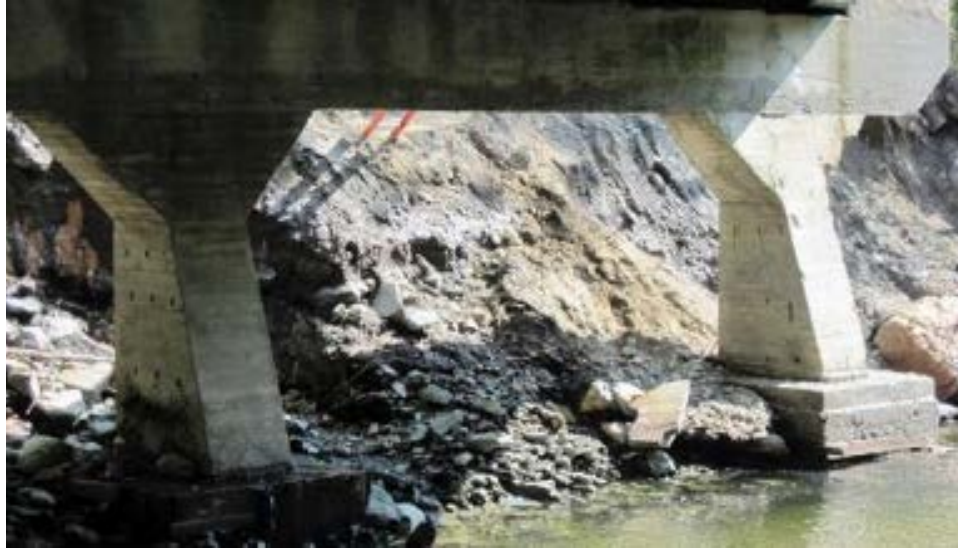
*(a) Halifax C2001-B17 Bridge: loss of original riprap and backfill, resulting in the free standing abutments and scour to beneath the footing of the spread footing base*

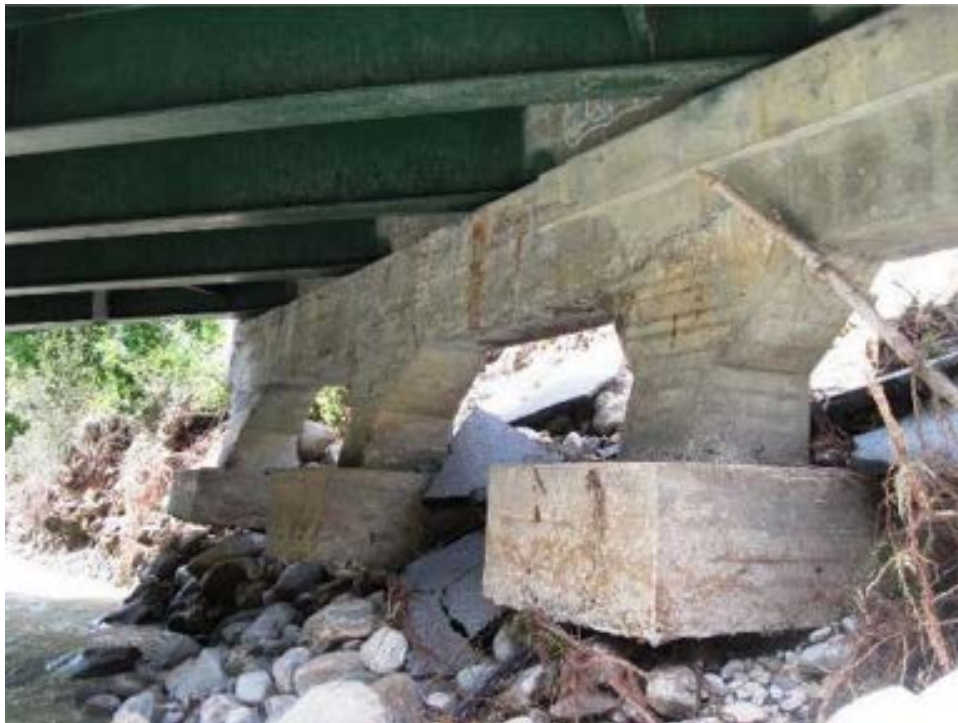
*(b) Jamaica VT30-B78 Bridge: flanking behind the wingwall abutment, with scour beneath the bridge foundation, with no apparent damage to the concrete foundation, and no major settlements to the foundation*

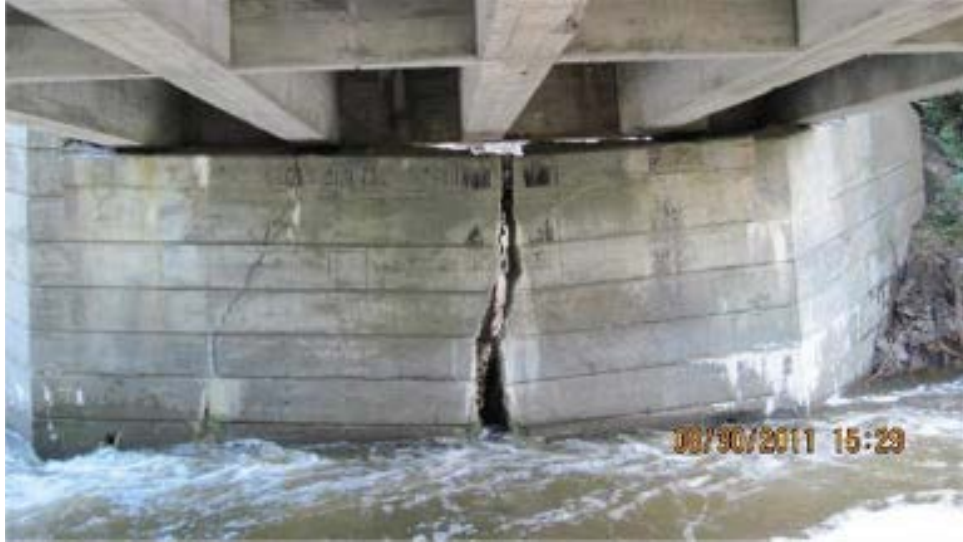
*(a) Brownington C2001-B9 Bridge: fracture to the foundation, due to scour beneath the footing and settlement of substructure*

Major damage is that which requires the rebuilding or replacement of the structure. Examples of major damage include cases where the bridge was washed away or has significant foundation settlement requiring replacement. Damage level and type were determined through observation of the pre- and post-storm inspection photos when available. When photos were not available, records from bridge inspections were used to quantify and characterize the damage. Characterizing the level and type was done without knowledge of the repair costs. Of the damaged bridges, 66% were categorized as having minor damage, 20% as having moderate damage, and 14% as having major damage.

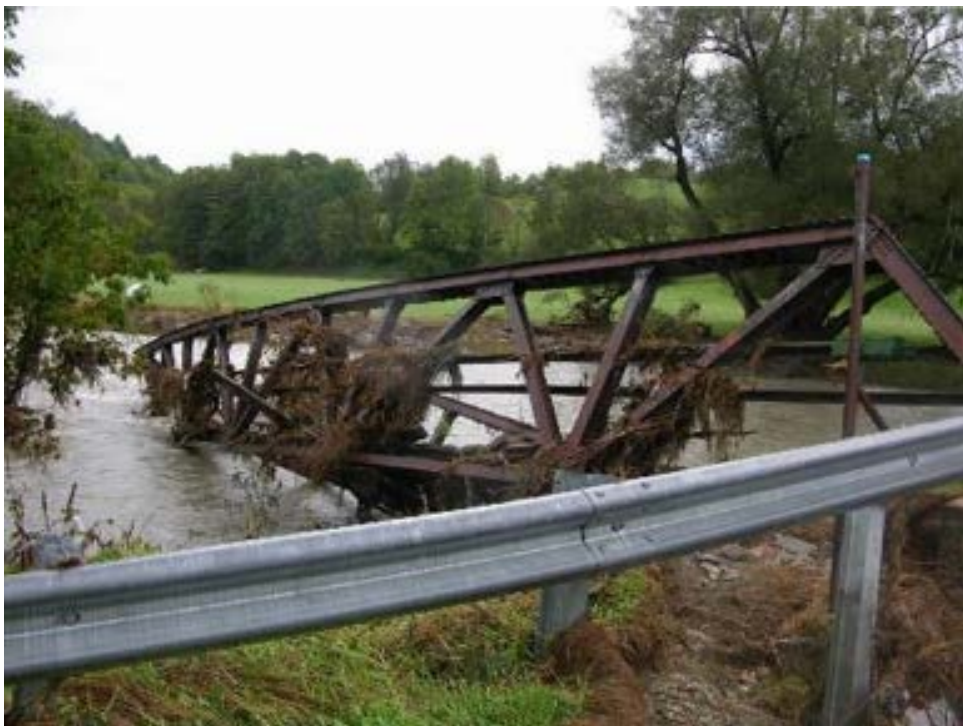
*(b) Moretown C3024-41 Bridge: collapse of the steel truss bridge from the apparent loss of one of the bridge foundations*

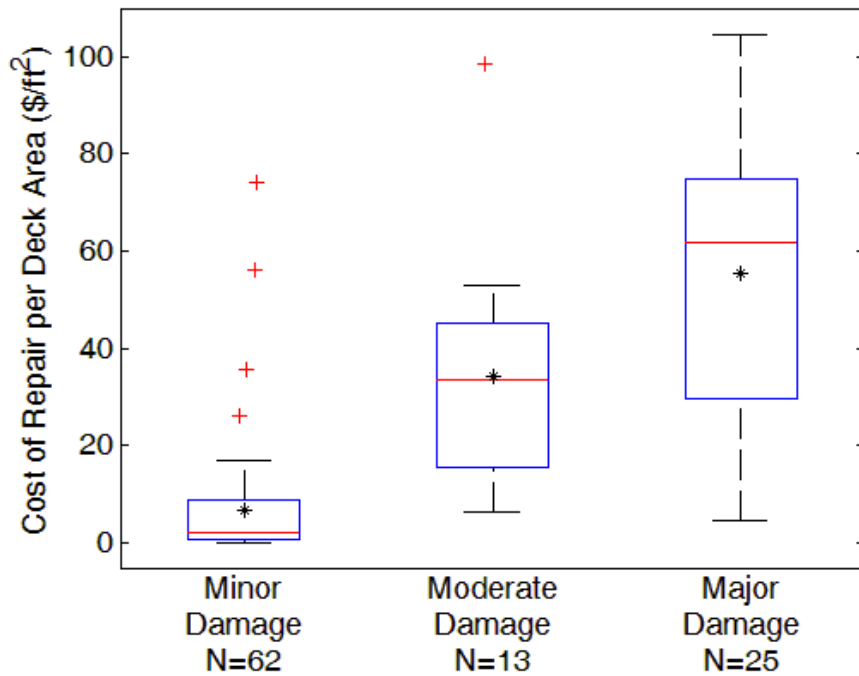
(a) Estimated cost of repair versus damage level

(b) Estimated cost of repair per deck area versus damage level

Figure 2.9: Estimated cost of repair, and estimated cost of repair per area for Town bridges

The VDEM list of damaged bridges included cost estimates for repairing the bridge back to its pre-storm condition. A comparison of bridge damage level to the cost of repair, in U.S. dollars and dollars per deck area is shown in Figure 2.9. The horizontal line within each box plot represents the median, the edges of the box are the 25<sup>th</sup> and 75<sup>th</sup> percentiles, and the whiskers extend to the most extreme data points not considered outliers. Outliers are plotted individually, and the asterisks indicate the mean. Figure 2.9 shows that the cost of overall repair corresponds well with increasing levels of damage, and when normalized by deck area, provides a good trend among their averages. When bridge damage, represented as cost per square foot of deck area, is partitioned by damage type (Figure 2.10), it can be seen that scour damage has a much greater cost whereas the damage due to flanking is well below (less than \$200/ft<sup>2</sup>) damage.

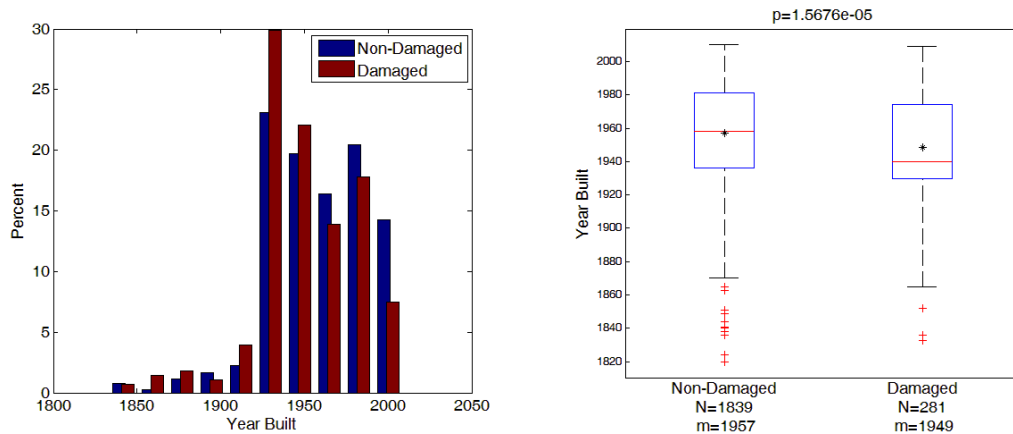
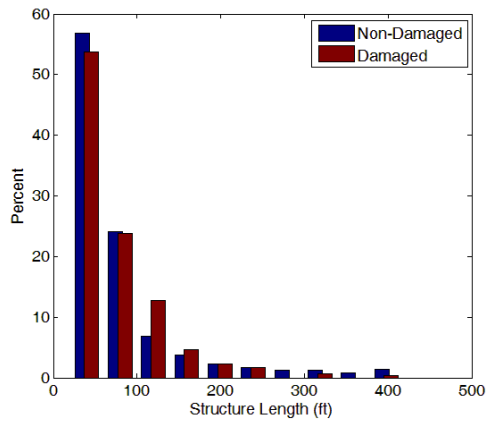
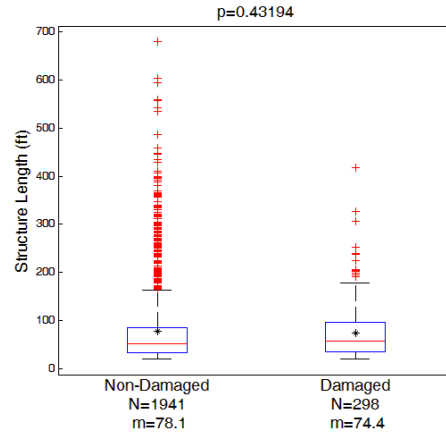
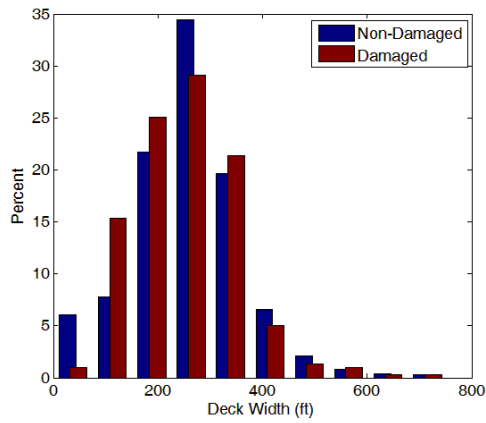
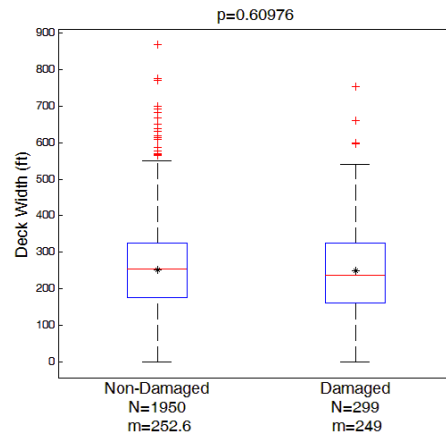
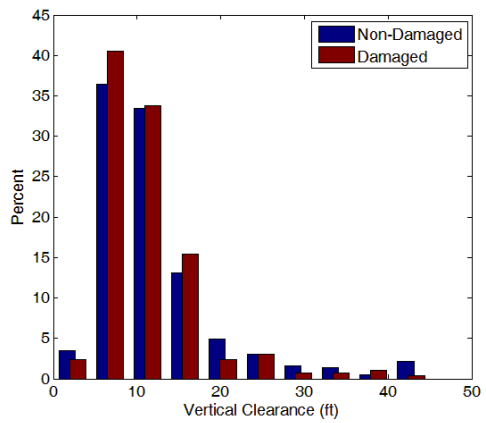
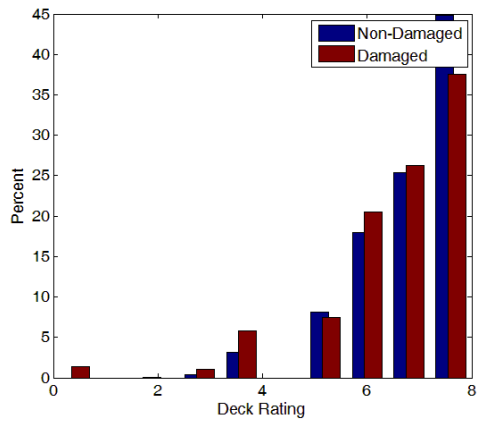
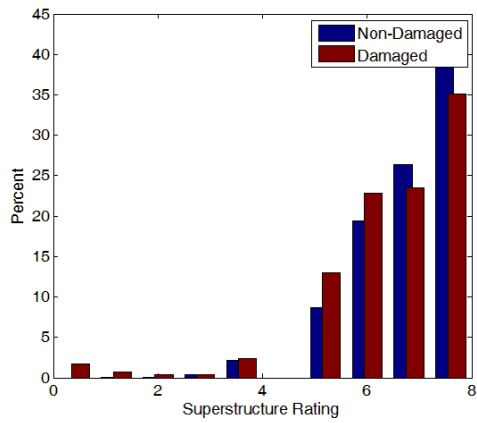
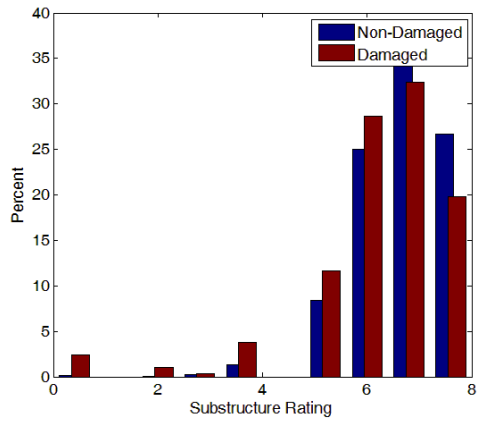
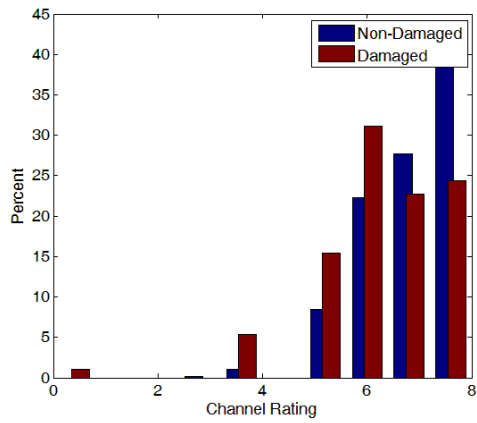
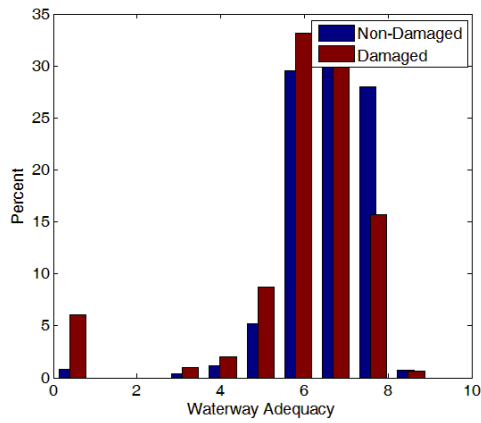
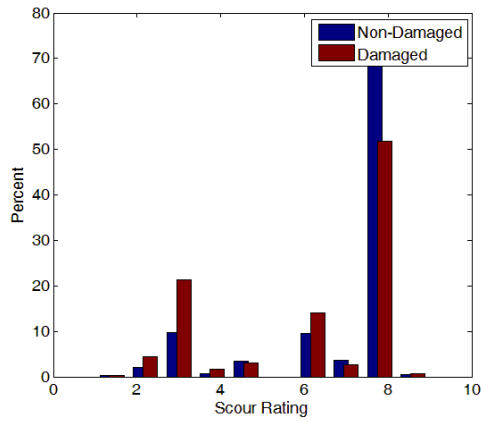
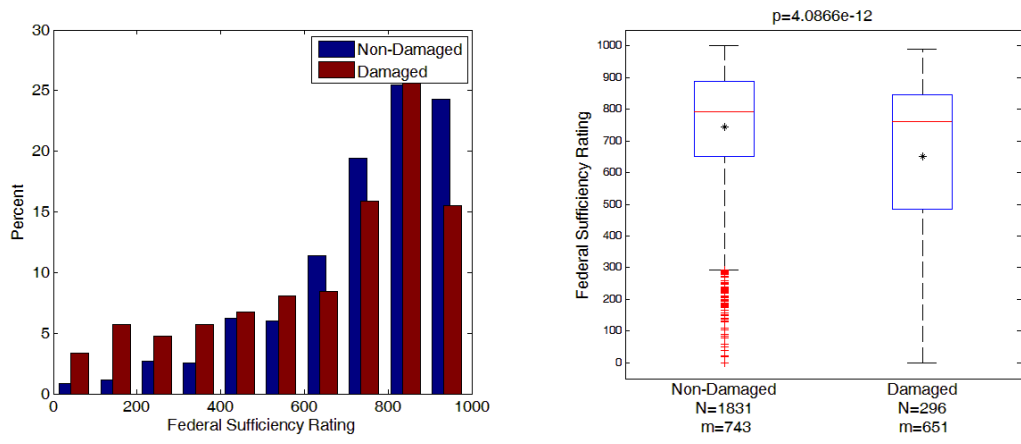
Figure 2.12: Statistical comparison of damaged and non-damaged bridges using bridge inspection data

Through the creation of a comprehensive bridge inventory, the damaged bridges were identified, and their inspection records were accessed. Using the NBIS records, the bridge history, geometry, and inspection ratings are available. Results of the analysis of the bridge inspection variables can be seen in Figure 2.12.

non-damaged bridges, showing that damage was related to a factor other than the size and capacity of a bridge. The vertical clearance shows a significant difference, with damaged bridges having a lower value. The low clearance may have been related to the amount of debris observed in damage inspections, or have led to potential superstructure damage. Because of the magnitude of discharge in the flooded streams, it was hypothesized that damaged bridges might have had shorter spans, but that is not evident from the structure length alone.

Analysis of bridge inspection parameters show that bridges damaged in Tropical Storm Irene were significantly older, and had poorer inspection ratings. The ratings for damaged bridges were significantly lower for the following categories: deck, superstructure, substructure, channel, waterway adequacy, scour, and federal sufficiency rating. The pre-storm condition of the damaged bridges was lower, and there appears to be a select group of bridges that had critical ratings prior to the storm. The sufficiency rating is a collection of the prior ratings, and is used as an overall indicator. Further analysis will be needed to determine if the numerous low ratings correspond to a set of deficient bridges. The scour rating, though significantly lower for damaged bridges, still has over 50% of damaged bridges rated as non-scour critical. These results indicate that a low rating may show vulnerability to scour, however, a high rating does not show immunity particularly in an extreme event such as Tropical Storm Irene.

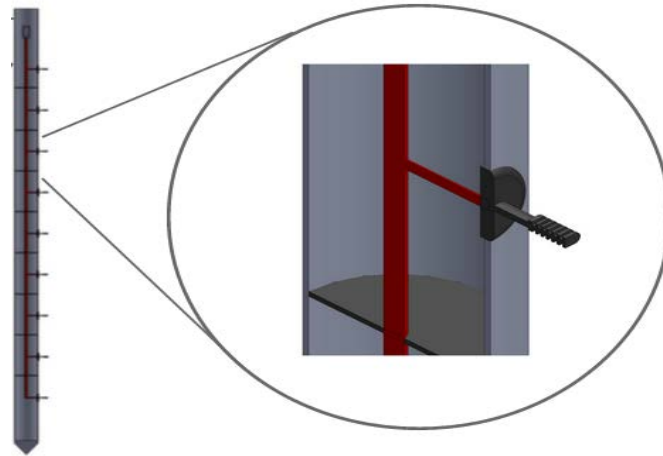
Figure 3.3: Proposed Smart Rod

The proposed “Smart Rod” scour sensor consists of acceleration or vibration sensors placed at incremental depths. The sensor arms that extend from the sensor rod remain buried in the bed material until they were exposed by scour. The flow of water activates the sensor, alerting the user of the depth of scour. Recording post scour redeposition is also possible because if deposition occurs, the sensors will cease to move. The sensor device could use segmented components which can be linked together to increase the sensor length to meet site-specific needs. In addition to the motion sensors, temperature sensors could be included to provide a combination of measurements to try to predict the depth of the soil water boundary. A schematic of the sensor concept appears in Figure 3.3. The overall functional scheme of the sensor network is depicted in Figure 3.4.

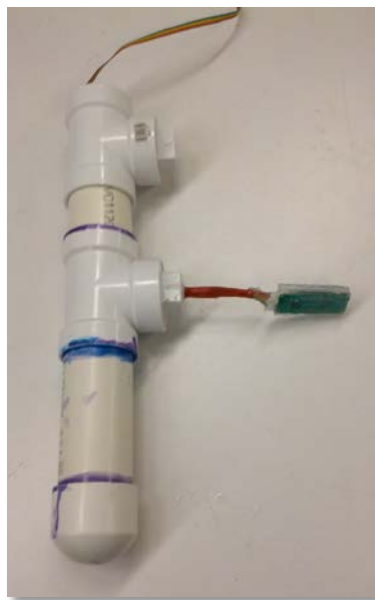
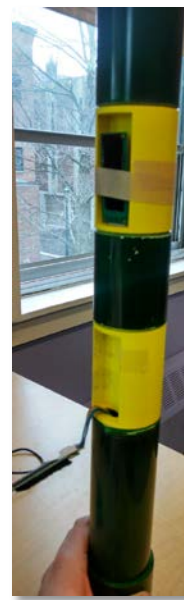
(a) Using PVC

(b) Using 3D printing

Figure 3.5: Smart rod prototypes

The design of the smart rod can be divided into three main categories: physical, electronic, and programming. The physical components are currently made of PVC pipes and 3D printed components, and in the future that will probably be changed to a non-corrodible metal. Figure 3.5 shows photographs of two prototypes developed thus far. Figure 3.5a shows a unit made out of off-the-shelf PVC pipes and accessories. Figure 3.5b shows a unit developed using components made with a 3D printer.

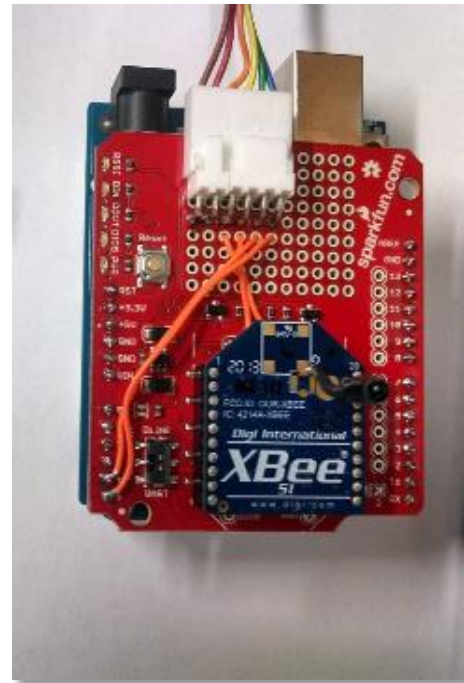
*Figure 3.6: Accelerometer (red) and Arduino Pro Mini (blue)*      *Figure 3.7: Arduino Uno (red) and Xbee (blue)*

The next step is to transmit the data, from the Arduino Pro Mini to the Arduino Uno. The Arduino Uno is the cap board, seen in Figure 3.7. This interprets the data from the various Pro Mini and accelerometer combinations to determine if any of the sensors are activated. The benefit of having the Pro Minis sending out digital data is that there only has to be one set of wires running down the entire length of the sensor array. The Arduino Uno will determine if any of the sensors are activated, and if they are, it will transmit data wirelessly to the data logging hub.

Attached to the Arduino Uno is the Xbee, as seen in Figure 3.7. This is a wireless communication unit that can easily be networked with other Xbee's operating on the same frequency. These devices allow for two way communication which allows the users to get the data if they want to check on the sensors outside of the normal communication schedule. The Xbee sends the data to the data logging hub.
