AN EXPERIMENTAL STUDY ON THE CORROSION SUSCEPTIBILITY OF RECYCLED STEEL FIBER REINFORCED CONCRETE

ABSTRACT

Keywords: Corrosion, RSF, fiber pullout test, RSFRC, splitting tensile test.

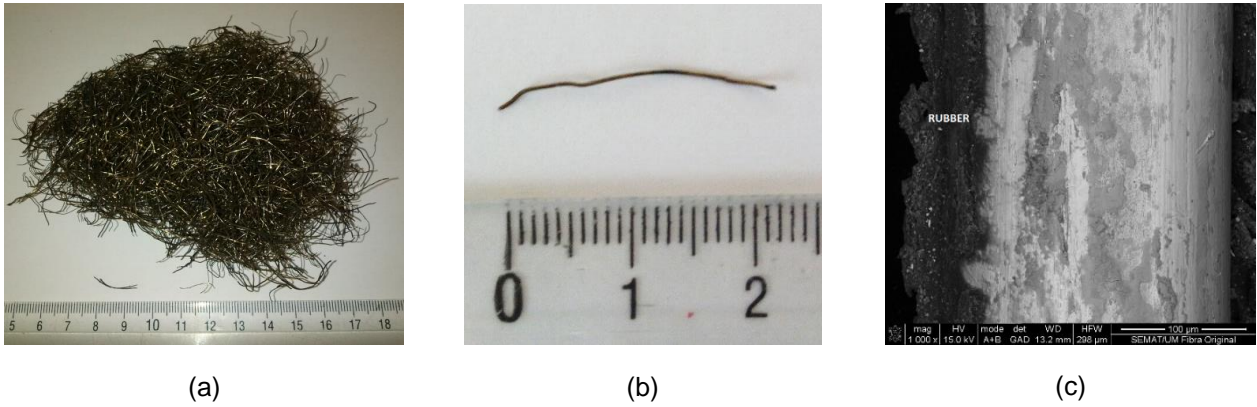
Figure 1 - Recycled steel fibers: (a) general view of multi fibers (b) general view of the geometry of a single RSF (c) SEM micrograph of the surface of a single RSF (Reference)

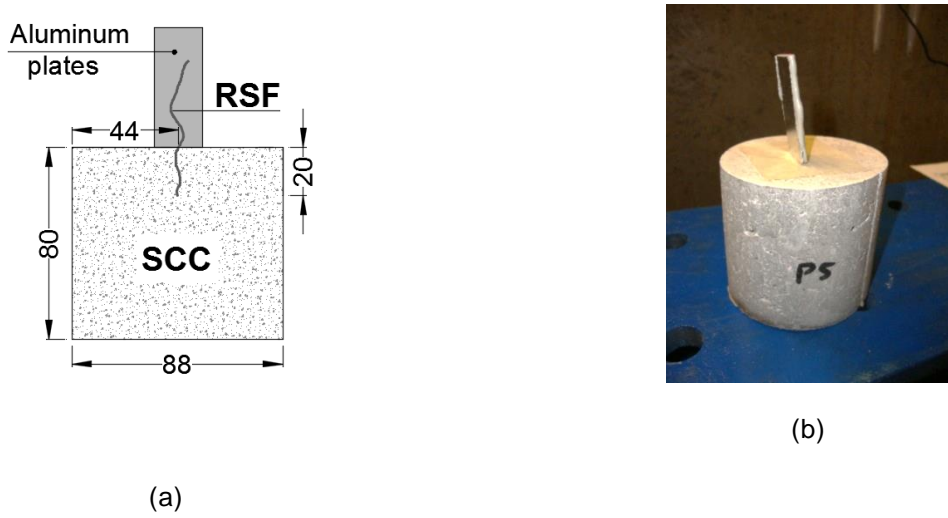
Figure 2 - Pullout SCC specimen

For the pullout tests a single RSF was centrally embedded on a cylindrical SCC specimen with 88 mm diameter and 80 mm height. The RSF was positioned as perpendicular as possible, with an embedded length of 20 mm (Figure 2a). Prior to testing, two aluminum plates were attached to the free loaded end of the RSF (Figure 2b), in order to avoid undesired rupture or slippage of the fiber at the gripping system of the testing machine.

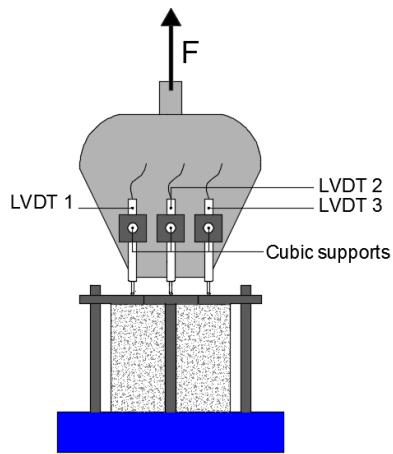
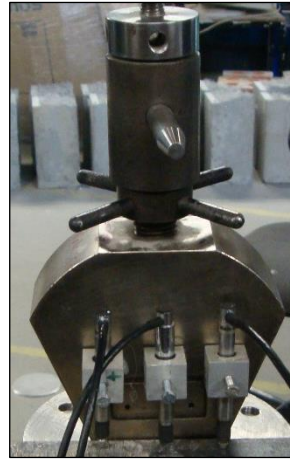
Figure 3 – Test setup for fiber pullout tests [43] (a) (b) Specimen front view (c) (d) Specimen back view

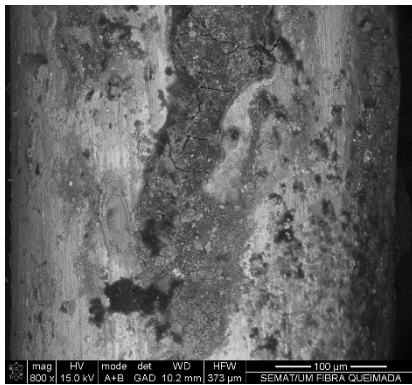
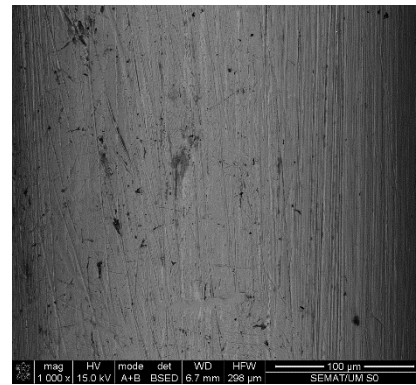
Figure 4 - SEM micrographs of the surface of a single RSF of: (a) Class 2 (T=350°C), (b) Class 3 (Polished)

in class 1 and 11 tests in class 3). On the one hand, higher pullout loads were attained with the elimination of the rubber debris. On the other hand, this can be also attributed to the effect of higher temperatures on the fiber surface, which has increased the hardness and brittleness found in nano-indentation tests, as well as the formation of micro cracks, as shown in Figure 4b.

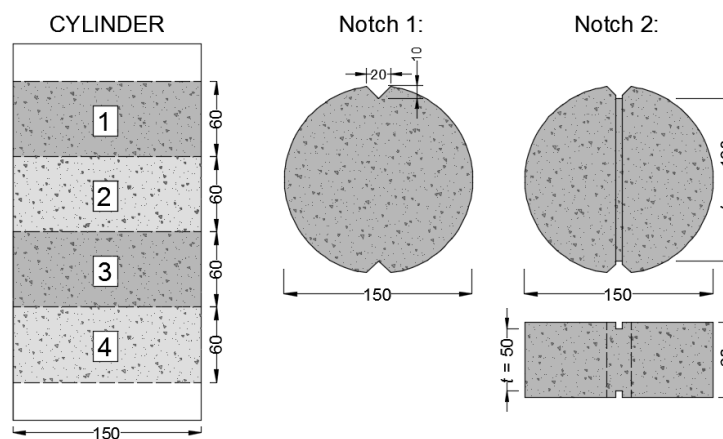
Figure 5 – Cutting of cylinders in $\phi 150 \times 300$ mm specimens and implementation of the respective specimen's notches (units in millimeters)

specimen, 5 mm deep notches were executed parallel to the loading direction, in order to set the specimen's fracture surface along the notched plane (notch 2 in Figure 5). Following the procedure adopted by di Prisco *et al.* [41], a V-shaped groove with 45° inclination was also implemented at the extremities of the notched plane, as illustrated in Figure 5 (notch 1). The objective of this V-shaped groove was to induce a stress field corresponding to an almost pure mode I fracture in the notched plane.

where P is the compressive load, and t is the thickness and h_{lig} is the effective length of the notched region that defines the plan of failure. The nominal values for t and h_{lig} are equal to 50 mm and 130 mm, respectively (Figure 5).

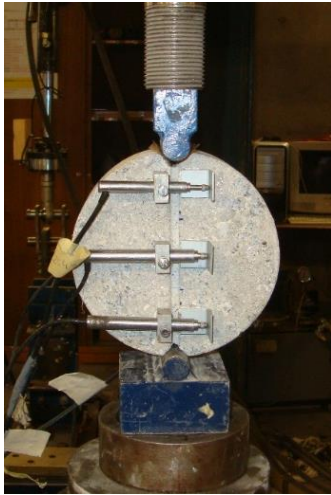
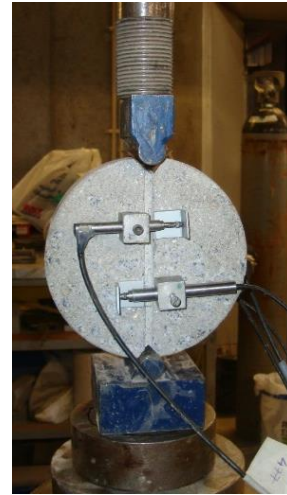
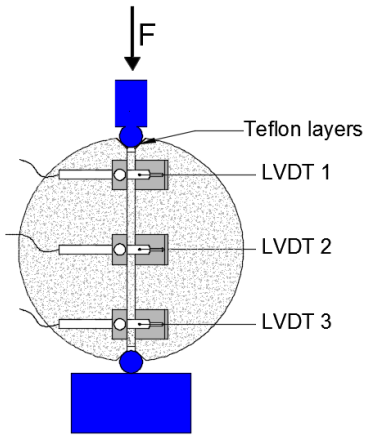
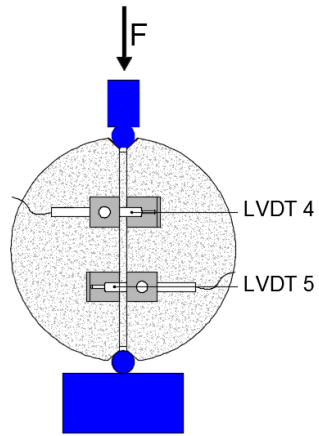
Figure 6 – Test setup for splitting tensile tests (a) (c) Specimen front view; (b) (d) Specimen back view; (e) Specimen lateral view (units in millimeters)

The crack width in X-axes corresponds to the average values measured by the five LVDTs shown in Figure 6. Note that the indicated crack widths were measured during the loading stage of the specimens.

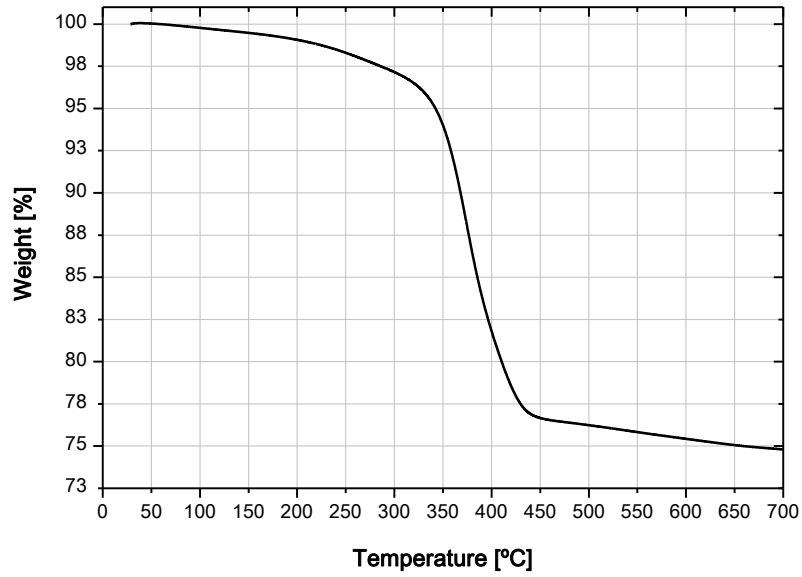
Figure 7 – TGA analysis of RSF up to 700 °C

The range of decomposition temperatures of the rubber waste was settled from thermogravimetric analysis (TGA). Using this technique, the mass loss of RSF versus temperature was monitored up to 700°C at a constant heating rate of 10°C/min. It was found that heating at 10°C/min up to 350°C followed by 60 minutes at this temperature was adequate to eliminate the rubber debris from the RSF surface, as will be discussed in section 3.1.

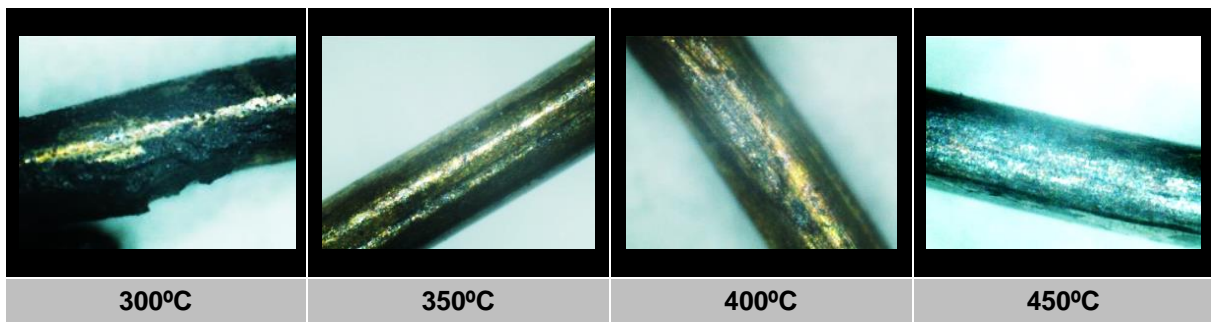
Figure 8 – Images of the RSF after firing for 1 hour at the selected temperatures

300°C, 350°C, 400°C and 450°C. Figure 8 shows the photos taken with a digital microscope after each of these heat treatments. From visual inspection and weight variation analysis, it was found that temperatures above 350°C were effective to remove the rubber waste from fibers surface. The temperature of 300°C was not effective since part of the rubber still remained on RSF surface (Figure 8). For this reason and also considering the economic point of view, the temperature of 350°C was defined for the heat pre-treatment of RSF (class 2).

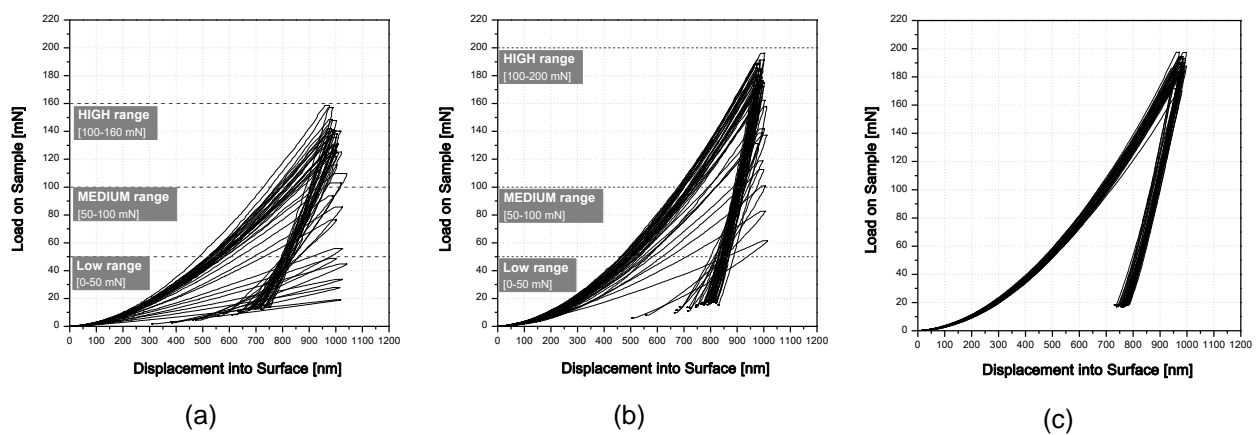
Figure 9 – Load vs. displacement curves obtained in nano-indentation tests of RSF: (a) Class 1 (reference); (b) Class 2 (350°C); (c) Class 3 (polished)

According to Fig. 9c and Table 3, the treatment by manual polishing (RSF of class 3) caused a homogenization of the RSF microstructure and increased the hardness of RSF. This increase in hardness can be explained by the transformation of the retained austenite into martensite due to the strain induced by plastic deformation that occurs during the polishing process (referenced in the literature by “strain-induced martensitic transformation” [59]).

Concerning the Young’s Modulus values, they are in the same range as those reported in the literature [60], except for RSF of class 1. As also reported in [61], the Young’s Modulus did not significantly vary with temperature. The unexpected low value for the untreated RSF (132 GPa) can be just a consequence of the great variability observed in the indentations performed to this material (Fig. 9a). The large number

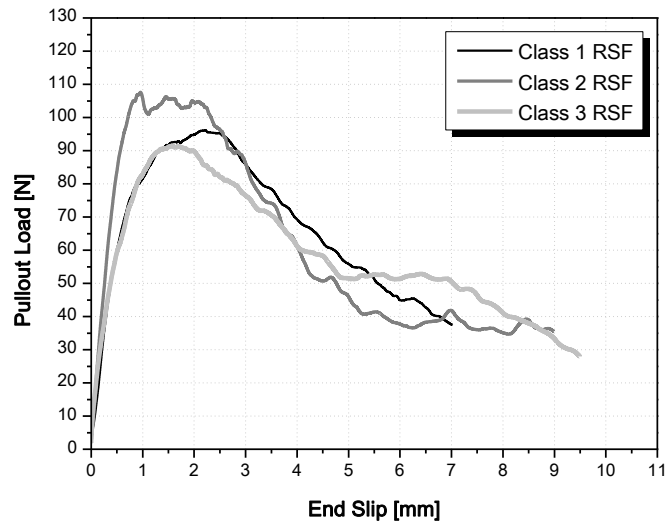
Figure 11 – Average Pullout load vs. End slip curves obtained in fiber pullout tests of RSF

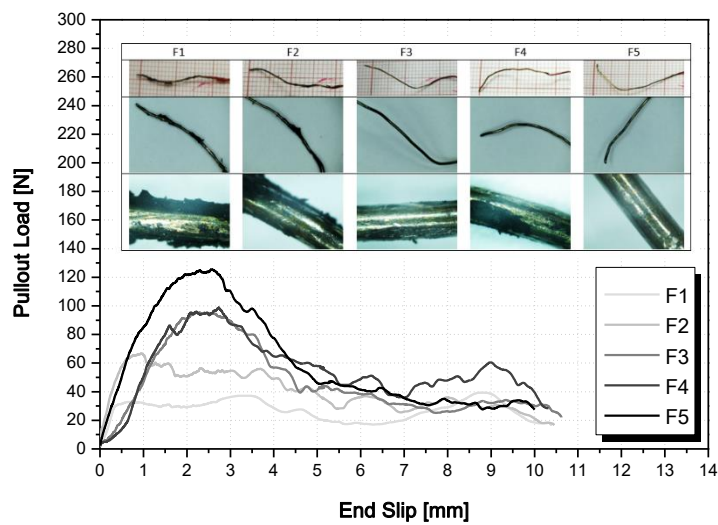
Figure 12 – Average Pullout load vs. End slip curves obtained of five different types of RSF class 1 (The level of rubber attached to the fibers decreased from F1 to F5)

Taking only into account the average pullout loads, we may conclude that the rubber debris attached to the RSF surface (class 1) had a minor effect in the pullout behavior of RSF, since the average pullout load was similar to those of clean RSF (classes 2 and 3) (Figure 11). However, this should be valid only when the rubber debris attached in the fiber surface does not cover a significant surface area. In fact, taking into account the pullout load versus slip curves of five types of RSF with very different rubber contents, it was found that for relevant amounts of rubber debris there was a significant decrease of the pullout strength with the increase of rubber (F1 and F2 – Fig. 12). For low amounts of rubber, which was more common, slight variations on rubber content was not significant (F3 and F4 – Fig. 12). In addition, the irregular shape of RSF had also a significant influence in the fiber pullout behavior, comparing F4 with F5 which practically are free of rubber (Fig. 12). As expected, the RSF with more irregular and twisted embedded length showed higher fiber pullout load and greater probability of fiber rupture (F4 and F5 - Fig. 12). In sum, as shown in Figures 13a and 13c, a high dispersion of the results was obtained in these pullout tests (class 1 and 3), being essentially affected by two main factors; the amount of attached rubber and the fiber geometry.

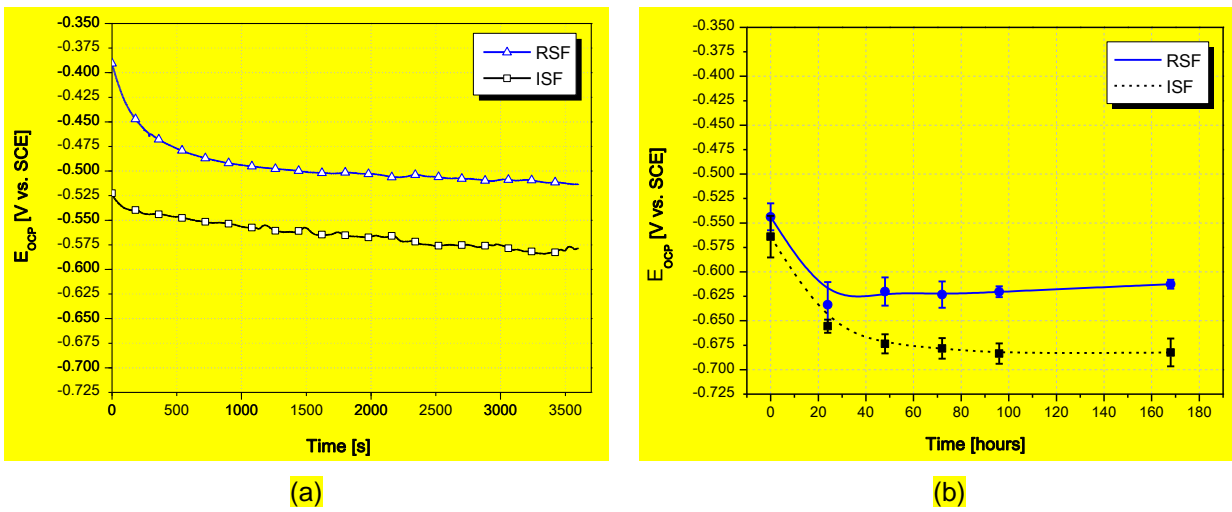
Figure 14 – Evolution of E_{OCP} in RSF over the immersion period of:
 (a) 1 hour (Series I), (b) 7 days (Series III). Results are compared with those reported in [21].

The average values of E_{OCP} during the immersion period of series I and III are presented in Figure 14. The values of RSF are compared with those of ISF reported in [21]. It was found that for 60 minutes of chloride immersion, the corrosion potential was approximately constant, both in RSF and ISF. In Series III, the corrosion potential sharply decreased after one day of immersion, indicating an increase in the general corrosion of the fiber. Afterwards, the potential of RSF fully stabilized up to 7 days of immersion as found in ISF. More positive corrosion potential values have been recorded for the RSF in comparison to the ISF. Electrochemically, this difference is very small (about 70 mV), and can be considered as insignificant.

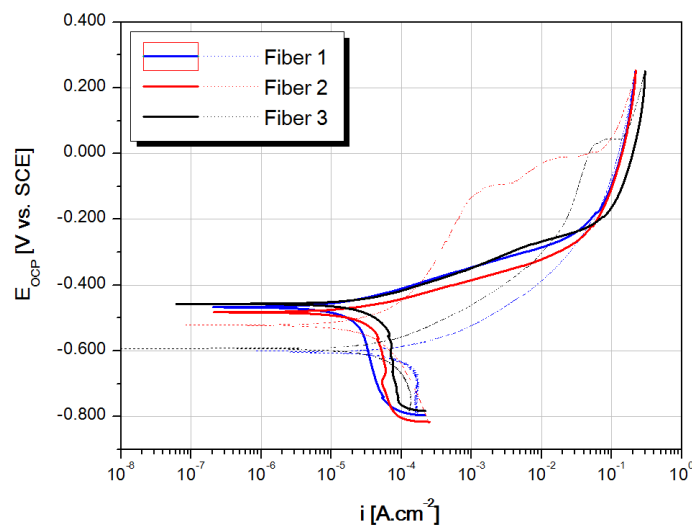
Figure 15 – Cyclic polarization curves in three RSF of class 1 – Series I (forward & reverse scan)

Figure 15 shows the polarization curves obtained in the cyclic polarization tests performed on three RSF of class 1 after 1h of chloride immersion (Series I). Small differences were found between different fibers. The obtained curves show that the corrosion of the reference RSF is generalized in its surface, since the current density values recorded in the reverse scan are smaller than those obtained in the forward scan, which means that there is no evidence of localized corrosion.

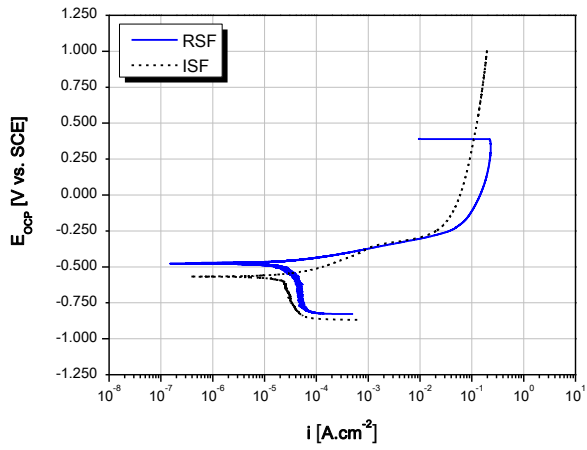
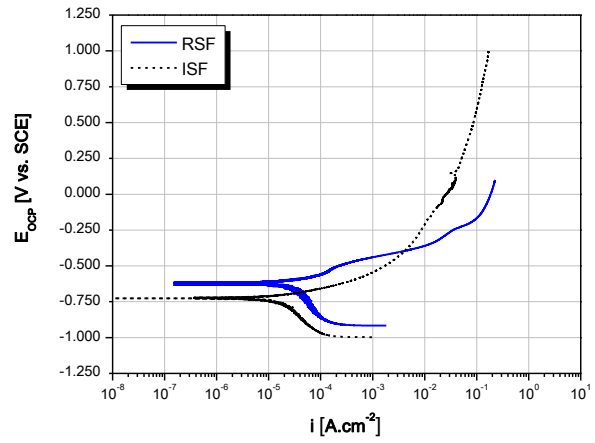
Figure 16 – Potentiodynamic polarization curves after the immersion period of:
 (a) 1 hour (Series II), (b) 7 days (Series III). Results are compared with those reported in [21].

Figure 16 shows the polarization curves obtained for fiber 1 in test series II and III comparing with the homologous curves obtained with ISF [21]. Due to the reduced diameter of RSF comparing with that of ISF, the rupture of RSF occurred during the polarization (Figure 16a; $E = 391.1$ mV). To avoid this phenomenon in Series III, the upward potential was limited to up 100 mV.

polarization resistance, R_p , obtained from the potentiodynamic polarization curves of Series II and III. In both Series II and III, the $E_{(i=0)}$ of RSF presented more positive values compared to ISF, as also shown in Figure 16. This seems that the chemical composition of RSF surface (Cu species – 5.41% and Zn species – 3.53% of concentration determined by XRF) improved the corrosion performance of the steel [63, 64]. However, the cathodic branches of polarization curves (oxygen and hydrogen reduction) achieved greater current values for RSF than ISF according to Figure 16, which means higher corrosion rates for RSF. It seems that RSF are more susceptible to corrosion than ISF because they showed higher values of i_{corr} and lower values of R_p .

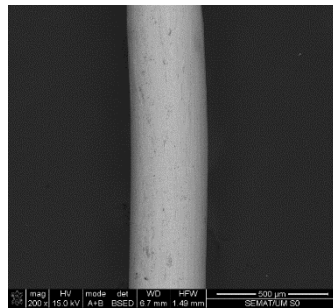
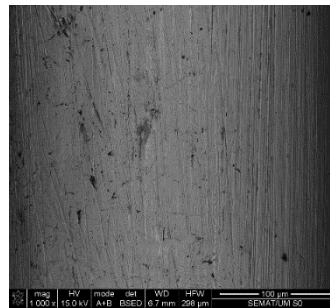
Figure 17 – SEM micrographs of the surface of polished RSF before polarization tests (without corrosion)
 Magnification: (a) 200x (b) 1000x

It is worth to mention that it **was** very difficult to perform the electrochemical tests with the RSF of class 1 and 2, due to the non-uniformity of the fiber surface comparing with that of RSF of class 3 (as shown in SEM micrograph of Figures 1c and 4). Therefore, no accurate conclusions can be drawn regarding the effect of rubber debris in the corrosion behavior of RSF.

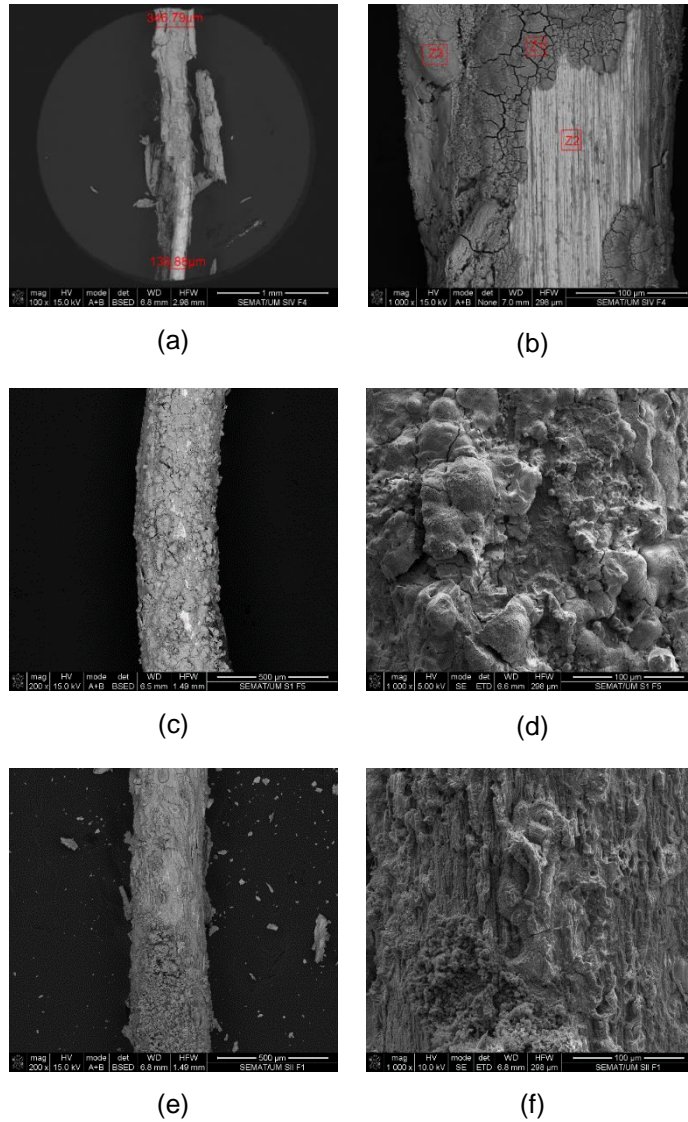
Figure 18 – SEM micrographs of the surface of polished RSF after polarization tests (with corrosion):
 Potentiodynamic polarization (Fiber 4 – Series II): Magnification: (a) 100x (b) 1000x (atomic contrast by
 backscattered electrons of chemical elements)
 Linear polarization (Fiber 5 – Series IX): Magnification: (c) 200x (d) 1000x
 Linear polarization (Fiber 1 – Series X): Magnification: (e) 200x (f) 1000x

After the electrochemical tests, scanning electron microscopy (SEM) analysis were carried out in some fibers to analyse the effect of the corrosion action **on** their surface, in order to analyze the influence of corrosion in terms of surface configuration. SEM micrographs of non-corroded and corroded polished RSF are shown in Figures 17 and 18, respectively. The great effectiveness of the hand polishing performed to remove the rubber waste from the RSF surface is confirmed in Figure 17. The micrographs presented in Figure 18 show that the corrosion of RSF is generalized, forming a homogeneous **layer** of iron oxides in their surface.

Figure 18b evidences the atomic contrast by backscattered electrons of chemical elements presented in the corrosive products. Through this micrograph, a chemical analysis was carried out to identify these elements. The main chemical elements identified were carbon, C, oxygen, O, and iron, Fe, with the following composition in each zone: Z1 – 53.29% O, 12.25% C, 30.82% Fe; Z2 – 23.25% O, 23.98% C, 48.01% Fe; Z3 – 53.07% O, 12.08% C, and 30.02% Fe. These elements were the result of the corrosion process, and when combined formed higher concentration of iron oxides in zones Z1 and Z3 due to the limited presence of oxygen in zone Z2 (23.25%). It was also remarkable the presence of elements such as Cu and Zn, which should be related with the brass coating commonly deposited on the top of the steel wire for tire cord to increase the adhesive bonding when is embedded in rubber. These elements showed greater atomic percentage in the class 1 RSF (1.54% of Cu and 0.86% of Zn, on average), which means that polishing (class 3 of RSF) was eventually able to remove part of the brass coating during the cleaning process (average of 1.19% of Cu and 0.64% of Zn, on average).

The presence of corrosion products, along with the significant reduction of the fiber diameter, proves the severe damage occurred after the potentiodynamic polarization test (Figure 18a). The rough, irregular and porous appearance of the fiber surface, which confirms the presence of corrosion products, is also remarkable in the fibers that were subjected to linear polarization (Figure 18d and 18f). After 7 days of chloride immersion, the release of accumulated products reveals the greater progress of the corrosion phenomenon (Figure 18e and 18f).

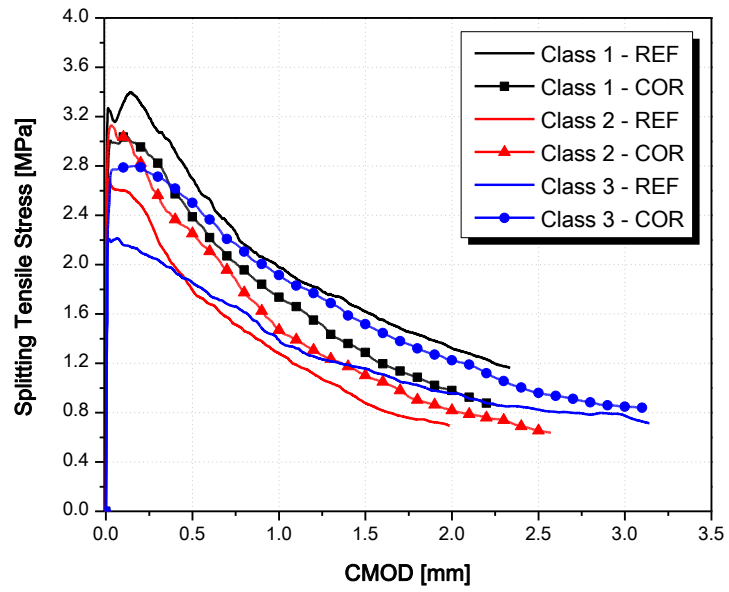
Figure 19 – Average splitting tensile stress versus crack width for specimens with RSF of class 1, 2 and 3, not exposed to NaCl solution (REF) or under corrosion action (COR)

Figure 19 shows the average splitting tensile stress ($\sigma_{t,split}$) versus crack width curves, where $\sigma_{t,split}$ was determined from the following equation, as proposed by di Prisco *et al.* [41]:

For specimens of class 1 RSF, the corrosion action caused a slight decrease of the average stress at crack initiation (7.9%) and the average post-cracking tensile strength (10.3%). However, for RSF of class 2 and 3, the corrosion action led to the increase of the average stress at crack initiation (16.2% in class 2 and 26.2% in class 3).

The reference specimens of class 1 RSF showed the highest average stress at crack initiation (3.27 MPa) and the highest average post-cracking tensile strength (3.40 MPa), which means that the two methods used to remove the small percentage of rubber from the fibers surface led to a decrease of the splitting tensile strength of the RSFRC specimens (Figure 19). It is also important to note that the RSF of class 1 used in reference specimens were mostly at the level of F3 and F4 of Fig. 12, with few rubber debris attached. Taking also into account the monotonic pullout tests in section 3.3, these results suggest that in specimens of class 2 RSF a significant amount of fibers had broken during the splitting tests. Considering also the dispersion of the pullout tests results represented in Fig. 13, it can be seen that RSF of class 1 (Fig.13a) can achieve a higher level of pullout load than RSF of class 2, which may justify the highest average splitting tensile stress showed by class 1 RSF.
