Cultural Resources Survey of a Proposed Reverse Osmosis Water Treatment Plant, El Paso County, Texas

Texas Antiquities Permit No. 7366

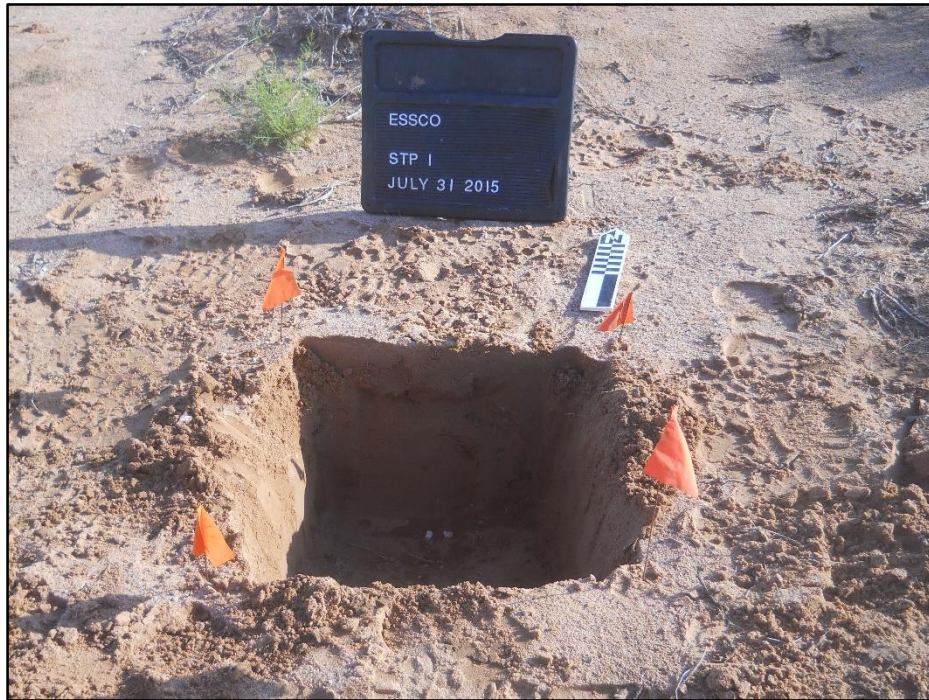
Figure 4. Shovel test pit 1, looking north.

STP 1 was placed west of a north/south oriented access road and east of Isolated Occurrence 1 in an area characterized by accumulated sands. This shovel test pit was excavated to a depth of 35 cm below ground surface (bgs). The soil sequence included 24 cm of unconsolidated reddish yellow (7.5YR6/8) sand sediments overlying 9 cm of compact, reddish-brown (7.5YR8/2) silty loam with caliche filaments. This basal soil rested upon bedrock caliche (Figure 4). No artifacts were recovered from the screened fill, and no buried features were encountered during excavation of the shovel test pit.

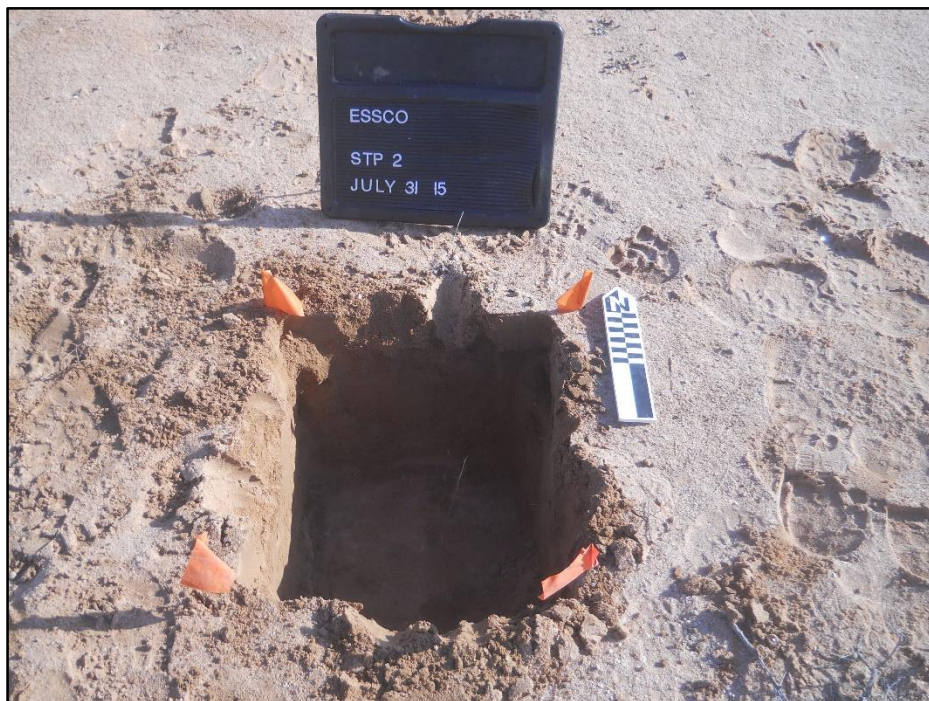
Figure 5. Shovel test pit 2, looking north.

STP 2 was placed in the north half of the parcel, west of the north/south access road and in an area of coppice dunes and accumulated sands. This shovel test pit was excavated to a depth of 37 cm bgs. The soil sequence included an 8 cm thick layer of light tan (7.5YR6/4)-unconsolidated surface sands that blanketed a 27 cm thick reddish yellow (7.5YR6/8) sandy loam deposit. This compact matrix contained noticeable caliche filaments. Directly beneath the second stratum was a shallow compact reddish (7.5YR6/4) loam unit with clear calcic inclusions. This 3 cm thick basal soil rested upon bedrock caliche (Figure 5). No artifacts were recovered from the screened fill and no buried features were encountered during excavation of the shovel test pit.

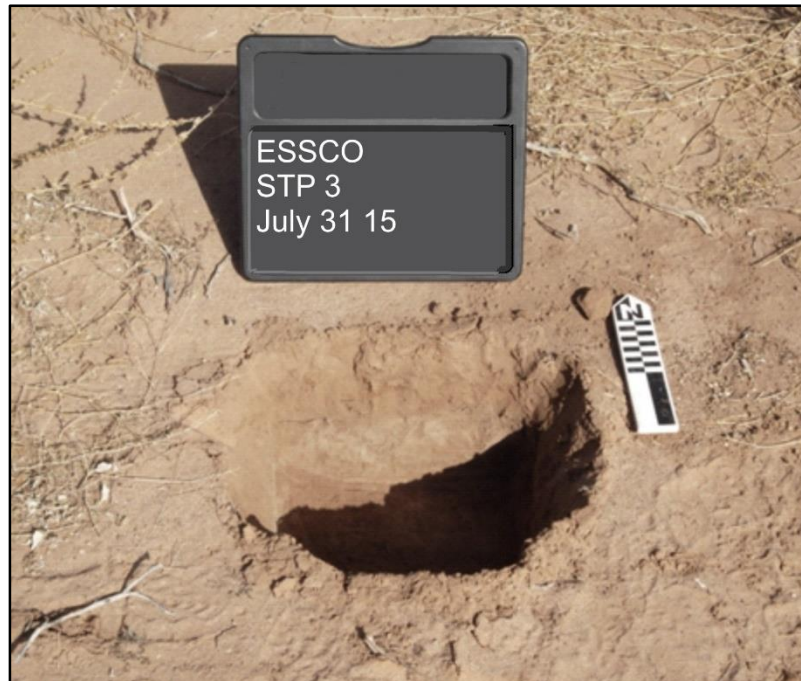
Figure 6. Shovel test pit 3, looking north.

STP 3 was placed approximately 25 m north-northwest of STP 2, west of the north/south access road, again in an area of coppice dunes and accumulated sands. This shovel test pit was excavated to a depth of 39 cm bgs. The soil sequence included a 10 cm thick layer of light tan (7.5YR6/4)-unconsolidated surface sands which blanketed a 25 cm thick reddish yellow (7.5YR6/8) sandy loam deposit. This compact matrix contained noticeable caliche filaments. Directly beneath the second stratum was a shallow compact reddish (7.5YR6/4) loam unit with clear calcic inclusions. This 4 cm thick basal soil rested upon bedrock caliche (Figure 6). No artifacts were recovered from the screened fill, and no buried features were encountered during excavation of the shovel test pit.
