Teng et al. Journal of Cardiovascular Magnetic Resonance 2011, **13**:64 http://www.jcmr-online.com/content/13/1/64

Characterization of healing following atherosclerotic carotid plaque rupture in acutely symptomatic patients: an exploratory study using in vivo cardiovascular magnetic resonance

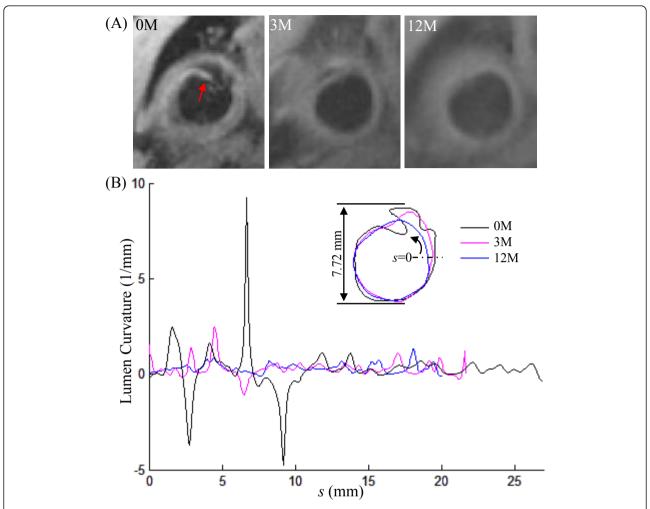
Figure 1 In vivo CMR-images showing the healing process which can be characterized using lumen curvature. (A): T₁ CMR image at baseline (0 month; 0 M) showing ruptured fibrous cap (red arrow) and the healing observed after 3 and 12 months (3 M and 12 M); (B): the corresponding lumen contours and the lumen curvature curves.

Lumen curvature has been recently introduced to describe the vulnerable site (plaque shoulder), where the rupture likely occurs [13]. Briefly, as shown in Figure 2A, the curvature at point a is the reciprocal of the radius (1/r) of the circle determined by a and the two adjacent points, a_1 and a_2 . FC rupture, ulceration and erosion will all lead to an irregular lumen surface. It can be captured by the sharp peaks of the curvature curve along the lumen length. As shown in Figure 1A, at the onset of ischemic symptoms (0 months), FC rupture and erosion were observed. The curvature curve reached its positive peaks at the crack positions (marked by green and brown arrows in Figure 1) and negative peaks at the positions in which tissue encroached upon the lumen (red arrow in Figure 1; black line in Figure 1B).

As shown in Figure 1A, healing was observed during the recovery period with the lumen contour becoming smoother at 3 months and 12 months. Corresponding quantitative comparisons between the curvature at baseline, 3 months and 12 months are made in Figure 1B. It can be seen that curvature became much flatter at 12 months. Comparisons of maximum and minimum lumen curvatures of the patient group without any recurrent event are visualized in Figure 3A &3B. The maximum lumen curvature decreased significantly from 3.33 [2.42, 5.43] (median [inter quartile range]; mm⁻¹) at baseline (0 M) to 2.68 [1.78, 3.97] at 3 months and 2.53 [1.74, 3.45] at 12 months (p values are 0.011 and 0.001, respectively). The minimum lumen curvature increased from -1.83 [-2.89, -0.92] at baseline (0 M) to -1.19 [-1.86, -0.51] at 3 months and -0.96 [-1.93, -0.36] at 12 months (p values are 0.005 and 0.0002, respectively). Although the roughness decreased from 0.100 [0.054, 0.164] at baseline to 0.082 [0.051, 0.138] at 3 months (Figure 3C), there was no significant difference (p = 0.130). With a further decrease, a significant difference was found at 12 months (0.079 [0.050, 0.130]; p = 0.043).

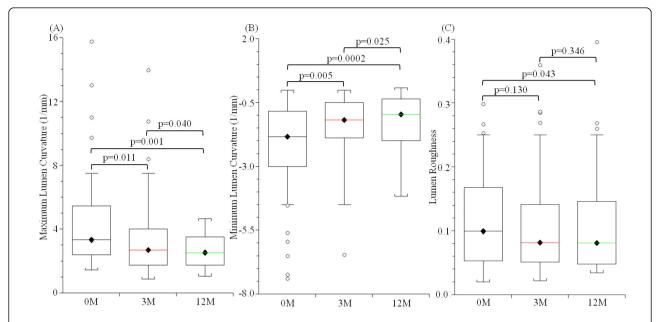
Figure 3 Comparison of maximum curvature, minimum curvature and lumen roughness over time. In summary, the lumen became smoother while healing occurred in the patient group (n = 23) without recurrent events. (A): maximum lumen curvature decreased with time; (B) minimum lumen curvature increased with time; and (C) the lumen roughness decreased.

To our best knowledge, this is the first study tracing the healing process after FC rupture, ulceration or erosion, except for a single case report [6] and one recent short report [7], and the only study to use the lumen curvature and roughness to describe this process. The results indicate that healing occurs after the acute ischaemic event in those without recurrence (Figure 1A). In the patient group without any recurrent events, the absolute values of maximum and minimum lumen curvature became smaller during the follow-up period (Figure 3A & 3B) as well as the lumen contour roughness (Figure 3C). Such a tendency was less clear in the patient group with subsequent
