St Serf's Church tower, Dunning, Perthshire

Data Structure Report SS13.07

By Ewan Campbell

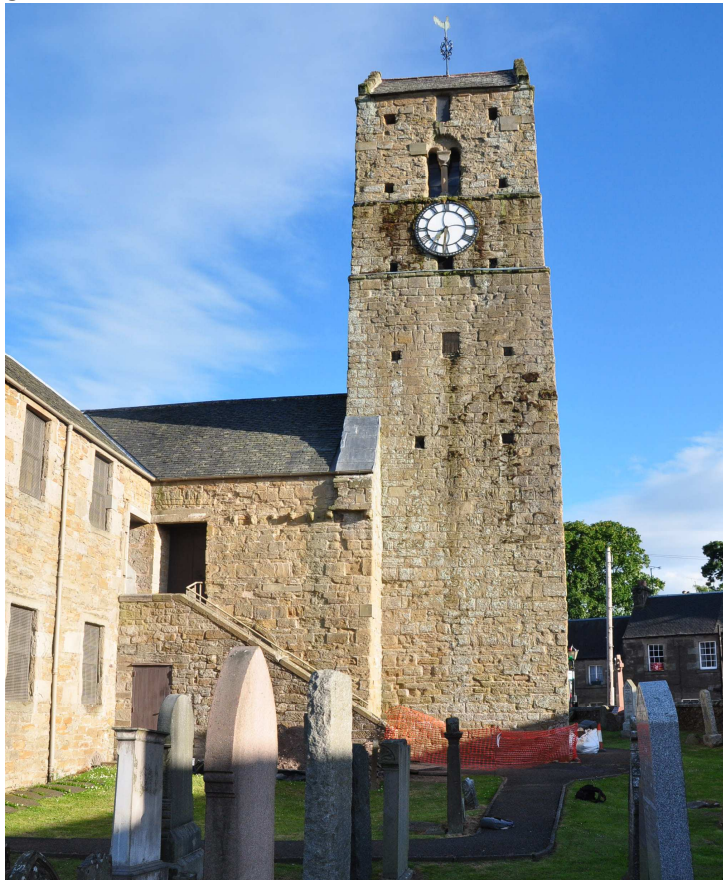
Fig 1 Location of excavation at base of tower with its Romanesque belfrey opening and holes for wooden gallery. Note the 19th-century loft stairway concealing the 12th-century north doorway.

The tower as it stands today is approximately 5.50m square externally (note incorrect measurements in Fawcett 2008). It is built of a soft yellow sandstone of the Lower Devonian period Scone Sandstone Formation, which outcrops locally (and formed the bedrock in trenches SS13.04 and SS13.06). There was a quarry for this stone 300 metres south of the church in Dunning Park, and other exposures along Dunning Burn. The stone is easily weathered and has suffered badly from erosion, being much softer than the more normal reddish purple sandstone of this Formation. Some stonework of the church has been replaced in recent years, including some of the central shafts of the original 12th-century belfry openings (Fig 1).

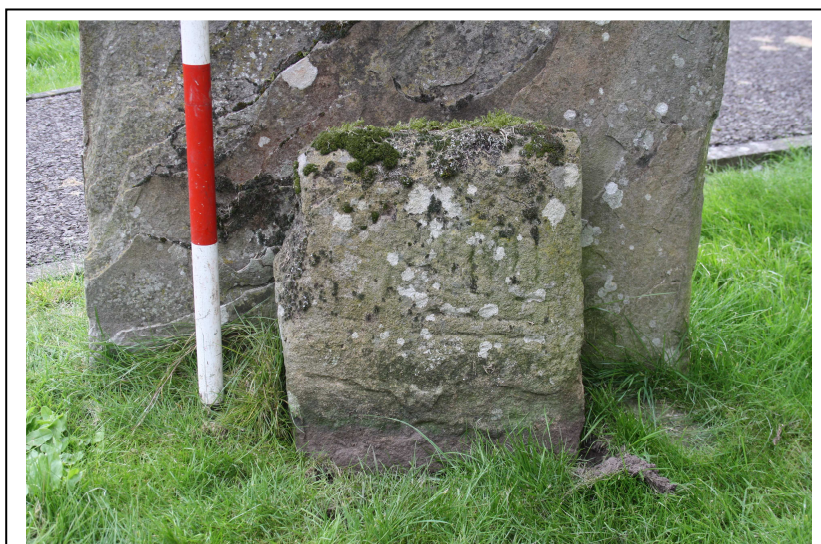
Fig 4 Newly discovered part of decorated ?cross in the churchyard

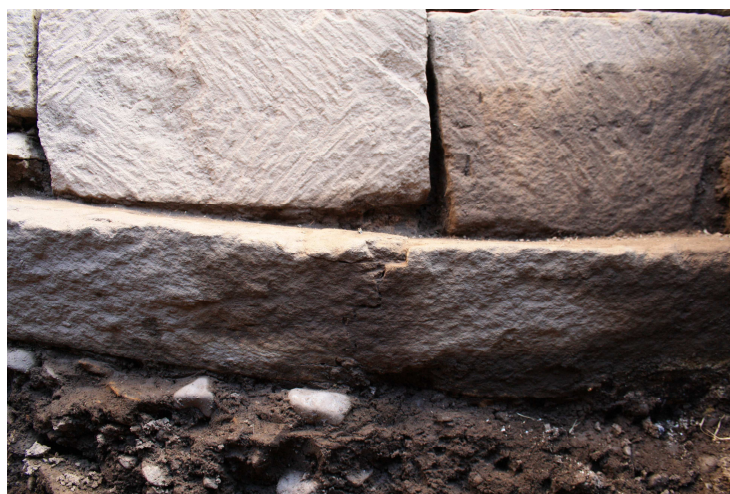
Fig 5 Detail of toolmarks on tower plinth 4707 (above), and lack of them on early structure 4711 (below)

The main walls of the church (4706) and tower (4710) were built of identical ashlar blocks of yellow sandstone of varied height and lengths, roughly coursed. The blocks were unweathered in the area excavated, and retained details of the toolmarks (Fig 5). The toolmarks were diagonal, usually covering the whole surface in one direction, but sometimes in a diamond pattern. The chisels used appear to have been toothed. Similar diagonal toolmarks were seen on the medieval masonry (?13th century) at Forteviot church.

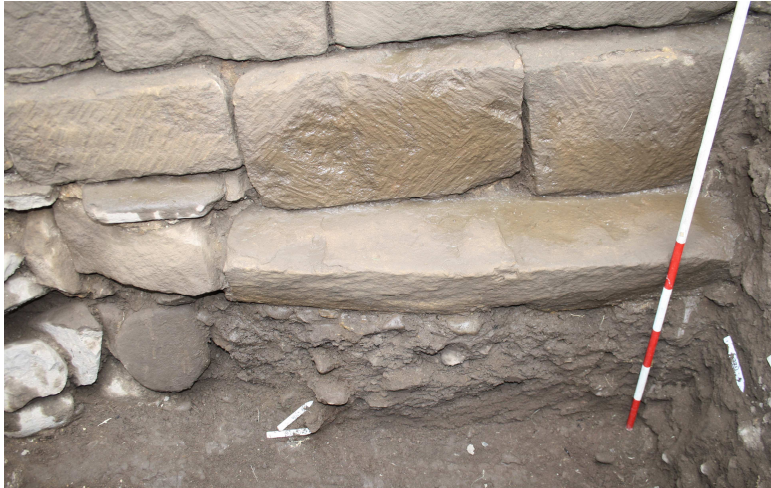
Fig 7 The early structure 4711, showing different foundation from boulders of 4723, and jumbled stonework of intersection with plinth of tower. Note early Burial 4 (white tags) running under foundations.

The western part of the foundation of the tower was of entirely different character to that of the rest of the church. The blocks of 4711, the lowest course, were not ashlar, and only 0.15m thick (Fig 7). They ran at angle more north of east than the tower walls (276° from grid North as opposed to 270°), and lacked the boulder foundation of the tower and nave walls. Instead 4711 had a foundation material of grey-brown soil full of gravel and small cobbles, with fragments of sandstone (4721) (Fig 7). This filled a foundation trench (4720) about 0.3-0.4m wide and only 0.2m deep, and contained disturbed human remains (SF 4712). This material was cut by the boulders of the foundation trench of the medieval church (4723) and clearly pre-dated it. The edge of this trench continued eastwards beyond the junction of the two structures, suggesting that part of 4711 had been removed by the building of the boulder foundation 4723. The junction of the medieval plinth and foundation with the early structure was characterised by a section of jumbled stones, clearly inserted to try and match the two structures together (Figs 6, 7). There was a small patch of mortar, similar to that of the later building, under 4711, but about 0.10m lower in level. It is

surprising that the weight of the tower was supported on such an insubstantial foundation, with no signs of subsidence in the overlying masonry, though the long slab of the foundation was fractured.
