Romanova, Anna, Mahmoodian, Mojtaba and Alani, Morteza A. (2014) Influence and interaction of temperature, H₂S and pH on concrete sewer pipe corrosion. *International Journal of Civil, Architectural, Structural, Urban Science and Engineering*, 8 (6). pp. 592-595. ISSN 1307-6892

Influence and Interaction of Temperature, H₂S and pH on Concrete Sewer Pipe Corrosion

Anna Romanova, Mojtaba Mahmoodian, Morteza A. Alani

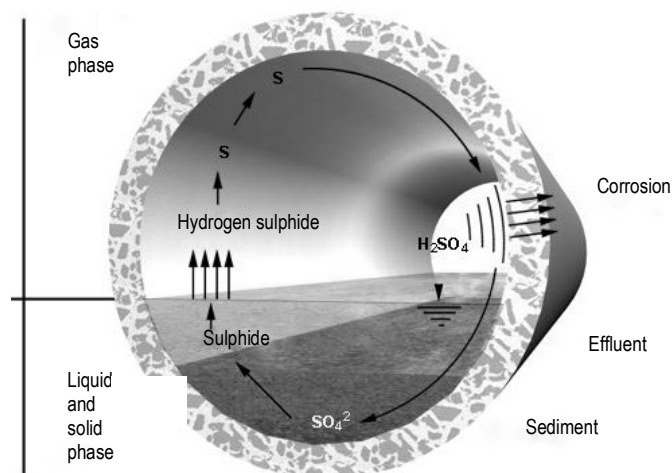
Fig. 1 Microbially induced concrete corrosion in sewer [19]

The process of sewer pipe corrosion has been studied since 1940th and a set of representative knowledge has been gained over years, which are referred to as microbially induced concrete corrosion (MICC) [12]. The bacteria class *Acidithiobacillus thiooxidans* [12]-[14] which are active in the effluent biofilm [15] convert sulphate to sulphide [16]. Some part of sulphide is released in atmosphere as gaseous hydrogen sulphide (H₂S) [16]. Further, the hydrogen sulphide is oxidised [17] to sulphuric acid (H₂SO₄), which subsequently attacks susceptible pipeline materials [18]. Fig. 1 demonstrates the chemical reaction of microbially induced concrete corrosion process in sewer pipe.

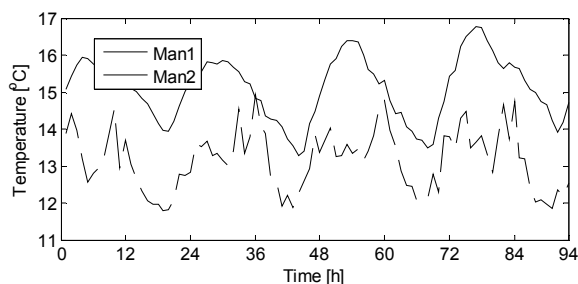
Fig. 1 Effluent temperature for Manhole 1 and Manhole 2 for a period of 4 days in the beginning of April shown in hours

The effluent temperatures for both manholes were found to follow very similar daily trend, however each of them has individual hourly pattern. Fig. 1 represents the data of effluent temperature recorded at a manhole 1 and manhole 2 in 5 days period in the beginning of April, where zero is set at 10am.

The data on Fig. 1 and for all other graphs was resampled to represent an average value for each given hour. Overall, in Feb-Apr the temperatures measurements minimum, maximum and mean for Man1 and Man2 were, 10.8°C, 17.1°C, 13.2°C and 11.6°C, 17.6°C, 15.1°C, respectively. In general the temperatures in Man2 are found to be higher and this is thought to be influenced by a closer location to the rising main, pumping station and generally the industrial sector which have larger use of hot water.

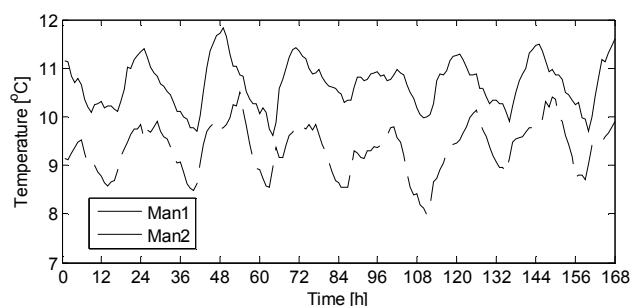
Fig. 2 Ambient temperature for Manhole 1 and Manhole 2 for a period of 1 week in the beginning of March shown in hours

The ambient temperatures for both manholes were found to follow overall an identical pattern. The general pattern of this behavior for both manholes is illustrated in Fig. 2, with zero set at midnight. From Fig. 2 it can be noted that the temperature in Man 1 is generally slightly lower for that compared with Man 2, with mean temperature values of 9.3°C and 10.6°C, respectively. Overall, in Feb-Apr the temperatures measurements minimum, maximum and mean for Man1 and Man2 were, 7.6°C, 12.9°C, 10°C and 8.7°C, 13.8°C, 11.2°C, respectively. The temperatures increased over the day with peak times at 11pm-4am after which they declined. This coincided with the discharge of overflow in the pumping station which generally takes place at midnight or when the chamber is full. However each manhole had manhole-specific minor pattern which is thought to be governed by house hold and industry activity in the area.

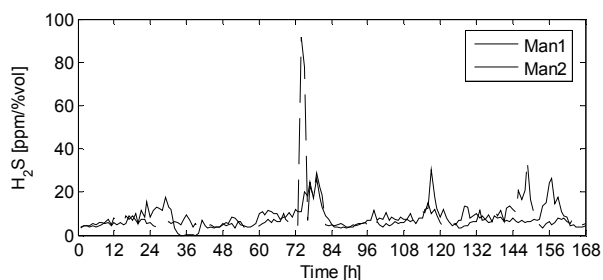
Fig. 3 Hydrogen sulphide concentration for Manhole 1 and Manhole 2 for a period of 1 week in the beginning of March shown in hours

The concentration of hydrogen sulphide for both of the manholes was measured with the sensor being placed in the middle of the manhole at 600mm above the effluent. The measurements of H₂S are presented on Fig. 3, where the data is shown for the same time period as in Fig. 2. From the figure it can be noted that the pattern of H₂S concentration is similar for both manholes even though they were located far apart and governed by different rising mains and pumping station conditions. Although, it should be noted that the operational time for all pumping stations in experimental area is the same. Graph identified large peak of H₂S at Manhole 1 at 91ppm/ % vol, where manhole 2 identifies only 29ppm/%vol. A similar peak tends to appear app. every 48h closer to midnight.

Overall, in Feb-Apr the measurements of the H_2S concentration minimum, maximum and mean for Man1 and Man2 were, 3, 134, 12 and 0, 168, 12, respectively. Even though the minimum and maximum values of both of the manholes varied, the mean of 12ppm/%vol was observed in both, whereas in most of the times a value of 3-5ppm/%vol was recorded.

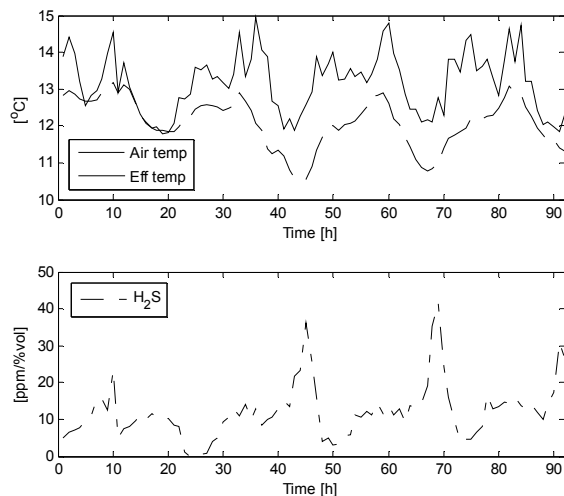
Fig. 4 Temperatures and hydrogen sulphide concentration for Manhole 1 for a period of 4 days in April shown in hours

The interaction between parameters of ambient temperature, effluent temperature and concentrations of hydrogen sulphide was investigated. Fig. 4 demonstrates the recorded data for the above for first four days in April for Manhole 1, with zero starting at 10am.

The data suggests that there is a relation between the ambient and effluent temperatures as they follow the same hourly pattern (which is governed by the effluent temperature, which in turn is related to domestic and industrial activities) and daily trend (governed by effluent temperature and general temperature of air outside the manhole). Furthermore, it can be noted that the H_2S level peaks together with the general decrease in temperature inside the manhole in late evening and early morning hours (during this time the general household and industrial activity is minimal, the flow levels are low to

moderate which allows for gas build-up). Furthermore, there is an apparent 10h shift in H_2S level increase and decrease behavior compared to temperatures. The above findings were confirmed for both of the manholes during Feb-Apr period.
