1st International Conference on Natural Hazards & Infrastructure

28-30 June, 2016, Chania, Greece

The lesson learnt after Emilia-Romagna earthquakes on precast RC structures: a case-study

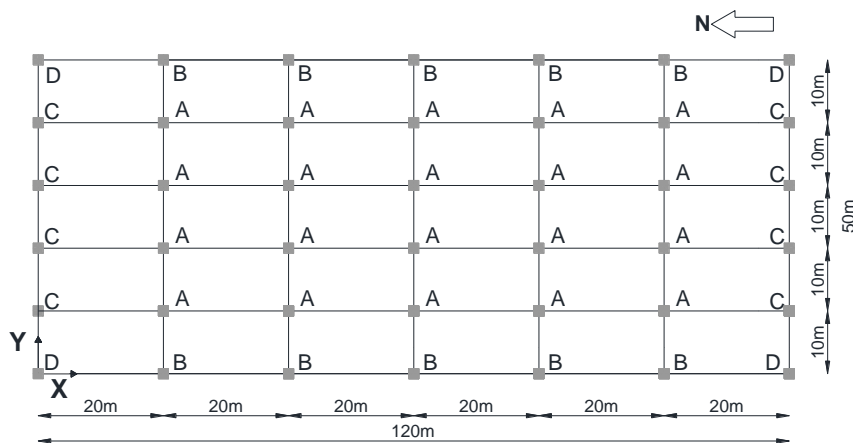
The investigated case study is a precast building located in Mirandola (Modena, Italy), designed and built in 1990. It has the typical features of column structures: it consists of an assemblage of precast RC columns, fixed at the base with isolated socket foundations. Fig.1 shows the plan view of the structure. The total height of the columns is equal to 7.3 m and the structure has 8.9m high vertical panels along the perimeter. The total seismic weight of the structure is equal to about 3.0 kN/m².

Figure 1. Plan view of the case study

Four different typologies of columns are identified in the structure by taking into account the cross-section dimensions, the longitudinal reinforcement and the applied axial force (see the labels in Figure 1). According

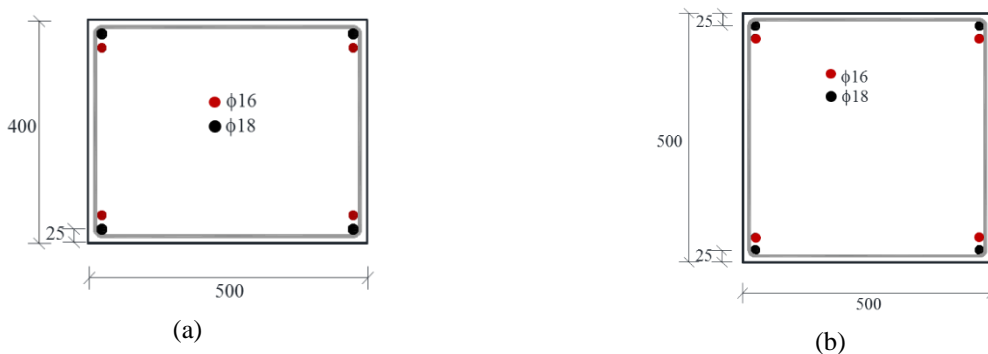
1. rectangular shaped columns (40cmx50cm), reinforced with four 16mm diameter bars and four 18mm diameter bars ($\rho=0.91\%$) in Figure 2(a);
2. square-shaped columns (50cmx50cm), reinforced with four 16mm diameter bars and four 18mm diameter bars ($\rho=0.73\%$) in Figure 2(b).

Figure 2. Cross-sections and reinforcement details of columns: (a) A and C columns; (b) B and D columns

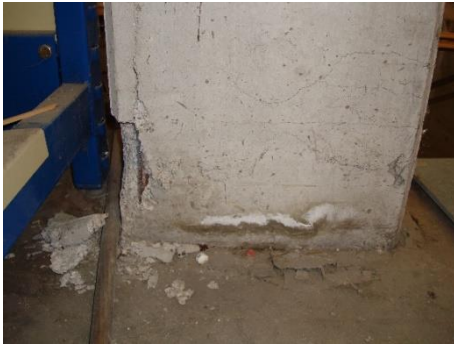
- Precast columns experienced significant rotations at the base: large cracking and spalling of the concrete demonstrated the attainment of the yielding strength of the elements (Figure 3). The columns damage caused an evident rotation of the structure along the X direction (Figure 4 4).
- The principal beams experienced small relative displacements with respect to the supporting columns (Figure 5(a)). The amplitude of the experienced displacements did not exceed the contact surface of the beams (23cm): no loss of support phenomena of principal beam occurred in the structure after the two seismic events.
- The roof elements experienced larger relative displacements with respect to the supporting principal beams and some elements collapsed because of the loss of the support phenomenon (Figure 5(b)).

Figure 3. Damage at the column base after the event on May 29th

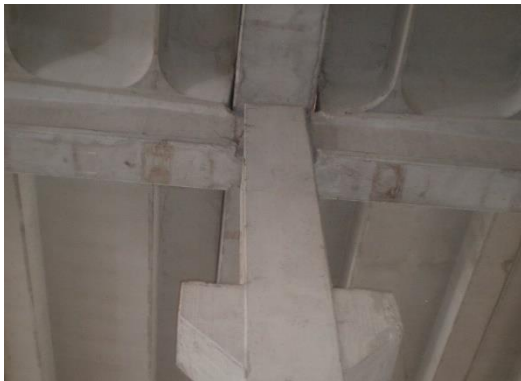
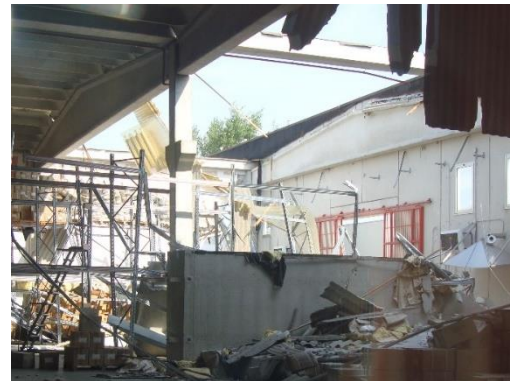
Figure 5. Damage of the connection systems after the event on May 29th: (a) relative displacement between beam and column and (b) loss of support of the roof elements

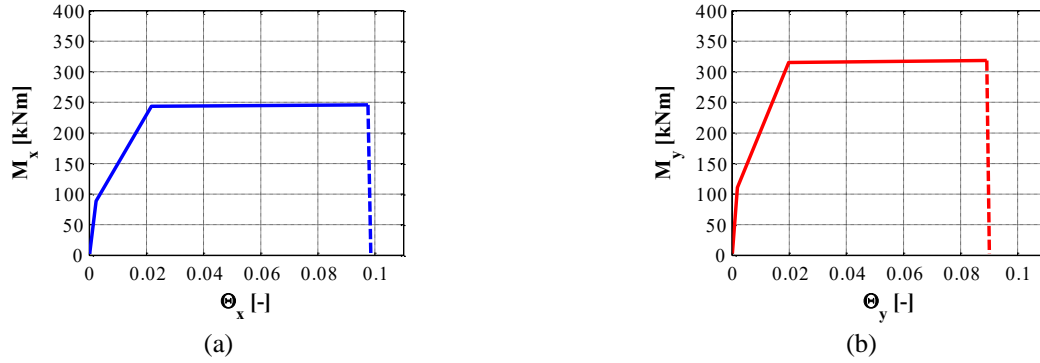
The dissipative behavior of the structure is concentrated at the base of the precast columns, whereas all the horizontal structural elements (beams, girders and roof elements) are introduced in the model as elastic elements. A lumped plasticity approach is assumed in order to simulate the inelastic response of the columns. The moment-rotation envelope of the columns hinges consists of three characteristic points: the cracking, the yielding and the ultimate point. The cracking point (moment and rotation) is defined based on the gross section properties. A fiber analysis of the cross-section provides the yielding moment value, whereas the ultimate moment is defined by considering a very low hardening (1%) value, assumed only for numerical purposes. The yielding and ultimate rotations are evaluated according to Fardis and Biskinis (2003). The hysteretic rule follows the indications given in Ibarra et al. (2005). Fig.6-Fig.8 show the moment-rotation curves for the columns in the case-study around the two horizontal directions.

Figure 6. Moment-rotation envelopes of the column A around (a) the X direction and (b) the Y direction

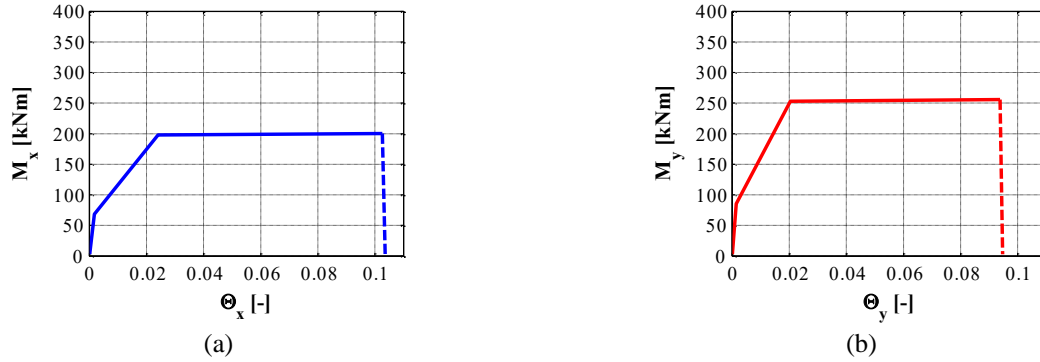
Figure 7. Moment-rotation envelopes of the column C around (a) the X direction and (b) the Y direction

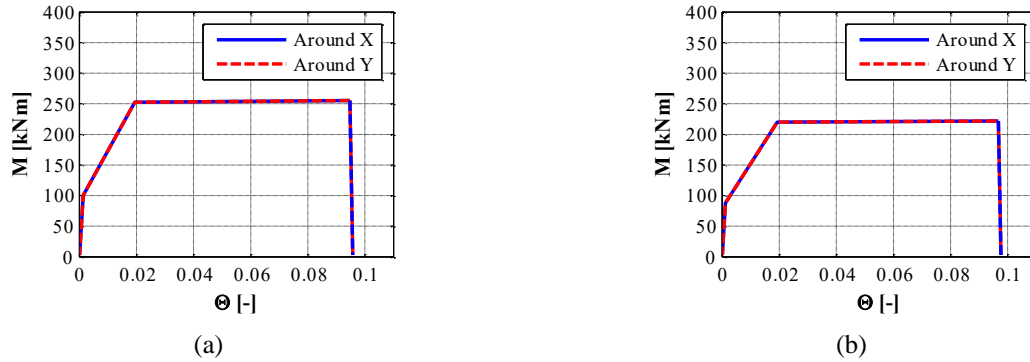
Figure 8. Moment-rotation envelopes of (a) the column B and of (b) the column D

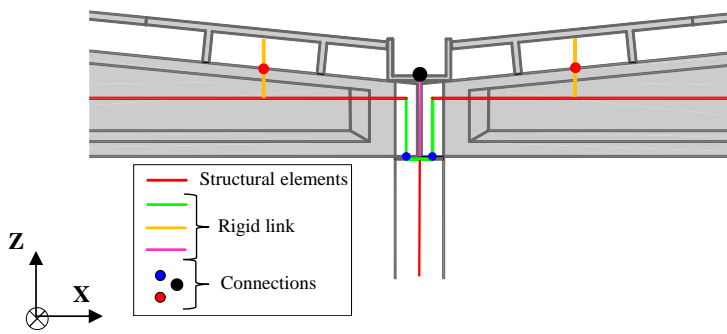
Fig.9 and Fig.10 show the layout of the elements and the considered eccentricities for all the connection systems. The connections are defined by “equal DOF” constraints between the two linked elements. With regards to the beam-to-column connection (blue circles in Figure 9), the translational degree of freedom along the X direction is not constrained: in this direction a model of the friction connection is implemented. Similarly, the translational degree of freedom along the Y direction is not fixed for the roof-to-beam connections (red circles in Figure 9 and in Figure 10). Moreover, in both these two connections, the translational degree of freedom along the Z direction is not constrained, in order to evaluate the influence of the vertical components of the earthquakes. The frictional connections between the structural elements are introduced in the nonlinear model by means of the “Flat slider bearing” element of the OpenSees library. A Coulomb model is assumed for the frictional behavior and the initial elastic stiffness is defined as the shear stiffness of the neoprene pad ($G=2.7\text{MPa}$). In the vertical direction (Z direction), the neoprene compressive stiffness is assigned, while a free displacement is allowed in the opposite direction, in order to capture the element uplift. The compressive stiffness is evaluated by assuming Young’s modulus equal to 6MPa. The friction coefficient (μ) are evaluated according to Magliulo et al. (2011). The beam-to-column connections have a friction coefficient equal to 0.12 and 0.14 for the largest and the lowest axial force, respectively. The roof-to-beam connections have a friction coefficient equal to 0.12 in the case of the big roof elements and 0.13 for the small ones.

Concerning the connection between the secondary beams (girders) and the columns (black circle in Figure 9), a hinge is assumed, according to the features of the connection system. Therefore, the girder-to-column connections are able to avoid the relative displacements between the two connected elements in the Y direction.

Figure 9. Structural elements layout and connections position in the X direction

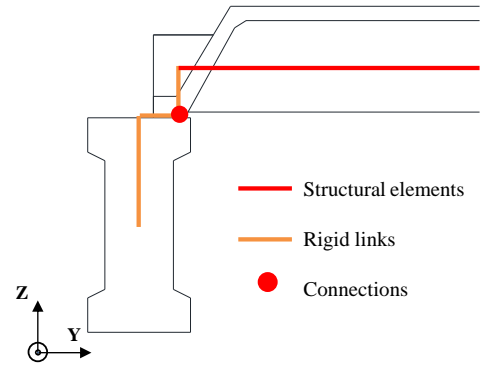
Figure 10. Structural elements layout and connections position in the Y direction

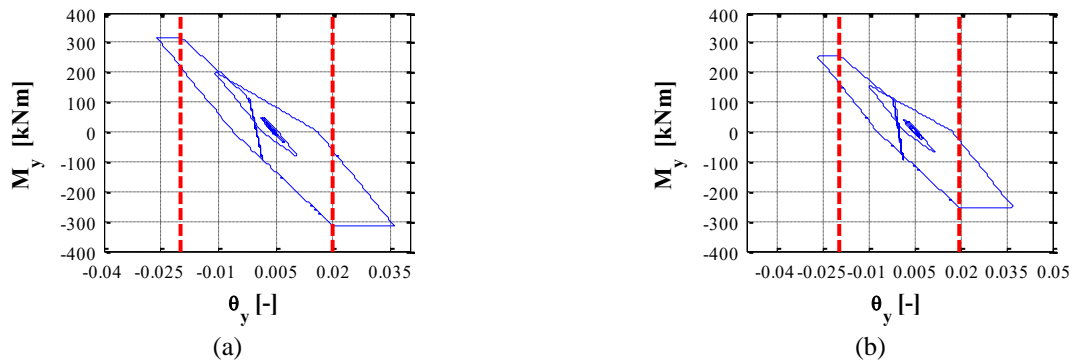
Fig.11 shows the moment-rotation curves of some plastic hinges at the columns base, obtained under the three components of the event on May 29th. The results confirm the field observation that inelastic rotations occurred in the columns along the X direction. However, the maximum rotations at the columns base are smaller than their ultimate values; this result also agrees with the observed structural response, which did not show a global collapse due to large column rotations.

Figure 11. Moment-rotation envelopes around the Y direction: (a) column A and (b) column B. The red dashed lines shows the yielding rotations of the adopted plastic hinges

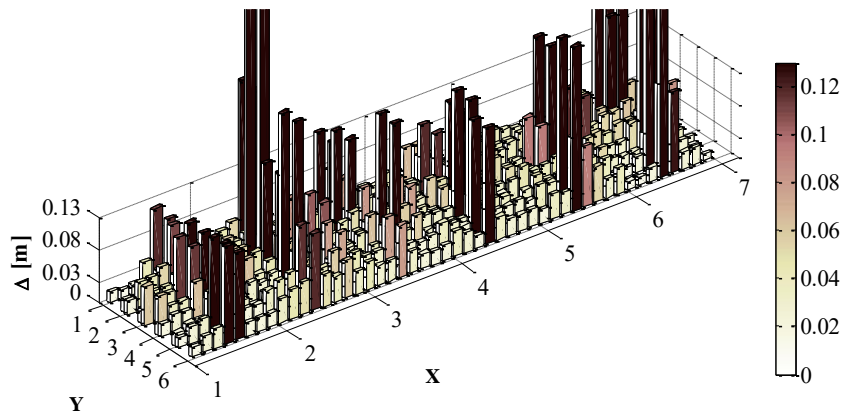
Fig.12 shows the roof-to-beam relative displacements along the Y global direction (i.e. the longitudinal direction of the roof elements) under the three components of the second earthquake (May 29th): each bar of the histogram corresponds to one roof connection and its height represents the relative displacement amplitude. According to these results, during the second event occurred in Emilia-Romagna, many roof elements experienced dislocations and some elements lost their support since the relative displacement is larger than the contact surface (13cm). This evidence agrees with the real response of the roof elements. The main cause of this damage is given by the strong seismic action in the vertical direction, recorded during this event. Such an excitation significantly decreased the frictional strength of the connections, as demonstrated by the many elements experiencing uplift phenomena during the nonlinear analysis. This evidence is demonstrated by the outcomes of the analyses performed by neglecting the vertical component of the earthquake. Fig.13 shows the relative displacements of the roof-to-beam connections recorded without the vertical earthquake component: the displacements of the friction connections are always smaller than 5cm.

It is worth underlining that the recorded failures of the roof elements in the analysis do not perfectly match the real loss of support cases. This limit of the study can be overcome by simulating the elements collapse during the analysis.

Figure 12. Relative displacements at the roof-to-beam frictional connections under the three components of the earthquake on May 29th

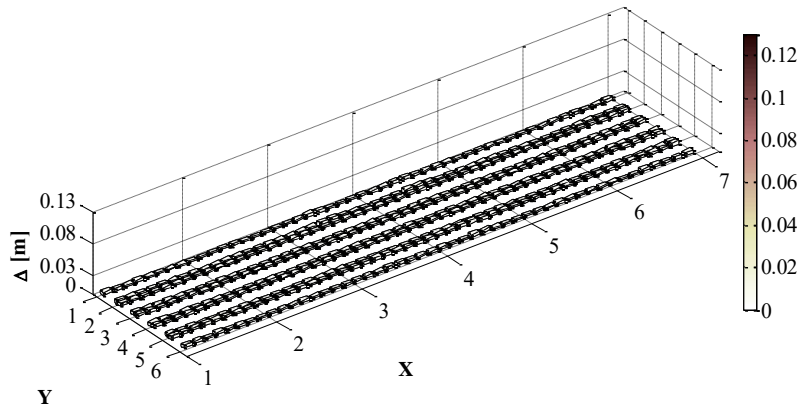
Figure 13 Relative displacements at the roof-to-beam frictional connections under the two horizontal components of the earthquake on May 29th

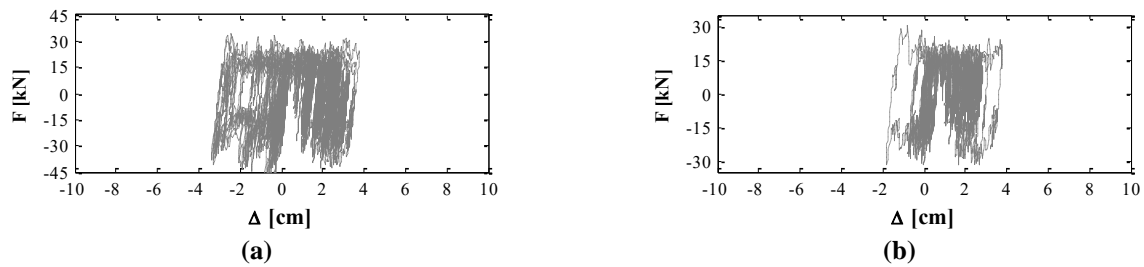
Fig.14 shows the force-displacements envelopes for some representative beam-to-column connections. In these envelopes, the deformation is the relative displacement between the beam and the column and the force is the shear force in the connection in the X direction (i.e. the longitudinal direction of the principal beams). These results are obtained by the dynamic analysis with the records of the second event (May 29th). The results agree with the experienced damage: the beam experienced some relative displacements with respect to the column; however, these displacements never achieved the width of the supporting base (23cm). The numerical results justify the absence of unseating phenomena of the principal beams. The occurrence of two consecutive severe seismic events at the same site can cause more severe damage due to the cumulative effect. In the investigated case study, the cumulative damage is not considered. This assumption is justified by the low damage recorded during this event. If the dynamic analysis is performed with the accelerograms of the first earthquake (May 20th), small relative displacements (about 2cm) of both roof elements and principal beams are recorded; moreover, during the first event the columns do not experience any inelastic excursions. These results are not reported in this paper for the sake of brevity. Further details are reported in Ercolino et al. (2016).

Figure 14. Force-deformation envelopes of the beam-to-column frictional connections under the records of the earthquake on May 29th: (a) columns A and (b) columns B
