Lateral Response of Cold-Formed Steel Framed Steel Sheathed In-line Wall Systems Detailed for Mid-Rise Buildings

Abstract

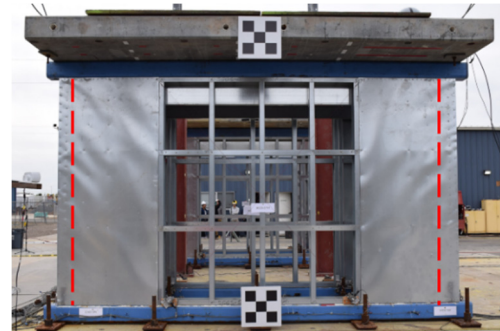
(b) SGG-2B ("Type II" shear wall detailing)

Figure 4: Front view of the specimens
Note: Dashed lines show location of tension tie-rods

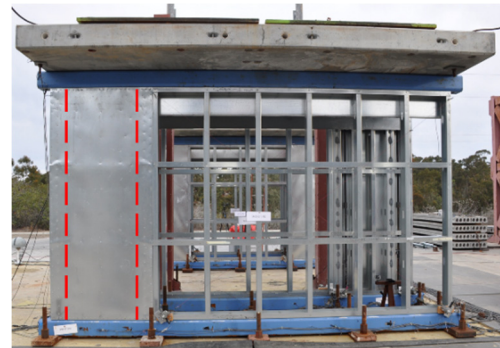
(c) SGG-1 (single shear wall unsymmetrical configuration)

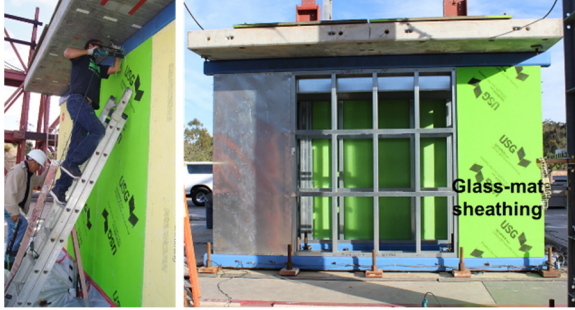
(a) Glass-mat sheathing installation

Firecode Type X. Figure 5 shows the different steps involved in the EIFS application. It should be noted that specimen SGG-2B was not designed and detailed with any members collecting and carrying the shear to the shear wall segments at the ends, this specimen is not a code compliant Type II shear wall as defined in AISI S400.

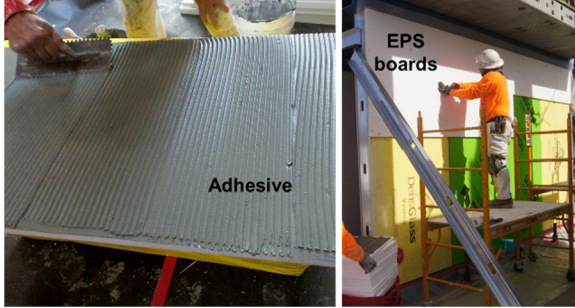
(b) 1" thick Expanded Polystyrene (EPS) foam boards attached using cement adhesive

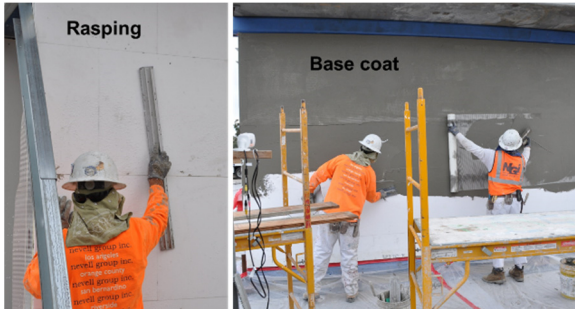
(c) Rasping of foam boards before base coat application with embedded reinforcing mesh

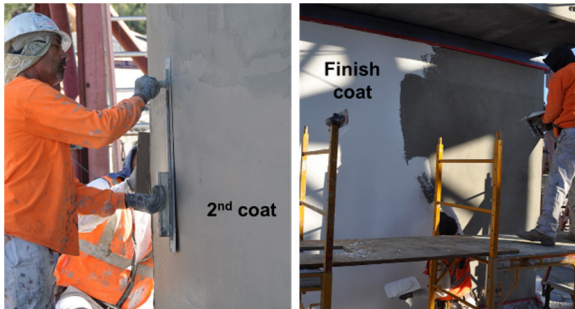
(d) Second coat and finish coat application
Figure 5: Steps involved in EIFS application

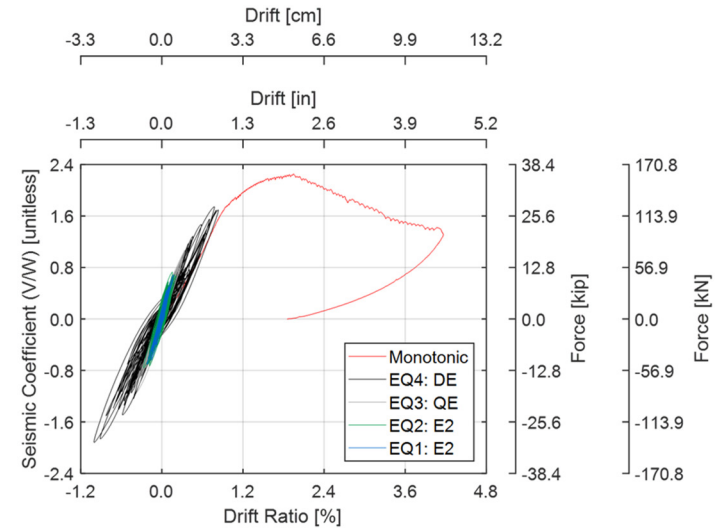
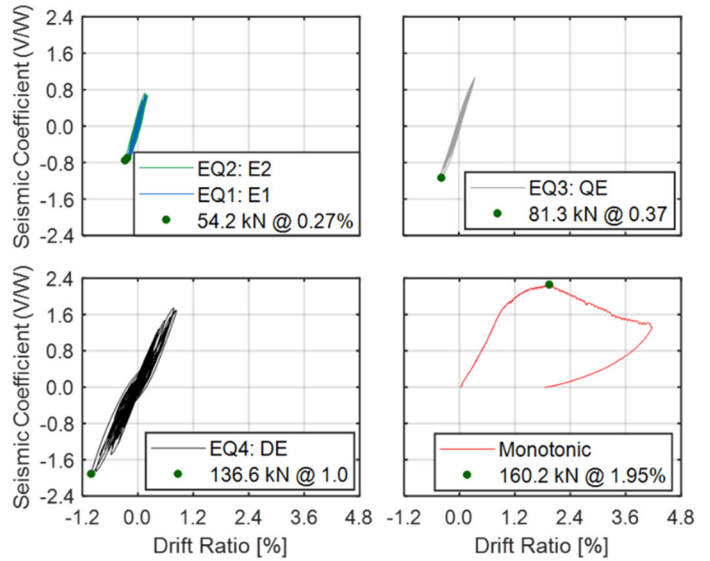
Figure 8: Force-displacement response of SGGs-1 specimen

Following the sequence of increasing amplitude earthquake motions as described above, and monotonic pull tests for select specimens, the force-displacement behavior of the specimens at different damage states could be derived. Figure 8 shows the force displacement behavior for the baseline specimen SGGs-1 during the earthquake tests and the subsequent monotonic pull test. Specimen response was essentially linear for the first three earthquake tests, with less than 0.4% achieved drift ratio and shear force below 50% strength. The specimen started showing non-linearity during the design event with 1% drift demand and 85% lateral strength. During the monotonic pull test, the specimen reached strength at 160.2 kN (36.0 kip) at a drift ratio of 1.95% and during continued pull demonstrated a post-peak degradation of 40% at 4.15% drift ratio. The elastic stiffness of the specimen, defined as the secant stiffness at 40% strength, was measured as 83.0 kN/cm (47.4 kip/in).

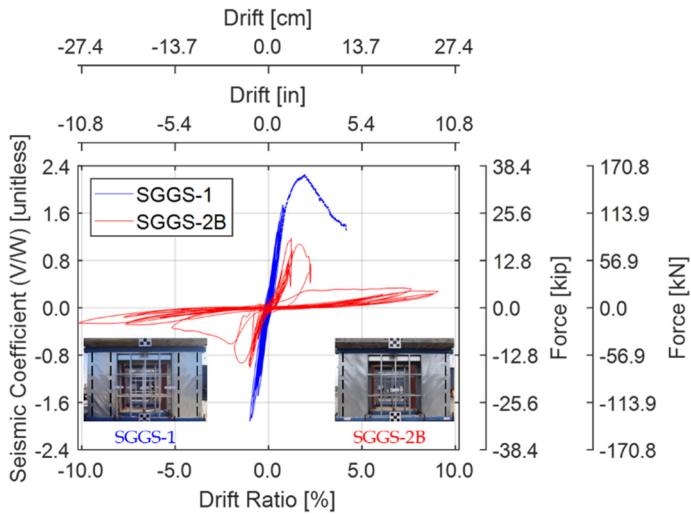
Figure 10: Force-displacement response of SGGS-2B specimen compared with SGGS-1 baseline specimen

The force-displacement response of specimen SGGs-2B ("Type II") remained essentially linear for the earthquake tests EQ1 to EQ3 with the achieved drift ratio less than 0.2% and shear force approaching 40% strength. The specimen showed non-linear behavior during EQ4 as drift demand reached 0.7% and shear demand approached strength. The specimen reached strength at 84.1 kN (18.9 kip) at a drift ratio of 1.22% during earthquake test EQ5 when it was pushed into the post-peak response as the drift demand exceeded 10%. The elastic stiffness of the specimen was measured as 70.7 kN/cm (40.4 kip/in).

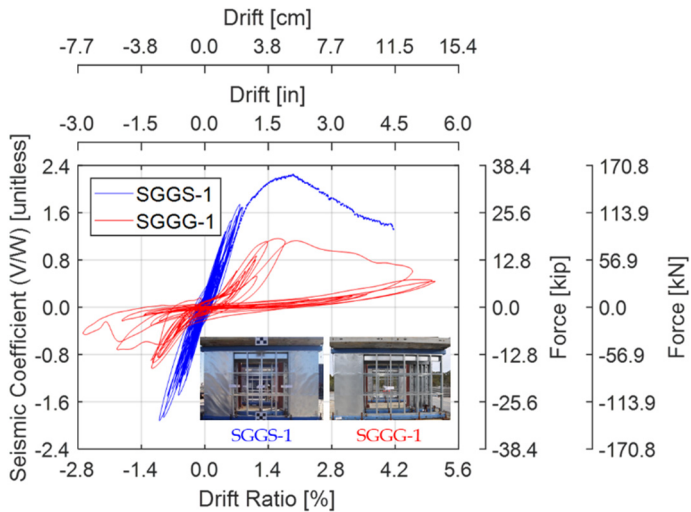
Figure 11: Force-displacement response of SGGG-1 specimen compared with SGGS-1 baseline specimen

Similarly, for specimen SGGG-1, an unsymmetrical wall configuration with a single shear wall, the force-displacement response of the specimen remained essentially linear for the earthquake tests EQ1 to EQ3 with the achieved drift ratio reaching 0.5% and the shear force approaching 55% of strength. The specimen showed non-linear behavior during EQ4 as the drift ratio demand reached 1.0% and shear demand reached 90% strength. The specimen reached strength at 82.7 kN (18.6 kip) at a drift ratio of 1.60% during earthquake test EQ5 when it was pushed into the post-peak region with drift demand exceeding 5%. The elastic stiffness of the specimen was measured as 39.1 kN/cm (22.3 kip/in).

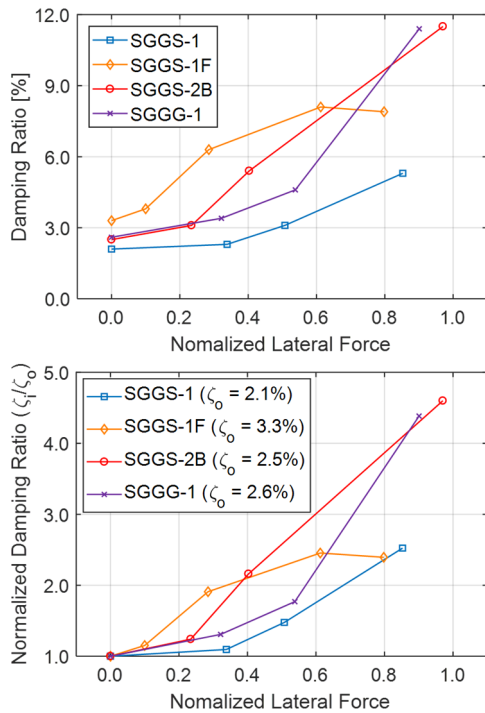
Figure 13: Evolution of damping ratio during earthquake tests

These components offered appreciable damping with each specimen offering between 2-3% damping (ζ_0) in their undamaged state. Amongst them, SGGS-1F had the highest damping ratio in its undamaged state at 3.3%. This can be attributed to the significantly greater number of fastener connections used to attach the gypsum and glass-mat panels. However, as specimens SGGS-2B and SGGG-1 incurred damage to their framing during the higher intensity earthquake tests, they demonstrated a larger

damping ratio. It should be noted that for specimen SGGS-1F, earthquake tests EQ4 and EQ5 had to be repeated due to top mass slip. Because the specimen had already incurred damage during those tests, the dynamic characteristics obtained after their repetitions show a sudden jump due to the accrued damage.

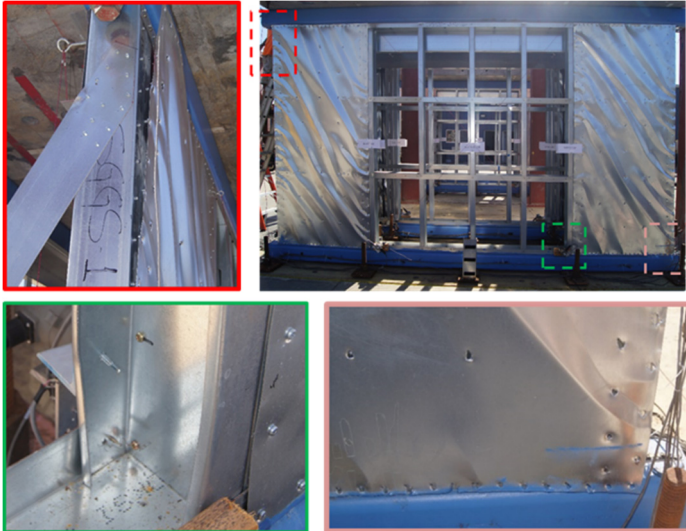
Figure 14: Photographs of SGGS-1 at end of monotonic test

Non-linear behavior in specimen SGGS-1 initiated in earthquake test EQ4 along the shear wall tension field with buckling of the steel sheet widely distributed and readily observable lines of plastic deformation, remaining prominently visible at the end of the test. Fastener tilting and bearing onto the steel sheet was visible in ~20% of screws following this test, with most clustered at the corners of the steel sheet directly along the main diagonals of the tension field. Most of the damage occurred during the monotonic pull, when extensive shear buckling of the sheet was observed as the width of the tension field increased with drift demand, widening to include most of the steel sheathing. At the end of the monotonic pull test, local buckling of the gravity stud adjacent to the shear segment compression stud pack at diagonally opposite locations of the gravity wall segment was observed. However, the compression stud packs or track framing members did not experience any visible damage. By the end of the test, most screws showed some form of damage. Sheet pull over or edge tearing had spread from the corner to quarter height of the chord studs and a third length of top and bottom tracks and a few field screws in the middle of the sheet. Away from the main diagonal, fasteners along the off diagonals showed some tearing of sheet as screws tilted to large angles. Fasteners furthest away from the spread of tension field action showed bearing/tilting damage that they had suffered during earthquake tests primarily. Photographs documenting these physical damage observations are shown in Figure 14.

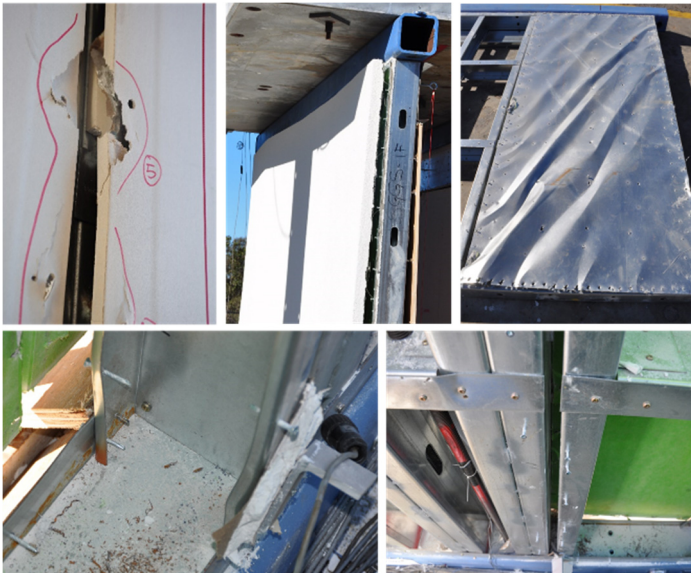
Figure 15: Photographs of SGGS-1F at end of monotonic test

Specimen SGGS-1F also showed non-linearity during earthquake test EQ4 and EQ5, see Figure 15. Cracks in the EIFS layer could be seen along the height at the two ends of the walls with the embedded reinforcing mesh stretching across them. On the interior face, the gypsum panels experienced corner and boundary crushing against each other and ledger framing. One gypsum board became loose due to screw pull-through. Most of the damage occurred during the monotonic pull, as the EIFS layer along with the glass-mat sheathing panel substrate separated from the steel sheet underneath beginning from the two wall ends and propagating towards the gravity bay in the middle. The glass-mat sheathing had pulled over the fasteners connecting it to the CFS framing. EIFS layer could be seen to have warped out of plane. The gypsum panels on the inside suffered local crushing around the fasteners before becoming loose and detaching completely, pulling over the fasteners connecting it to the framing. A few framing screws for compression stud packs failed in head shear. As a result, the stud packs slipped along the bottom track. Bottom and top tracks were also damaged locally in the shear wall segments near the tension rod locations. Local buckling of the gravity stud adjacent to the shear segment compression stud pack at diagonally opposite locations of the gravity wall segment was observed, similar to SGGS-1 specimen. After

removing the EIFS layer, plastic deformation of the exposed steel sheet due to tension field action could be seen spread over the majority of sheet face. Sheet tearing and pull-over the fastener heads could be seen at the corners of the sheets and along the bottom edge.

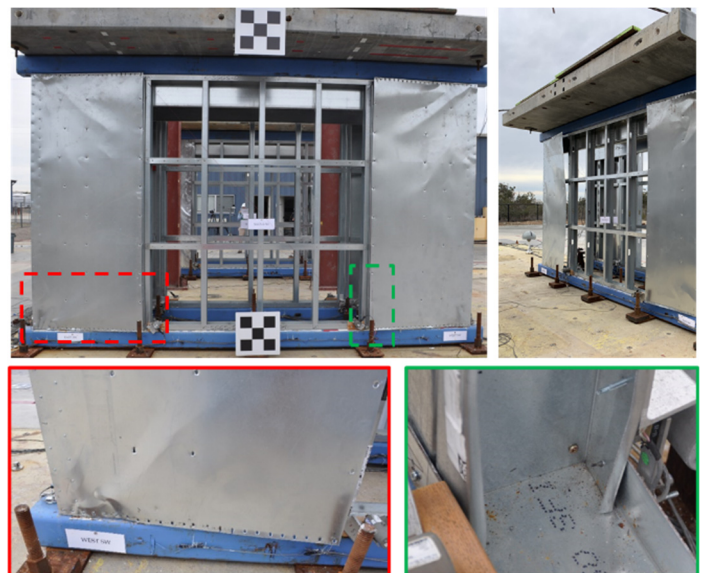
Figure 16: SGGS-2B specimen damage photographs after earthquake test EQ5

Specimen SGGS-2B showed non-linear behavior during EQ4 as the drift ratio demand reached 0.7%. At this point, all fasteners on the interior edge of the steel sheet were damaged extensively. Approximately 50% of the fasteners observed tearing along the steel sheet edge due to head tilt, while another 20% showed sheet pull over the screw head. Even at this intensity, plastic damage to the steel sheet was minimal. However, during earthquake test EQ5, the specimen was pushed into the post-peak region. Steel sheet pulled over the screw heads along the entire interior edge of

sheet losing its entire ability to transfer any lateral load. Still, plastic damage to steel sheet remained minimal. Framing suffered extensive damage due to high drift demands. Chord stud pack and field stud framing connections suffered head shear failure. Local buckling of the gravity stud adjacent to the shear segment was observed. Bottom and top tracks also were locally damaged. Photographs documenting these physical damage observations are shown in Figure 16. However, it should be noted that even after being pushed to 10% drift, the system did not collapse and the residual drift after this earthquake test was insignificant, demonstrating the efficacy of the tension tie-rod system to prevent collapse.

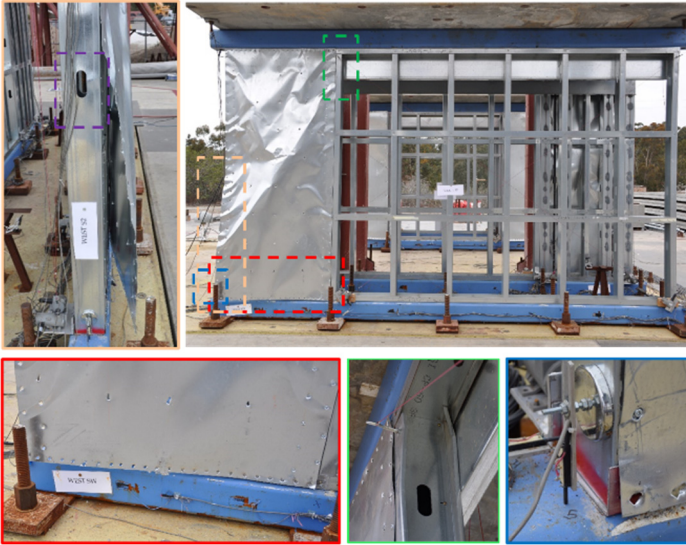
Figure 17: SGGG-1 specimen damage photographs after earthquake test EQ5

Specimen SGGG-1 showed non-linear behavior during EQ4 as the drift ratio demand reached 1.0%. However, all damage was confined to the widening of the tension field and distributed buckling of the steel sheet. Fastener tilting and bearing onto the steel sheet was visible in ~20% of screws, with most being edge screws clustered at corners of sheet along the main diagonals of the tension field. However, during earthquake test EQ5, the specimen was pushed into the post-peak region as the drift demand exceeded 5%. Extensive shear buckling of the sheet was observed during the earthquake test as width of tension field grew to cover the entire steel sheet. At the end of the test, steel sheet had pulled over ~40% of the fastener heads. Others also showed tearing or bearing due to tilting at large angle. Framing suffered extensive damage due to high drift demands. Chord stud pack and field studs framing connections failed in head shear. Due to framing connection failure, chord stud packs slipped along bottom track. Gravity stud adjacent to the shear segment showed local buckling. Photographs documenting these physical damage observations are shown in Figure 17.
