A Multidisciplinary Approach to
the Study of Slope Instability in Derbyshire,
with particular reference to Matlock

Thesis submitted to the University of Nottingham
for the degree of Doctor of Philosophy, May 1989

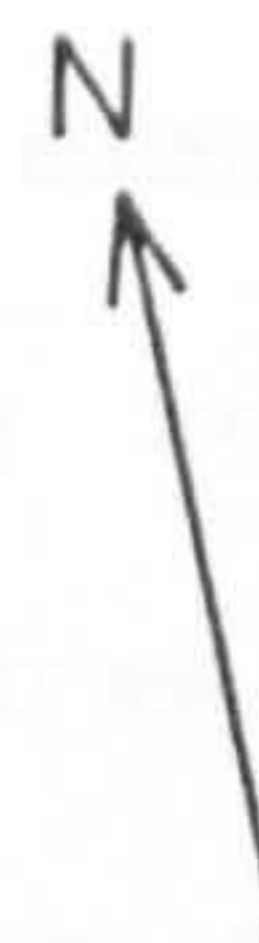
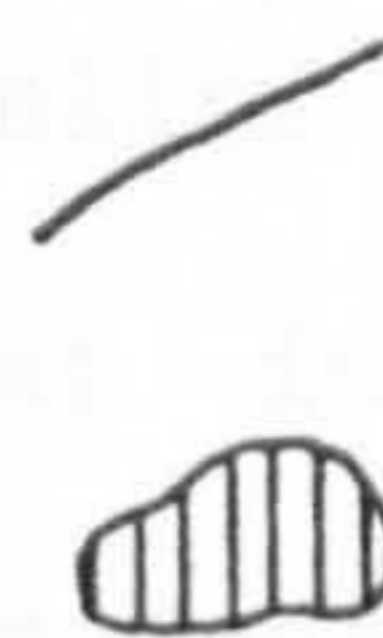
Figure 2.6 Landslides and Geology of the Edale Region

- R Roaches Grit
- K Kinderscout Grit
- S Shale Grit
- Mam Tor Beds
- Edale Shale

- Limestone
- Basalt
- Dolerite

- Fault
- Landslide

As weathering can produce a decrease in strength it follows that there will be a drop in the Factor of Safety of the slope. At Mam Tor in Derbyshire instability is periodic, with relatively frequent small movements occurring especially during wet periods, separated by major failure events every several years. It can be assumed that the Factor of Safety is permanently close to unity so that an increase in ground water level may be sufficient to trigger minor movements. Vear (1981) and Steward (1984) suggest that pyrite oxidation at depth within the slide is responsible for the relatively occasional major movements by weakening the rock through the removal of material and by the consequent change in pore-water composition which affects shear strength. Johnson and Vaughan (1983) propose that this pyritic shale may also have contributed to instability at Alport Castles landslide (Figure 2.6) where it outcrops at the base of the landslide.

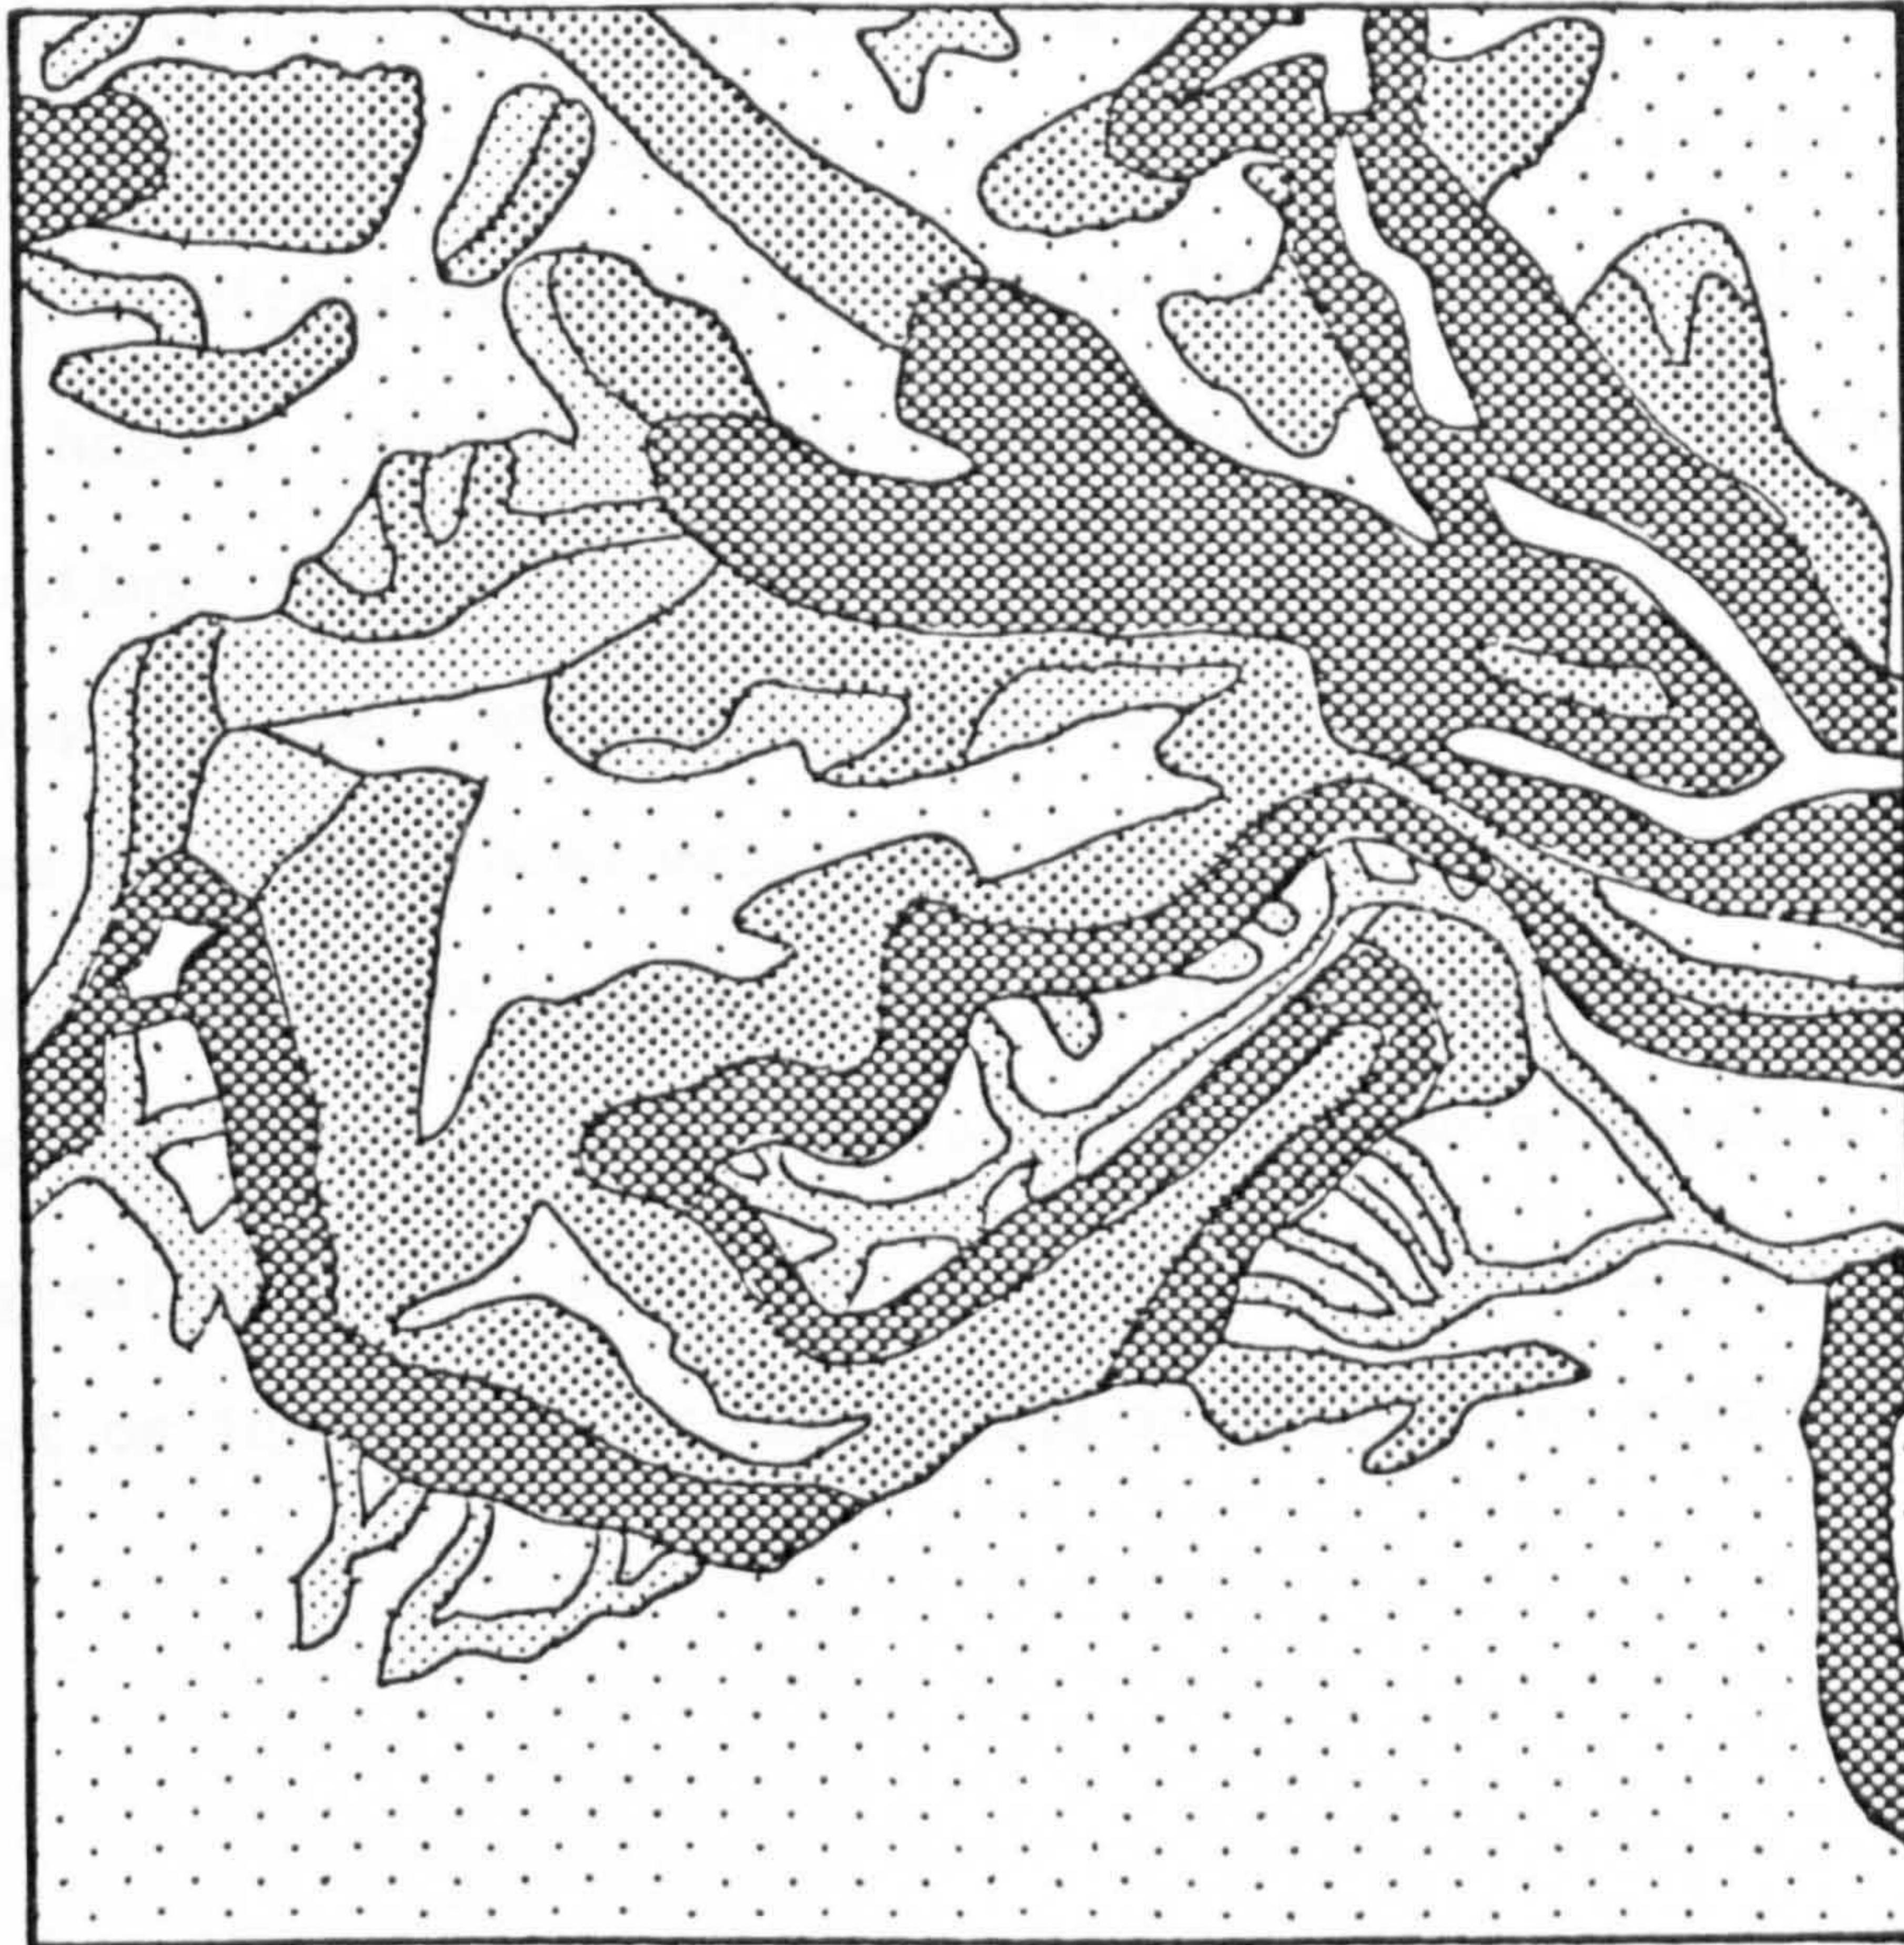
Figure 2.10 Landslide Hazard Zonation of Edale
- derived from Landsat TM imagery

(see text for explanation of hazard categories)

In Figure 2.10 the above factors have been combined to produce a preliminary landslide hazard map. The land identified as relatively flat has been classed as being the most stable. River banks in the flat areas and slopes well above the sandstone/shale contact without streams or coves are considered to be of low potential hazard. Slopes above this lithological contact but with undercutting streams and coves, together with the broad band on the contact without streams or coves have been grouped as being of moderate instability. The slopes of greatest potential hazard are those on the sandstone/shale contact with coves, streams or reservoirs. If the location of landslides is

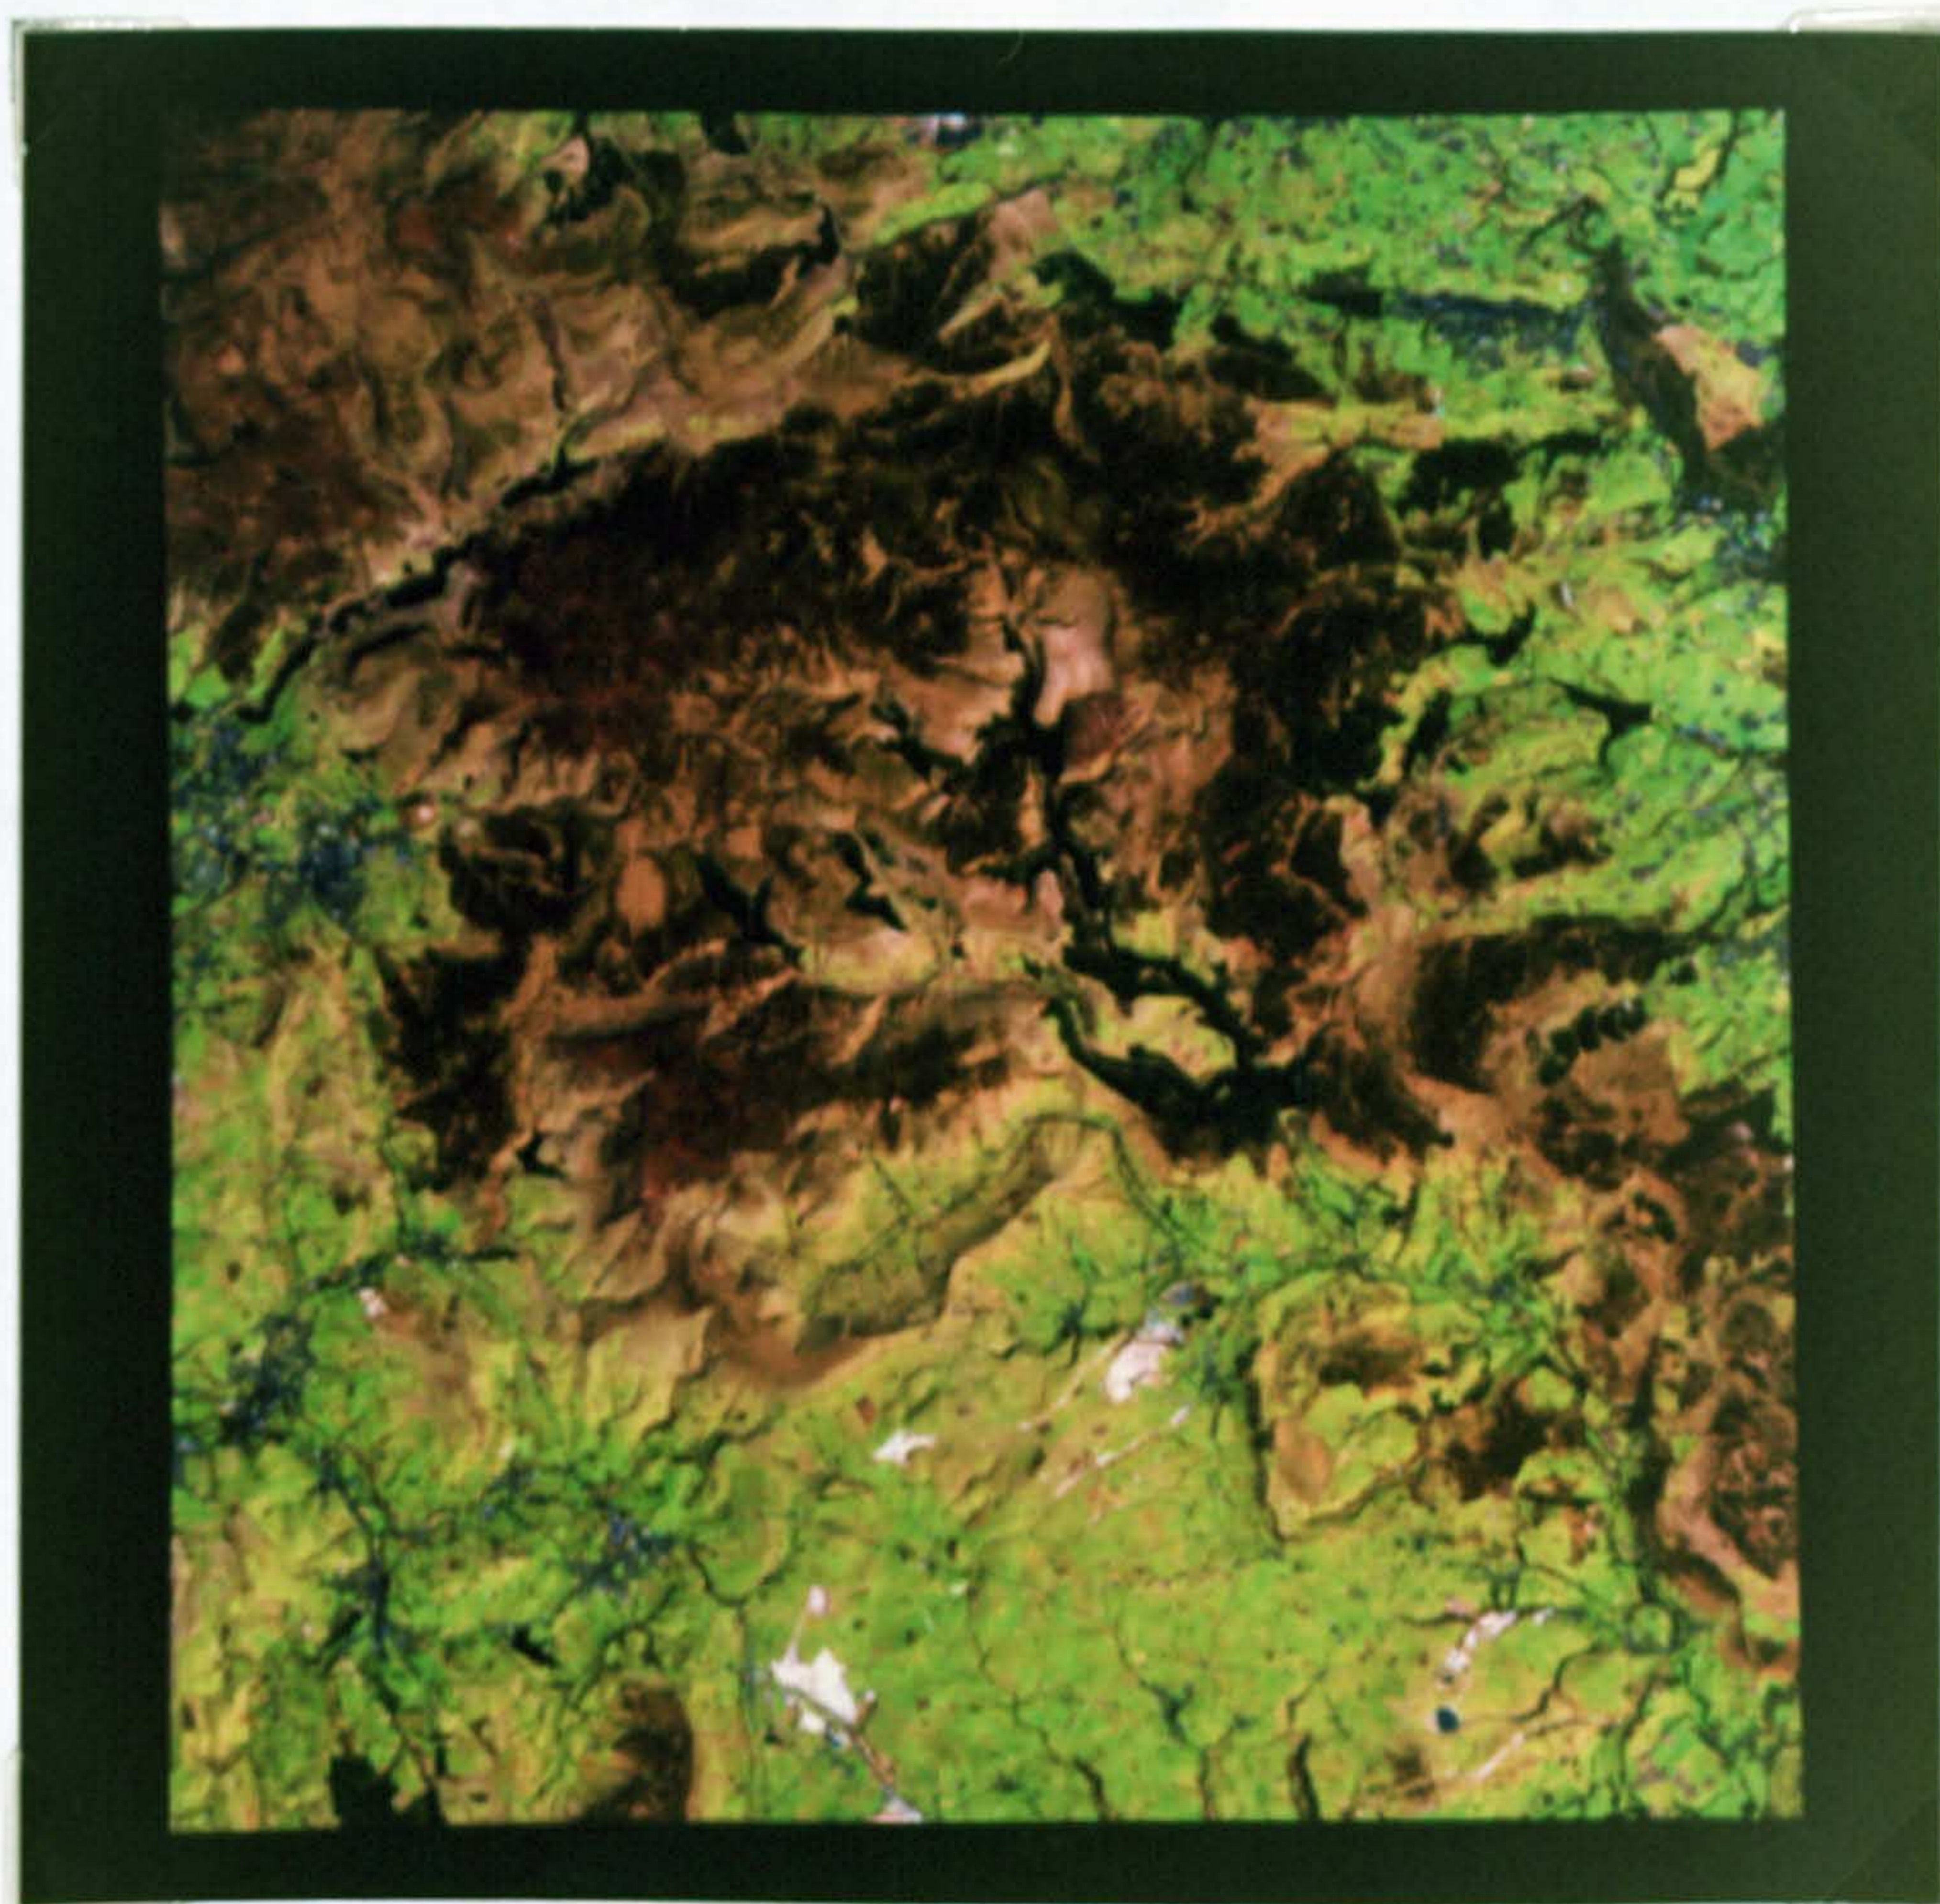
PLATE 3.1 LANDSAT TM IMAGE (BANDS 5, 4 AND 1)
OF THE DARK PEAK

False Colour Composite 5,4,1

Sampling rate: 2,2

(Plate 2.2). A more regional view was then obtained at a scale of 1:123,000 with every second line and second pixel displayed (Plate 3.1), and finally more detail for part of the scene was provided at 1:31,000 with every line and every pixel (Plate 2.4). Further image processing was found to offer no additional information about the lineaments. With reference to maps it was found that no roads or railways had been misinterpreted. The valley floors are covered by head deposits, therefore, it is debateable as to whether lineaments in the bedrock would be detected in these areas. Figure 2.7 should be used with Plates 2.1 to 2.3 to show the positions of the lineaments; the solid lines represent those lineaments which were detected by several observers and, therefore, more confidence may be placed in these as being real features. It must be remembered, however, that the geological nature of these linear features has not been verified and they do not coincide with known faults, and that they do not represent a complete data set.

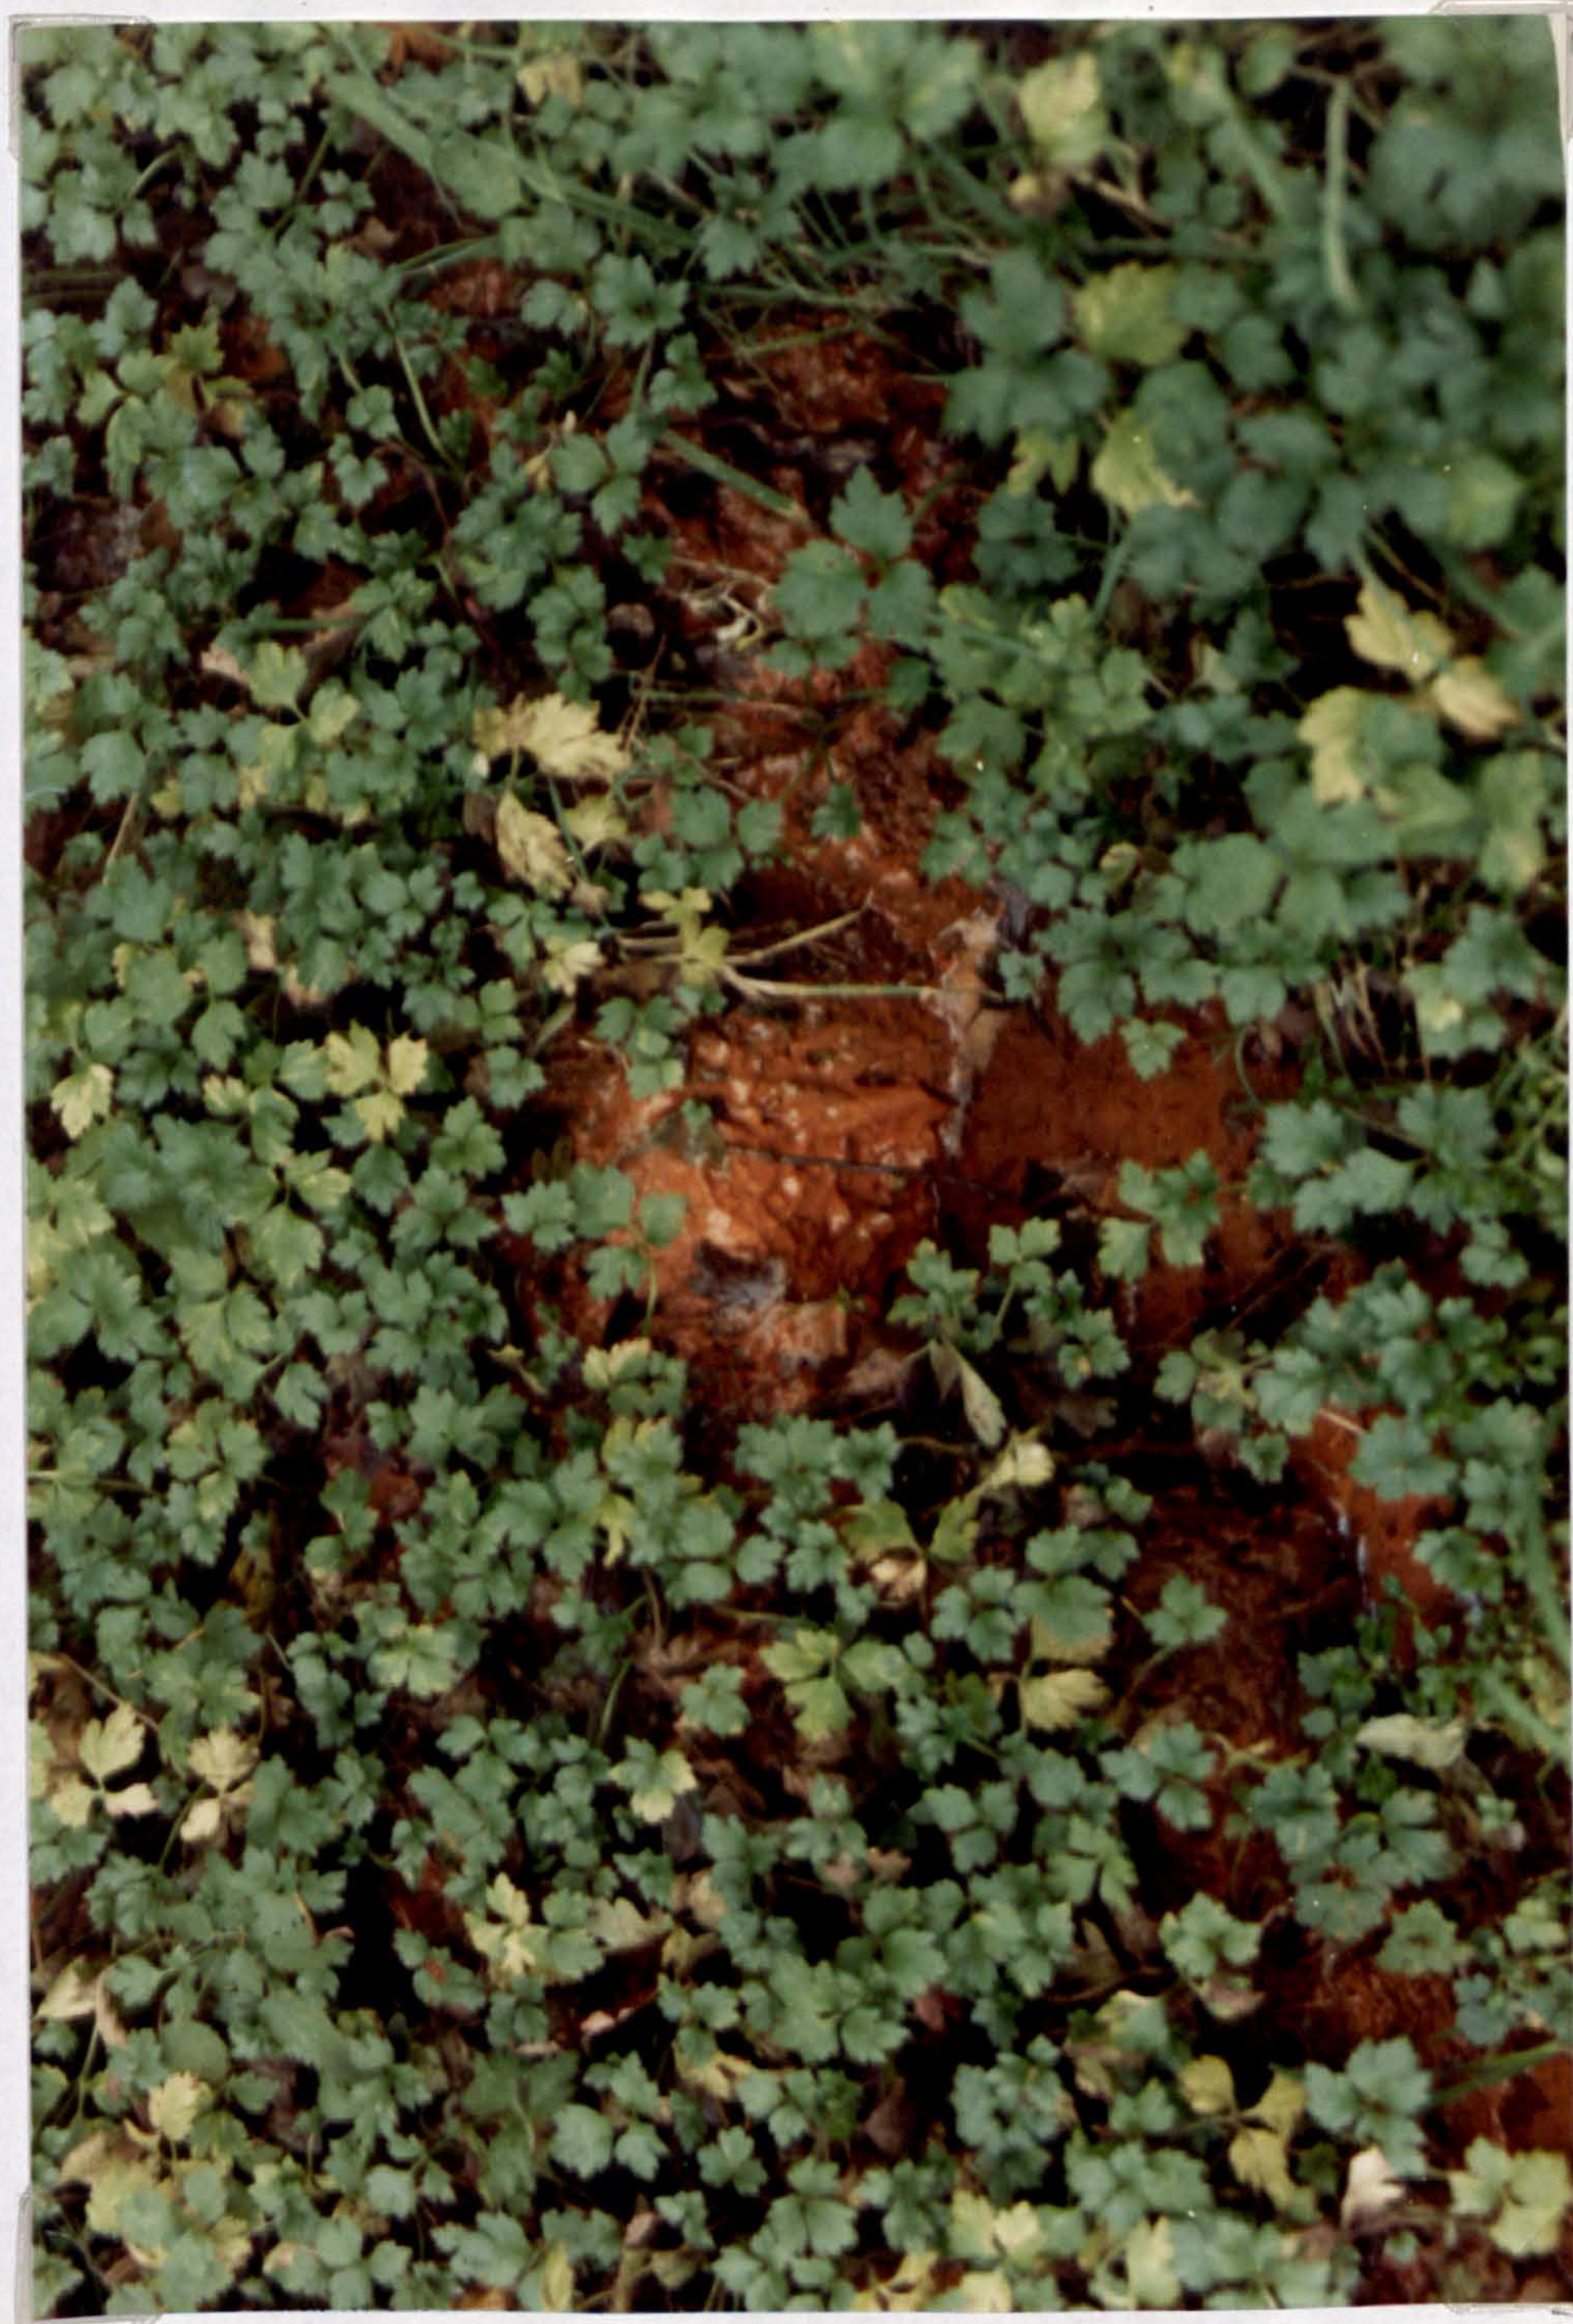
PLATE 6.1 OCHREOUS SPRING ON OKER HILL LANDSLIDE

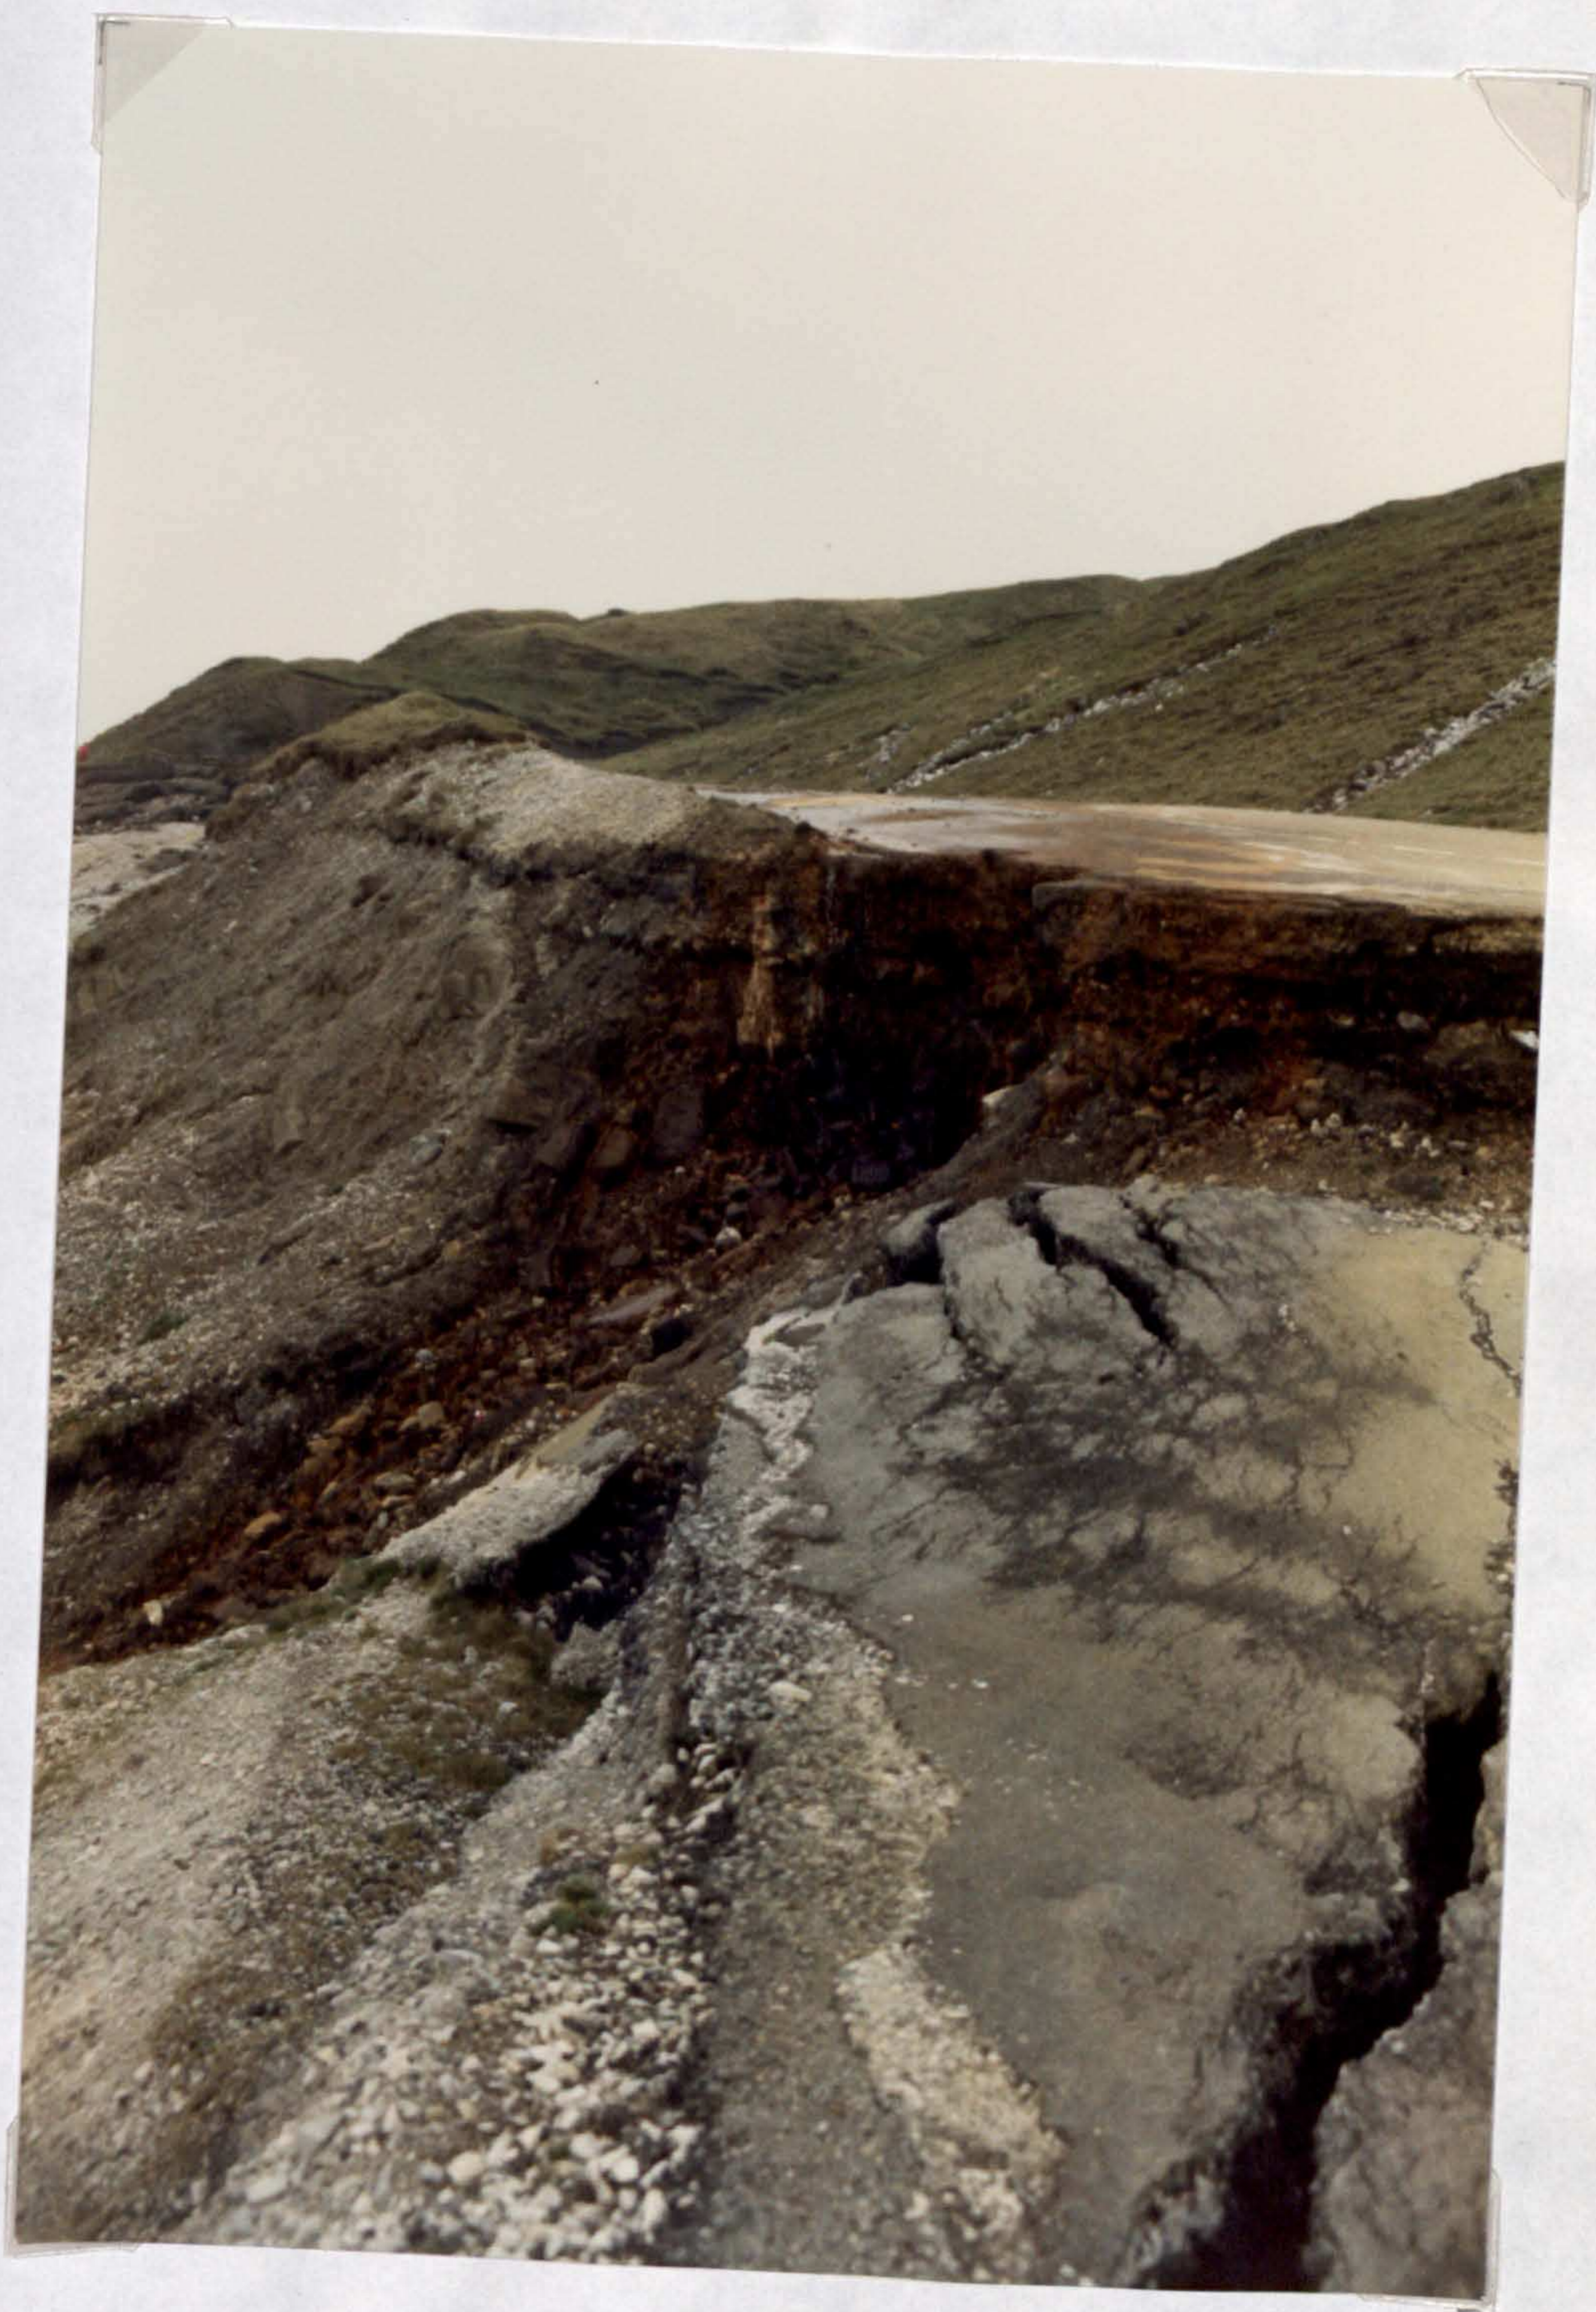
PLATE 6.2 OCHREOUS PRECIPITATE AT MAM TOR LANDSLIDE

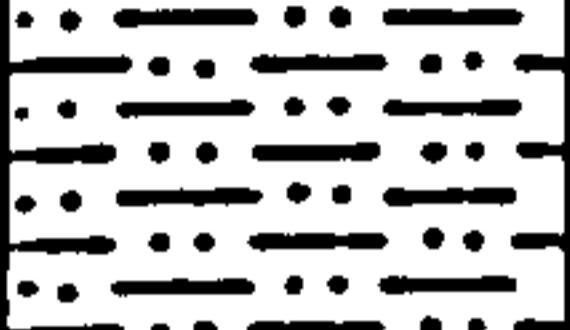
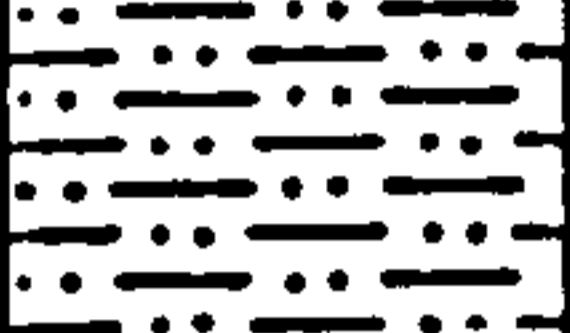
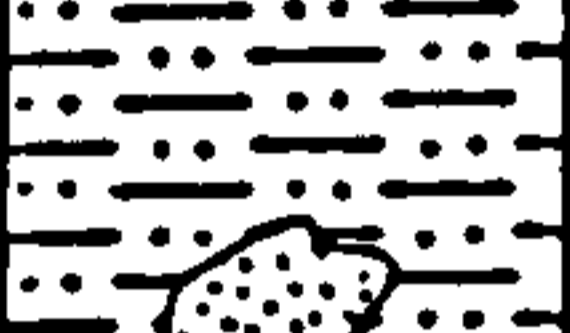
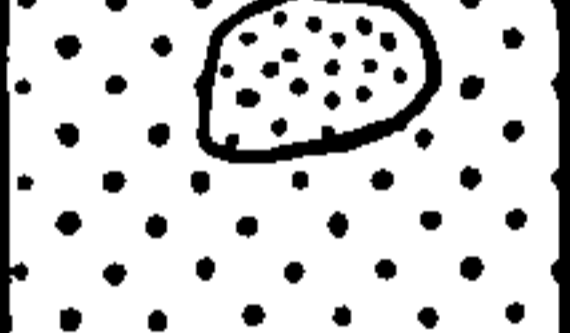
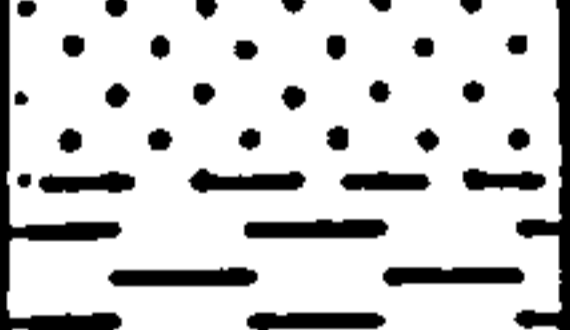
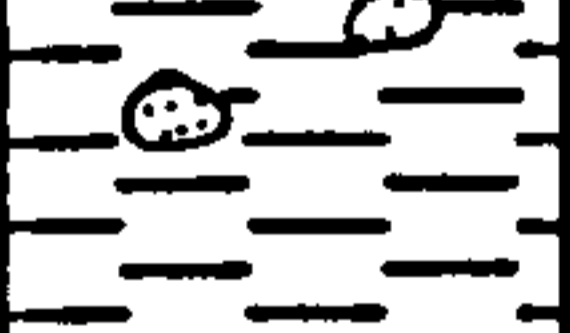
SILTY CLAY - orange/brown with numerous small sandstone clasts (~30mm length) Large sandstone fragment (~80mm length)
1.0

Gradual transition from sand to silty clay to clay.
4.0

GREY CLAY with grey fine-grained sandstone / siltstone fragments + shale lithorelicts with orange/brown iron-staining on surfaces.
4.5

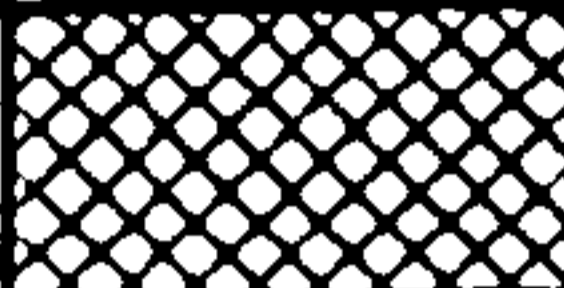
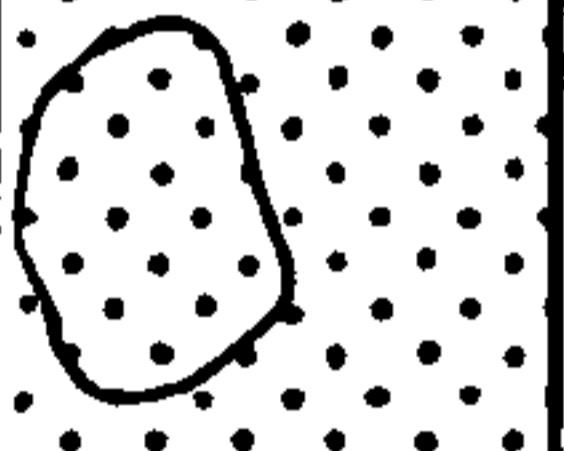
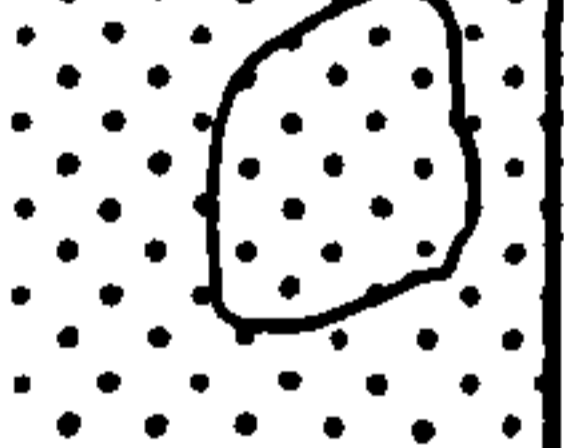
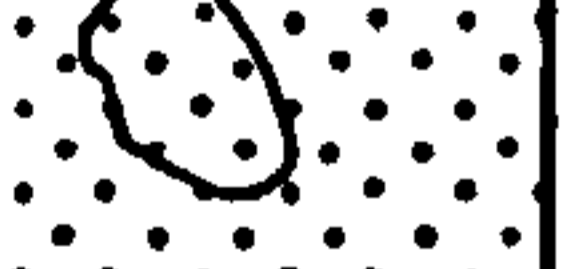
SAND + SILT with sandstone boulders orange
1.5

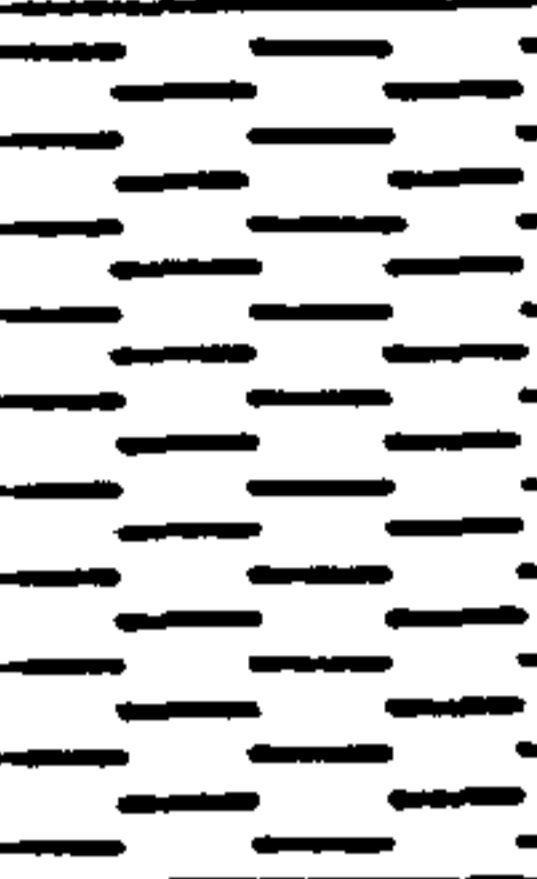
II-I	Core broke up on extraction from sampling tube Shale - v. crumbly matrix with shale fragments - Shale more intact & harder. Slight weathering during storage
