University of Nottingham
School of Mechanical, Materials, Manufacturing
Engineering and Management

*The Effect of Damage on the Energy Absorption
Potential of Composite Structures*

D.A.Bailey
B.Eng(Hons)

Thesis submitted to the University of Nottingham
for the degree of Doctor of Philosophy
June 2005

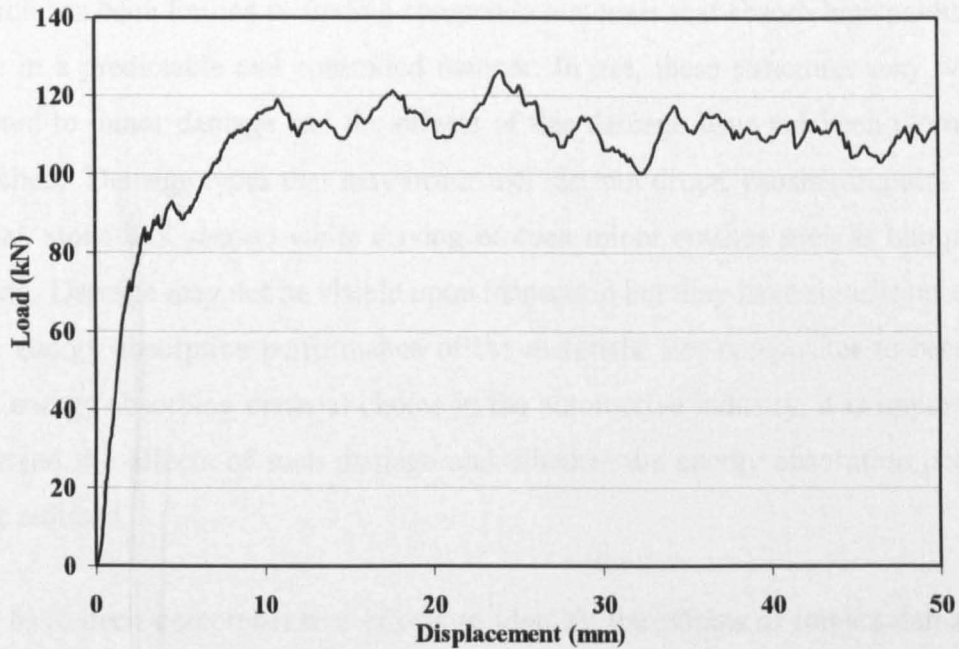
Figure 1-3 – Typical load-displacement curve of an 89.1mm, 4mm wall thickness, CoFRM glass/polyester tube failing progressively by splaying [from preliminary tests, see Section 4.3]

Failure of the sample will occur when the applied stress, σ_{nom} , reaches the ultimate compressive stress of the material, σ_{UC} . However, a trigger, in the form of a 45° bevel at one end of the tube was used. This produces a stress concentration caused by the reduction in cross-sectional area. As samples crush, load increases until a steady state load is achieved and a splaying mode of failure observed (see section 2.2.1). If the maximum stress in the sample at this steady crush load is less than σ_{UC} , then samples will continue to crush and a load-displacement curve like that in Figure 1-3 can be achieved.

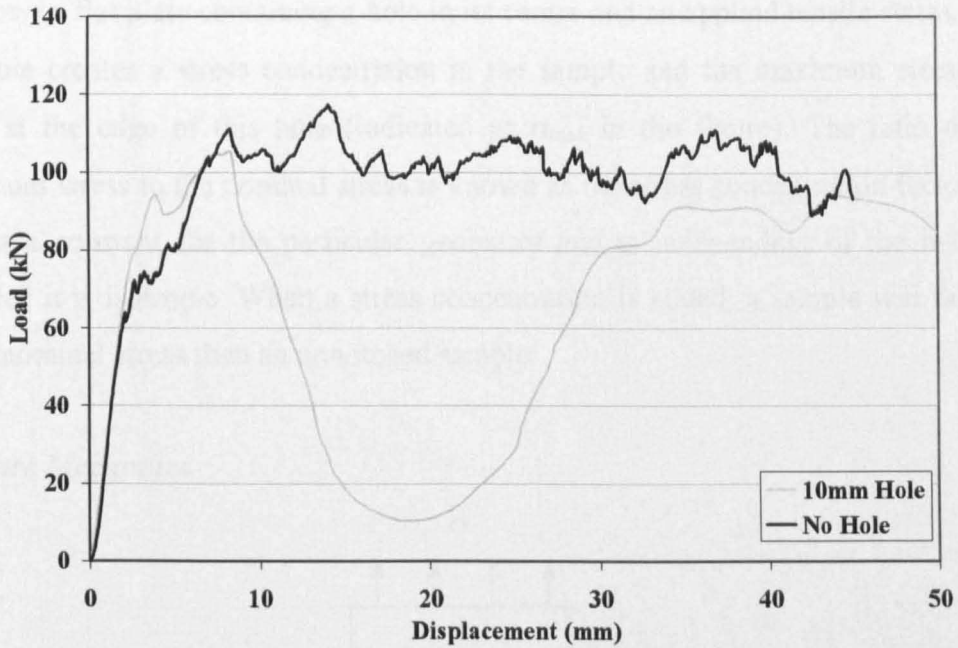
Figure 1-4 – Load-displacement curves of an undamaged 89mm diameter, 4mm wall thickness glass CoFRM/polyester tube and one containing a 10mm drilled hole
[from preliminary tests, see Section 4.3]

Preliminary tests conducted by the author at Nottingham (1999) have shown that drilling a 10mm hole through a composite tube, 89.1mm in diameter with a 4mm wall thickness, caused significant reductions to the energy absorption potential of the material. Figure 1-4 shows the load-displacement curve for an undamaged tube and one containing a 10mm drilled hole. During testing of the sample containing a hole, cracks were seen to propagate from the hole and drop in load, and thereby energy absorption, were observed.

Fast fracture, originating at the damage area will occur if this maximum stress is greater than σ_{UC} . The subsequent load displacement curve produced would be similar to that of the sample containing a 10mm hole in Figure 1-4. The load level and subsequent specific energy absorption are reduced due to the loss of a steady crush.

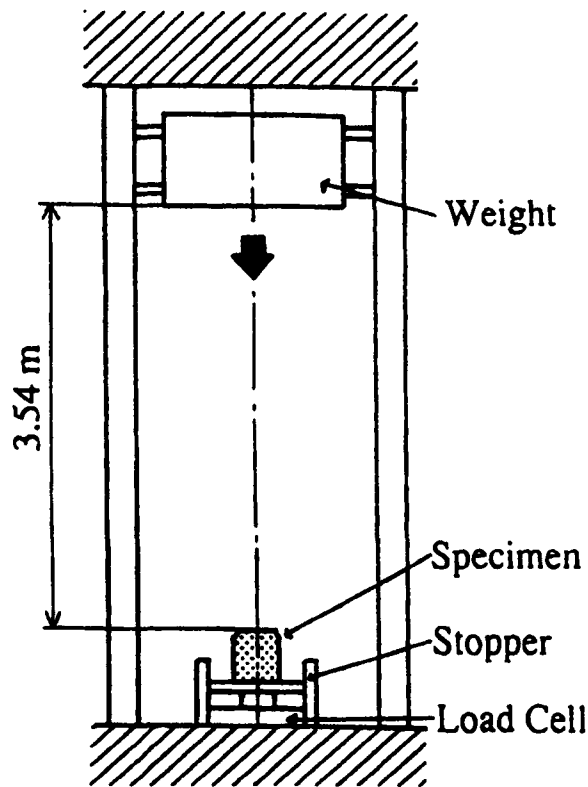
Figure 2-15 – Schematic diagram of drop tower used by Hamada and Ramakrishna [43]

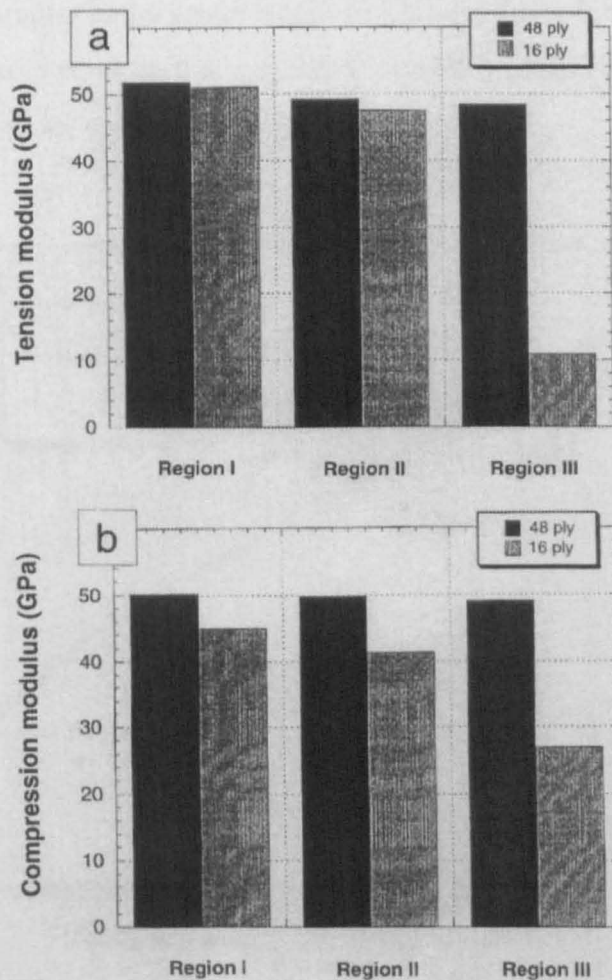
Figure 2-18 – Axial moduli for the impacted laminates tested by Sjögren et al [52]

Sjögren et al [52] investigated the elastic properties of impacted carbon/epoxy laminates. 16-ply and 48-ply laminates were manufactured from Hexcel HTA/6376C prepreg and subjected to impact from a 7.5mm radius impactor. The 16-ply samples were impacted at 8J, the 48-ply samples at 30J. Tensile and compression tests at 0.5mm/min were performed on specimens cut from three distinct regions of the laminate. The undamaged material was designated Region I, the region with mainly delamination Region II and the most damaged region, containing matrix cracks, delamination and fibre breakage, Region III. The effects of the impact damage on the tensile and compressive moduli are shown in Figure 2-18.

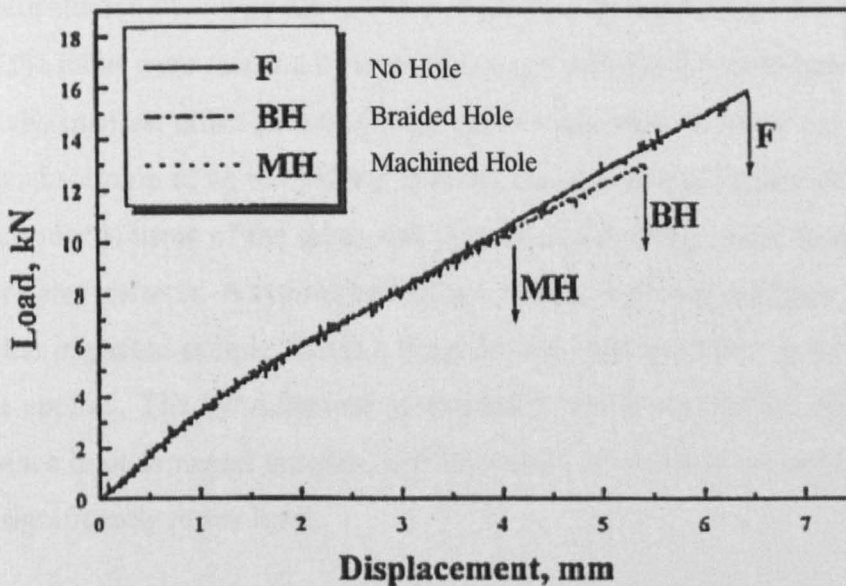
Figure 2-19 – Load-displacement curves for the tensile tests of braided glass/epoxy samples containing holes conducted by Nakai et al [53]

Nakai et al [53] performed tensile tests on braided glass/epoxy samples containing a braided hole and a machined hole. The braided hole was fabricated by inserting a Teflon® pin in the centre during the braiding process and the machined holes made by drilling. The samples had a gauge length of 120mm, the hole was 6mm in diameter and tensile tests were conducted at a speed of 1mm/min. Figure 2-19 shows the load-displacement curves for the three samples tested.

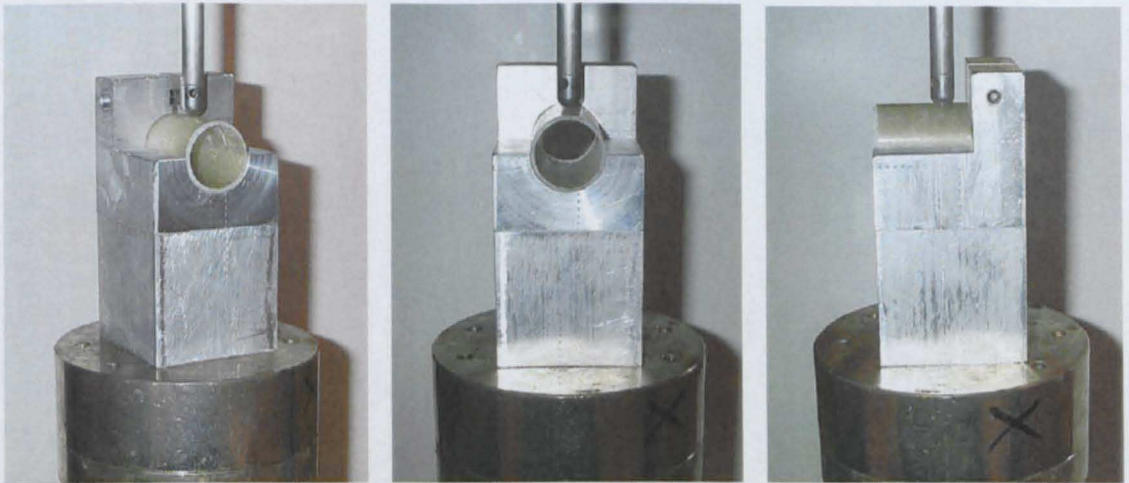
Figure 3-12 – Fixture used to add damage to and drill small (38.1mm diameter) tubes

and fixture for the large (89.1mm diameter) tubes are shown in Figure 3-11 and for the small (38.1mm diameter) tubes in Figure 3-12.

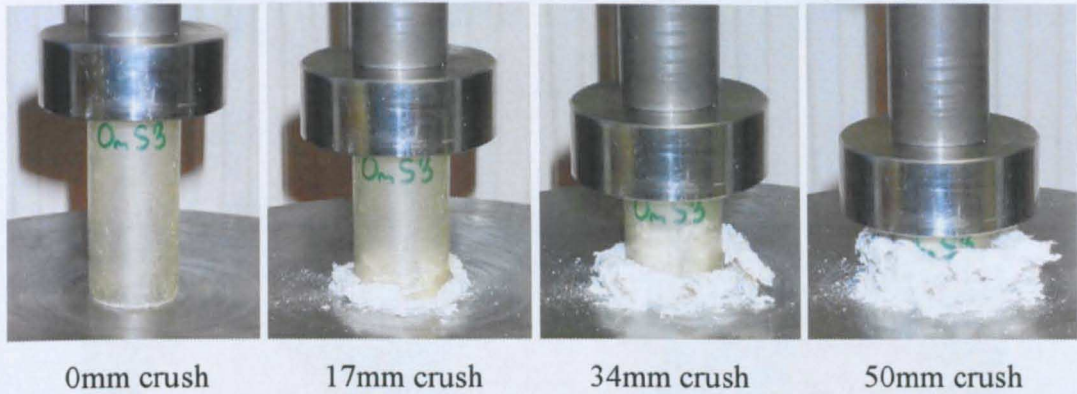
Figure 4-9 – Quasi-static crush of an undamaged, 38.1mm diameter CoFRM/Norpol tube (sample 3)
