### Generation of Mechanical Frequency Related Harmonics in the Stray Flux Spectra of Induction Motors Suffering from Rotor Electrical Faults

# Generation of Mechanical Frequency Related Harmonics in the Stray Flux Spectra of Induction Motors Suffering from Rotor Electrical Faults

**Index Terms** — Fault diagnosis, Flux Monitoring, Induction motors, Rotor Faults.

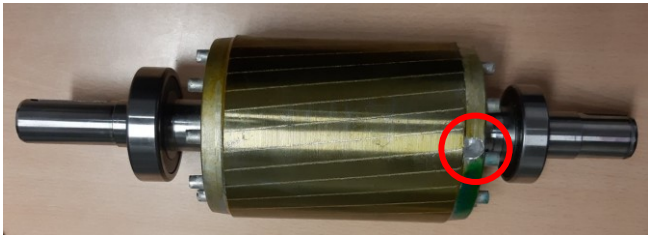
Fig. 10. The rotor with one broken rotor bar.

To test the validity of the FEA simulations, two identical squirrel-cage induction motors have been tested under healthy operation and under one broken rotor bar fault. The tested motors have the following characteristics: 400V, 50Hz, 4kW and 4 poles.
