Fatigue and bending behaviour of friction stir welded DH36 steel

Steven Fowler · Athanasios Toumpis* · Alexander Galloway

Department of Mechanical & Aerospace Engineering, University of Strathclyde; James Weir Building, 75 Montrose Street, Glasgow, G1 1XJ, United Kingdom

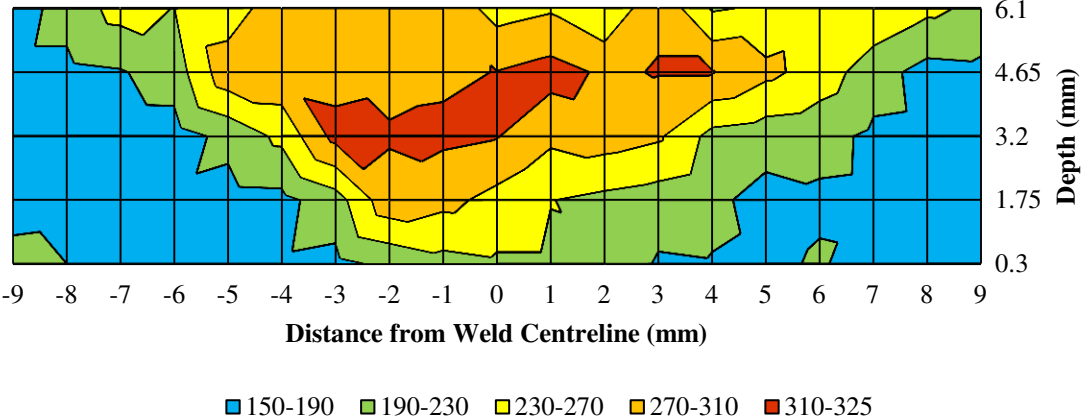
The hardness profile depicted in Fig. 6 indicates a gradual increase in hardness with increasing distance from the PM towards the weld centre; this is typical of most FSW joints. The maximum hardness was found in the centre/AD side of the TMAZ. This observation corresponds to the formation of bainite in the microstructure (Section 3.1.1). The temperature of the AD side during FSW is higher than the RT side [8] thus inducing faster cooling rates in that region. Faster cooling rates lead to the formation of harder phases such as bainite.

Fig. 6 Vickers hardness distribution throughout the weld

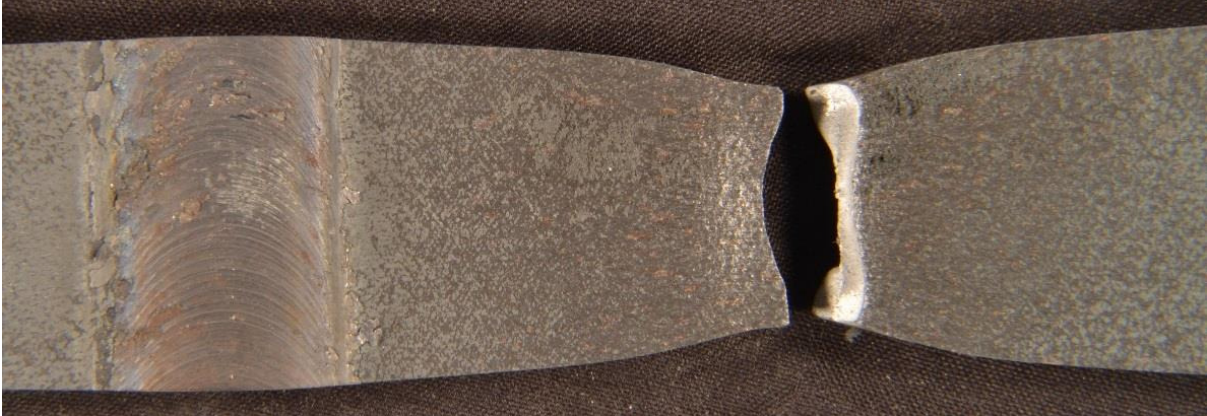
The reduced grain size in the welded region corresponds to an increase in yield strength. Consequently, all transverse tensile samples fractured in the PM under tensile loading. A typical image of the samples’ top surface in presented in Fig. 7. Necking is clearly visible, hence indicating ductile fracture with plastic deformation of the steel. The recorded data for each tensile test are presented in Table 3.

Fig. 7 Tensile sample fracture in parent material

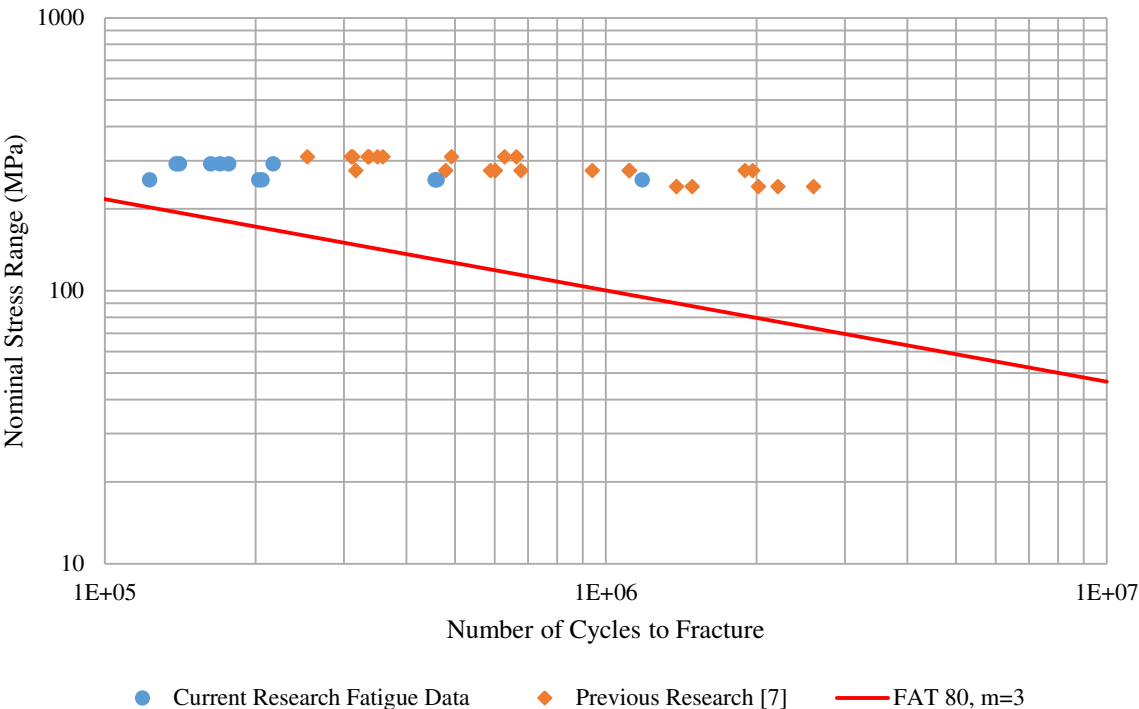
The fatigue data is plotted in Fig. 8. In order to put the results into context, a comparison has been made against the recommended performance of fusion butt welds provided by the International Institute of Welding (IIW) [23]. This has been achieved by plotting the data against the most relevant fatigue class (FAT). The fatigue class indicates the characteristic stress range which results in fatigue life of $2 \cdot 10^6$ cycles at 97.7% survival probability. Each fatigue class is dependent on the nature of the weld. For this research, the FAT 80 line was used as this correlates to the weld examined (detail No. 214 in Ref. [23]).

Fig. 8 Fatigue data for as-welded fatigue samples relative to FAT 80 line

The data in Fig. 8 demonstrate inferior fatigue strength in comparison to previous FSW fatigue data on DH36 steel [7]; this is largely due to the severe weld root flaw. However, as all results are above the IIW recommendation defined by the FAT 80 line, the weld exhibits acceptable fatigue performance should it be assessed by fusion welding recommendations.

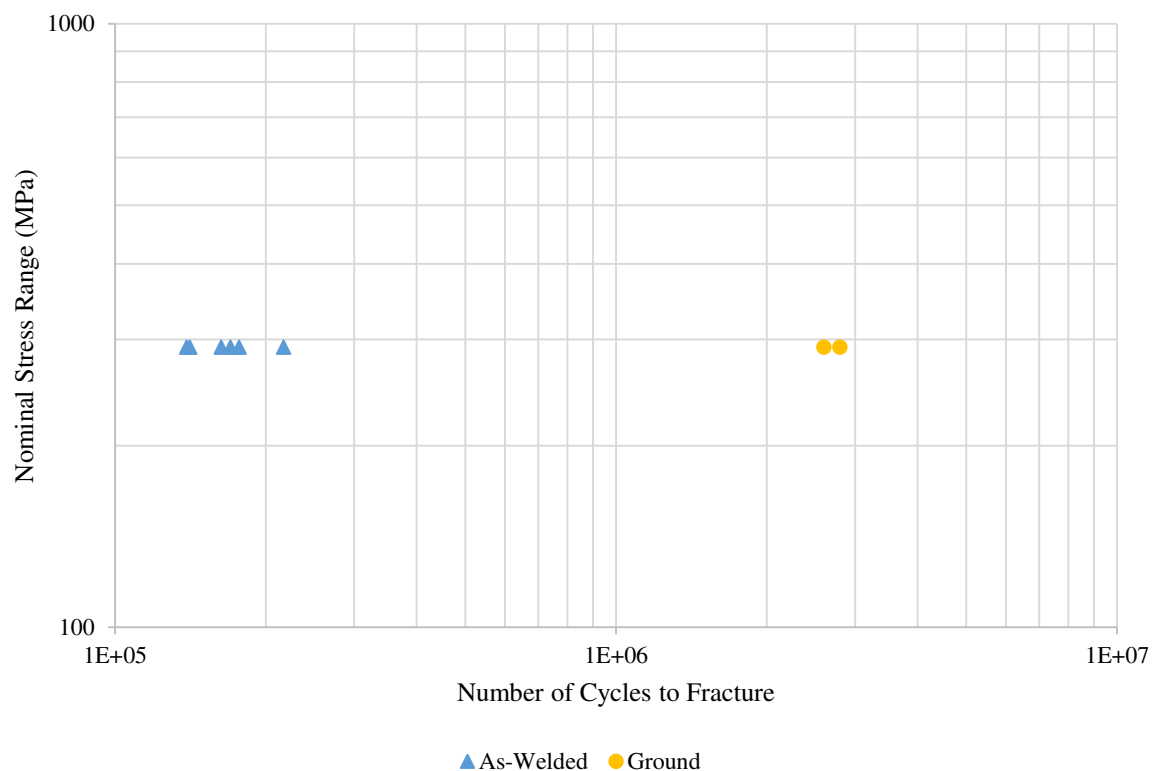
Due to the reduced fatigue performance in comparison to prior findings [7], two additional samples were tested having removed the top and bottom surface flaws. Removing any process related flaws allowed for the weld material itself to be tested, thus enabling a valid comparison with the as-welded samples. The depth of the weld root flaw and lap defects was measured to be 450 μm and 550 μm for the top and bottom surface respectively. The specimens were milled and then ground to the appropriate depth and both tested at a stress range of 80% yield strength. The results are presented in Fig. 9 along with the as-welded specimens for the equivalent stress range.

As both ground fatigue samples exceeded $2.6 \cdot 10^6$ cycles, the tests were terminated without fracture. Therefore, the results gathered indicate superior fatigue performance in ground samples. This highlights the detrimental effect of top surface defects and of the inadequate tool penetration on the fatigue performance of steel FSW.

Fig. 9 Fatigue data for as-welded versus ground samples at 80% stress range
