**Peat, Tom and Galloway, Alexander and Toumpis, Athanasios and Harvey, David (2016) Evaluation of the synergistic erosion-corrosion behaviour of HVOF thermal spray coatings. Surface and Coatings Technology, 299. pp. 37-48. ISSN 0257-8972 ,**

# Evaluation of the synergistic erosion-corrosion behaviour of HVOF thermal spray coatings

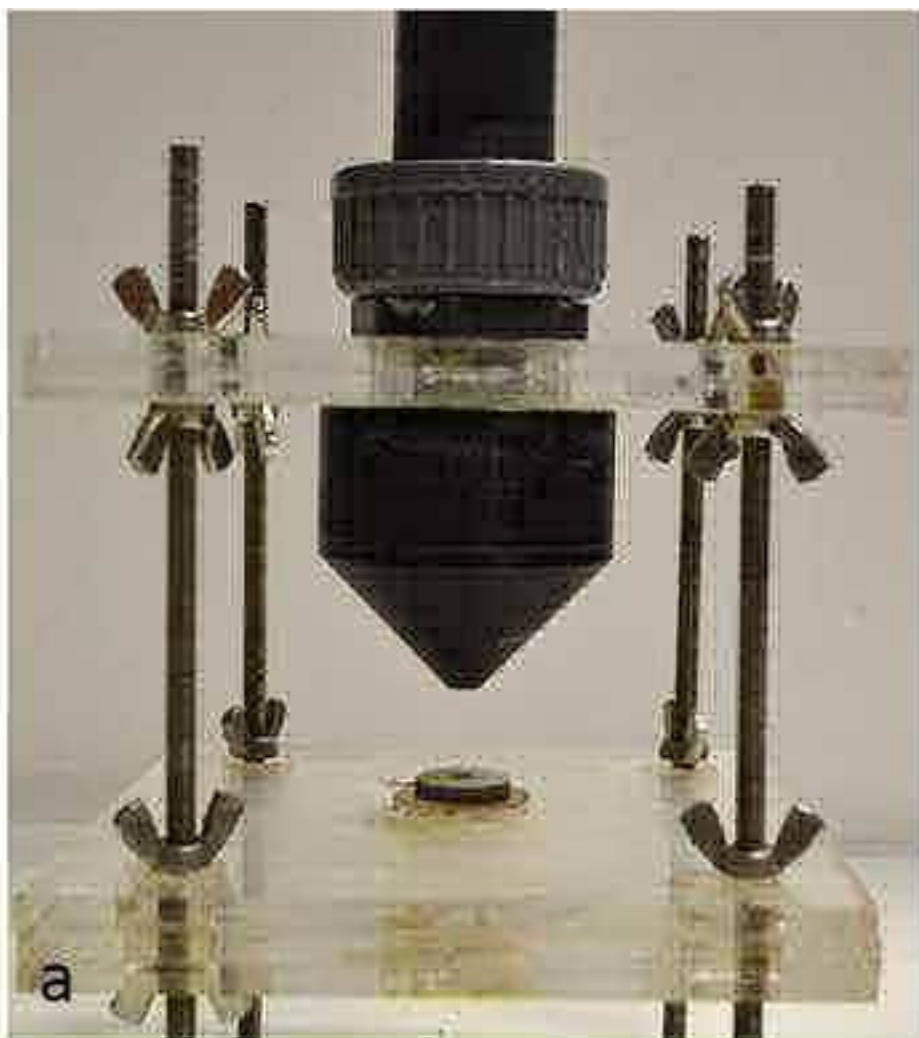
**Figure 3**  
[Click here to download high resolution image](#)

**Fig 3.** Jet nozzle and specimen in situ for liquid impingement at a)  $90^\circ$  angle of attack, b)  $30^\circ$  angle of attack.

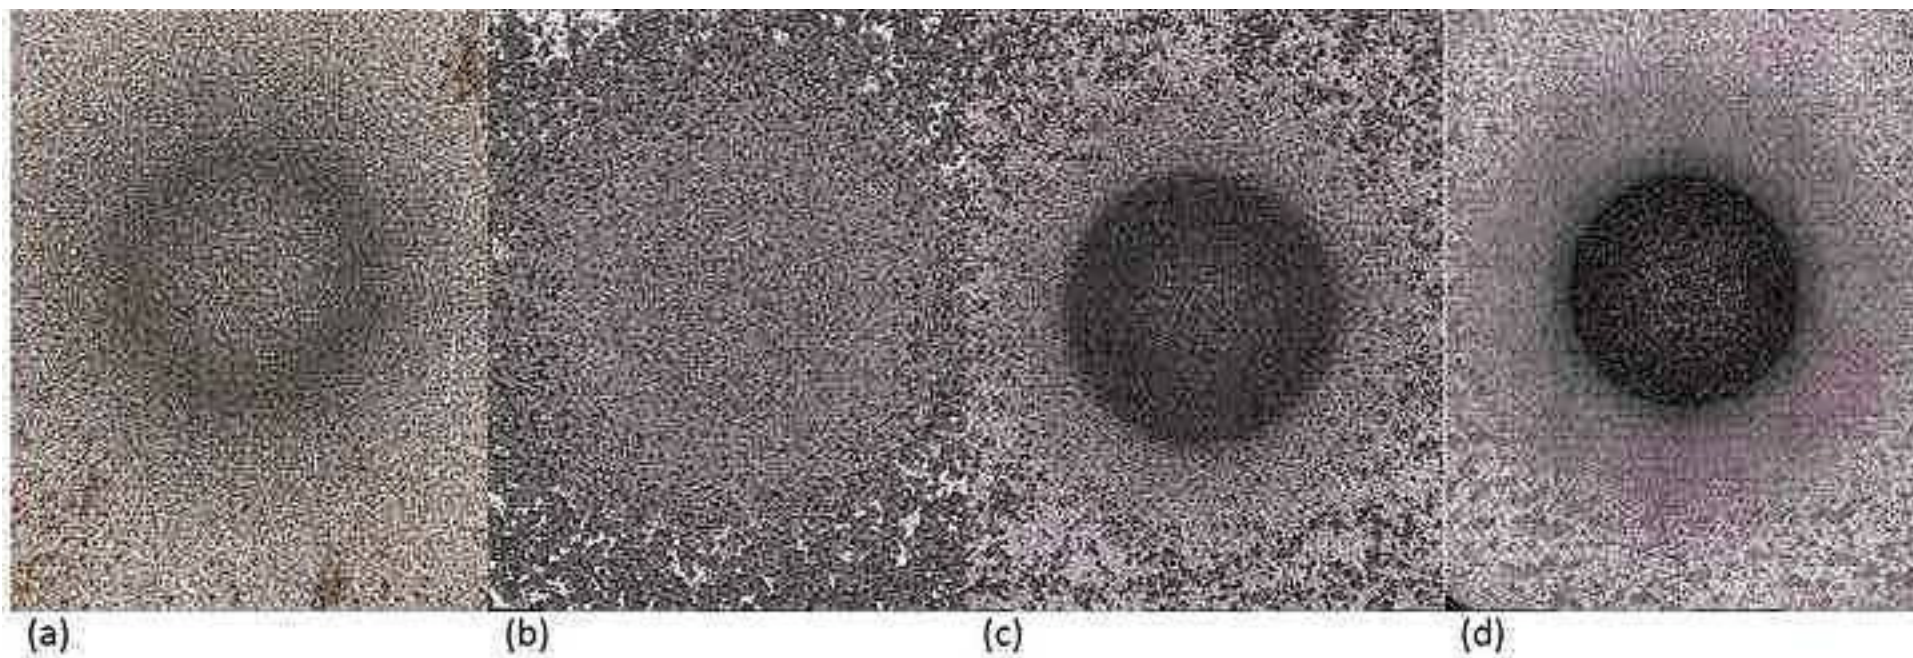
Figure 4  
[Click here to download high resolution image](#)

A typical wear scar for each of the three coatings as well as uncoated S355 was captured using an Alicona optical imaging system; these are highlighted in Figure 4. The specimens exhibit two distinct zones within the impinged area. The central region represents the direct impingement zone and relates to the area of the test specimen located immediately beneath the 4 mm jet nozzle. The exit diameter of the nozzle correlates to a directly impinged region of  $12.6 \text{ mm}^2$ . The outer zone indicates a turbulent region that experiences significant sliding erosion as particles are forced outwards at high velocity

The typical wear scar for each of the three coatings and the uncoated S355 was captured using an Alicona optical imaging system and is highlighted in Figure 4. Figure 12 depicts a comparative analysis of the wear scar depths from each coating material following 1-hour free erosion – corrosion impingement, measured using a surface profilometer. Wear scar depth was corroborated using an Alicona with results being shown in Table 7. It is evident that the  $\text{Al}_2\text{O}_3$  coating has developed the largest wear scar, with a maximum

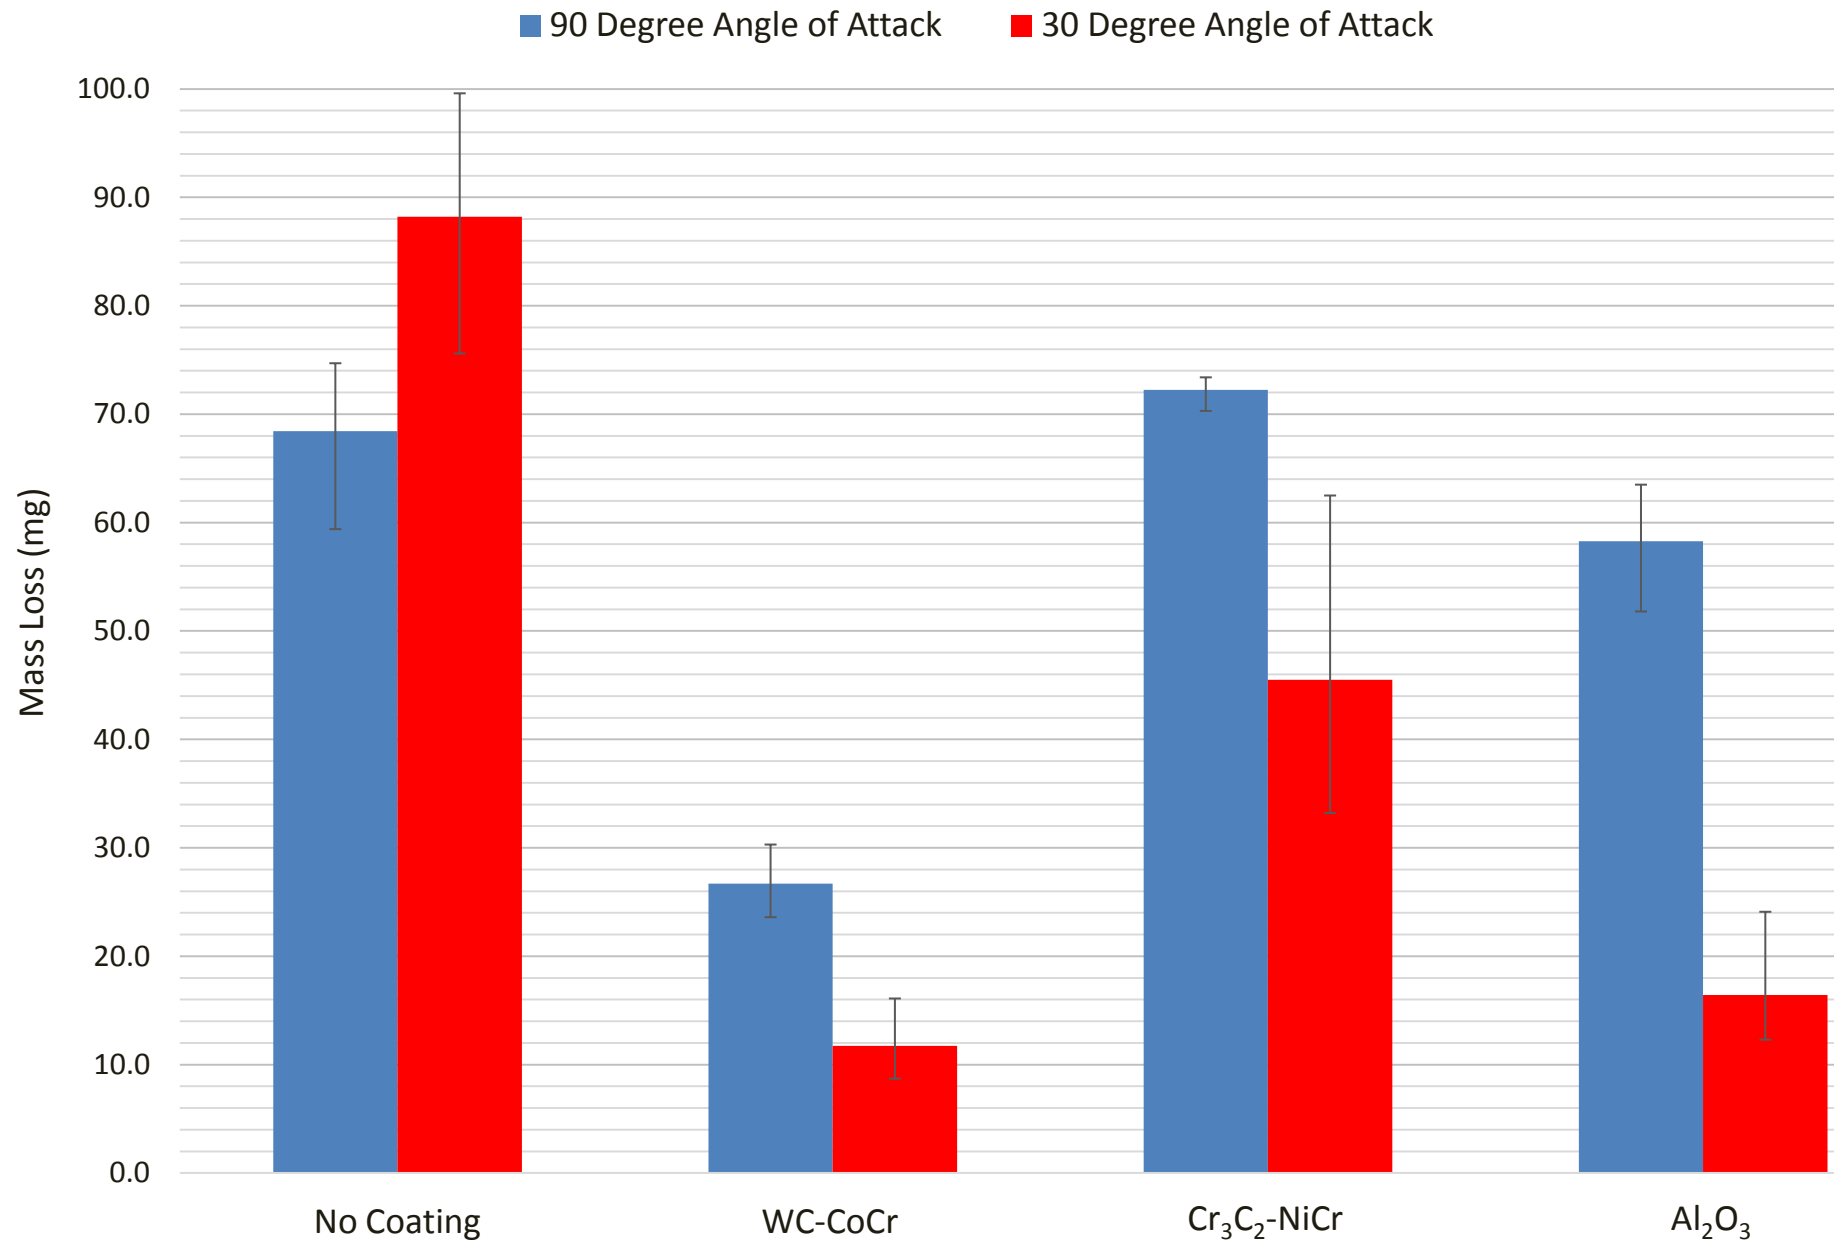
**Figure 6**  
[Click here to download Figure: FIG6.xlsx](#)

Figure 6 displays the influence of the angle of attack on the free erosion-corrosion mass loss. The average mass loss for each coating type is shown over three test replicates for both 90° and 30° angle of attack. Error bars indicate the range of individual test results. It should be noted that the indicated mass loss for Cr<sub>3</sub>C<sub>2</sub>-NiCr and Al<sub>2</sub>O<sub>3</sub> specimens also includes mass loss from the substrate material, due to the coatings being breached within the highly aggressive test conditions.

Despite its high hardness, the Al<sub>2</sub>O<sub>3</sub> coating has experienced significant mass loss under 90° angle of attack, with the calculated average mass loss being close to that of uncoated S355. In contrast to impingement at 90°, the Al<sub>2</sub>O<sub>3</sub> specimen exhibits substantially less mass loss under impingement at 30°. This is in agreement with the reported findings [15] in which the increased quantity of carbides results in maximum damage occurring at higher angles of attack. A similar mechanism exists within the Cr<sub>3</sub>C<sub>2</sub>-NiCr specimens, with attack at 90° causing greater mass loss than the uncoated material. The coating suffered less degradation at 30°, however still proved the poorest performing coating of the three. Reduced mass loss over the Cr<sub>3</sub>C<sub>2</sub>-NiCr and Al<sub>2</sub>O<sub>3</sub> coated specimens demonstrates the ability

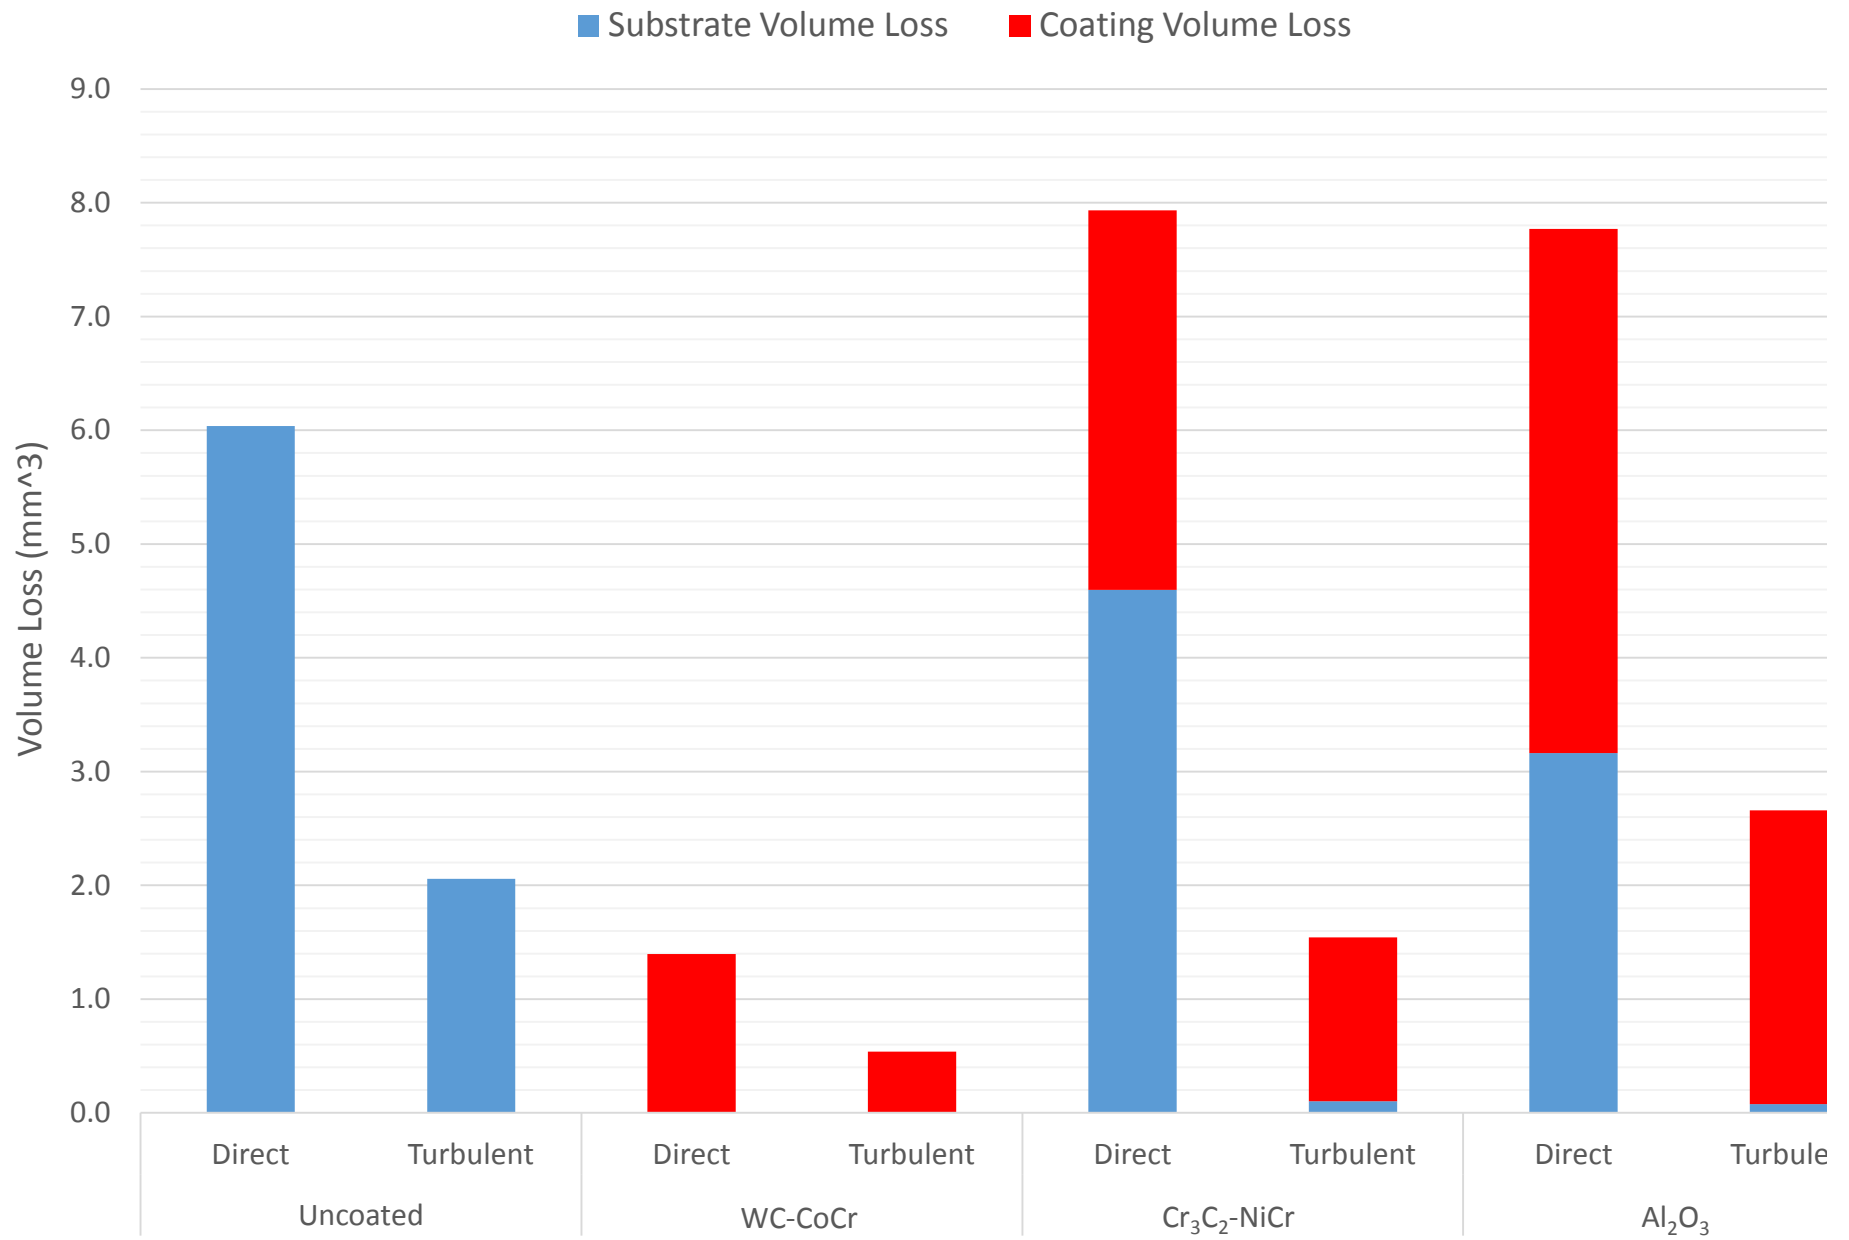
**Figure 8**  
[Click here to download Figure: FIG8.xlsx](#)

Figure 8 depicts the resulting volume loss within the wear scar, highlighting the volume loss from the coating layer and substrate, for both the directly impinged and turbulent regions. Volume loss in the turbulent region is determined by measuring the

difference in volume losses between the entire wear scar and the directly impinged region using the Alicona surface analysis system.

The data presents a number of noteworthy trends;  $\text{Cr}_3\text{C}_2\text{-NiCr}$  specimens suffered the greatest loss of material from the specimen substrate, with total volume loss in the direct zone comprising approximately 40% coating loss and 60% substrate loss. WC-CoCr is the only coating that has not been penetrated following 1-hour of exposure to the impinging slurry. Without the deep impact crater observed in other specimens, the impinging particles are free to scour across the surface of the WC-CoCr coating, eroding a wider area of material as demonstrated in Figure 5. The total volume loss recorded in WC-CoCr is approximately 20% of the value recorded for the uncoated material. Both  $\text{Cr}_3\text{C}_2\text{-NiCr}$  and  $\text{Al}_2\text{O}_3$  specimens have sustained substantial damage to the substrate material immediately beneath the directly impinged zone. This has formed a deep crater; increased depth of this crater correlates to the reduced respective volume loss from the turbulent region, with the shallower WC-CoCr wear scar promoting increased sliding erosion in the turbulent zone.

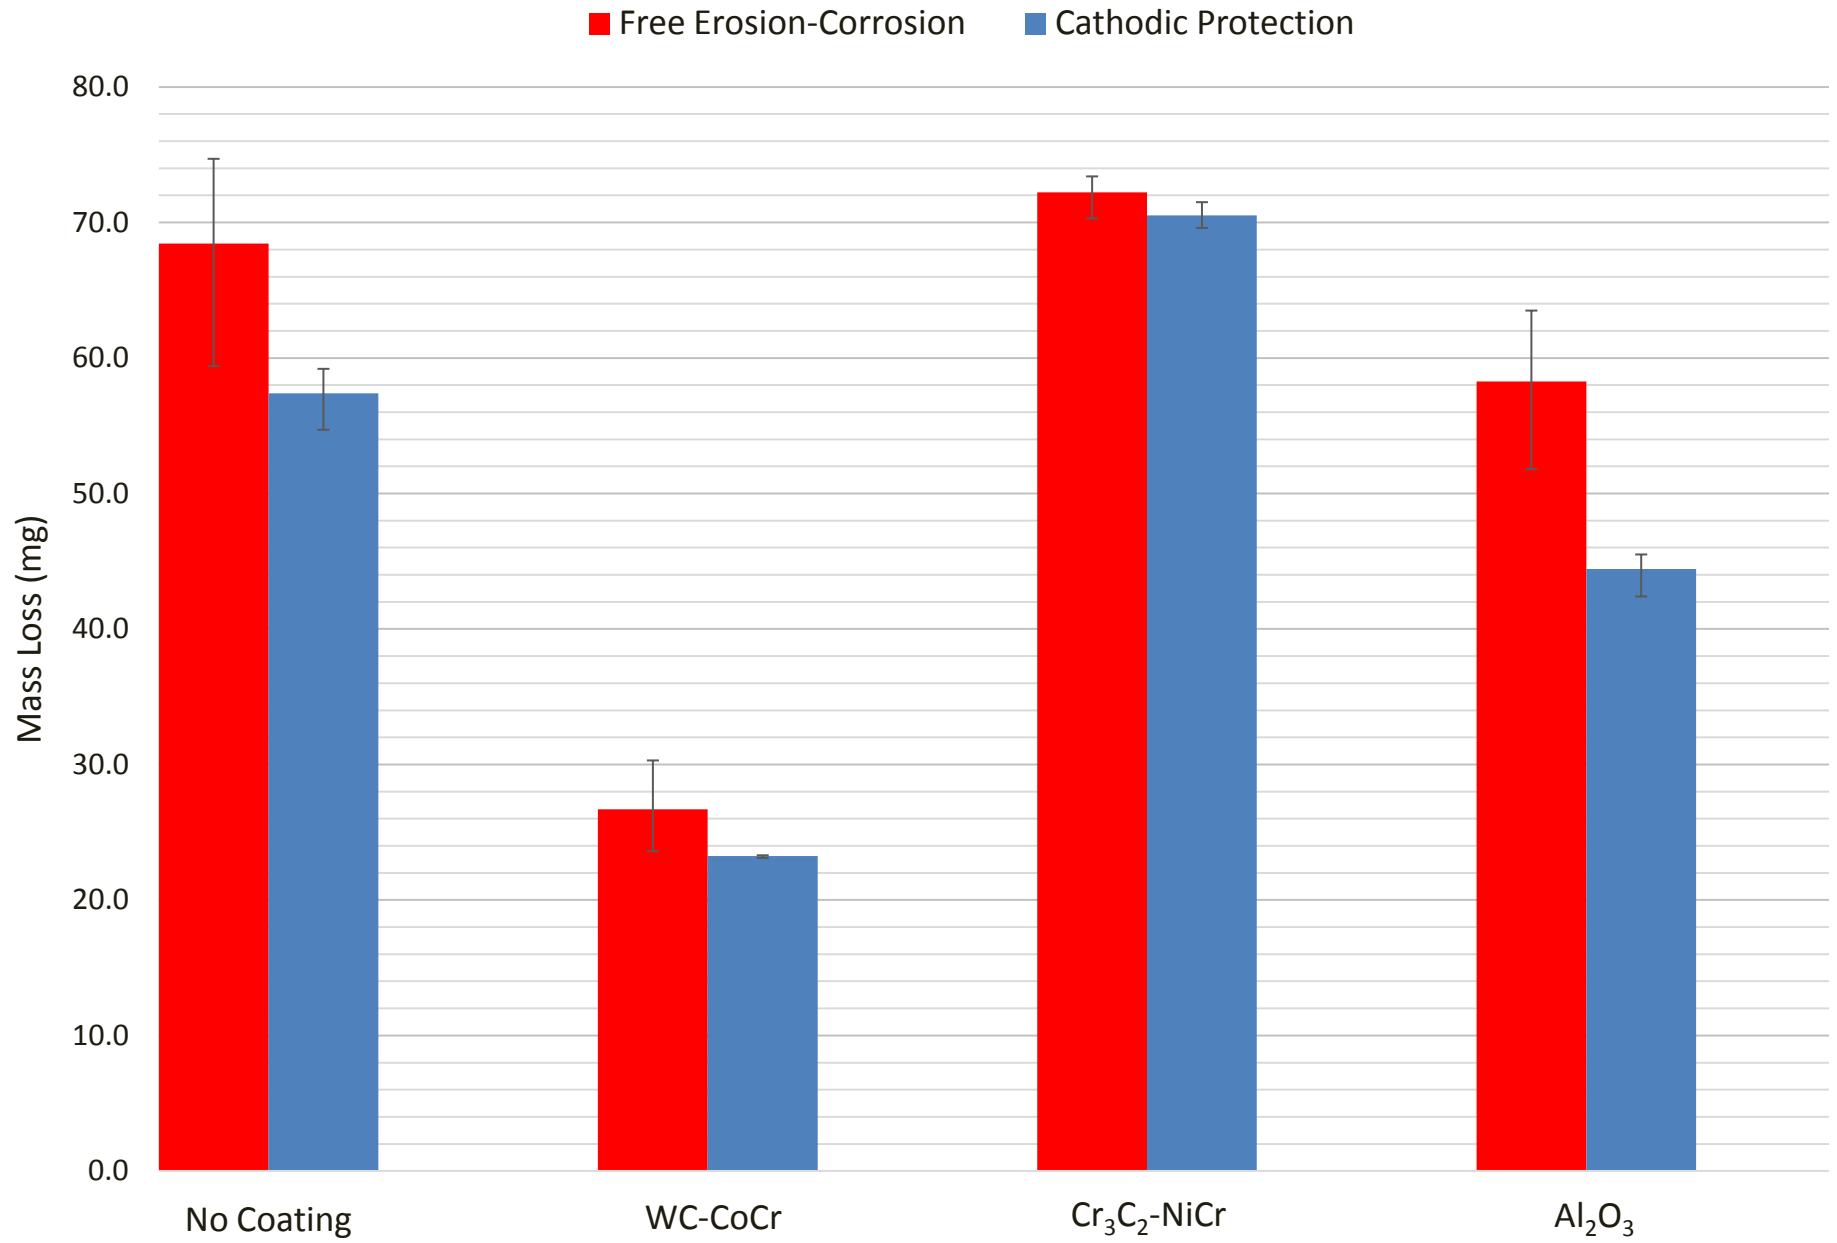
**Figure 9**  
[Click here to download Figure: FIG9.xlsx](#)

Electrochemical measurements are necessary to determine the contributing factors of erosion, corrosion and the synergistic effects of both to the total mass loss. Figure 9 illustrates the average mass loss variation between the three coatings under free erosion – corrosion conditions and with applied CP.

Erosion-corrosion mass loss experiments show WC-CoCr coatings to yield around 60% reduction in mass loss with and without applied CP, over the uncoated substrate. Conversely, both  $\text{Cr}_3\text{C}_2\text{-NiCr}$  and  $\text{Al}_2\text{O}_3$  specimens resulted in enhanced mass loss when compared with uncoated S355 substrate. Applied CP has had the most significant impact on

the uncoated and  $\text{Al}_2\text{O}_3$  specimens, with mass loss of CP protected specimens measurably less than observed under free erosion – corrosion conditions.

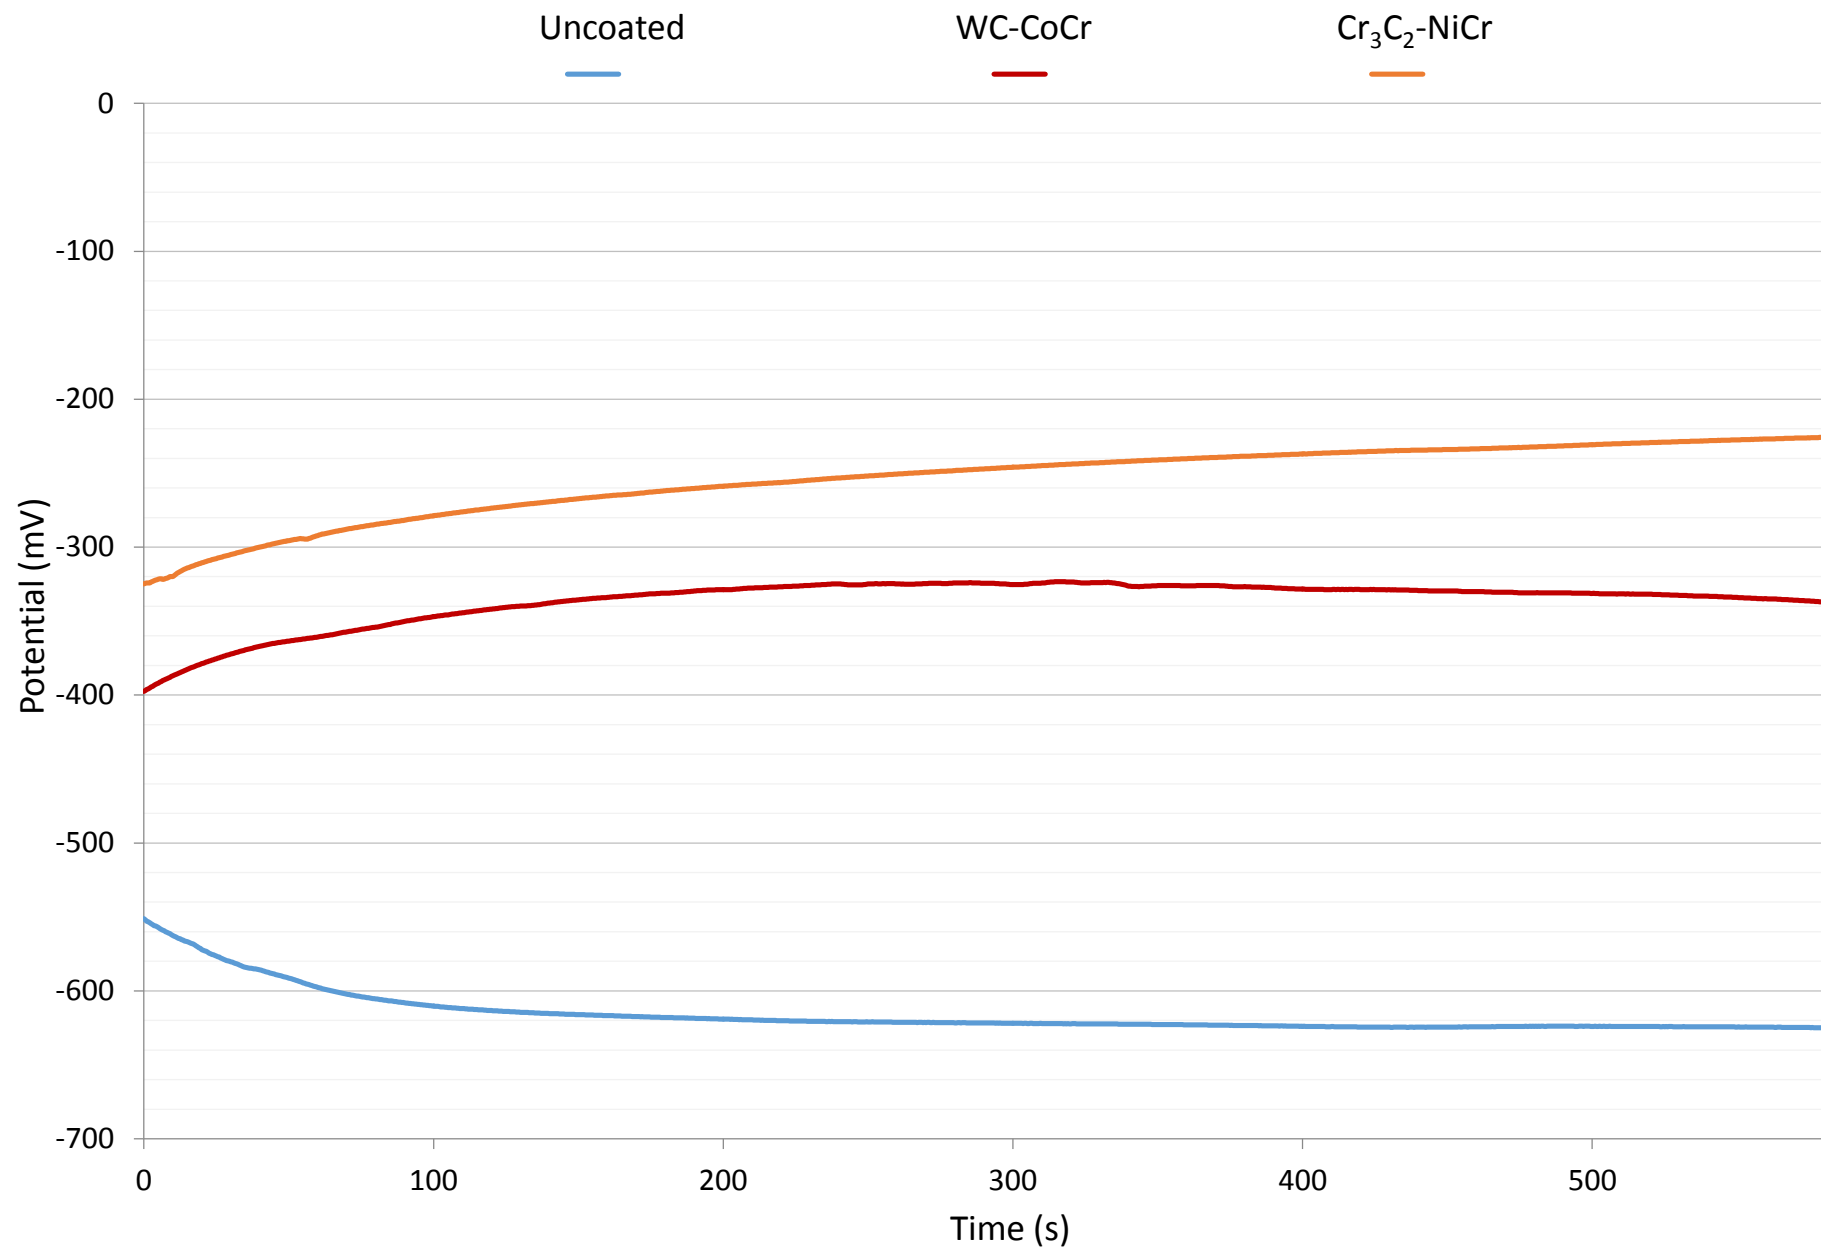
Figure 10a  
[Click here to download Figure: FIG10a.xlsx](#)

The application of CP necessitated the measurement of OCP for each coating material under both flowing and static conditions. Figure 10a outlines the variation in  $E_{\text{corr}}$  between the three coating types and the uncoated S355 substrate for static conditions, with Figure 10b showing results for flowing conditions.

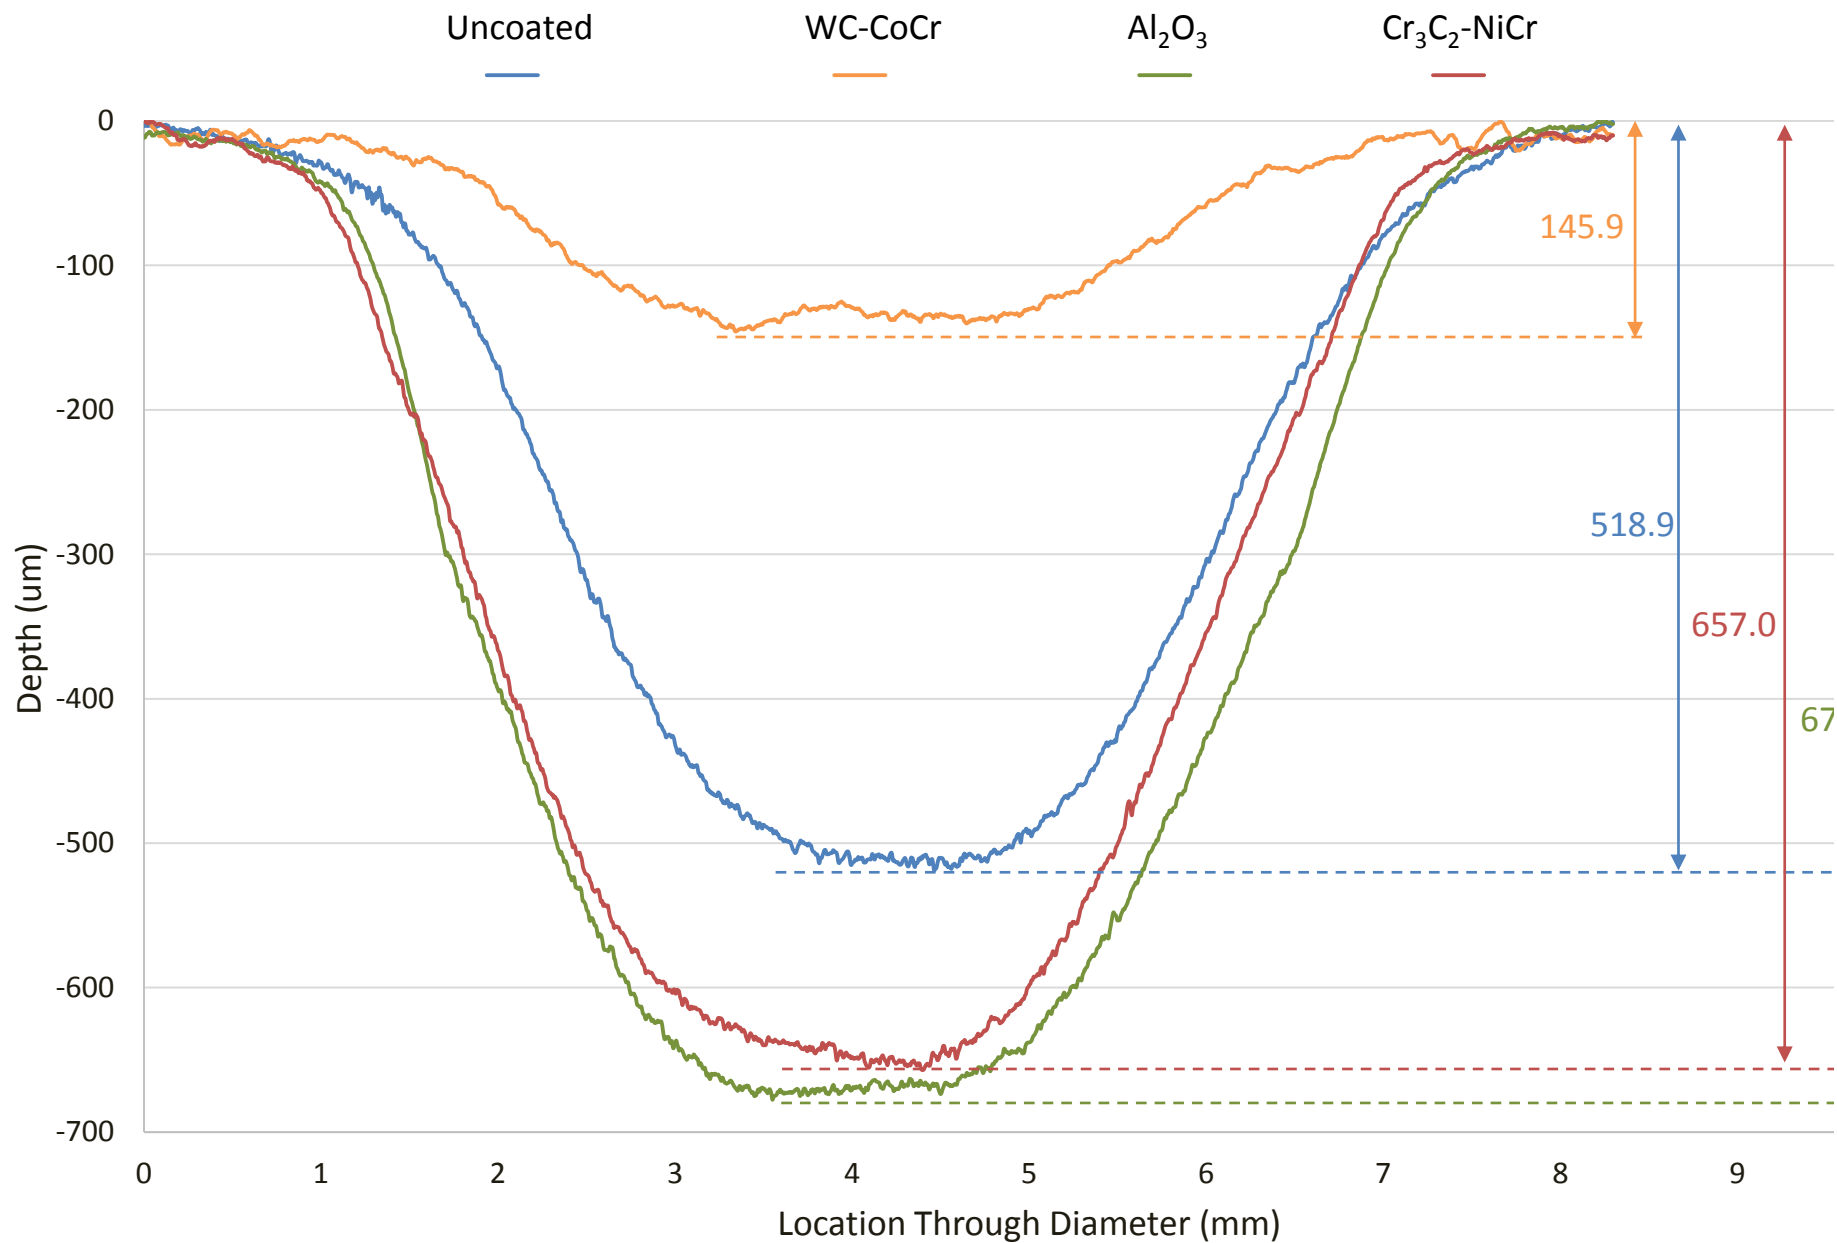
Figure 12  
[Click here to download Figure: FIG12.xlsx](#)

recorded depth of 678  $\mu\text{m}$ . The scar depth for  $\text{Cr}_3\text{C}_2 - \text{NiCr}$  was shown to be marginally shallower, however, given the comparably thin coating layer, the substrate penetration depth is 100  $\mu\text{m}$  greater than in the  $\text{Al}_2\text{O}_3$ . The recorded maximum wear scar depth for WC-CoCr was 141.7  $\mu\text{m}$ . With an indicated coating thickness of 180  $\mu\text{m}$ , the results verify that the coating layer has not been breached following the 1-hour liquid impingement test. The significant reduction in wear scar depth clearly demonstrates that WC-CoCr has provided superior protection of the S355 substrate over other assessed coatings.

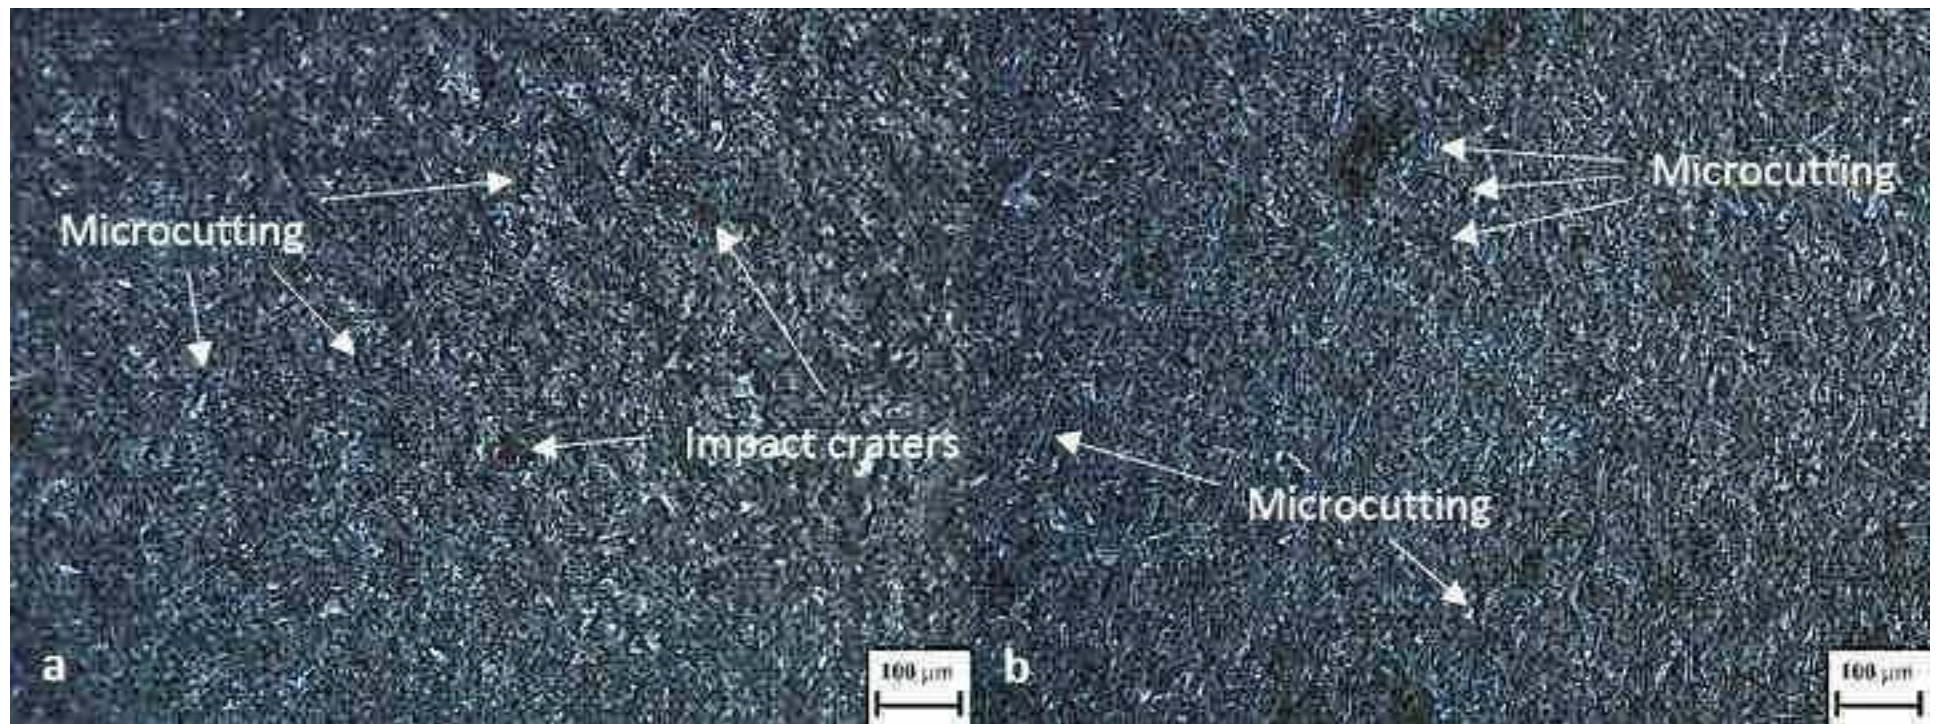
Figure 13  
[Click here to download high resolution image](#)

Figure 13a reveals enhanced surface roughness within the central impinged zone. Uncoated S355 shows evidence of wear marks in the form of microcutting and ploughing. Moreover, there exist small craters on the damaged surface caused by impinging sand particles. A similar result was noted by Santa et al. [49], who related increasing size of impact craters to increased impinging particle size. The production of craters on the surface leads to the presence of crater lips that are subsequently removed by the cutting motion of the particles as they move out from the centre of the directly impinged zone. The cause of material loss is therefore associated with repetitive plastic deformation caused by impinging particles followed by microcutting. Figure 13b highlights the directionality in the turbulent zone, with evidence of parallel scratch patterns and apparent microcutting [30].

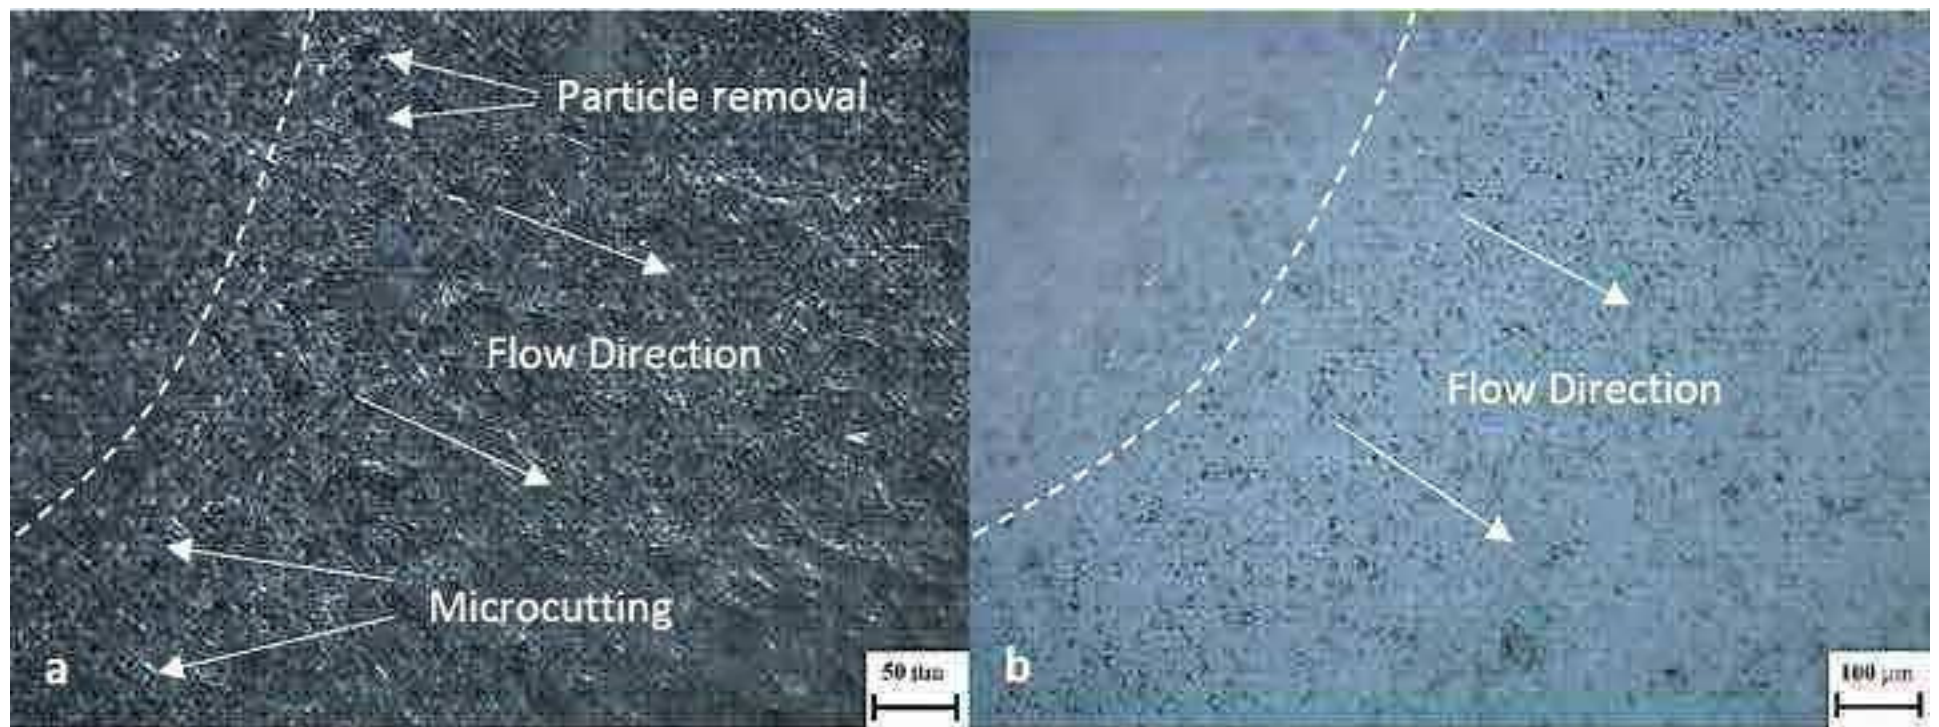
Figure 14  
[Click here to download high resolution image](#)

Figure 14a illustrates the damage to the Cr<sub>3</sub>C<sub>2</sub>-NiCr coated specimen within the outer turbulent region. Complete coating removal in the directly impinged zone results in a surface similar to that observed in Figure 13a. Examination of the turbulent zone reveals signs of directionality in the orientation of surface damage. It is therefore expected that the majority of erosive wear has been contained within the wear scar crater. However, as particles move outwards from the crater, they slide and graze across the surface of the coating resulting in the observed damage. Within the turbulent zone, there also exist signs of particle removal. The ability for particles to be pulled out of the coating matrix accelerates material removal by acting as an additional erodent and supports the high mass loss experienced by the Cr<sub>3</sub>C<sub>2</sub>-NiCr coated specimens.

material loss occurs rapidly with  $\text{Al}_2\text{O}_3$  particles spalling off. Owing to complete coating removal within the directly impinged zone, the structure in this region reflects the structure of Figure 13a. Figure 14b highlights the apparent directionality in the turbulent region surrounding the directly impinged zone. The lack of binder material has resulted in rapid removal of the protective  $\text{Al}_2\text{O}_3$  coating with removed alumina particles causing further damage to the exposed S355 substrate. This contributes to the enhanced mass and volume loss over uncoated S355.

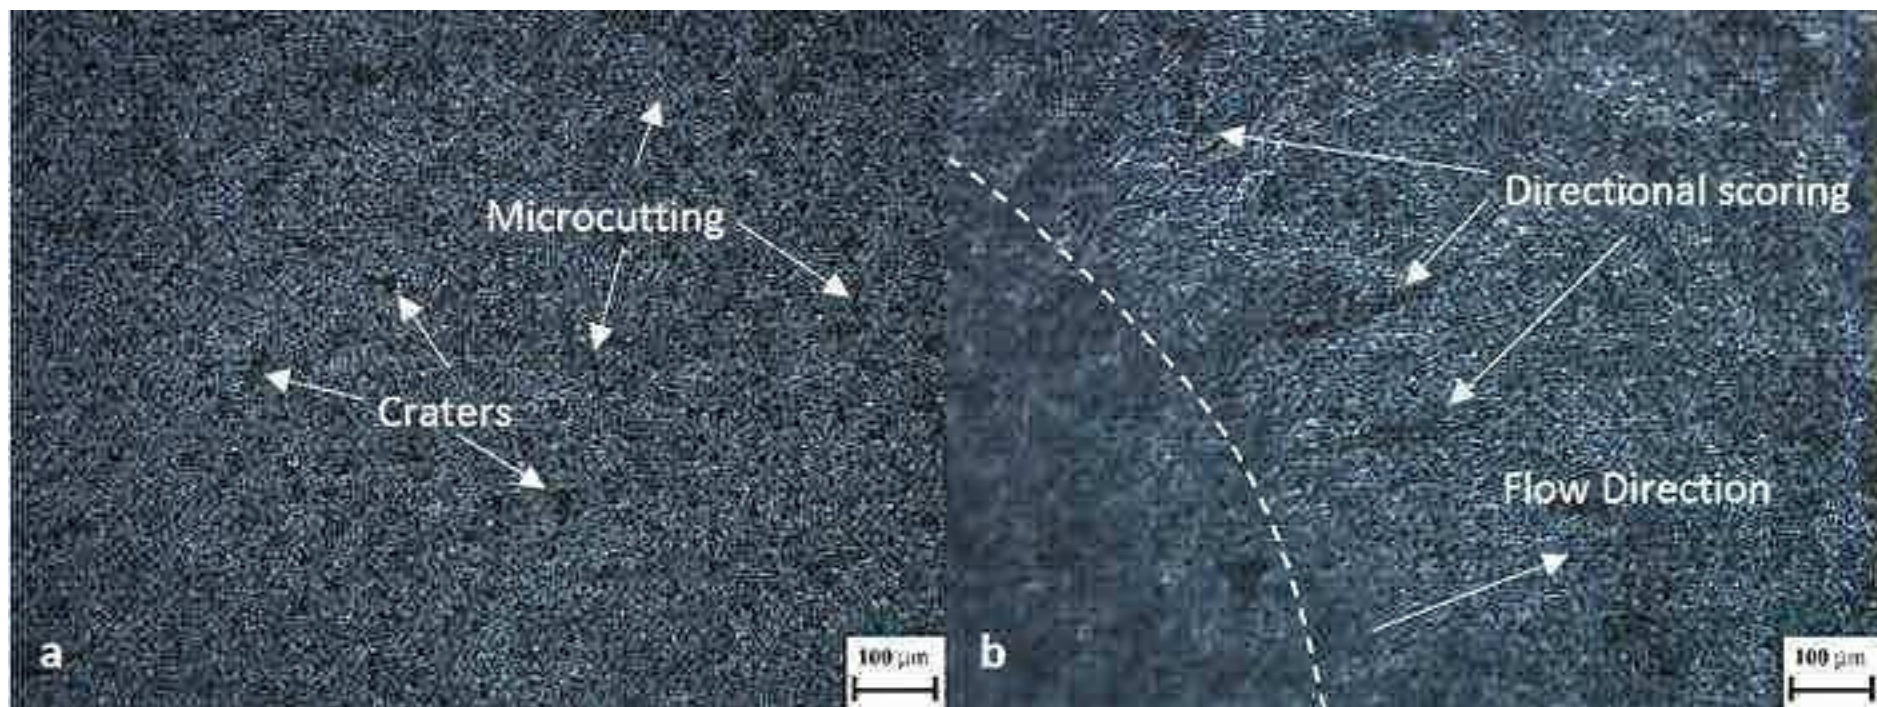
Figure 15  
[Click here to download high resolution image](#)

Micrographs of the central impinged and turbulent zones within the WC-CoCr coating are depicted in Figure 15 and reveal a wear mechanism similar to that observed in uncoated S355. There is evidence of impact craters within the directly impinged zone. The presence of craters indicates the surrounding material has retained its structure following impact. With continued liquid impingement, carbide particles fracture and cannot be retained by the cobalt matrix, with continuous flow eventually removing the particles from the coating matrix altogether. Corroborating results have been obtained by Thakur et al. [34]. The remaining cobalt binder has insufficient hardness to withstand the erosive conditions and is eventually removed. Microcutting is also evident and is linked to the ploughing of silica particles and removal of soft cobalt binder. The observations are in accordance with those reported in associated studies [50,51]. The superior wear performance of the WC-CoCr coating can be attributed to the cobalt binder effectively retaining the hard carbide particles within the matrix. The turbulent zone shown in Figure 15b depicts some signs of directionality but in contrast with other specimens, shows signs of more erratic wear. This is to be expected given the lack of a defined impact crater.

**Fig 15.** Optical image of WC-CoCr coated specimen following free erosion-corrosion test. a) directly impinged region, b) turbulent region [x100, Unetched].
