Brownlie, F. and Hodgkiess, T. and Pearson, A. and Galloway, A.M. (2016) Corrosive wear behaviour of various stainless steel alloys and a Stellite 6 weld cladding. In: 17th Nordic Symposium on Tribology, 2016-06-14 - 2016-06-17. (In Press) ,

Corrosive wear behaviour of various stainless steel alloys and a Stellite 6 weld cladding

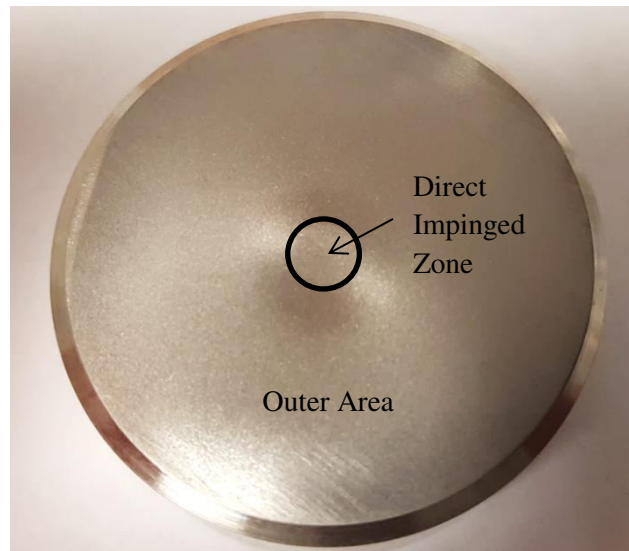
Figure 7: Wear scar on SS316 after 1 hr test at 90° impingement, highlighting the two distinct wear zones

The erosion-corrosion testing apparatus consists of a closed loop recirculating system, as shown in Figure 5. Tests were conducted with a submerged jet of 3.5%NaCl aqueous solution with suspended spherical silica sand of 2.4g/l concentration. The velocity of the jet was 18m/s with a testing temperature range of 16°C-27°C. Tests were conducted at two angles, normal incidence (90°) and a shallow angle (20°). Experiments were conducted for 1 hour. The diameter of the nozzle was 3.8mm. All samples were round with a diameter of 38mm. The distance between the nozzle and sample was kept at 5mm to ensure consistency in results. Examples of the typical wear scar at both angles are shown in Figures 6-7. The silica sand size distribution is shown in Table 3.

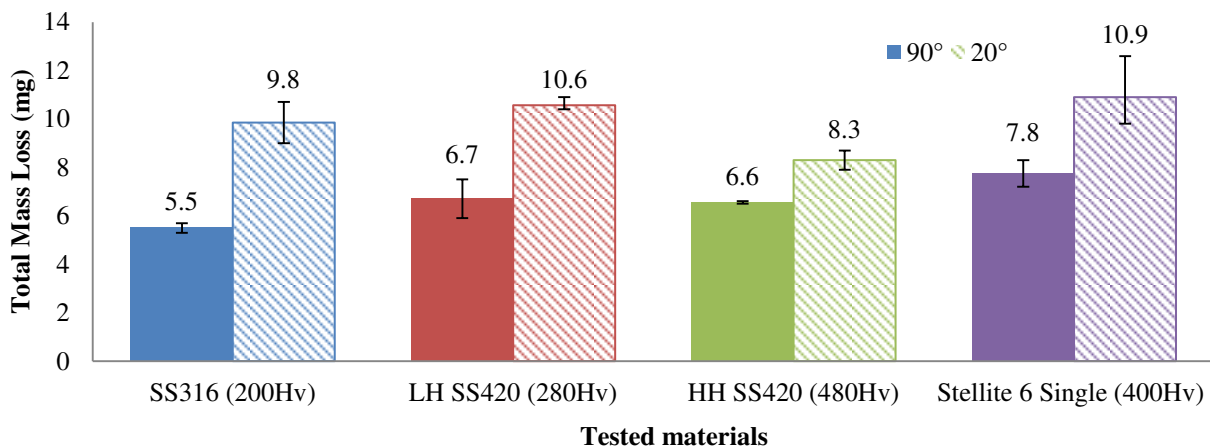
The overall erosion-corrosion performance of the tested materials was assessed by evaluating the total mass losses after each test. A minimum of four replicates of each material at both impingement angles was conducted. Figure 8 shows the average mass losses for each test material at both impingement angles.

Figure 8: Average mass losses for test materials at both impingement angles

Comparison of the mass losses between the impingement angles conveys a distinct increase in mass loss from 90° to 20° impingement tests. At 90° impingement, the SS316 was found to have the lowest mass loss. However, at 20° the high hardness martensitic SS420 had the lowest mass loss. The Stellite 6 weld cladding exhibited the largest average mass loss at both impingement angles.

From the total mass losses (Figure 7) it can be seen that all materials have greater mass losses under impingement at 20° than at 90°. Therefore, all materials are following the erosive ductile behaviour theory proposed by Finnie [15], despite their significant differences in hardness and any influence of corrosive processes. It should also be noted that materials have different microstructures apart from the SS420 samples. When comparing only the martensitic SS420 materials it is noticeable that the total mass loss at 90° impingement is similar, but at 20° impingement, the higher hardness SS420 has significantly less total mass loss. This indicates that the hardness for a martensitic microstructure is significant only at 20° impingement where the majority of the damage is low angle abrasion. The total mass loss of the Stellite material was the highest of all the materials tested at both impingement angles.

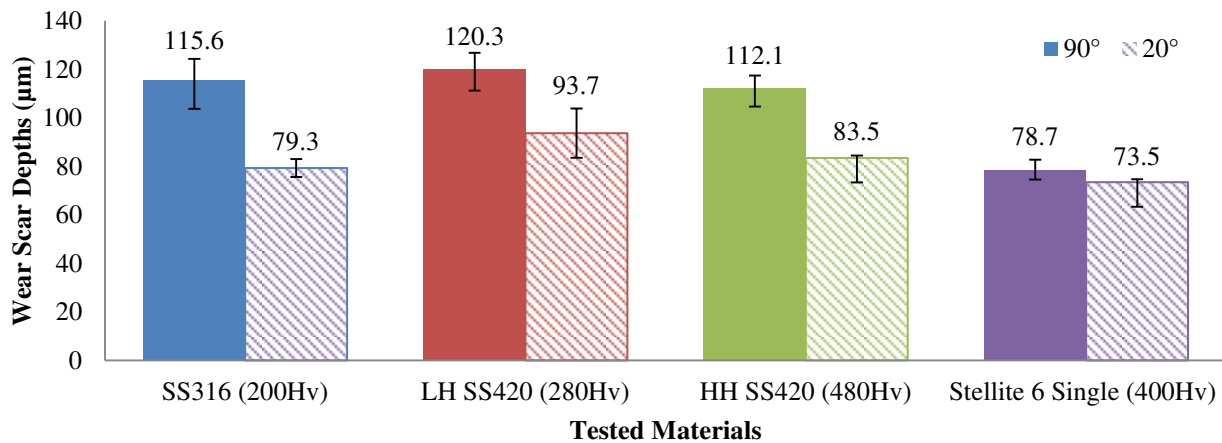
Figure 10 illustrates the average wear scar depths for the tested materials at both angles of impingement.

Figure 10: Average wear scar depths for the materials at both impingement angles

Wear scar depth measurements demonstrated that the wear scars were generally deeper in tests conducted at 90° impingement than these involving 20° angle. The Stellite 6 weld cladding demonstrated the lowest wear scar depths at both impingement angles. When comparing the average wear scar depth of the Stellite 6 weld cladding against the other tested materials, there was a 30-35% reduction in wear scar depth at 90° angle of impingement and a 7-22% reduction in wear scar depth at 20° impingement angle.

However, when comparing wear scar depths a different trend is found. These measurements indicate that the Stellite 6 weld cladding demonstrates the best direct impingement erosion-corrosion resistance of the tested materials at both impingement angles. There was a slight difference in the high and low hardness SS420 materials, but the wear scar depths were very similar indicating that there was not much difference between their performances in the DIZ. The SS316 had similar wear scar depths as the martensitic stainless steels. A reasonable explanation of this is local work hardening effects from the sand particles; which may also result in localised phase transformation from austenite to martensite [1,3,4,16].

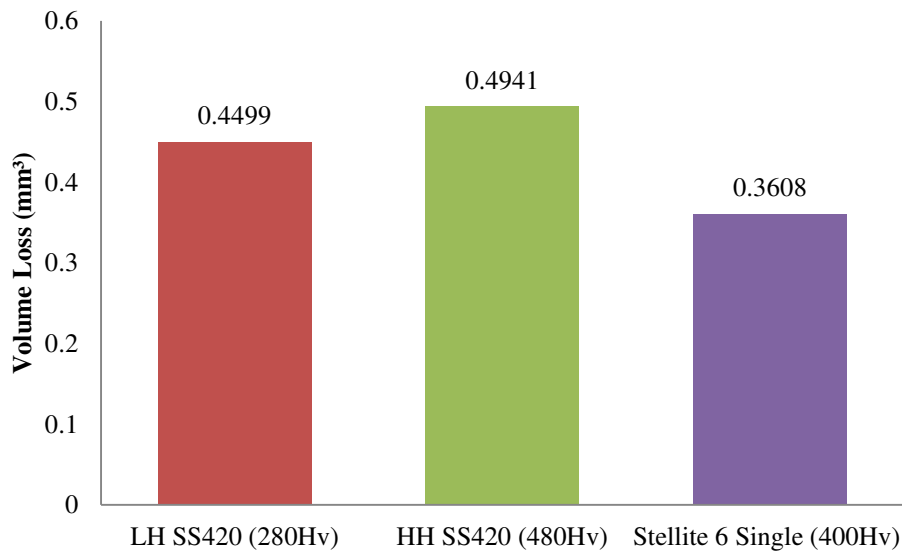
Figure 12: Volume losses of materials after 90° impingement tests

When volume losses are compared, there is some linkage to hardness, with the Stellite 6 weld cladding having the lowest volume loss with the high hardness martensitic SS420 having the greatest volume loss and the LH SS420 being an intermediate. There is also some linkage with wear scar depths and volume losses with Stellite 6 demonstrating the smallest material loss in both cases. However, the link is not so apparent for the martensitic stainless steels. A reasonable explanation for this is that the volume loss is dictated not only by the depth but also the shape of the wear scar. Therefore, a deep wear scar does not necessarily equate to a large volume loss, as can be seen in Figure 14.

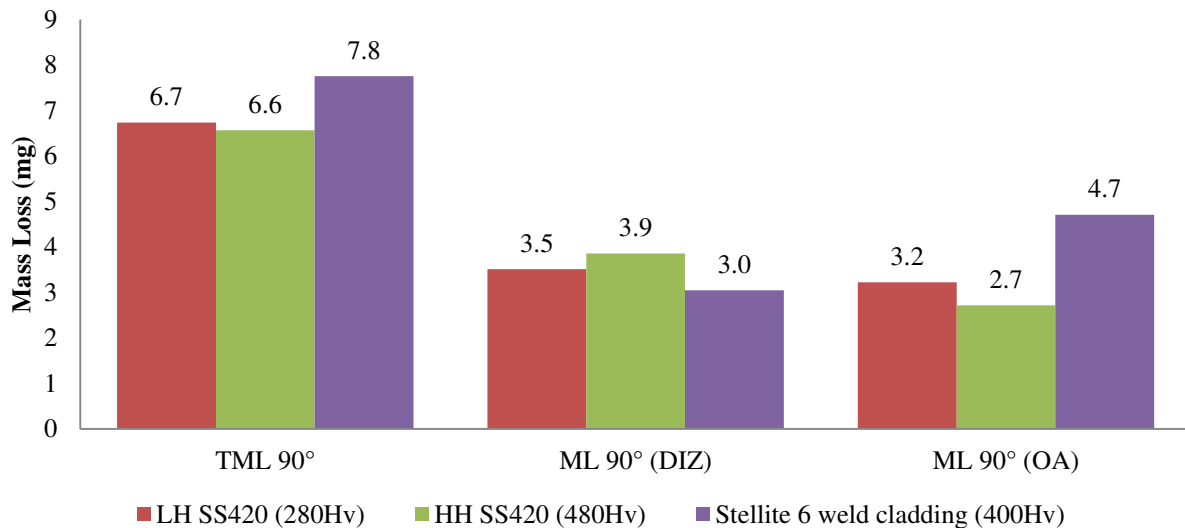
Figure 13 illustrates the breakdown of the mass losses into the two wear regions formed during 90° impingement testing conditions. The martensitic stainless steels demonstrated the greatest mass losses in the DIZ, due to the large volume loss, however they demonstrated a relatively low mass loss in the OA. The Stellite 6 weld cladding demonstrated the opposite trend; it had the lowest mass loss in the DIZ but portrayed the largest mass loss in the OA.

Figure 13: Breakdown of mass losses in the two distinct wear regions in 90° impingement conditions

The mass losses in the distinct zones (Figure 12) indicate that the Stellite 6 weld cladding has a slightly better wear resistance in the DIZ but in the OA its performance is significantly worse than that of the two martensitic stainless steels. It is well known that sliding abrasion resistance increases with hardness [17,18]. This relationship is demonstrated by the two martensitic stainless steels in that the HH SS420 has a reduction in mass loss when compared to the LH SS420. The high material loss in the OA of the Stellite 6 weld cladding, however, does not seem to correlate with its relatively high hardness. It may be that the relatively high mass losses of the Stellite 6 weld cladding in the OA are associated with enhanced pure corrosion or corrosion-induced synergy - especially as a synergy mechanisms may be facilitated by the complex microstructure of the Stellite (Figure 4).

In a general sense, Figure 13 clearly demonstrates how slurry jet tests that generate total mass loss data alone are likely to provoke interpretation of comparative material behaviour that is limited in scope and potentially

misleading in terms of the damage occurring in different regions of a component. This feature is clearly evident when comparing the performance of the Stellite weld cladding with the stainless steels in this study.

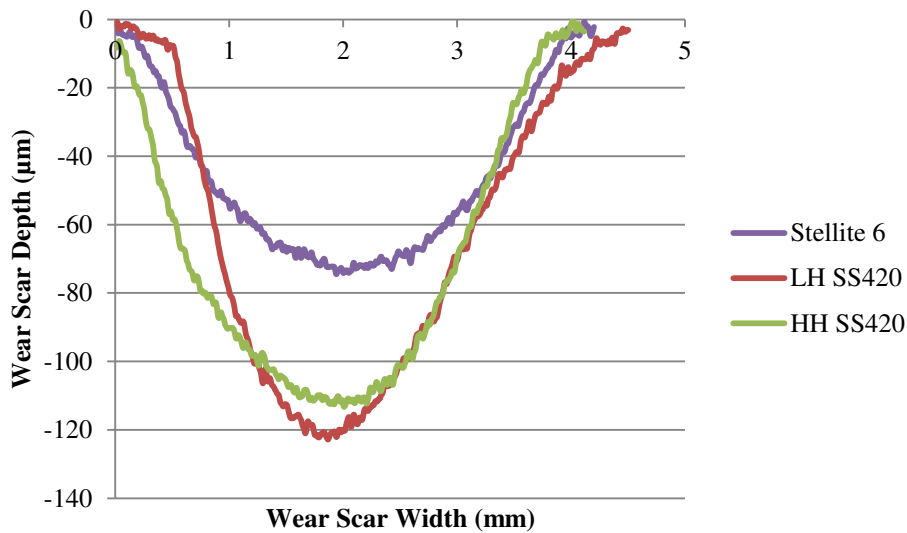
Figure 14: Comparison of wear scar profile for each of the tested materials
