# **Paper Title: ROBUSTNESS OF SIMPLE JOINTS IN PULTRUDED FRP FRAMES**

## ROBUSTNESS OF SIMPLE JOINTS IN PULTRUDED FRP FRAMES

Structural robustness of simple beam-to-column joints in pultruded frames is assessed through tension pull tests. The tying capacity and failure modes are determined from static tests on two batches of specimens for six joints. Tying resistance is an important joint property for maintaining structural integrity in frames in case of accidental loads. No tests have been previously reported to investigate this key structural property for the design of Pultruded Fibre Reinforced Polymer (PFRP) structures. The tension pull tests consist of a PFRP Wide Flange (WF) section bolted to a stiff steel baseplate by a pair of PFRP web cleats, and at the other end the tensile load is applied. One batch of three specimens has a WF 254×254×9.53 mm section with 100×9.53 mm cleats of equal leg-angle material and the other has a WF 203×203×9.53 mm with angles of size 75×9.53 mm. Tension versus displacement curves are plotted to establish linear-elastic response, damage onset, non-linear response and ultimate tensile strength. Damage initiation is characterised by audible acou

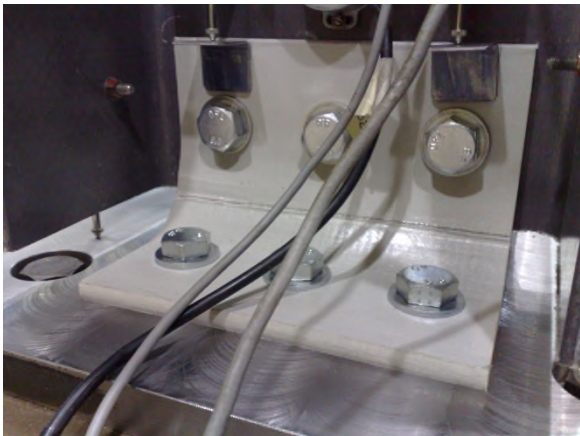
Fig. 4. Failure patterns for batch TP254\_3M16: (a) Before test; (b) After test; (c) Failed web cleat; (d) Vertical crack at the point of clamping.

The four parts in Figs. 4 and 5 are for photographs showing typical delamination cracking in the web cleats, and adjacent to the fillet radius. Part (a) is before resistance testing commenced, and part (b) afterwards. Part (c) shows a failed web cleat with part (d) used to expose vertical cracks at the line of clamping. This vertical fracturing close to a row of bolts is most prominent in Fig. 5(d), and is where the ultimate failure can be seen to possess a type of hinge mechanism. After disassembly there were no signs of bolt bearing failure in the PFRP beam web [20] or steel bolt failure, and neither of these distinct connection failure modes was expected. Damage within the cleats is assumed to be developing when there are audible acoustic emissions coming from the region of the cleats. Onset is followed by creation of hairline cracking and loss of contact between web cleats and the steel baseplate. Fracturing starts near the fillet radius, and as the tension imposed deformation increased it propagates from the radius along a leg towards the bolt row. Progressive damage growth eventually leads to the vertical cracking causing either loss of load-carrying capacity or instability of the specimen. In the case of the TP254 batch the loading was stopped at a displacement of about 18 mm (Fig. 6) because no further increase for  $P_{\max}$  (mean of 25kN) could be expected due to severe delamination cracks.

evident from cleat failure seen in Figs. 4 and 5 that a leg-angle ultimately fails due to a combination of extensive delamination damage and a through-thickness fracturing at three ‘hinge’ lines.
