This is a repository copy of *Finite Element Analysis of A Retrieved Custom-Made Knee Prosthesis*.

Sun, C, Wang, L, Wang, Z et al. (4 more authors) (2015) Finite Element Analysis of A Retrieved Custom-Made Knee Prosthesis. *Journal of Mechanics in Medicine and Biology*, 15 (3). 1550020. ISSN 0219-5194

# FINITE ELEMENT ANALYSIS OF A RETRIEVED CUSTOM-MADE KNEE PROSTHESIS

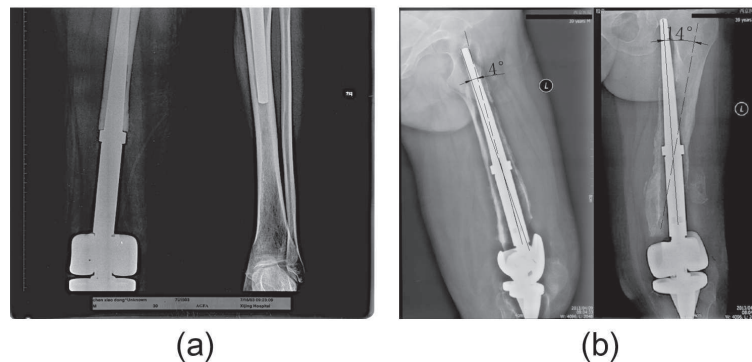
Fig. 1. CT images of the patient: (a) After primary arthroplasty, (b) 10 years after primary arthroplasty, before revision arthroplasty. The dotted lines represent the anatomical axis of the femur while the solid lines represent the axis of the femoral stem.

patient was diagnosed as prosthesis loosening post-surgery and sinus forming. Then a revision arthroplasty was operated. The CT images before the revision surgery are presented in Fig 1 (b). The misalignment angle between the and the axis of the femoral stem in frontal plane was  $14^\circ$  while in cortical plane was  $4^\circ$ . The retrieved prosthesis in revision arthroplasty is presented in Fig 2. From CT images as shown in Fig 1, the misalignment angle was increased during prosthetic service. Moreover, serious material loss was observed at the posterior region of the tibial plateau as shown in Fig 3 (a) and the CLSM (OLS4000, OLYMPUS, Japan) image is presented in Fig 3 (b).

Based on the observations in Fig 1, misalignment between the anatomical axis of the femur and the axis of the femoral stem was found to increase, which worsened

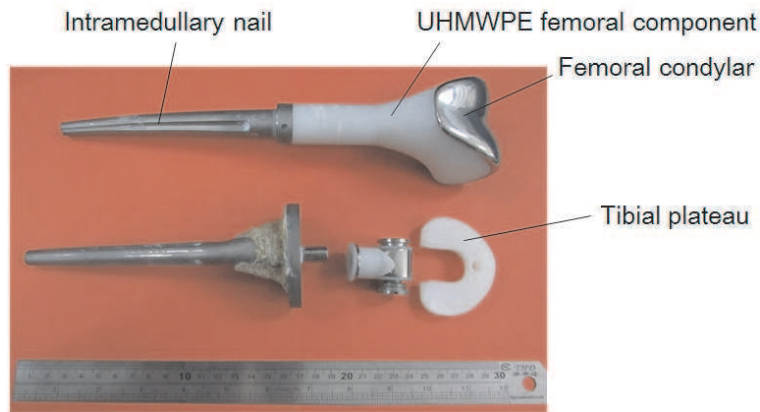
Fig. 2. Retrieved prosthesis showing the intramedullary nail, the femoral and the tibial parts.

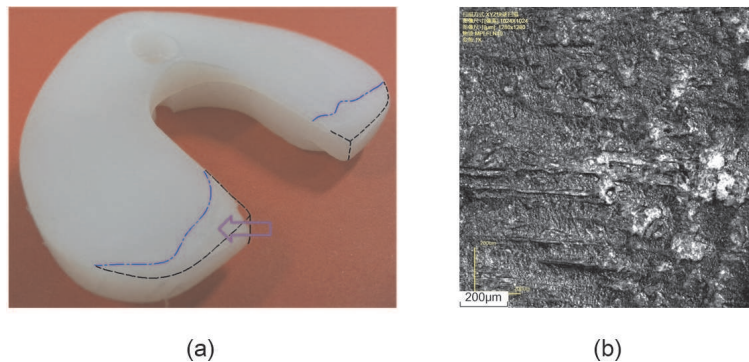
Fig. 3. (a) Retrieved tibial plateau; dashed line represented unworn outline of posterior region at tibial plateau. Dotted line represented boundary of worn area. (b) CLSM image taken on the surface of the posterior region at the tibial plateau (arrow).

of von Mises stress and contact pressure were found near the contact region between them. The close observation of the surface revealed a number of features as shown in Fig 3 (b). The worn surface morphology of the posterior region at the tibial plateau indicated wear mechanism including the scratching, the abrasion and the permanent deformation which related to the complex relative movement between the tibial plateau and the UHMWPE femoral component when the knee was under deep flexion during squatting or kneeling.

A great deal of material loss was found at the posterior region of the tibial plateau, corresponding to the high contact pressure area from the computational prediction. Fatigue wear occurred at the tibial plateau as it was under alternate loading which was much larger than the compressive yield stress of UHMWPE over a long period of time. The compressive yield stress of UHMWPE was 15-20 MPa in general.<sup>27,28</sup> Taking into account the impact of the relative sliding on the interface between the tibial plateau and the UHMWPE femoral component, a mass of material loss at the posterior region of the tibial plateau was produced. And then, wear debris, primary generated from the material loss of the UHMWPE components, would induce adverse biological response that leads to osteolysis and aseptic loosening.<sup>29-32</sup> Most Asian population had the habit of squatting or kneeling which would cause the collision between the tibial plateau and the UHMWPE femoral component. The collision would have caused great shock or stress on both tibial and femoral components. Furthermore, the proximal femoral prosthesis was lack of bony support.<sup>33</sup> Hence, the femoral stem had to bear bending moment which came from the collision. Besides, great von Mises stress was applied to the intramedullary nail and the femoral stem of the prosthesis by the collision. Structural improvement and optimization or a reasonable selection of the custom-made knee prosthesis should be considered to avoid the collision when the joint was under fairly high flexion-extension angle. Proper clinical postoperative guidance<sup>34</sup> such as minimizing times and duration of squatting or kneeling of patients in postoperative training programme should be encouraged to lower the occurrence of the collision.

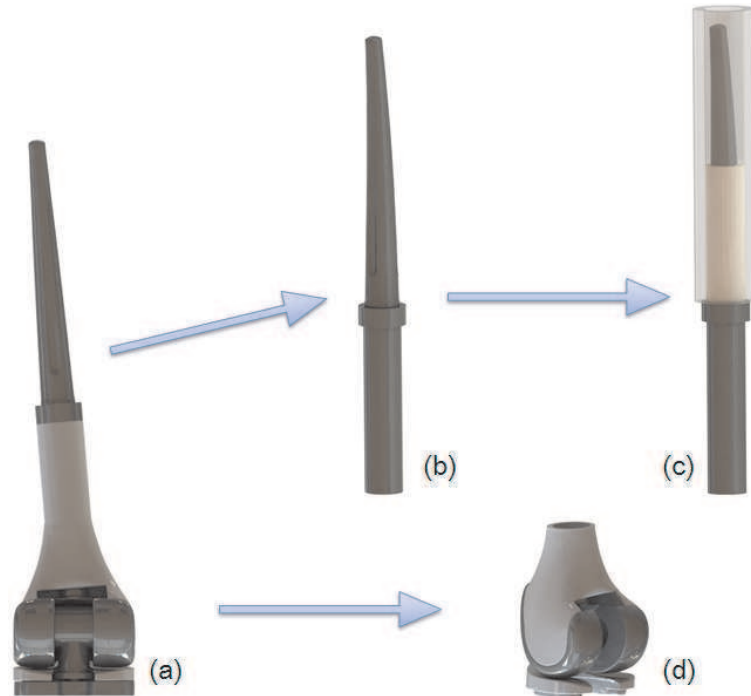
Fig. 4. 3D model of knee tumor prosthesis: (a) whole tumor prosthesis, (b) femoral stem, (c) femoral stem with femur and bone cement, (d) femoral condyle and tibial plateau.

Reverse engineering of artificial joints has been widely used in finite element analysis in order to obtain CAD models. First, the UHMWPE components of the prosthesis were scanned by micro-CT (Y. Cheetah, YXLON, Germany) while a laser scanner (Faro P12-7, Faro) was used for scanning the titanium alloy components. Mimics 10.01 (Materialise, Belgium) and Geomagic 12 (Geomagic, USA) were used to reconstruct 3D model from collected data. The femur was simplified as a hollow cylinder with 5 mm wall thickness which was determined from CT image of the patient. The void between the femur and the intramedullary nail was filled with bone cement. The assembled model of the whole prosthesis is presented in Fig 4.

the collision on the UHMWPE femoral component and the tibial plateau, a tibio-femoral contact model was developed as shown in Fig 4 (d). And an upper components model was separated from the whole model as shown in Fig 4 (c) for the purpose of finding out the effect of the misalignment angle on the stress/strain of the bone.

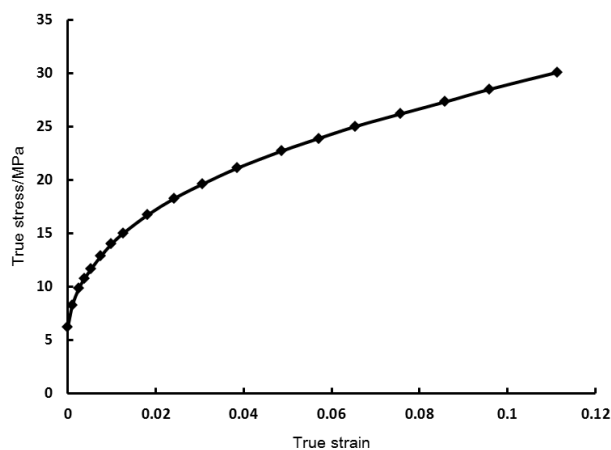
Fig. 5. Non-linear true stress-strain UHMWPE material model.

Three dimensional finite element models were created including a tibio-femoral model and an upper components model. All the materials were modelled as homogeneous, isotropic and linear elastic, except the UHMWPE which was modelled as non-linear elastic-plastic based on the true stress-strain constitutive relationship presented in Fig 5,<sup>21-23</sup> and all other material properties used in this study are given in Table 1.

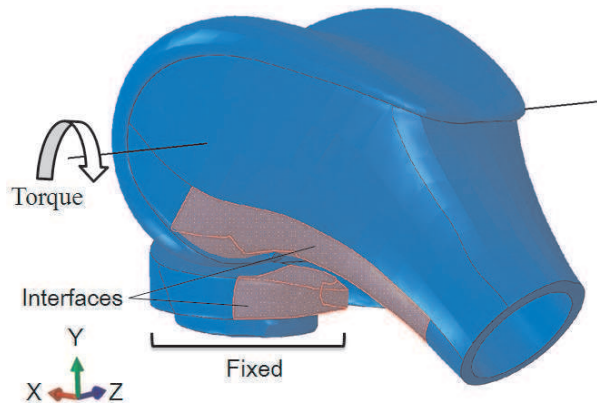
Fig. 6. FE model of tibio-femoral joint.

A simplified solid model which included the UHMWPE femoral component, the UHMWPE tibia plateau and the titanium alloy femoral condyle was imported to ABAQUS/CAE (Dassault, France) from Solidworks (Dassault, France). The titanium alloy femoral condyle was defined as rigid in the contact analysis since it has a much higher Young's modulus value compared with other components. Boundary conditions were applied to the model to imitate squatting when the flexion-extension angle reached approximately  $135^\circ$  as shown in Fig 6. All the six degrees of freedom of the bottom of the tibia plateau were limited. The translation along three coordinate axes and the rotation around the Z axis (the varus-valgus degrees of freedom of both the UHMWPE femoral component and the titanium alloy femoral condyle) were restricted, too. Relative motion between the UHMWPE femoral component and the titanium alloy femoral condyle was not allowed. A torque of 15 Nm, corresponding to the torque that the knee joint suffered under squatting, was estimated from a simple statics analysis<sup>25</sup> and applied to the rigid body femoral condyle around the flexion-extension axis of the prosthesis. Element type for the UHMWPE femoral component, the UHMWPE tibia plateau and the titanium alloy femoral condyle were chosen as C3D10M (a 10-node modified quadratic tetrahedron element) on account of its high accuracy and excellent performance in contact analysis. Mesh sensitivity was conducted, and a meshing size of 2 mm was found to be accurate enough as the relative error between meshing size of 2 mm and 1 mm was below 5%. The element number of the titanium alloy femoral condyle was 84701 and 63127 for the UHMWPE femoral component while the element number of the tibial plateau was 51051. Contact surface was defined as shown in Fig 6 to calculate the contact pressure when the collision between the UHMWPE femoral component and the UHMWPE tibia plateau occurred.

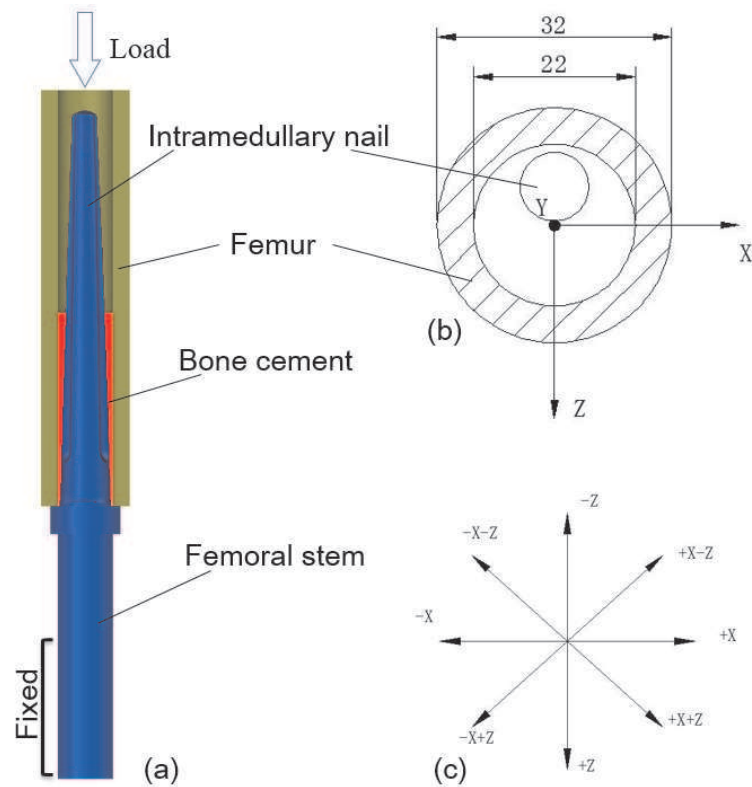
Fig. 7. (a) FE model of femoral stem, bone cement and femur. (b) The cross section of the model. (c) The illustration of misalignment direction.

Another solid model included the femoral stem, a simplified femur which the thickness was 5 mm and the bone cement was developed in ABAQUS/CAE. The femoral stem was defined as rigid body. As shown in Fig 7 (a), the interface between the bone cement and the intramedullary nail was tied, which was same to the interface between the femur and the bone cement. The lower part of the femoral stem was fully constrained. A pressure of 5.305 MPa corresponding to a concentrate force of 2600 N, approximately equaling to 4 times body weight for the patient's weight of 69 kg, was applied on the top surface of the simplified femur as shown in Fig 7 (a). For the purpose of the investigation of the effect of misalignment angle and direction on the stress in the bone, misalignment angles between the anatomical axis of the femur and the axis of the femoral stem were defined as  $3^\circ$  and  $6^\circ$ , respectively. As  $3^\circ$  is within the normal clinical error in arthroplasty<sup>26</sup> while  $6^\circ$  was chosen to study the consequence of an unsatisfactory surgery. The

misalignment direction was defined in Fig 7 (b) and (c): X was considered to be positive in the medial to lateral direction while Z was considered to be positive from posterior to anterior. Eight equally spaced misalignment directions were considered. Element type for the femoral stem, the femur and the bone cement was chosen as C3D10M and meshing size was 2 mm, which were same as the tibio-femoral contact analysis. The number of element of the femoral stem, femur and bone cement was 62435, 55522 and 17062, respectively.

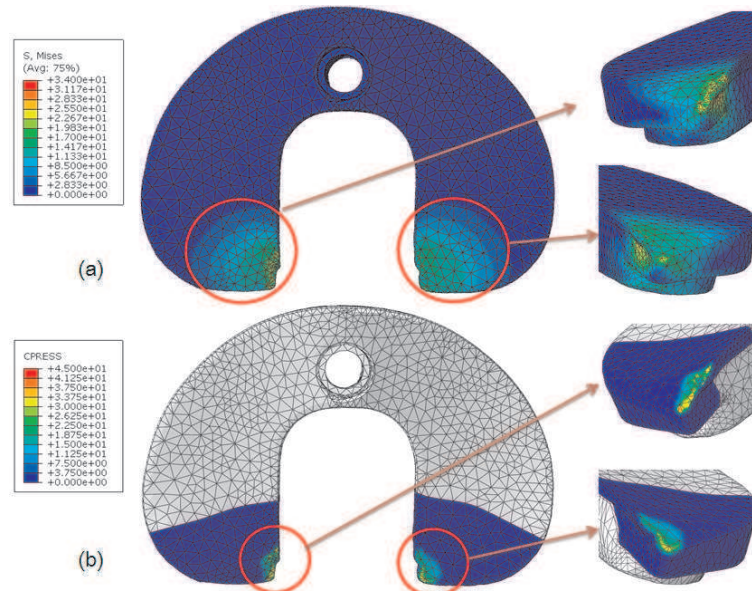
Fig. 8. The contour plot of the predicted (a) von Mises stresses and (b) contact pressure (MPa) at the tibial plateau.

The collision between the tibial plateau and the UHMWPE femoral component was simulated using FEA modeling. The maximum contact pressure on the surface of the tibial plateau was 44.88 MPa at the lateral part and the maximum contact pressure at the medial tibial plateau was 36.62 MPa. The estimated von Mises stress at the tibial plateau showed a large stress concentration near the interface between the tibial plateau and the UHMWPE femoral component. The maximum von Mises stress at the tibial plateau was 33.79 MPa at the medial plateau while at the lateral plateau was 31.22MPa. The estimated von Mises stress and contact pressure are presented in Fig 8.

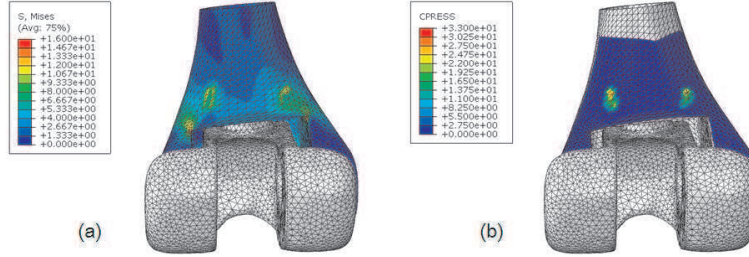
Fig. 9. The contour plot of the predicted (a) von Mises stresses and (b) contact pressure (MPa) at the UHMWPE femoral component.

In addition, von Mises stress and contact pressure at the UHMWPE femoral component were calculated and are presented in Fig 9. The local maximum von Mises stress was 15.58 MPa around the interface between the UHMWPE femoral component and the tibial plateau.

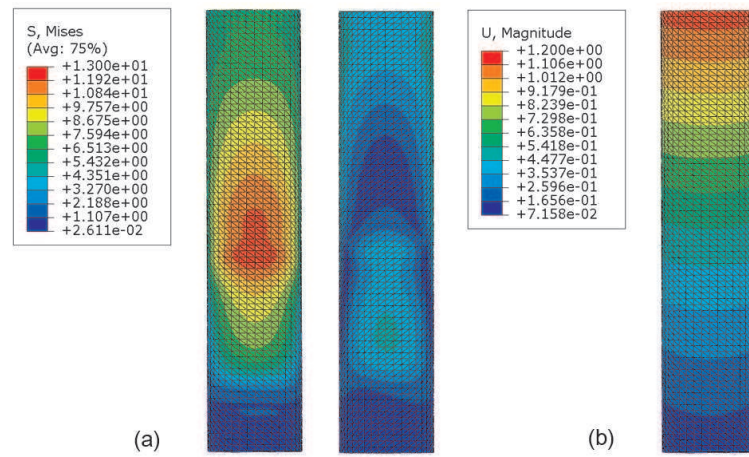
Fig. 10. The predicted von Mises stress (MPa) and deformation (mm) distribution at the femur when the misalignment angle was  $6^\circ$  in the Z direction.

The maximum von Mises stress together with the maximum deformation were predicted when the femur stem was at misalignment angles of  $3^\circ$  and  $6^\circ$  away from anatomical axis of the femur and are presented in Table 2. The predicted von Mises stress and strain distribution at the femur at a misalignment angle of  $6^\circ$ , in the positive Z axis direction of are presented in Fig 10 as an example. The maximum von Mises stress appeared on the same side of misalignment direction (see Fig 10 (a) left) near the middle section of the femur while the maximum deformation appeared at the proximal femur. And the comparison of these two groups is presented in Fig 11.

distribution at the femur when the misalignment was  $6^\circ$  in the Z direction as an example, as presented in Fig 10 (a) (right), the stress value is below 7 MPa at "-Z" side of the bone. This part of bone experienced a lower stress and consequently resulted in stress shielding and aseptic loosening.<sup>38,39</sup> The aseptic loosening further exacerbated the misalignment between the anatomical axis of the femur and the axis of the femoral stem. The increase of the misalignment angle, as evident from the CT image in Fig 1 (b), confirmed this viewpoint. In addition, the intramedullary nail was designed to fill the intramedullary space, and a relatively large diameter was chosen. This further accelerated the stress shielding.

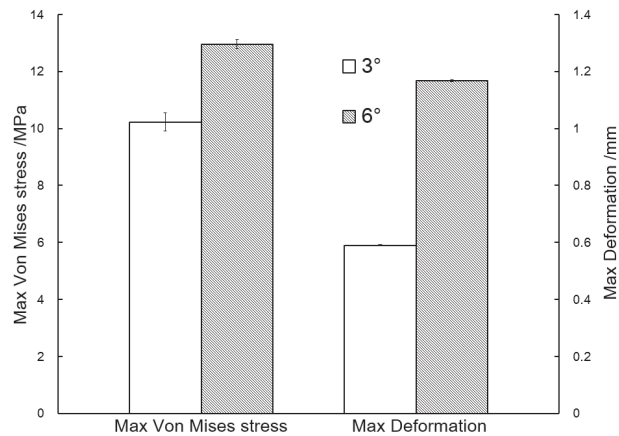
Fig. 11. The Maximum Von Mises stress and maximum deformation at the femur when misalignment angle was  $3^\circ$  and  $6^\circ$  respectively (error bar stands for standard deviation for eight directions).
