Flooding in Boscastle and North Cornwall, August 2004 Phase 2 Studies Report

Report EX 5160
Release 1.0
May 2005

On 16 August 2004 an extreme rainfall event took place near the north Cornwall coast when up to 200 mm of rain fell in a period of approximately 5 hours.. This rainfall led to severe flooding in the Valency and Crackington Stream catchments and serious flooding on the Rivers Ottery and Neet. This report describes the rainfall, and the flooding caused by the event. It was produced for the Environment Agency by HR Wallingford Ltd (HRW) with analyses of the meteorological, hydrological and hydraulic aspects of the event being undertaken by the UK Met Office (UKMO), the Centre for Ecology and Hydrology, Wallingford (CEH) and HR Wallingford, respectively. Field work and data collection for the Valency and Crackington Stream catchments were carried out by Halcrow and Royal Haskoning, respectively.

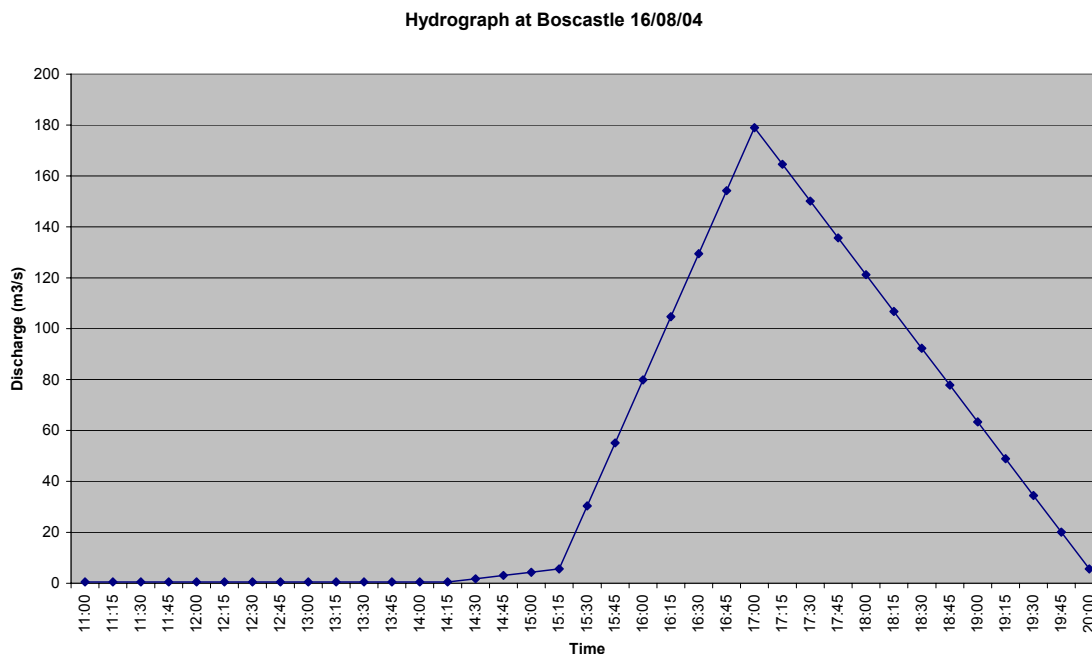
Figure 2.1 shows a reconstruction of the hydrograph shape at Boscastle based on the observations, this can be compared with the predicted hydrograph in Figure 6.30.

Figure 2.1 Reconstruction of the hydrograph shape at Boscastle

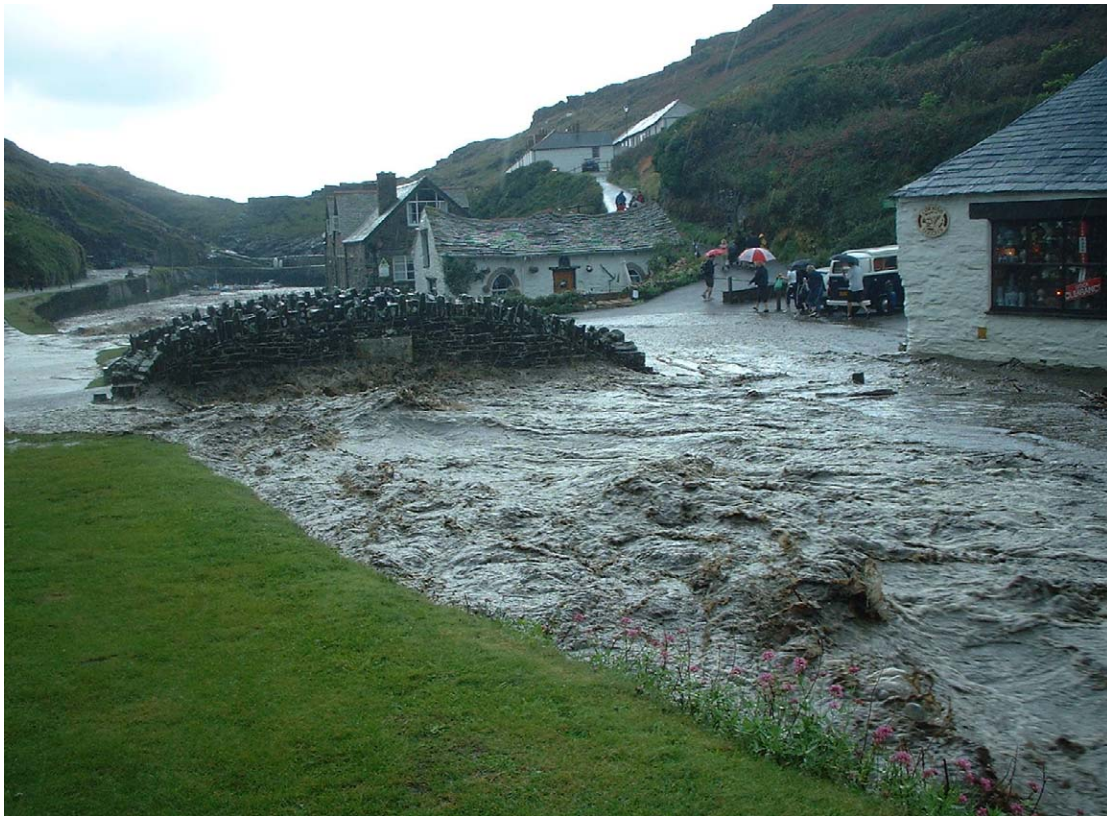
Plate 2.1 Flooding on the Valency River at the small bridge. River comes out of bank. (Stollery, 15:43 BST)

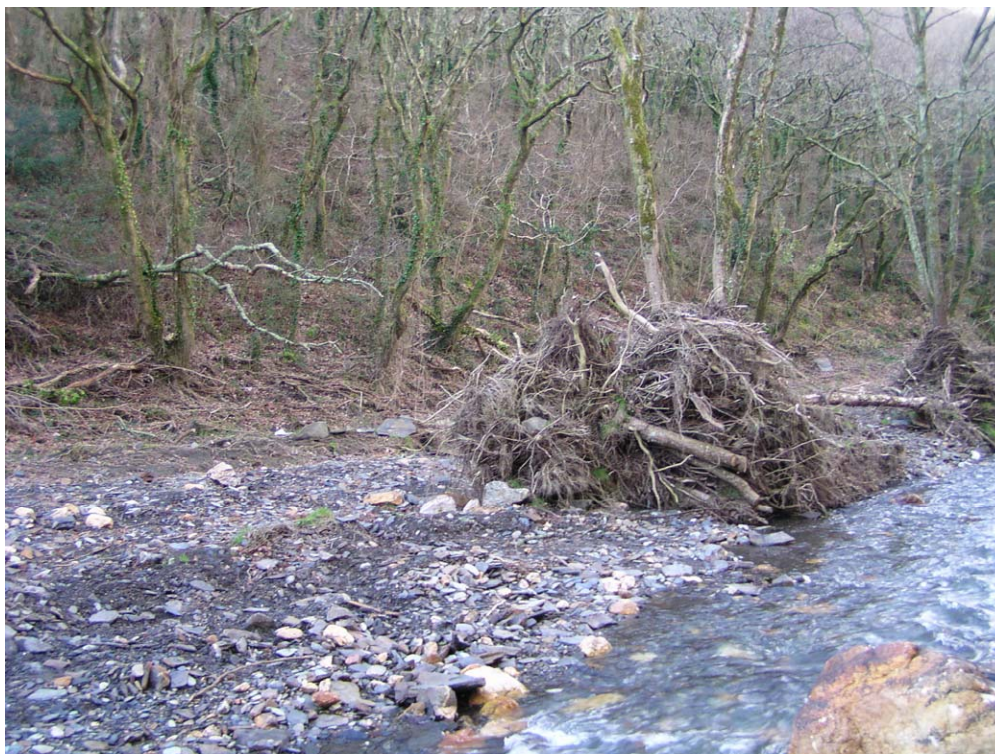
About 50 - 100 metres upstream of this reach there is a channel avulsion, with the new channel formed on the right floodplain. This is likely to have been caused by a build up of trash across the pre-flood main channel. The flow was displaced by the trash dam and eroded a new channel on the right floodplain, see Plate 3.1.

Plate 3.1 Channel avulsion caused by trash dam

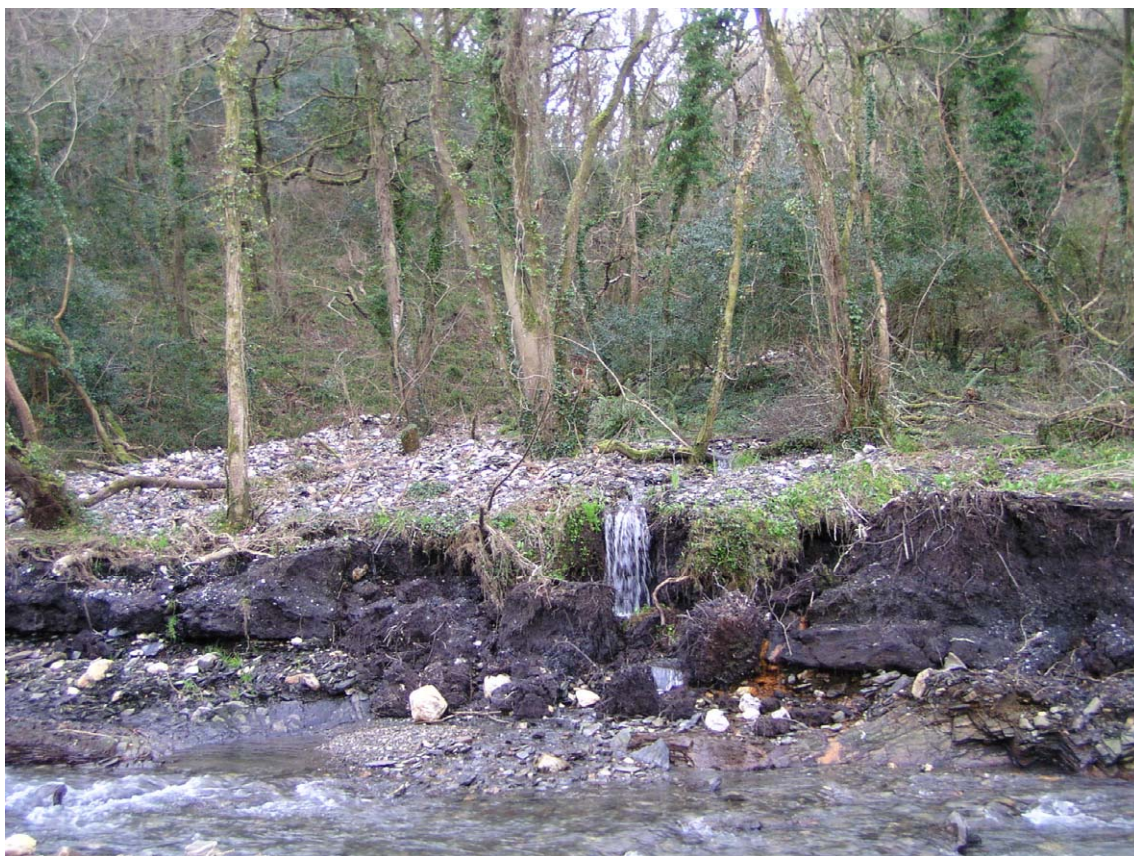
In the reaches immediately upstream and downstream from the tributary flowing from Minster Church (called Minster Stream in this account) there was an area of bank erosion, incision and lateral movement caused by the build up of trash. There were several trash dams, predominantly on the right bank, which had built up during the flood, causing a reduction in the velocity of the flood flow on the right bank and leading to deposition upstream of the trash dams. The channel had incised to bedrock. A headcut had been initiated on Minster Stream, just upstream from the confluence, occurring due to the difference in bed level resulting from the main channel incision, see Plate 3.2. There has been deposition on the alluvial fan of the tributary.

Plate 3.2 View from main channel looking towards Minster Stream showing deposition on the alluvial fan and a head cut where tributary enters main river channel

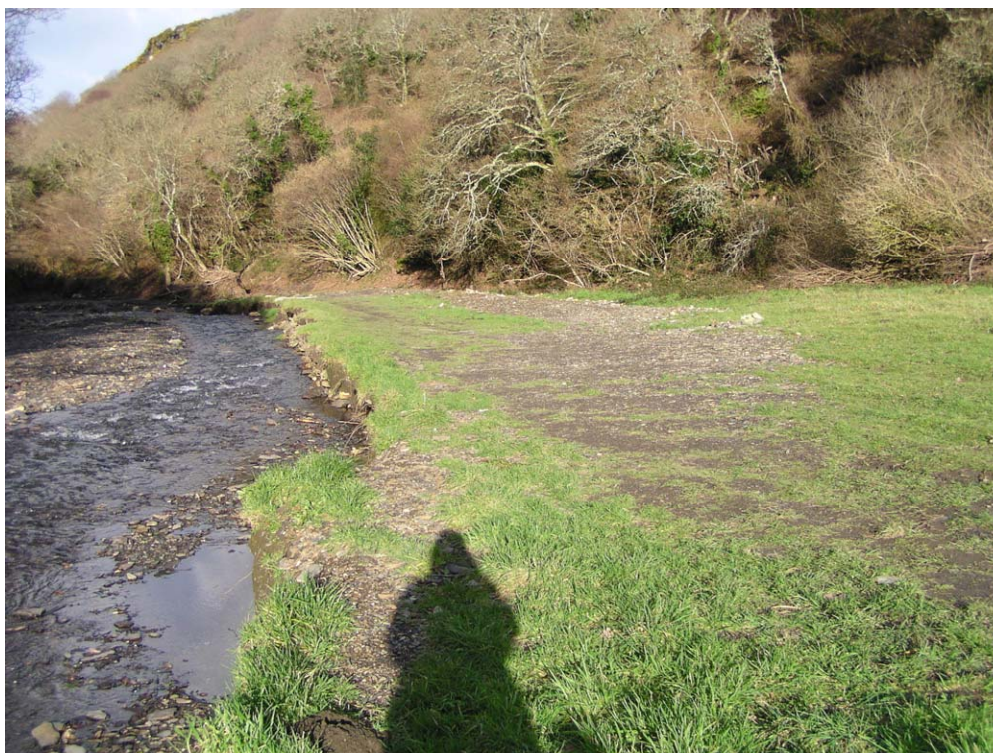
Plate 3.3 Deposition on right floodplain from flood recession

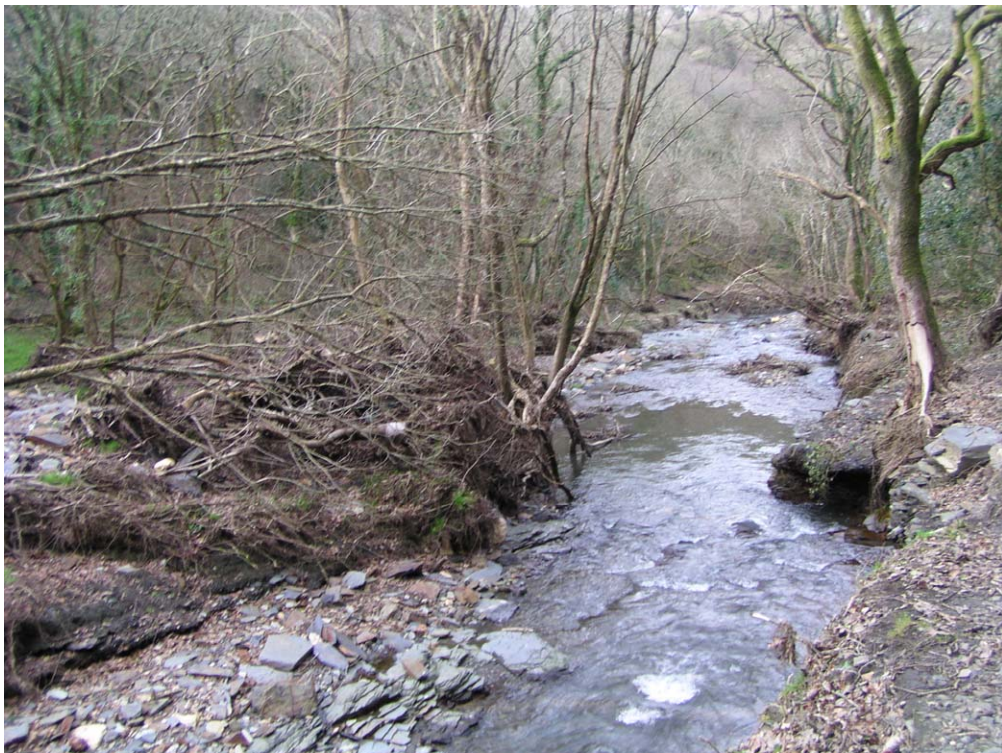
Plate 3.5 Trash dams causing local deposition and incision

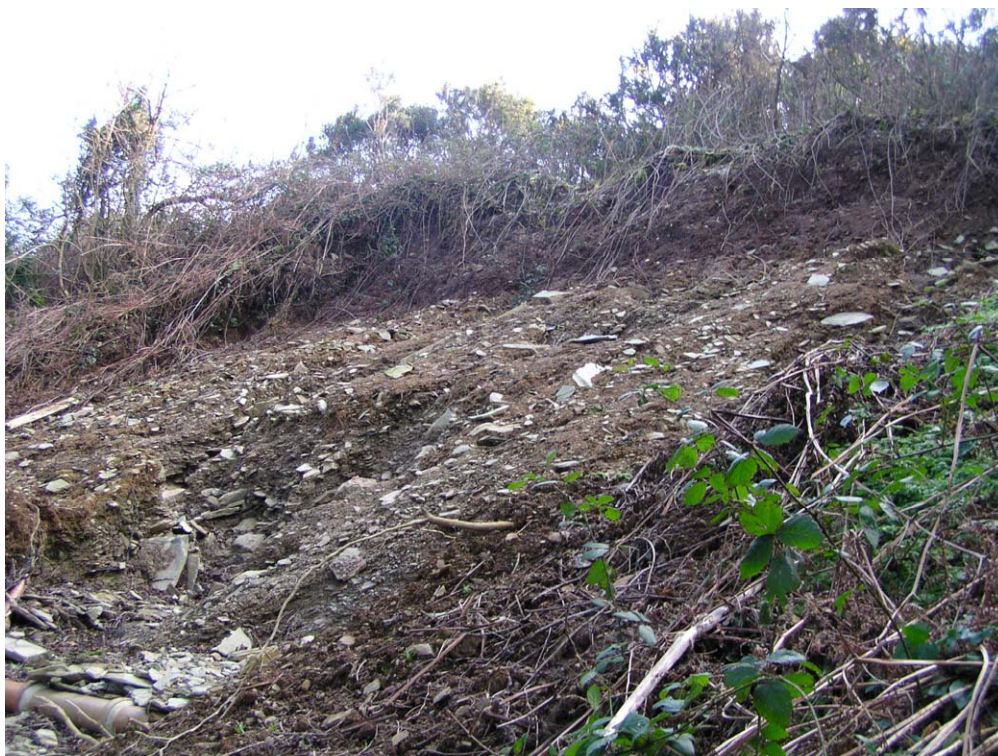
Plate 3.9 Land slipping on the valley sides of the River Jordan

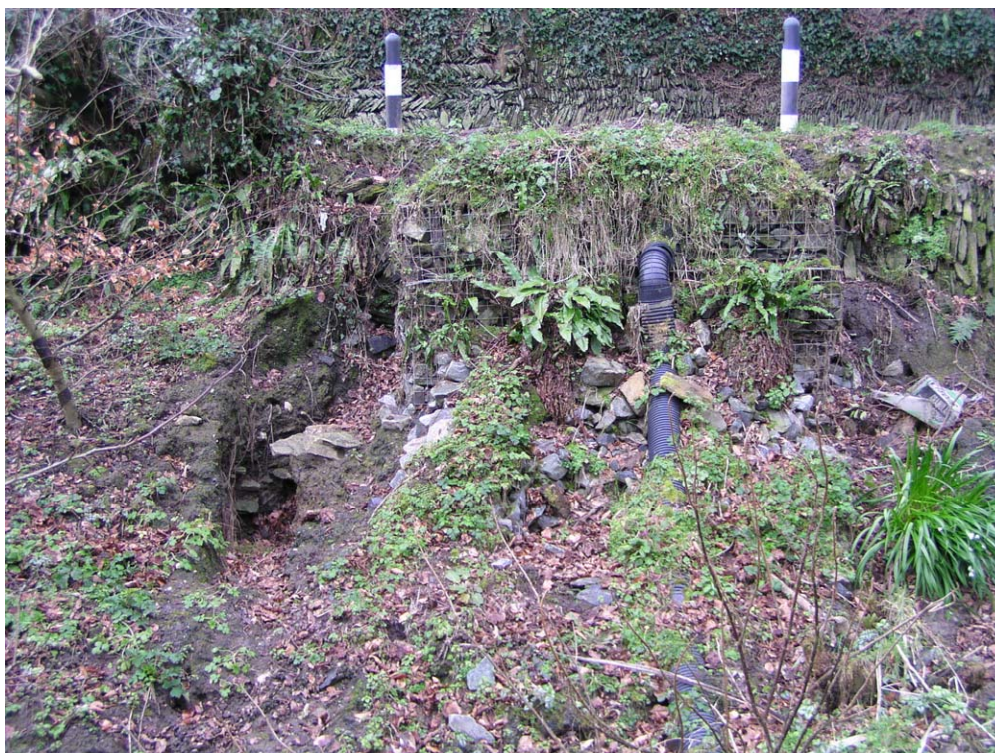
Plate 3.10 Overland runoff from roads causing erosion

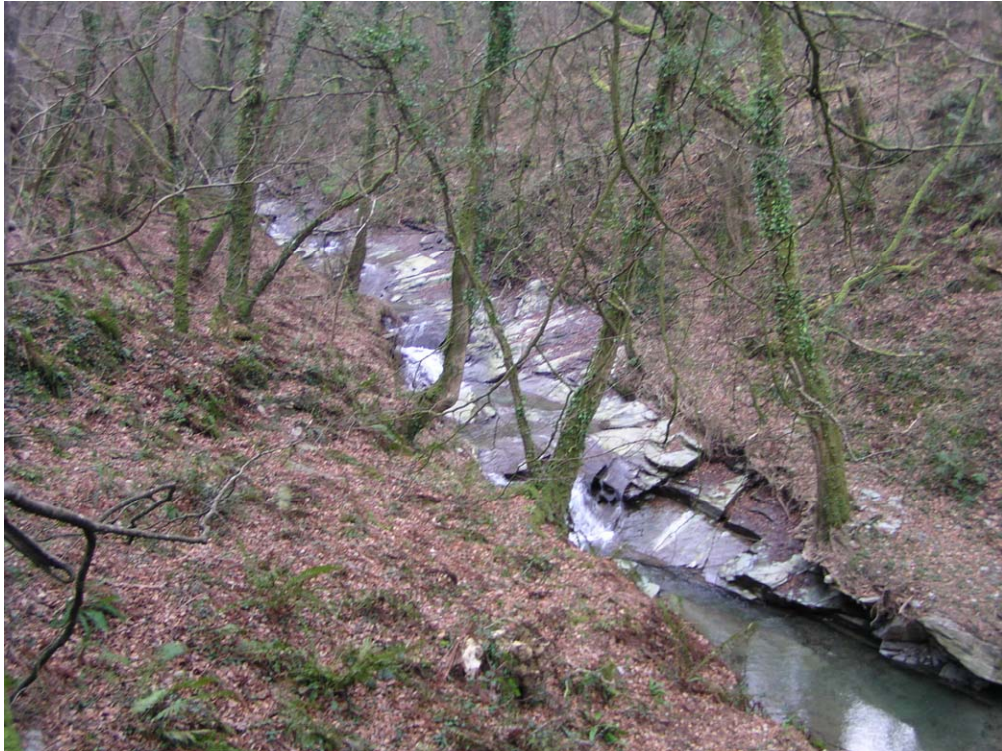
There was incision to bedrock along much of the tributary, which was up to 2m deep in places (see Plate 3.12). There were local areas of deposition where the slope decreases and, conversely, there was significant bank erosion in places. There were also a few areas of avulsion.

Plate 3.14 Incision to bedrock on the Lesnewth Stream

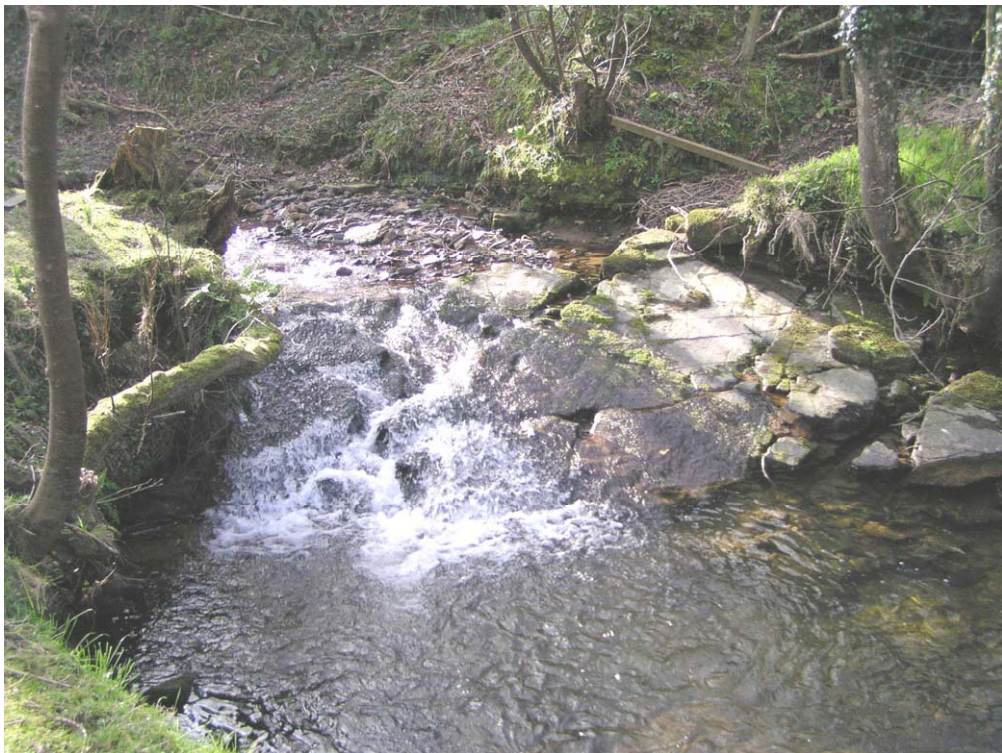
Plate 3.17 Pool caused by bedrock control

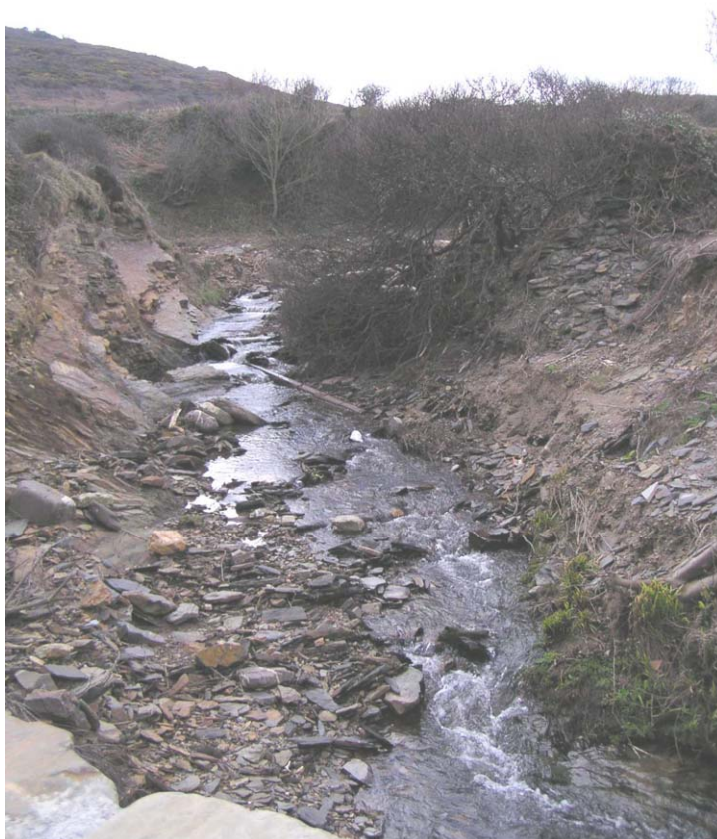
Moving 100m upstream from Mineshop Bridge, there was a trash dam which caused an avulsion, with the new channel cutting into the left floodplain. There was a headcut into the clay bed just upstream from the trash dam and pockets of deposition immediately upstream from the headcut. The predominant geomorphological impact though, was the severe incision that had occurred along this reach, in places down to the bedrock (see Plate 3.18).

Plate 3.18 Incision to bedrock

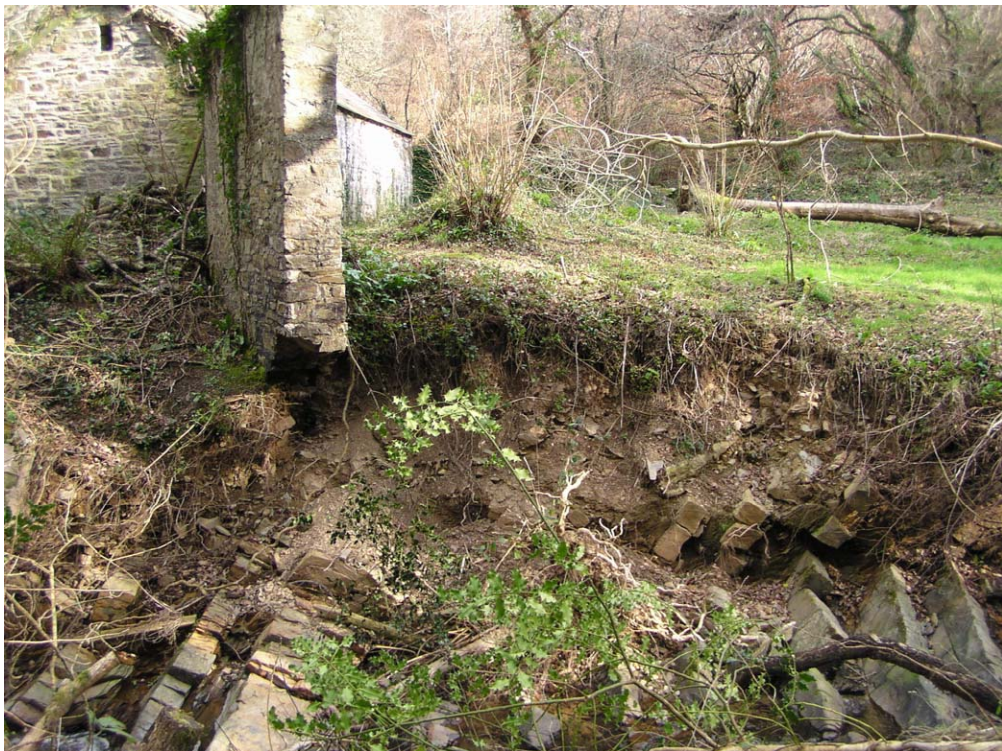
Plate 3.19 **Erosion of bank under stone building wall**

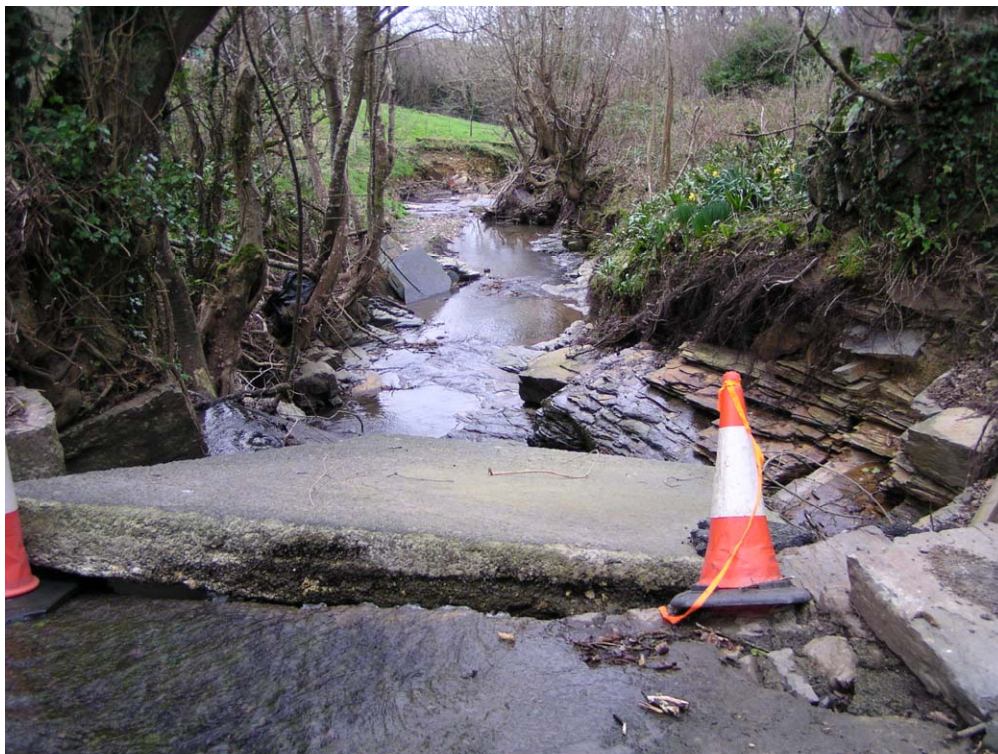
Plate 3.21 **Erosion at Lansweden ford**

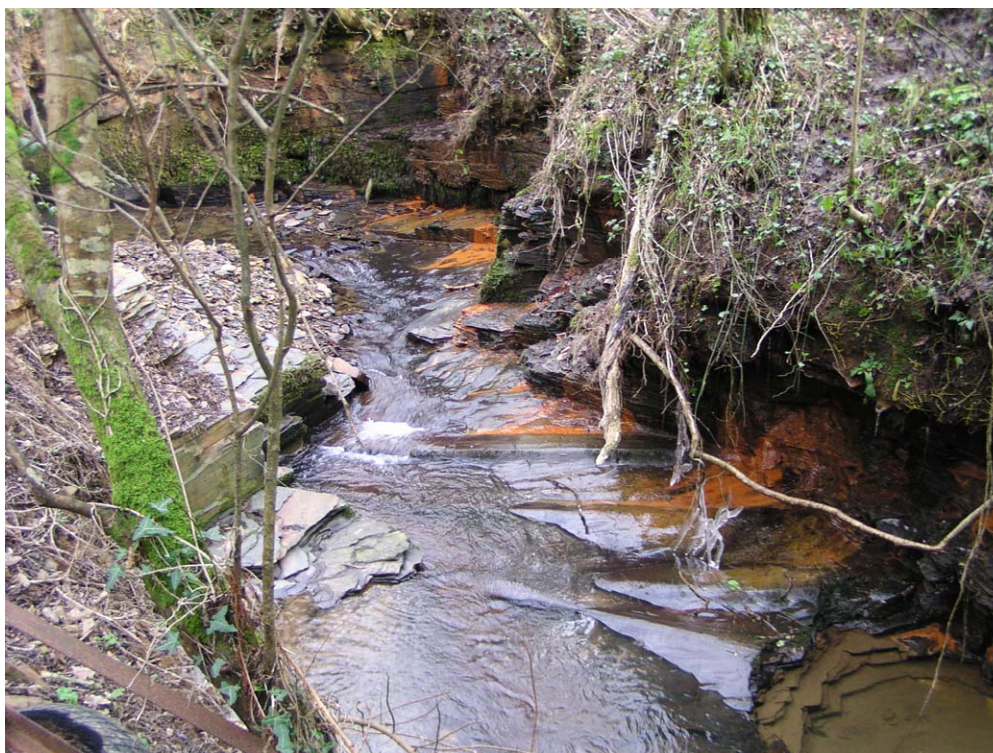
For 100m to 200m upstream from the confluence with Crackington Stream, there were pockets of bank erosion and widening on the Mineshop Stream. There was then a reach of severe incision to bedrock (see Plate 3.22). The incision and widening reduced further upstream.

Plate 3.22 Incised reach on Mineshop Stream

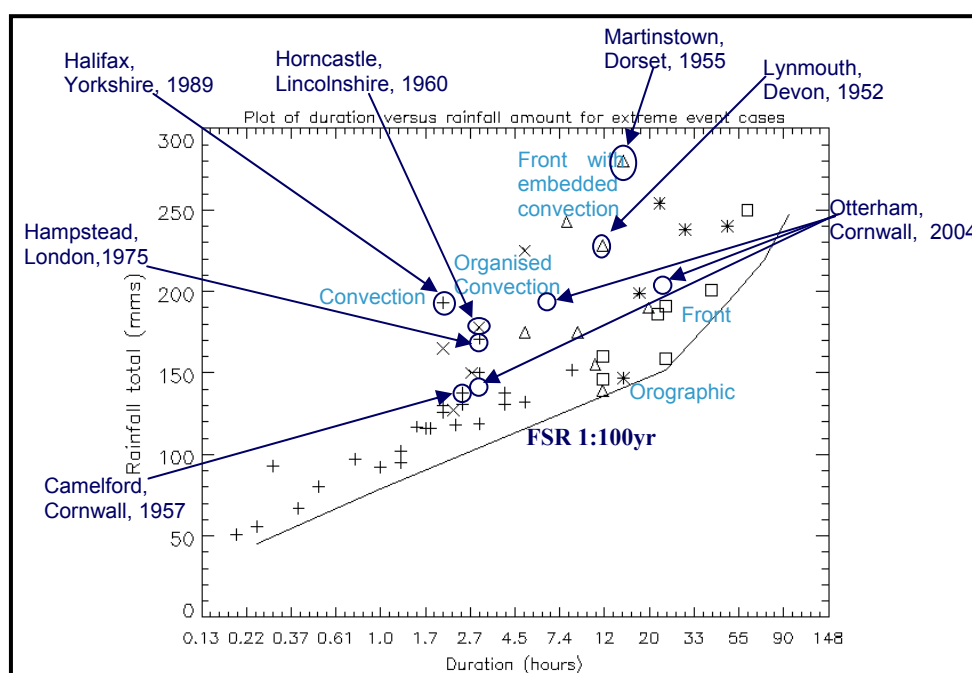
Figure 4.17 Extreme rainfall events of the 20th century with Boscastle superimposed. The dominant mechanism is convection (+), organised convection (x), frontal (□), frontal with embedded convection (△) or orographic (*).

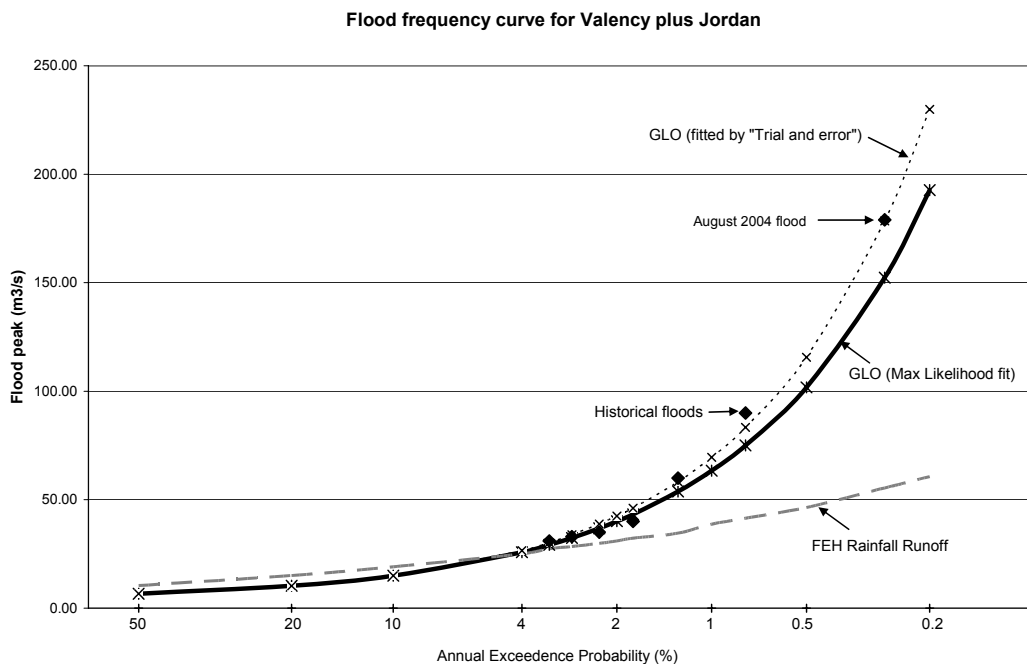
Figure 5.10 Estimated flood frequency curve for the Valency/Jordan catchment at Boscastle

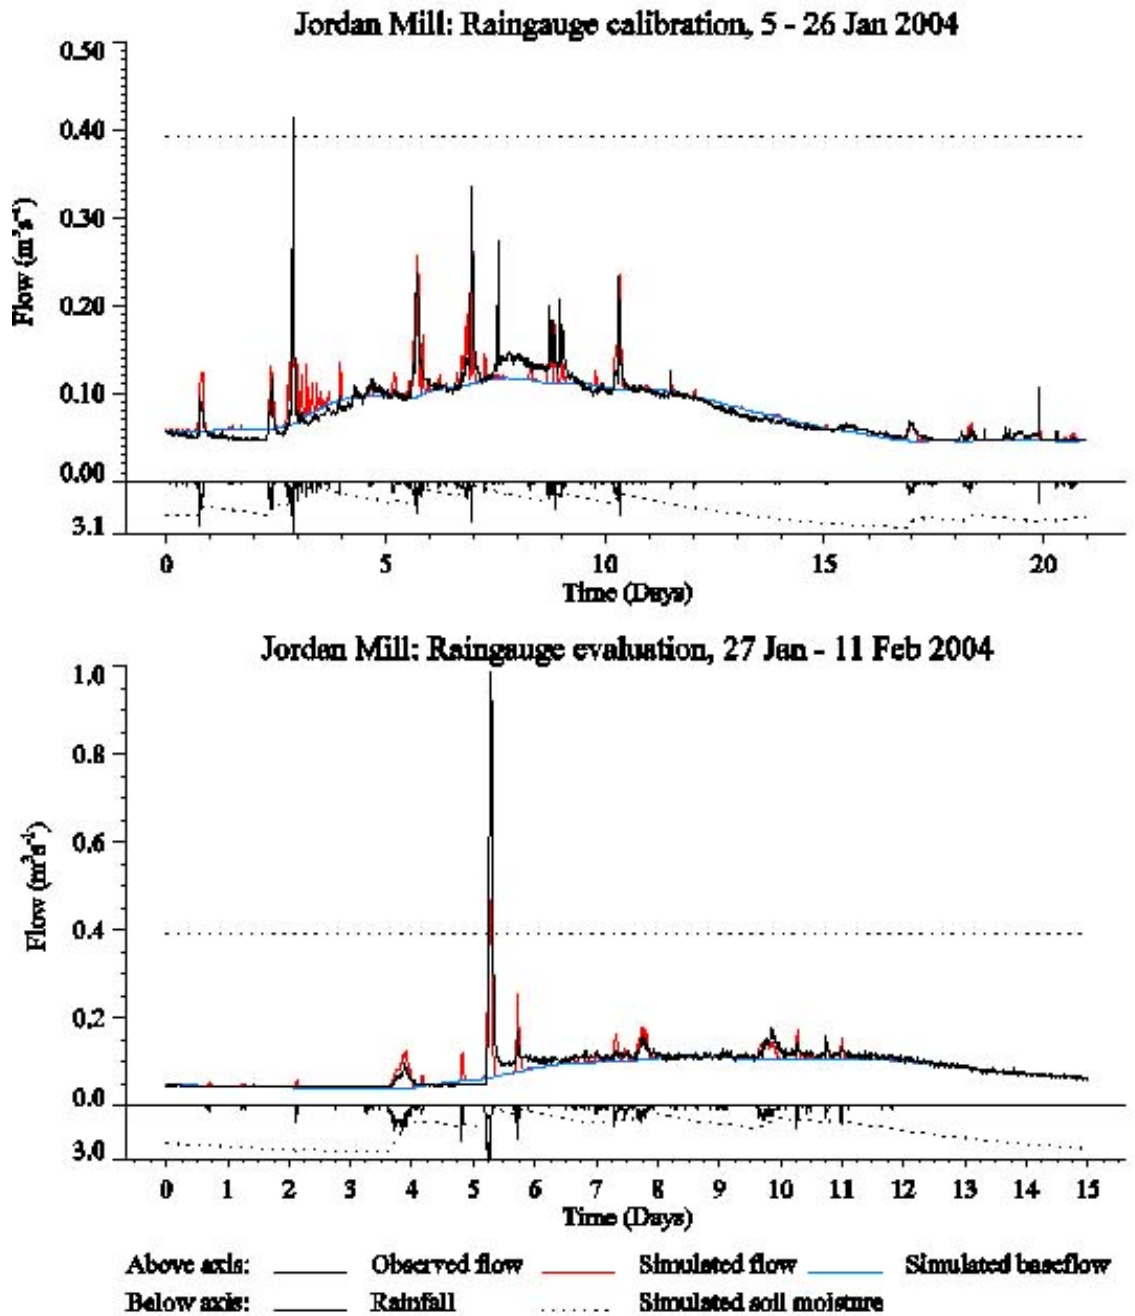
Figure 5.11 Hydrographs for calibration and evaluation periods for the Jordan catchment. The figure below the axis is the maximum 15 minute rainfall accumulation for the catchment. The horizontal dashed line indicates the upper threshold of the rating equation.

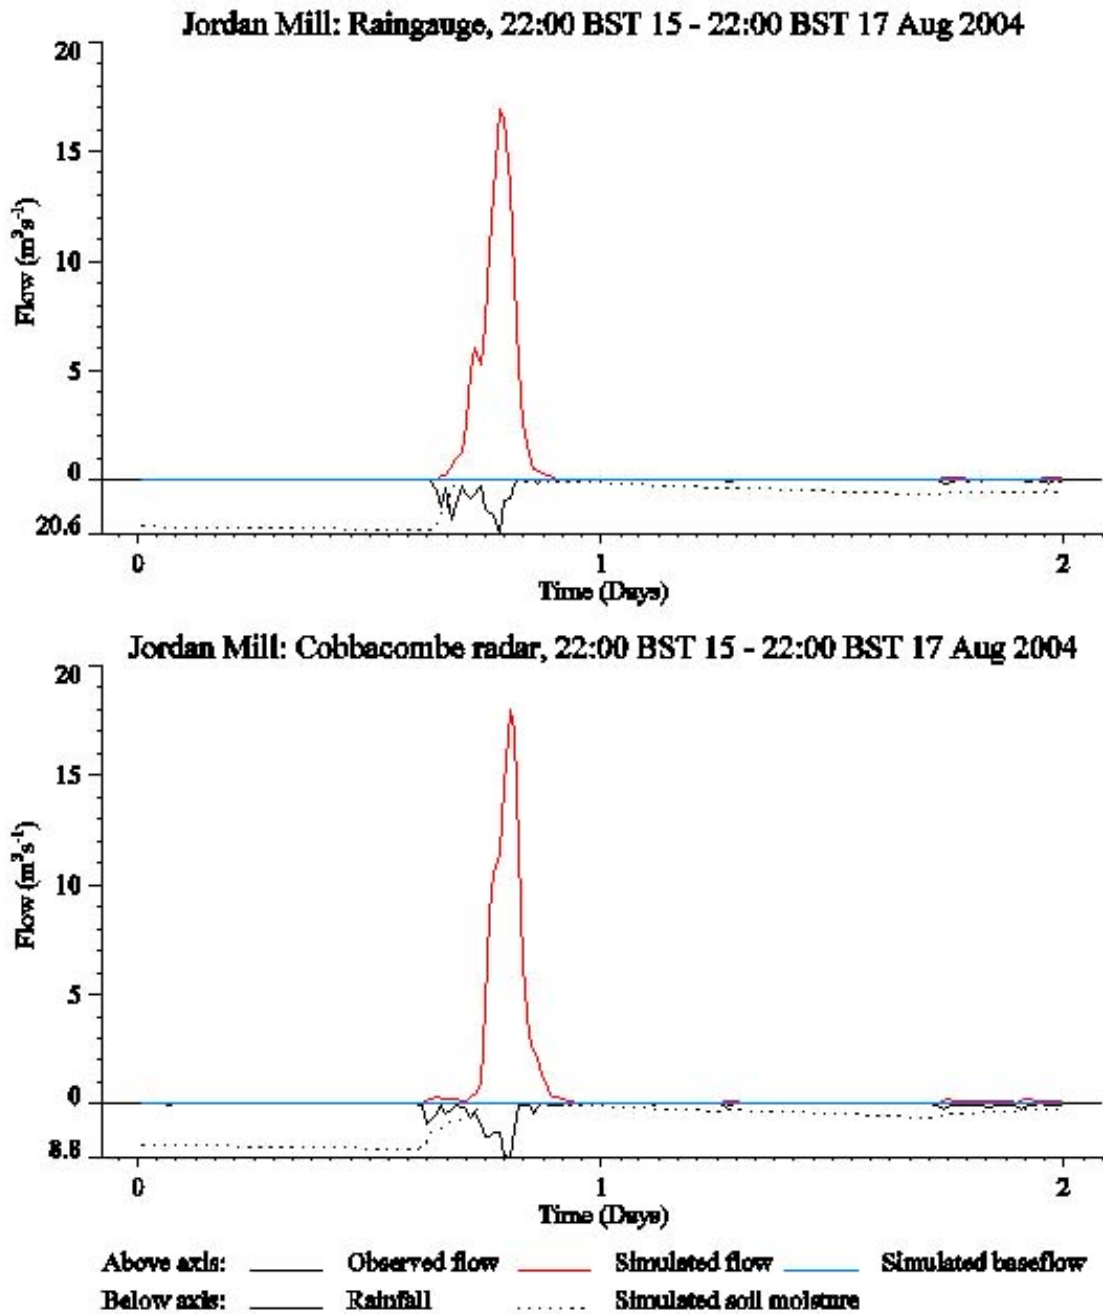
Figure 5.12 Hydrographs for the Boscastle event for the Jordan catchment using raingauge and Cobbacombe Cross radar data. The figure below the axis is the maximum 15 minute rainfall accumulation (for either raingauge or radar) for the catchment.

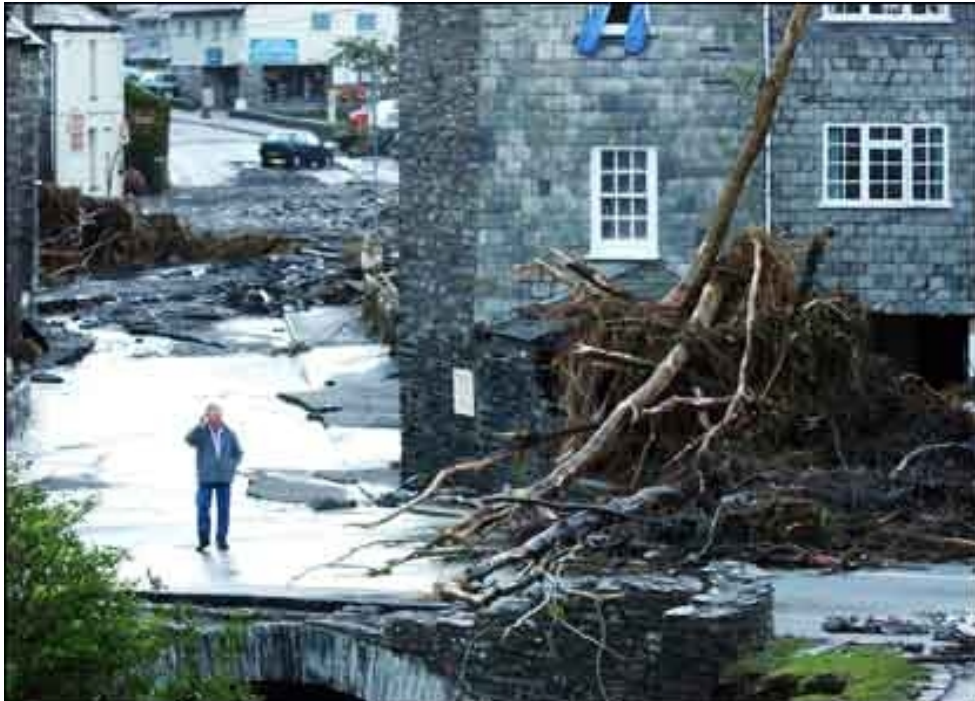
Plate 6.4 Photograph showing debris against the upstream parapet of the B3263 Road Bridge. Source: BBC

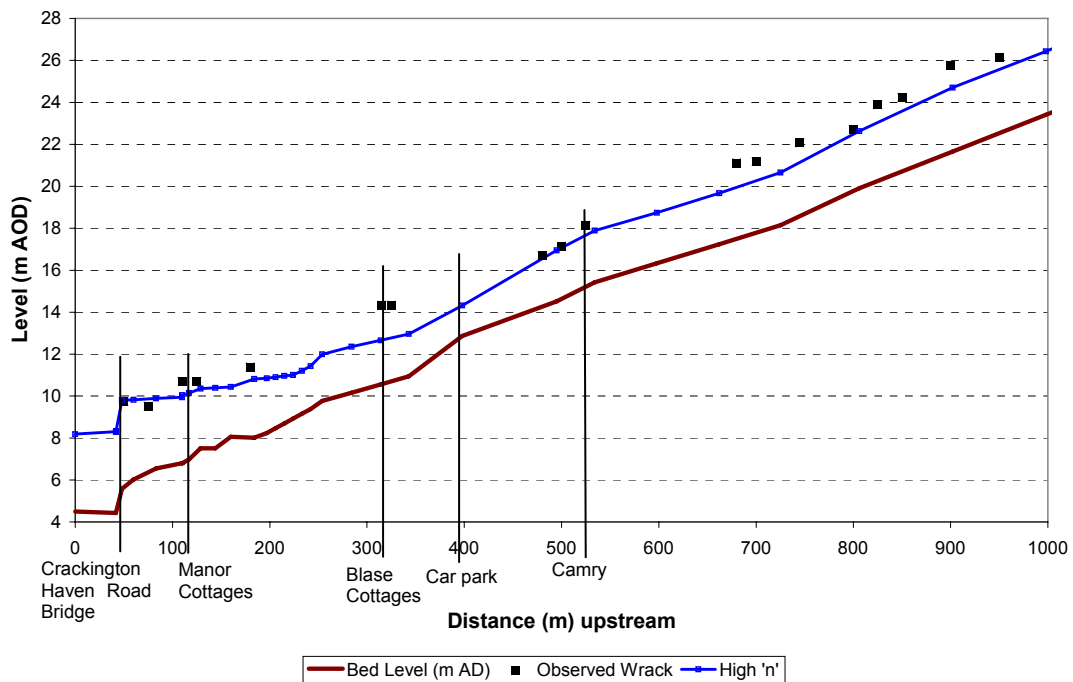
Figure 6.36 Water level compared to observed wrack levels in the downstream km of Crackington Stream modelled

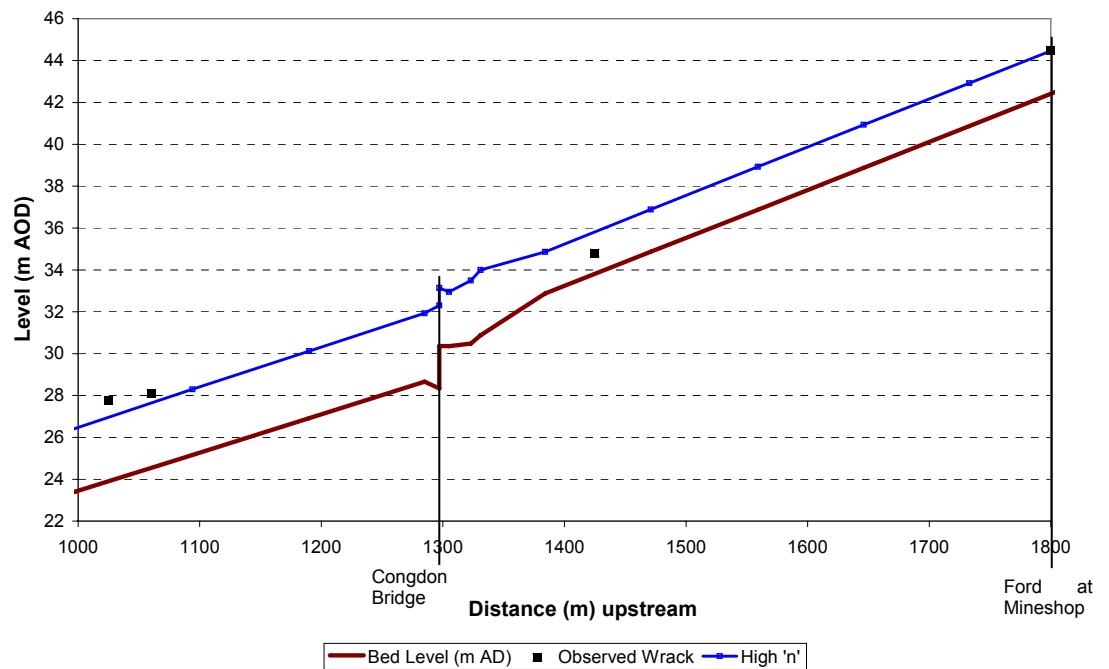
Figure 6.37 Water level compared to observed wrack levels in the upstream km of Crackington Stream

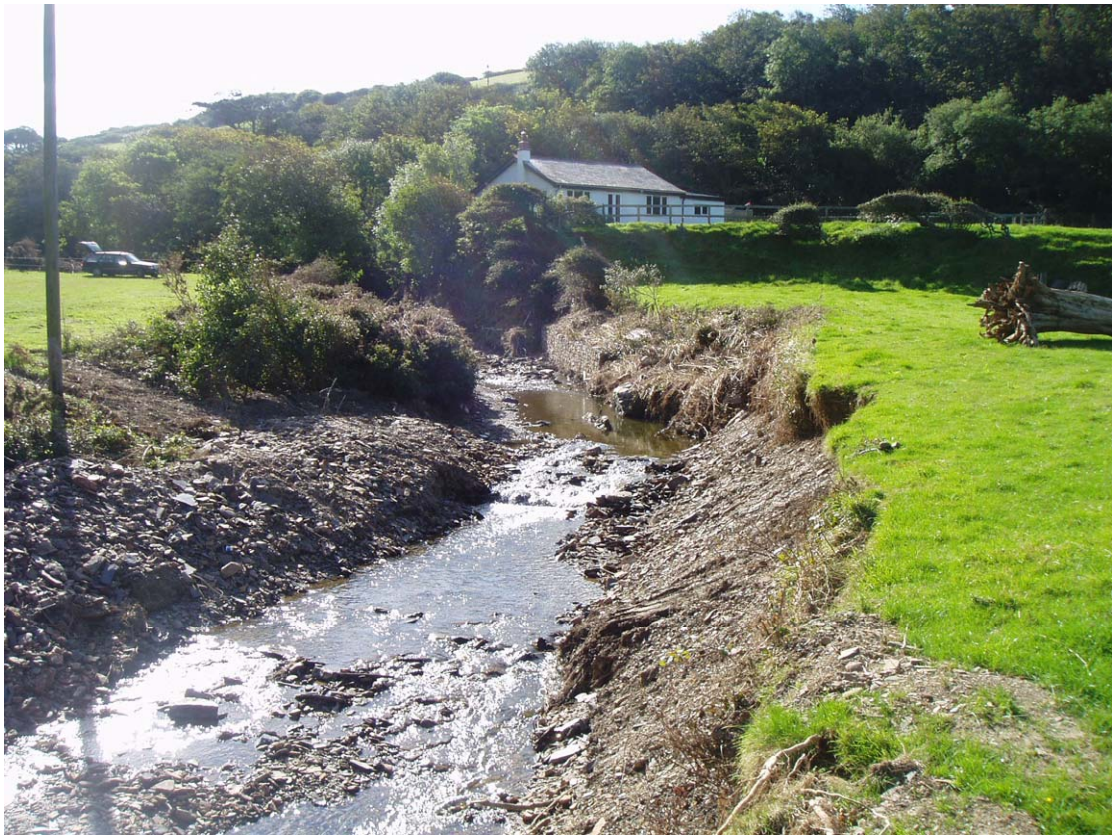
Plate 6.5 Conditions 500 metres upstream of bridge 1

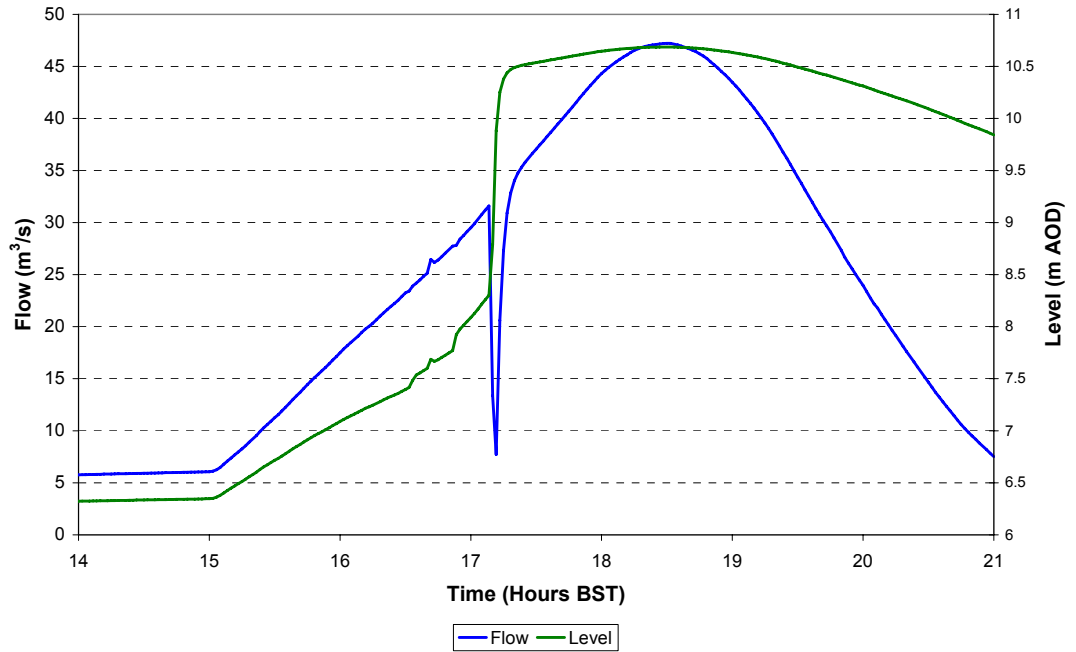
Figure 6.43 Impact of blockage to the Crackington Haven Bridge at bankfull

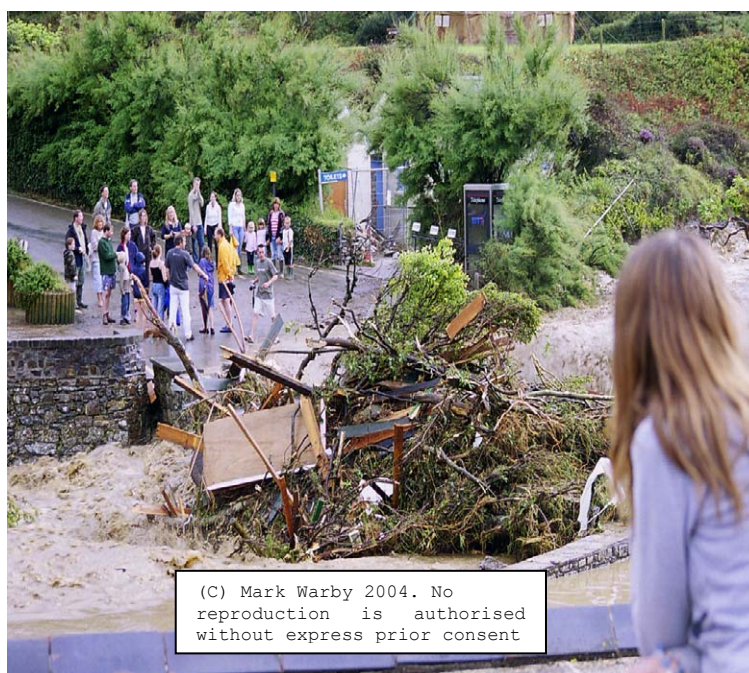
Plate 7.1 View from Coombe Barton Hotel toward the substantially blocked road bridge

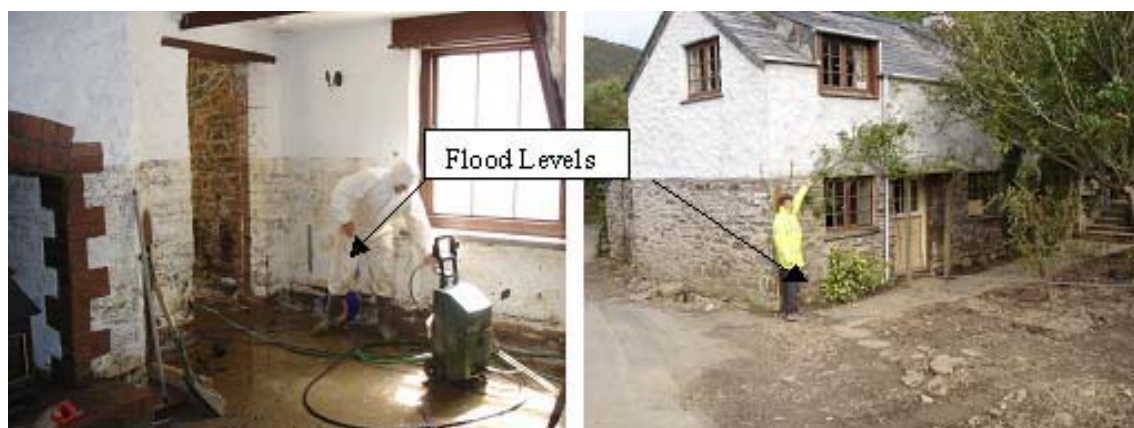
Photograph 2 – Flood levels at Manor Cottage and Chy-An-Pont
