Rock scour in Australia: some latest Queensland experiences

E. Bollaert

E. Lesleighter

S. McComber, P. Bozorgmehr, L. Fahey & D. Scriven

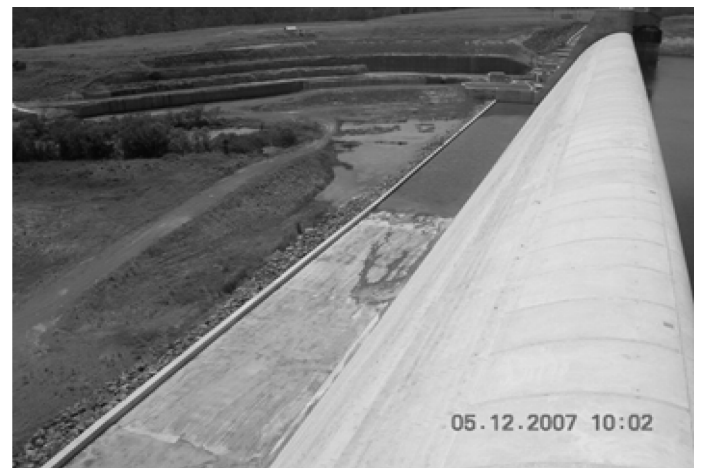
Figure 1. View of primary spillway of Paradise Dam

Figure 1 is a photograph of the dam and spillway, taken after dam construction and prior to severe flooding at the site. Figure 2 shows a sectional view of the primary spillway and apron.

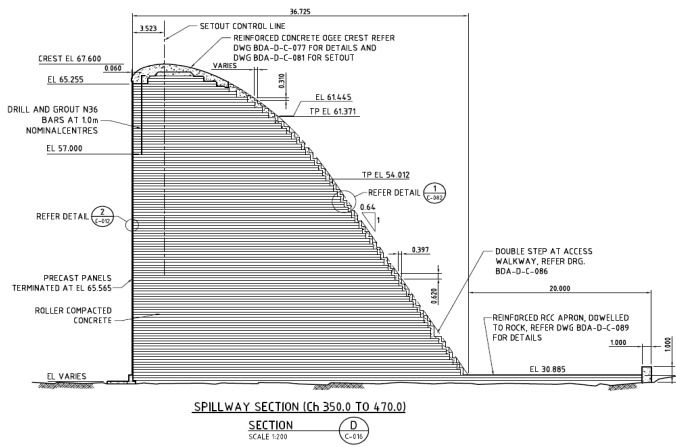
Figure 2. Sectional view of primary spillway of Paradise Dam

The crest is constructed in conventional reinforced concrete and the downstream stepped face is capped with reinforced concrete anchored into 620 mm tall RCC steps. At the base of the steps, spillway flows meet a horizontal apron of 20 m in length with a ver-

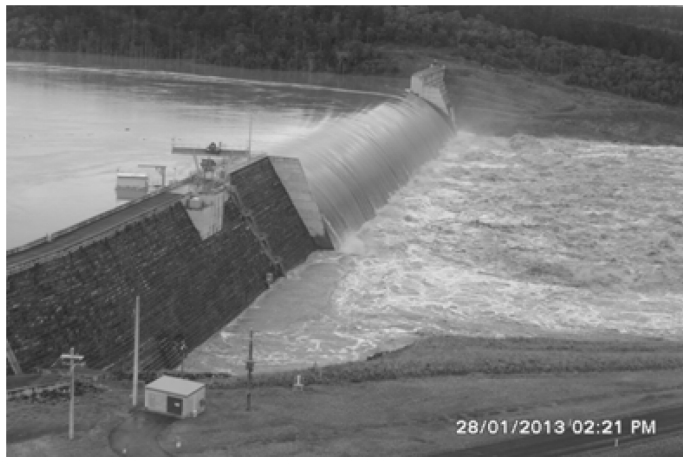
Figure 3. 2013 flood at Paradise Dam primary spillway

An appreciably larger flood (AEP of 1 in 180) occurred in January 2013 (Fig. 3). The peak reservoir level was EL 76.2 m, 8.6 m above the crest, and the corresponding discharge was 17,090 m³/s; a unit discharge of 54.3 m²/s. The Paradise outflow hydrograph is shown in Fig. 4.

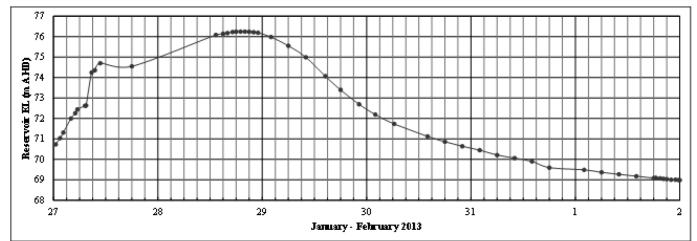
Figure 4. 2013 flood hydrograph at Paradise Dam

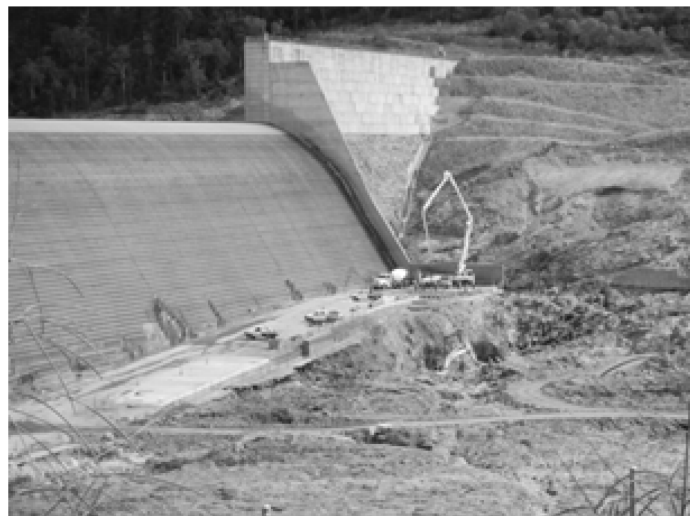
Figure 5. Rock scour at Paradise Dam following 2013 flood

In contrast with the 2010-2011 flood, the 2013 flood caused extensive and deep scour downstream of the apron, as well as removal of the 1 m high end sill of the concrete apron (Figs. 5-6).

The scour hole attained a depth of almost 15 m along the left hand side of the spillway, where the apron elevation was significantly higher than in the center and right hand side. The corresponding scour formation along the right hand side only reached about 3-4 m depth. Both scour holes significantly regressed underneath the concrete apron towards the dam foundations.

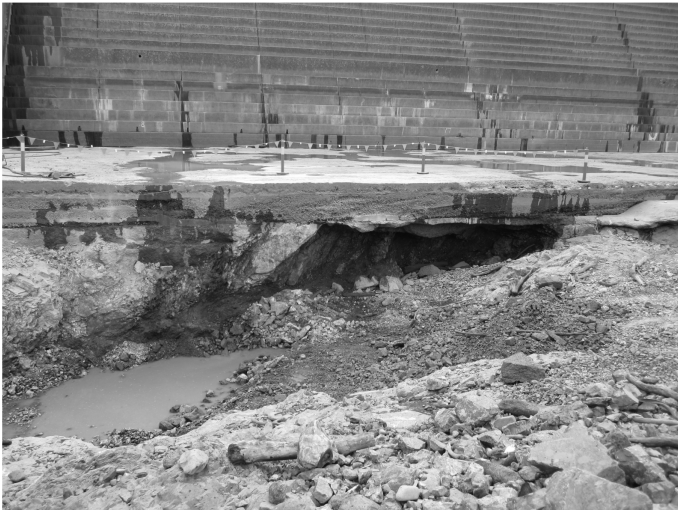
Figure 6. Apron undermining following 2013 flood

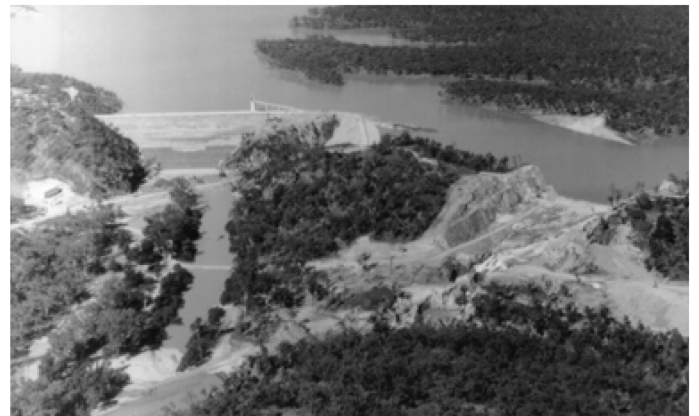
Figure 7. Aerial view of Boondooma Dam (left) and of unlined discharge chute (right)

Boondooma Dam is located on the Boyne River, approximately 20 km northwest of Proston. Construction of the dam was completed in August 1983. The spillway consists of a 2 m high, 115 m wide concrete crest and an unlined tapered discharge chute through a ridge of volcanic rock. A reinforced concrete Erosion Control Structure (ECS) was constructed 133 m downstream of the spillway crest. The purposes of the ECS were to ensure flows would spread evenly across the weaker rock zones and to create a non-scourable barrier. The drop of 7 m, downstream of the ECS, was to dissipate energy.

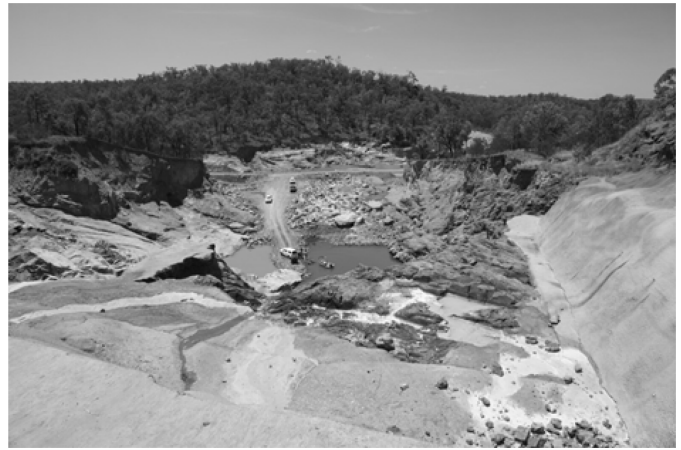
Figure 10. Large scour hole in downstream part of spillway following 2010-2011 flood event at Boondooma Dam

- Large scour holes in the spillway chute located between the spillway crest and the ECS. The deepest hole was located on the right hand side just upstream of the ECS (Fig. 9). There were also several other scour holes up to 1.5 m in depth over the chute.
- Severe scour to the chute downstream (Fig. 10)

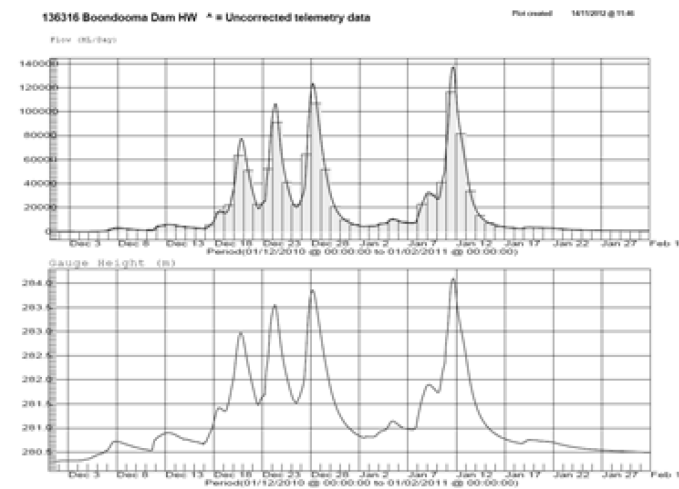
Figure 8. 2010-2011 flood reservoir levels and outflows at Boondooma Dam

Spilling commenced on 5 December 2010 and continued until the end of February 2011 (Fig. 8). The total inflow volume was recorded as 1,080,000 ML, which is 5.3 times the storage volume of the dam. There were four distinct flood peaks during this flood event. The highest peak occurred on 11 January 2011 at 3.7 m over the spillway. The peak discharge was approx. 1,600 m³/s (140,000 ML/day).

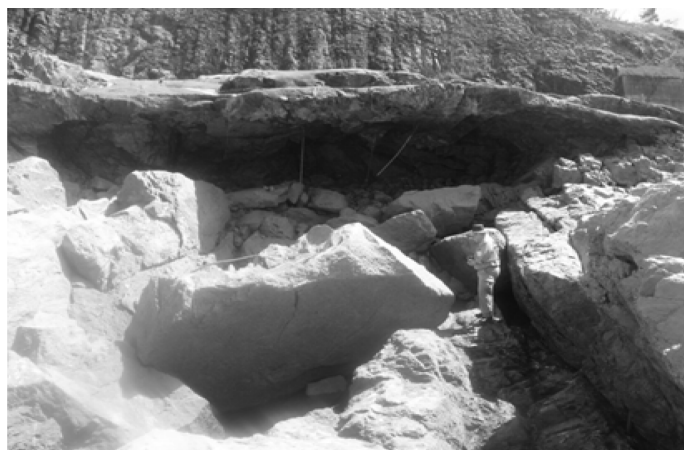
Figure 9. Large scour hole in spillway following 2010-2011 flood event at Boondooma Dam

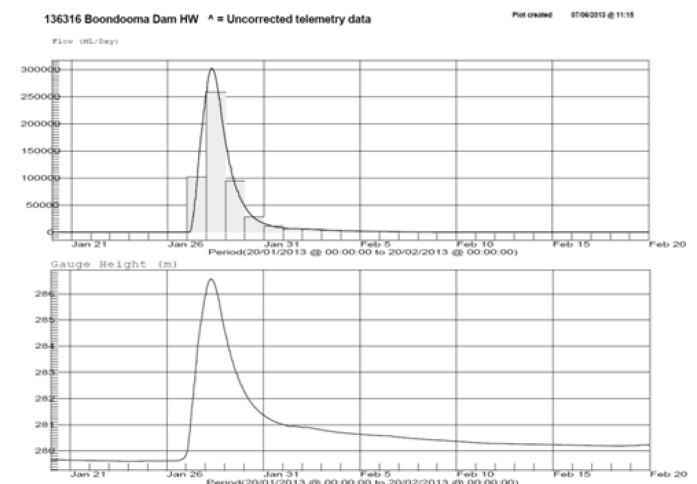
Figure 10. 2013 flood reservoir levels and outflows at Boondooma Dam

During the Tropical Cyclone Oswald weather event on the Australia Day long weekend in 2013, Boondooma Dam commenced spilling again. The dam spilled from 27 January and continued until 9 February 2013 (Figs. 11-12).

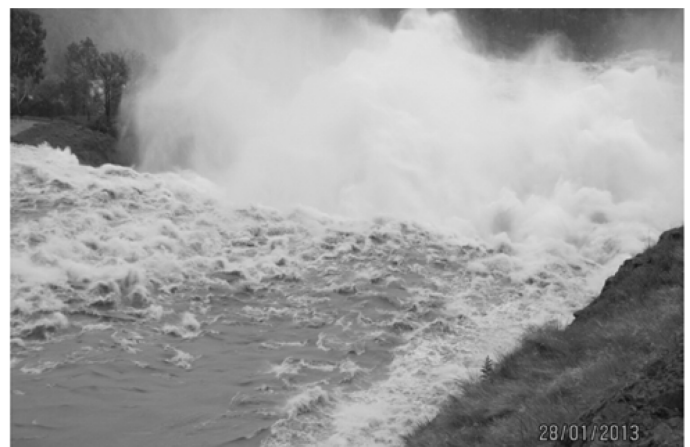
Figure 11. 2013 flood event at Boondooma Dam

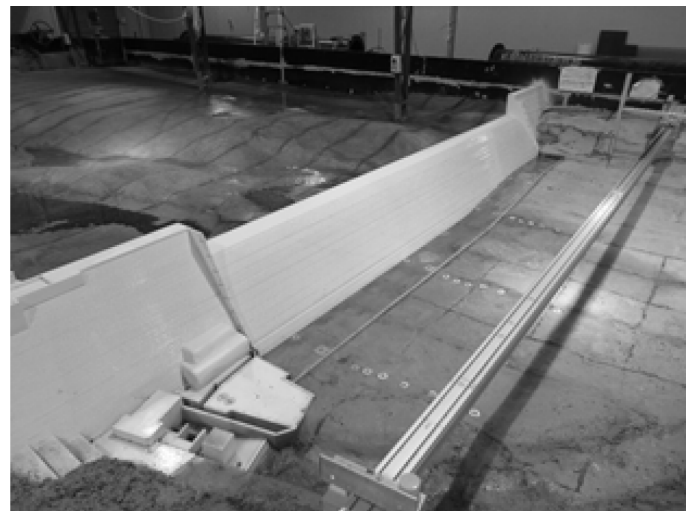
Figure 12. 1:70 scale physical model of Paradise Dam at MHL

A physical model was built and tested by the Manly Hydraulics Laboratory (MHL), Sydney NSW for detailed scour studies. The model was built to a scale of 1:70, with the ability to test for discharges up to the AEP 1 in 10,000 years. It was set up to investigate the spillway as-built condition, the post-2011 flood condition, the post-2013 flood condition including interim works, and studies of the secondary spillway overflow of the right abutment of the dam.

Figure 12 provides a view of a portion of the model with some of the flush-diaphragm transducers. Figure 13 shows the model operating at a mid-range discharge. Model instrumentation included more than 60 pressure transducers, a large number of piezometers, an Acoustic Doppler Velocimeter (ADV), with electromagnetic flow metering up to model discharges of 1,200 L/s. Figure 14 illustrates the pressure transducer coverage on several lines.

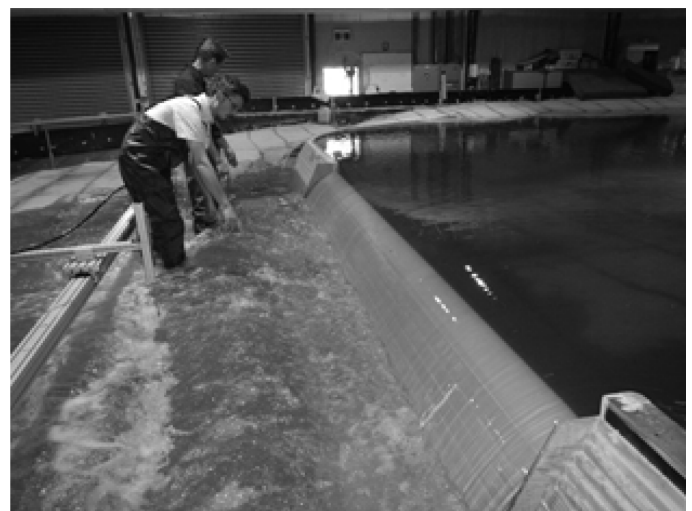
Figure 13. AEP500 flood at MHL physical model

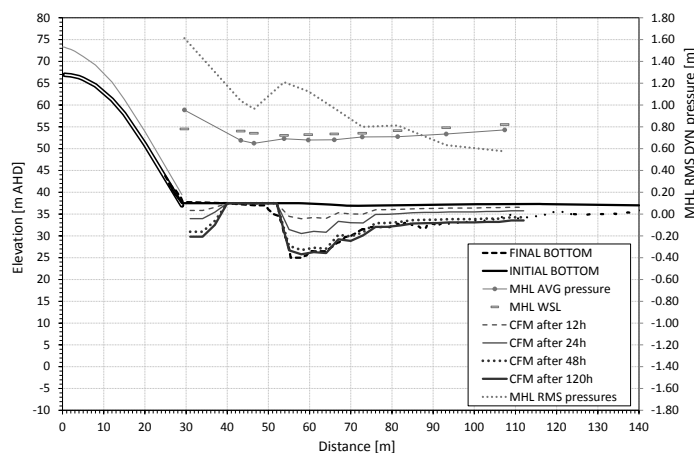
Figure 15. CSM calibration for 2013 flood at line 2

In the 2013 flood the rock scour was extensive. The figure shows the estimate of progressive scour with time for 6 to 120 hours exposure. These may be compared to the black dashed profile which is the surveyed profile following the 2013 flood.

The detailed analyses that have applied the CSM procedures passed through two stages of calibration using the actual flood hydrograph in histogram format, and use of the calibrated model to estimate scour flood various discharge scenarios. The calibration for the most part used the actual hydrographs of the 2013 flood. The calibration analyses for one of the profiles downstream of the spillway, Line 2 (see Figure 14), are shown in Figure 15.

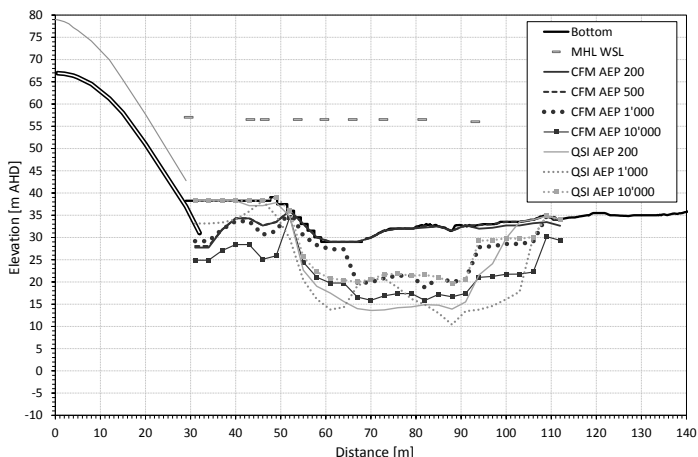
Figure 16. Computed scour potential at Paradise Dam for different AEP flood events

Figure 16 is an example of the estimated potential scour downstream of the existing apron for a range of discharges devised to represent a scenario of six floods with discharges ranging from an AEP of 100 to an AEP of 1 in 10,000. The Comprehensive Fracture Mechanics module is deemed to represent the possible scour progress for the selected hypothetical range of floods and discharges. It has to be noted that the scour profiles “under” the apron (distance

30m to 50m) apply to the possible scour in the event that the apron was actually removed.

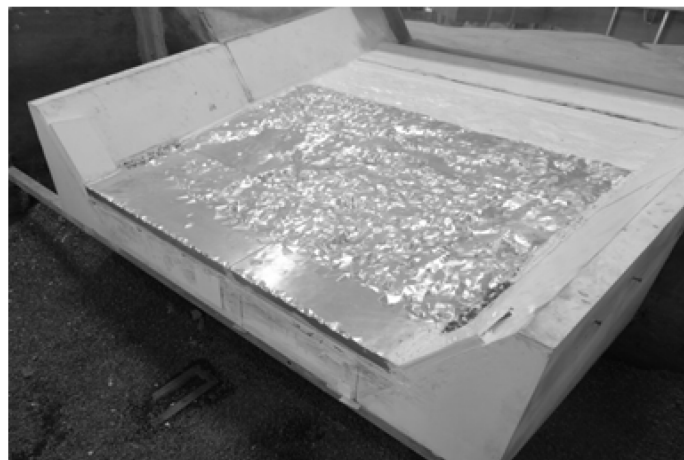
Figure 17. Upper chute arrangement with CNC milled aluminium

The modifications for the upper spillway chute were achieved through the use of a Computer Numerical Control (CNC) machining process. The surface profiles were obtained from laser surveys undertaken after both flood events. This survey data provided the input for the CNC machining. The post 2010/11 survey was undertaken following emergency repairs, and the post 2013 survey pre-repairs. A comparison between the two sets of survey data showed no major difference between the profiles; therefore, the post 2013 profile was adopted for the upper chute topography.

This method provided an accurate surface profile of the spillway upper chute floor by milling of aluminium billets to a desired accuracy. The choice of aluminium as base material was due to its advantages as listed below:

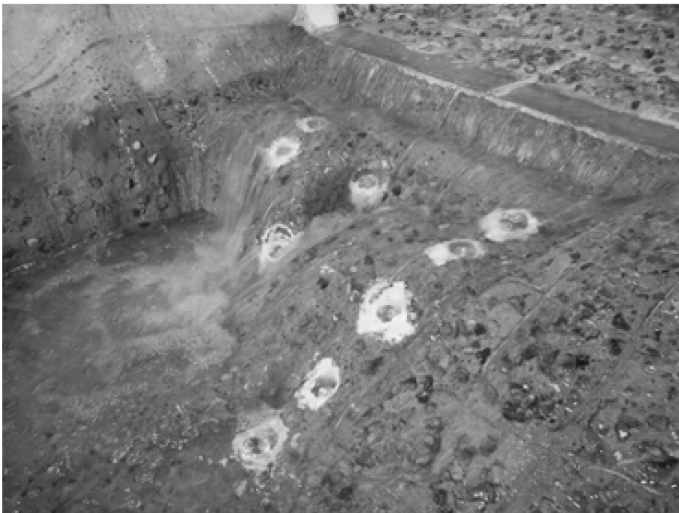
Figure 18. Lower chute post 2010/2011 arrangement

Due to the very rough, non-uniform nature and the variation in height of the scoured area in the lower chute, it was not possible to utilise the CNC methodology in this area. As an alternative, vertical aluminium templates (fitted together in a honeycomb effect), were used to generate the profile of this area. Vertical sections in two dimensions (parallel and perpendicular to the flow) were cut from aluminium using the two sets of survey data. The volume between templates was filled with sand and gravel, and the surface was capped with a 50 mm thick concrete layer. The maximum distance between templates was approximately 100 mm, which is equivalent to 8 m in the prototype. This meant that smaller topographical features would not be captured by the model. In order to mitigate this issue, the templates near the ECS (main area of scour) were placed at a closer spacing in order to capture features up to 4 m in the model.

To simulate the smaller changes in topographical features, gravel was placed onto the concrete capping during model construction, which also provides a degree of turbulence and aeration for flow characteristics.

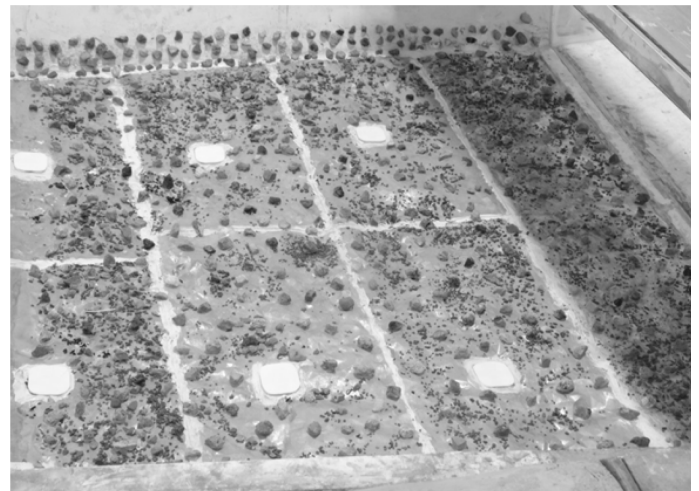
Figure 19. Upper chute arrangement with added gravel

In order to simulate the scoured rock surface, the surface profile was first machined in accordance with the post 2013 survey data. However, the finished surface lacked the necessary surface roughness. To simulate the roughness and turbulence in the model, several different sizes of gravel (between 5 and 20 mm) were trialed on the model surface. It was found that gravel sizes less than 10 mm had little effect in increasing the surface roughness. Therefore, 10-20 mm in size gravel was adhered to the aluminium surface in order to introduce surface roughness in the model. The larger size gravel (20 mm) was placed at a surface area coverage ratio of approximately 20%. Gravel of the same size was also adhered to the upper chute sloped wall surfaces, to a height above the highest flow depths. Once placed, observations of the jet behavior showed the model was consistent with the onsite observations during the 2010/11 and 2013 flood events.

However, there are drawbacks with this method. A 20 mm piece of gravel has an equivalent height of 1.6 m at full scale. This may compromise the form roughness to some extent. In the model it was observed that the negative impact of this gravel was mainly observed in small flood events (up to 1:30 AEP). As the modelling focused on flood events

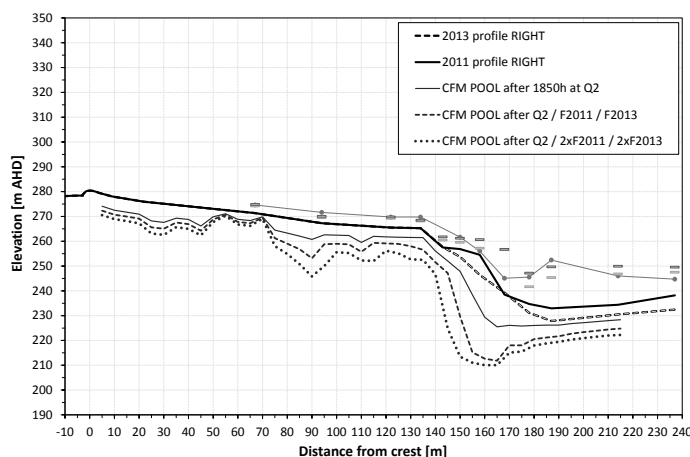
Figure 21. Computed scour potential at Boondooma Dam in the long-term (right hand side of chutes)

Figure 21 illustrates an example of long-term numerical scour predictions at the right hand side of the chutes, by adopting a flow duration curve that makes use of different AEP flood return periods.

First of all, it can be noticed that further significant scour would occur in the lower chute plunge pool, down to levels of about 210-215 m a.s.l., together with the most probable loss of the current ECS structure.

Also, significant scour is predicted through the upper chute, mostly starting along the scour vulnerable sub-vertical dykes. In fact, the dykes trigger scour in the surrounding more competent rock areas present along the upper chute. As such, in the long-term, potential loss of the upstream spillway crest cannot be excluded.
