Experimental analysis on the combined effects of corrosion and fatigue in reinforced concrete beams

Kássio Joe Stein
Ângela Gaio Graeff

This study focuses on an experimental analysis of the combined influence of corrosion and fatigue in reinforced concrete beams. Eight beams measuring 7 x 14 x 130 cm were cast; two beams were used as a reference with no degrading process; two beams were subjected to reinforcement corrosion at approximately 10% loss of mass; two beams were subjected to 200,000 fatigue cycles with a load capacity level of 0.5 and two beams were subjected to the combined effect of fatigue and corrosion. The results were obtained in terms of residual static flexural strength of the beams, aiming to compare

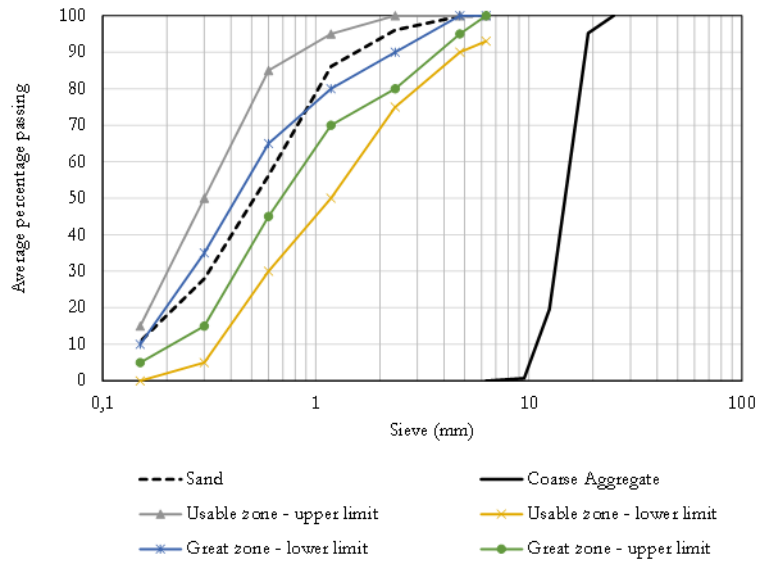
Figure 1 - Gradation curves of aggregates

Eight beams measuring 7 x 14 x 130 cm with a 25 MPa characteristic strength concrete were used for the experiments. The mix proportion of the concrete was 291 kg/m³ of High Early Strength cement, 844 kg/m³ river dragged sand and 1048 kg/m³ basalt coarse aggregate. The gradation curves of the aggregates are presented in Figure 1. Most of the sand was classified in the great zone and the coarse aggregate presented granulometric scale of 9.5/25, according to NBR 7211 (ASSOCIAÇÃO..., 2009). The characterization of the cement is shown in Table 1. The water to cement relation was 0.65. This proportion was based on previous experiments developed by Graeff (2007), whose studies used the same method to simulate corrosion and control the corrosion rate. The casting was divided in two groups due to limitation of the mixer capacity. The compressive strength of each group is shown in Table 2. The specimens were cylinders measuring 100 mm in diameter and 200 mm in height. The average compressive strength after 28 days curing, measured according to NBR 5738 (ASSOCIAÇÃO..., 2015) was 32.04 MPa. The slump test results of Group 1 and 2 were similar, 19 and 18 cm, respectively. The reinforcement steel used is shown in Figure 2. The hanger bars and stirrups were made of CA-60 and their diameter was 5 mm. The anchor bars had 8 mm diameter and were made of CA-50. The stirrups spacing was 5 cm. The bars and stirrups were attached to each other with annealed wire 18.

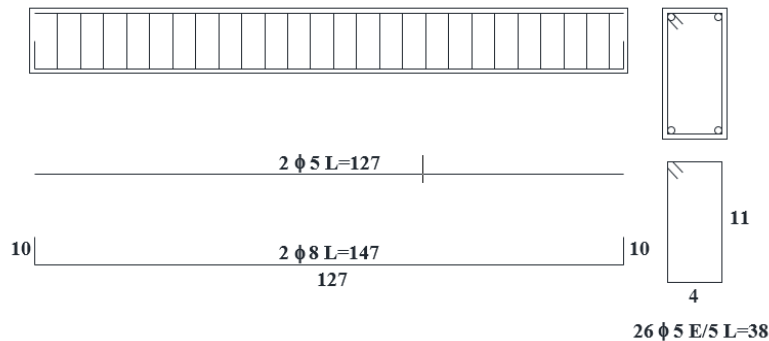
Figure 2 - Reinforcement steel configuration

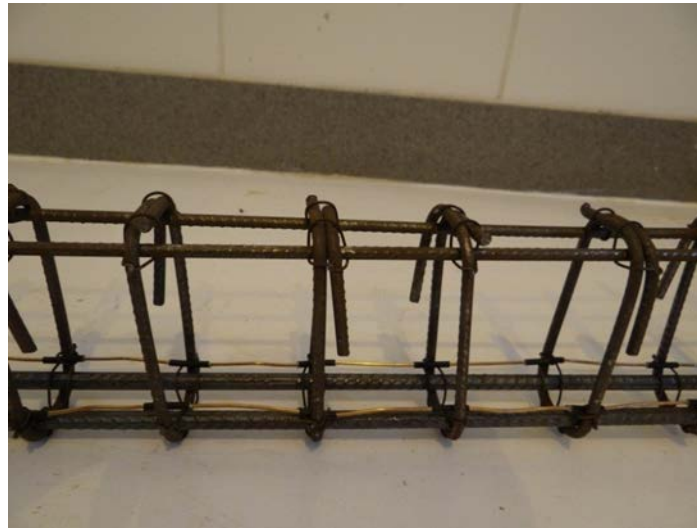
Figure 3 - Detail of the installation of copper wire

For the beams subjected to corrosion, prior to casting of specimens, the reinforcement was prepared with a copper wire to allow the acceleration of the corrosive process, as described next in the methodology section. The copper wire was placed above the longitudinal steel bar, attached to the shear stirrups, in such way that the wire was close but not in contact with the longitudinal bar, as shown in Figure 3. This procedure was carried out to reduce the probability of pitting.

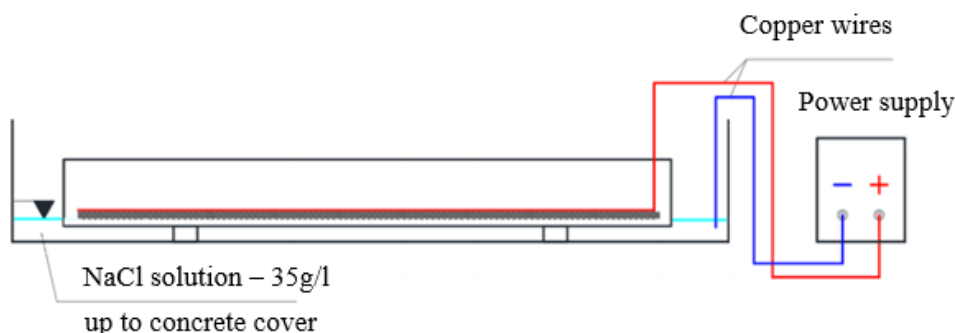
Figure 4 -Schematic procedure to accelerate corrosion

For the beams subjected to corrosion (CO) and corrosion combined to fatigue (CF), the intended corrosion degree was 10% by loss of mass of steel, which is considered critical in terms of structural behaviour (GRAEFF, 2007). The corrosion process was simulated electrochemically by chloride ingress. It's important to notice that the concrete cover represents a physical barrier against the ingress of any aggressive agents and plays an essential role when the problem is corrosion. According to NBR 6118 (ASSOCIAÇÃO..., 2014), the concrete cover of the reinforced concrete structures exposed to high aggressive environment should be 35 to 40 mm, depending on the structural element. However, the beams in this research were cast with concrete cover of 15 mm due to their geometric limitations. The schematic procedure used to accelerate corrosion is shown in Figure 4. In this procedure, the beams are placed in a separate

plastic pool with a 35 g/l chloride solution up to concrete cover of the beams. Plastic supports with 10 mm are placed below the beams to allow the solution to be in contact with the bottom part of beams. A power supply was used to allow the constant flow of $500 \mu\text{A}/\text{cm}^2$. This flow was chosen based on studies developed by Graeff (2007) and El Maaddawy and Souki (2003). Current flow rates above $500 \mu\text{A}/\text{cm}^2$ tend to create a cracking degree that does not represent what actually happens in real structures; on the other hand, low current flow rates would compromise the research schedule. The area that is considered is the one in contact with concrete and not the section area. A two-electrode system is used to apply the current. The counter electrode is immersed in the solution whilst the working electrode is connected to the copper wire installed prior to the casting of samples.

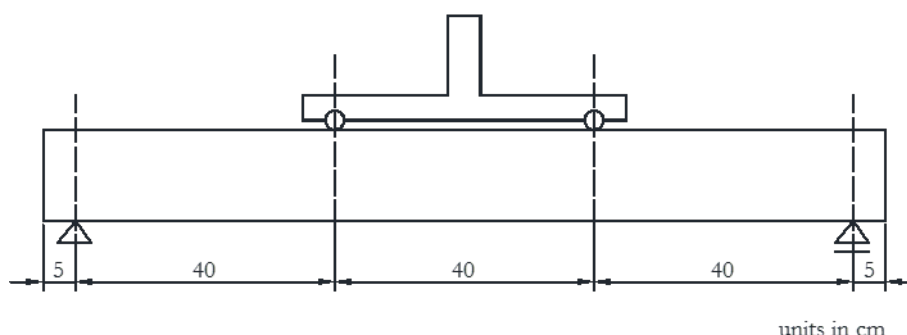
Figure 5 - Load configuration for static and fatigue flexural tests

The flexural fatigue loads were applied following a third point flexural test configuration, as shown in Figure 5. The same configuration was used to perform the static flexural tests to determine the load capacity of RE mixes.

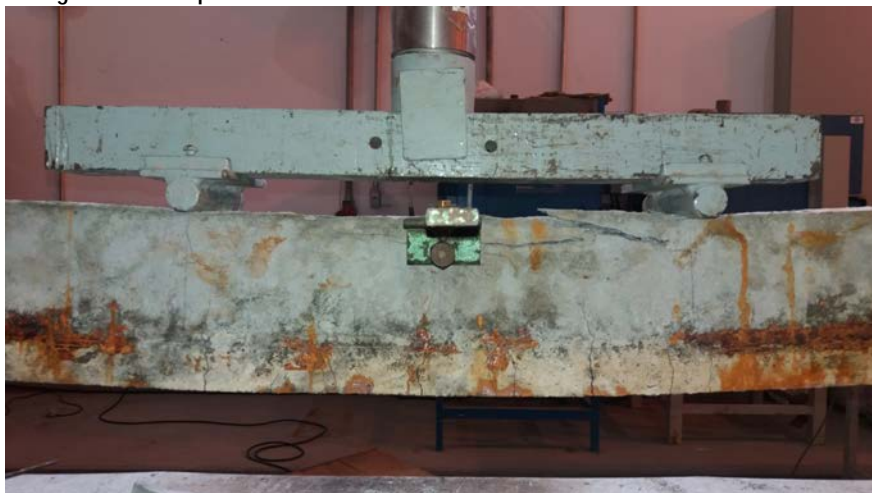
Figure 6 - Crushing of the compressed area of beam CO 9%

The failure of beam CO 9% occurred because of the concrete crushing in the compressed area, as shown in Figure 6. Beam CO 14% had its concrete debonded and its failure was due to a main crack in the pure flexural zone, according to Figure 7. Debonding is justified by the higher degree of corrosion and the amount of corrosion products. The comparison between the CO beams showed that the CO 14% had higher vertical displacement than the CO 9% for the same load, as expected. FA beams were subjected to cyclic loads when they were at the age of 60 days, just after finalising the corrosion process on CO beams. After applying the 200,000 cycles, the specimens were visually

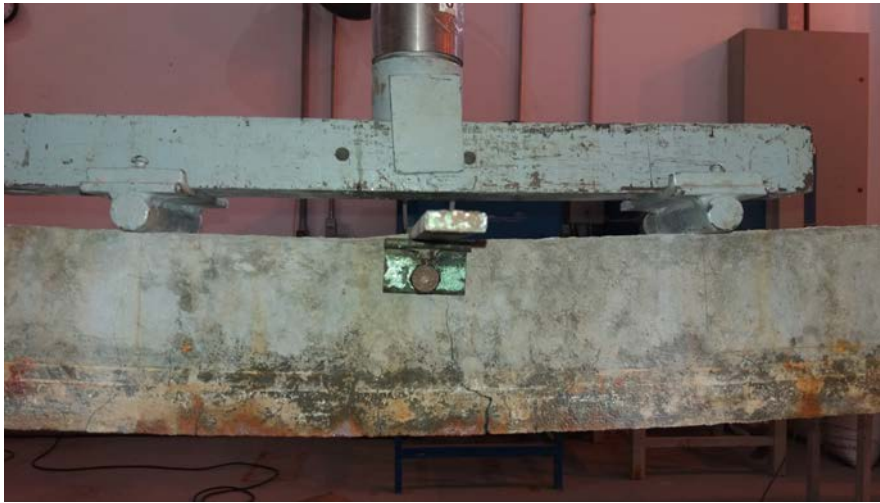
Figure 7 - Main crack in the pure flexural zone of beam CO 14%

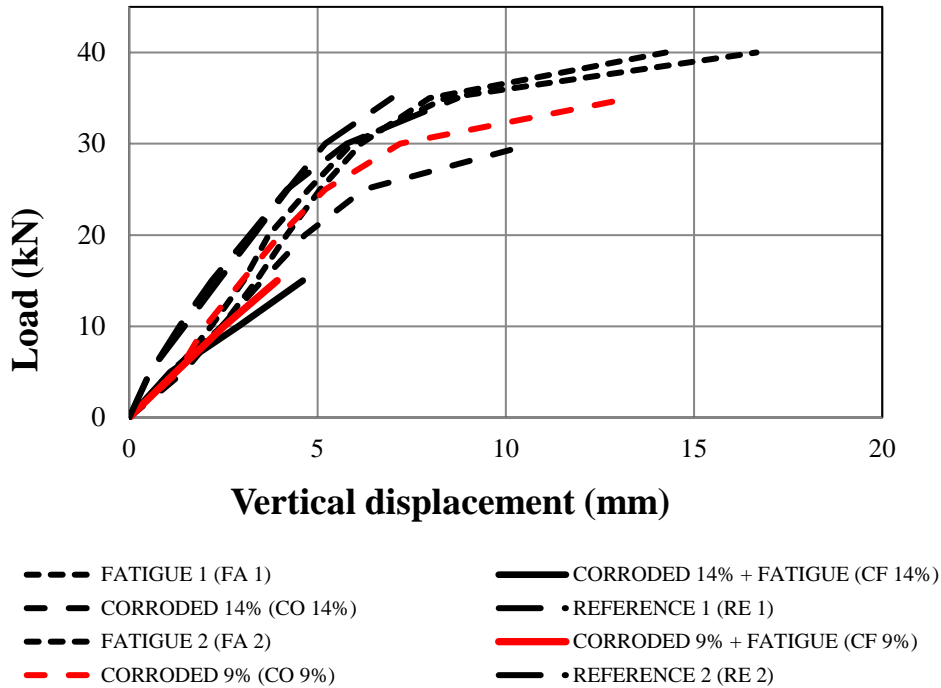
Figure 8 - Load x vertical displacement of beams

The graph of the load versus vertical displacement of the eight beams analysed in this research is presented in Figure 8. It is important to note that the displacements were manually recorded in intervals of 5 kN. The measurement system used was an analogic dial indicator Mitutoyo 50/0.01 mm 3058E.

It is important to mention that the last recorded point shown in the graph is not the load capacity of the beams, but the point at which it was possible to obtain the displacement. After this measurement, the beams were loaded up to failure and the measurement system removed to avoid damaging it. Load was applied in an in-between 5 kN load interval. Table 3 shows the load capacity of the eight beams.

It is possible to observe, by analyzing Figure 8 and Table 3, that the cyclic loads did not influence the results in terms of load capacity. However, the vertical displacements were higher compared to RE beams. This is probably due to the formation of internal microcracks that, even though not visible, may reduce the bond between concrete and steel.

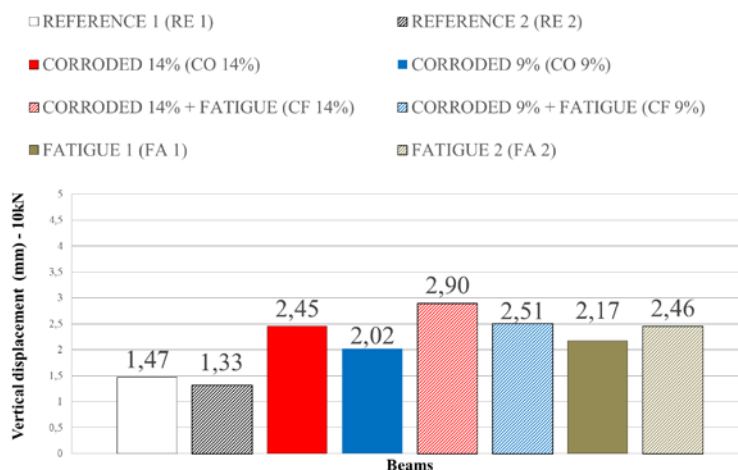
Figure 9 - Vertical displacement (mm) - 10 kN

higher than all other beams for loads above 10 kN. This behaviour was already expected considering the increasing in the displacements and number of cracks observed during the fatigue cycles, and it is probably caused by the loss of bond between steel and concrete, the reduction on the cross-sectional area of steel bars and the presence of cracks originated from the corrosion process. Figures 9, 10 and 11 show the vertical displacements at loads of 10, 15, and 20 kN.

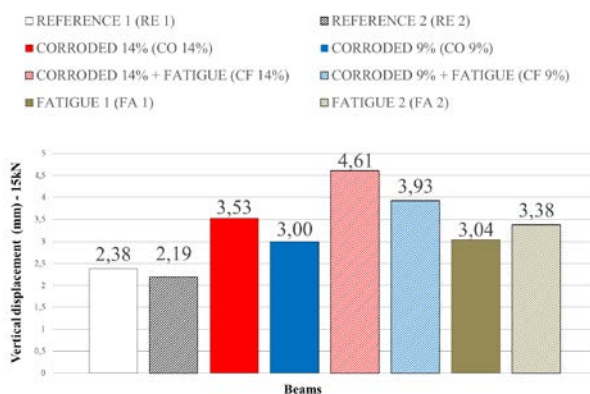
Figure 10 - Vertical displacement (mm) - 15 kN

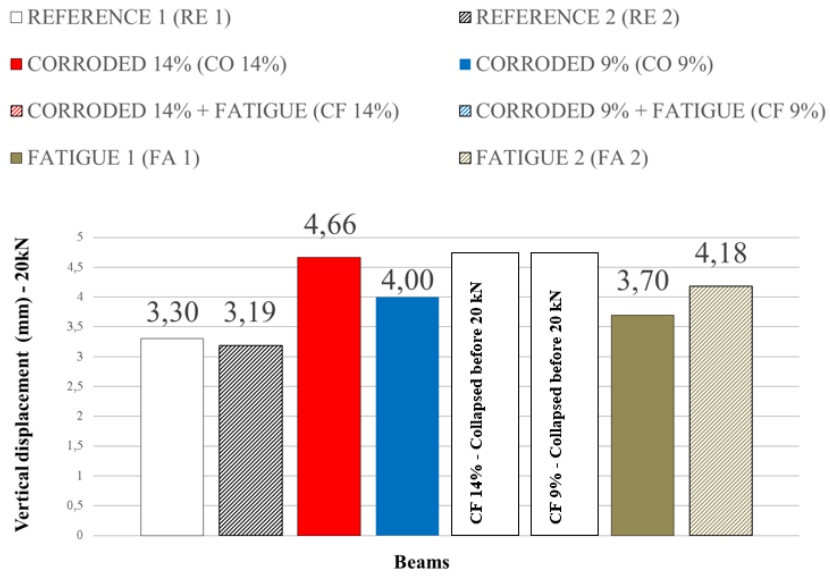
Figure 11 - Vertical displacement (mm) - 20 kN

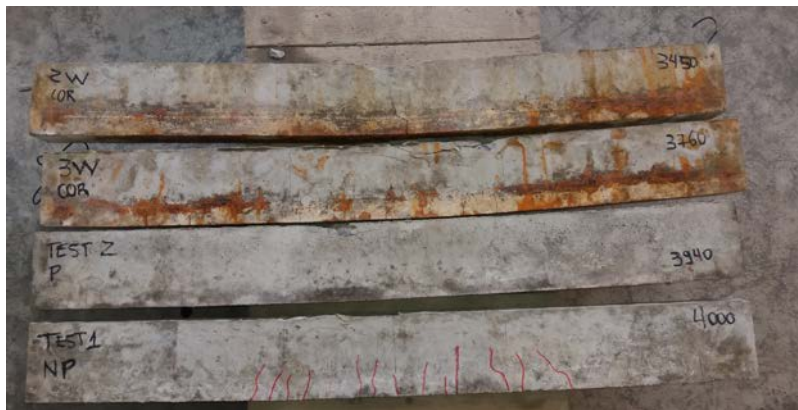
Figure 12 - Crack mapping of the CO and RE beams

cracks, and a sudden collapse. The crack mapping of the beams is shown in Figures 12 and 13. Figure 14 shows a schematic representation of the previous figures to facilitate the visualization of the mapping.

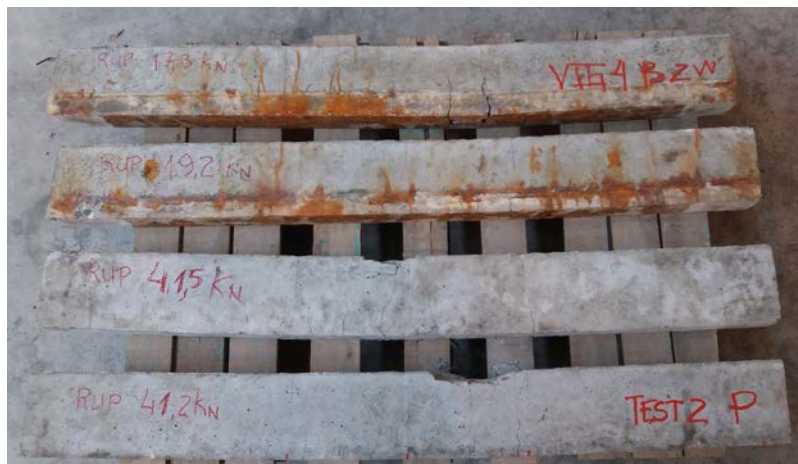
Figure 13 - Crack mapping of the CF and FA beams

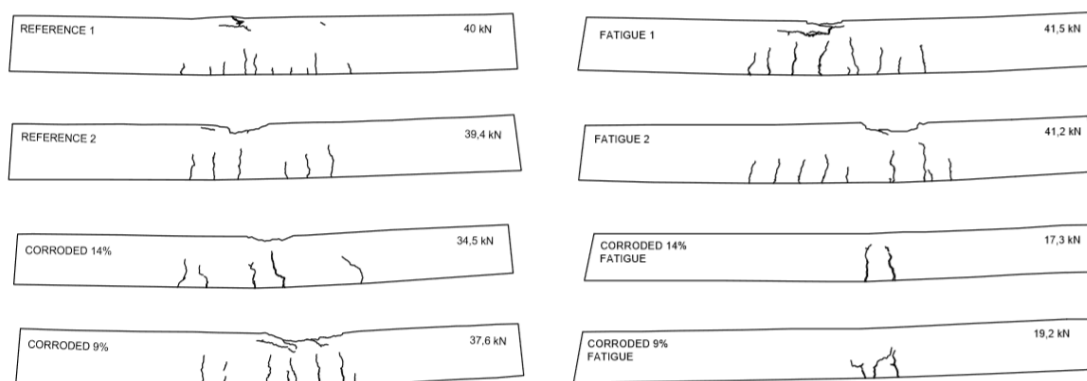
Figure 14 - Crack mapping of the beams
