## The Northwest Tropical Atlantic Station (NTAS):

### NTAS-19 Mooring Turnaround Cruise Report Cruise On Board RV Ronald H. Brown October 14 – November 1, 2020

## Technical Report

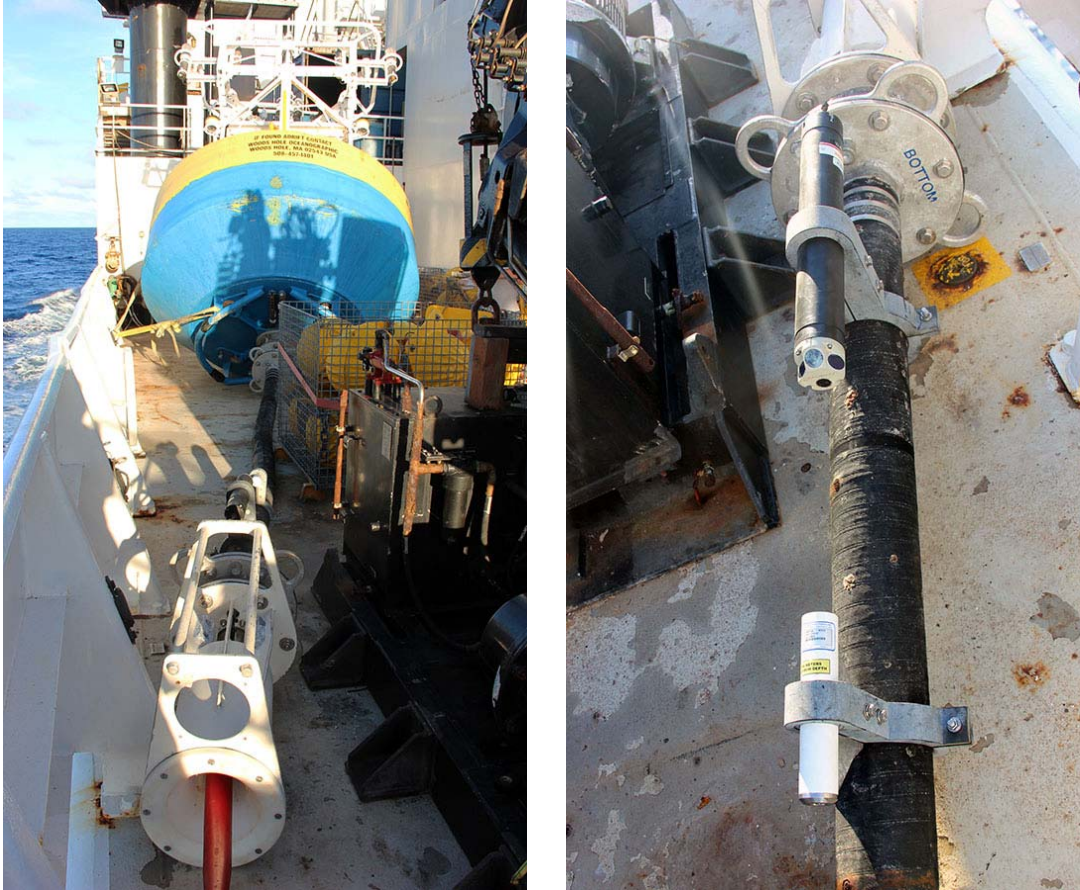
**Figure 5. NTAS-19 buoy assembly on deck. (left) Wire termination, bell mouth, EM chain, universal joint and buoy base. (right) SBE-39 temperature sensor and Nortek current meter mounted on EM chain.**

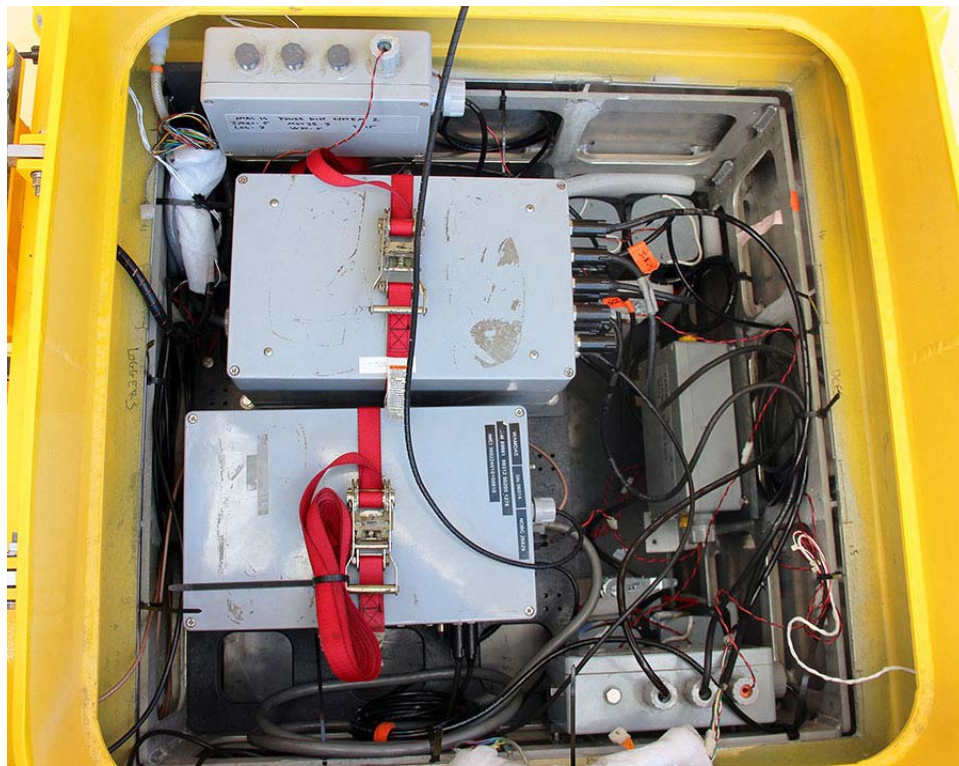
**Figure 7. NTAS-19 buoy well showing major electronic components.**

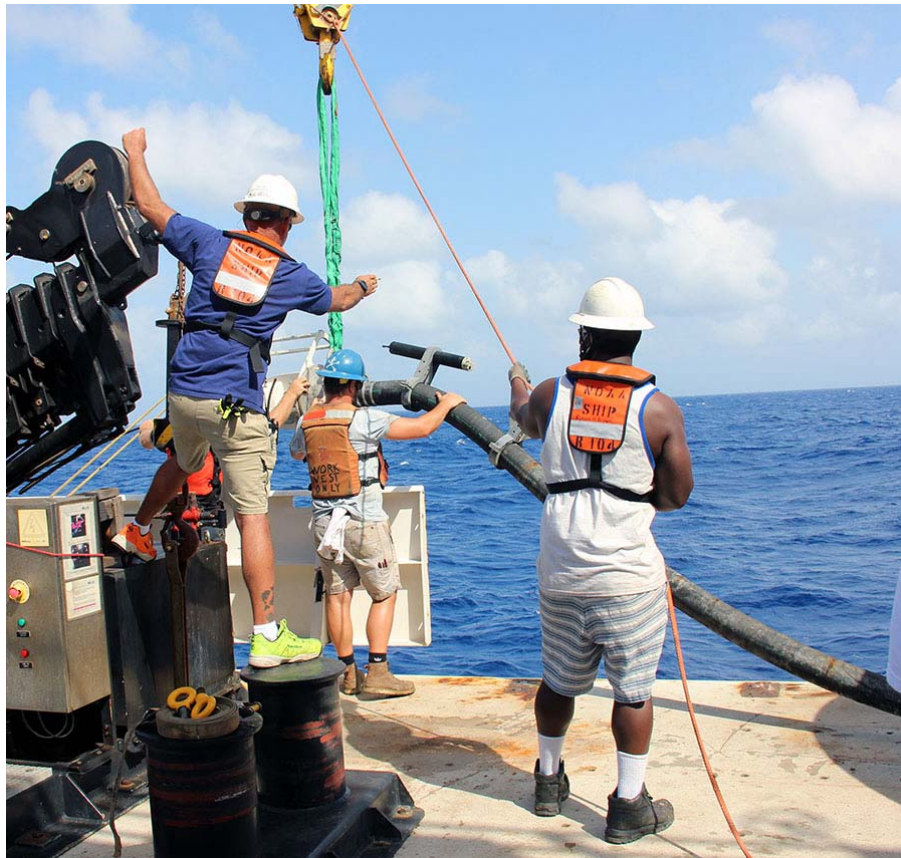
**Figure 9. NTAS-19 EM chain deployment. The crane lifts the EM chain over the port rail with the buoy still in place on the deck.**

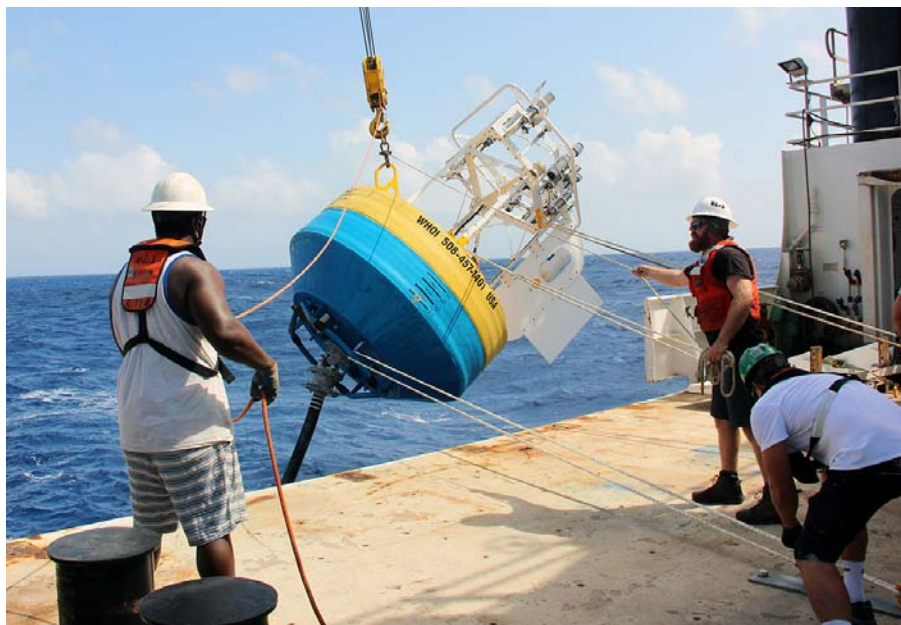
The release was eventually tripped with the buoy in the water. However, the crane headache ball swung across the tower and damaged the PRC sensor on the port side (System 1). The PRC module was later replaced with a spare using the small boat to send personnel to the buoy. It was unclear whether other modules had also been impacted by the headache ball, but based on a large discrepancy ( $\sim 40^\circ$ ) in wind direction after deployment, it was assumed that the port-side wind sensor was also damaged. The port WND module was replaced during the small boat trip, but this turned out to be the incorrect choice – the starboard wind direction was the one in error (see Sec. 2.b).

**Figure 10. NTAS-19 buoy deployment. Tag lines for the crane headache ball, quick release, buoy base, buoy deck, and buoy tower can be seen.**

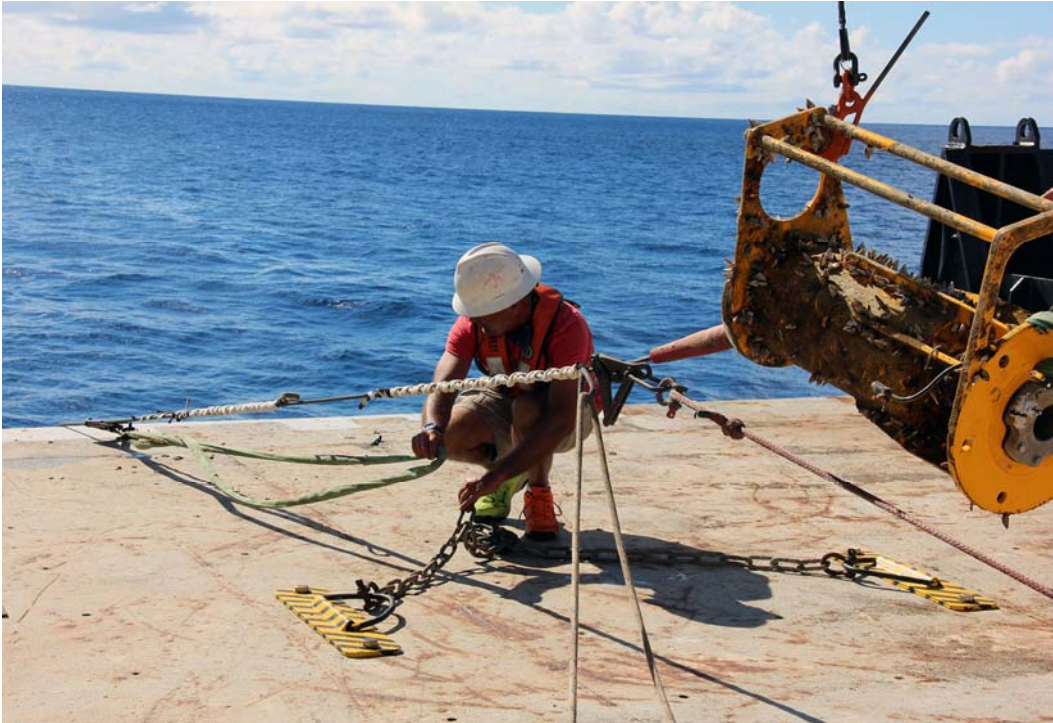
With the jacketed wire rope exposed, two soft eye Yale grips and two Klien grips were attached to the wire (Fig. 14). Tension was transferred to the Yale and Klien grips, the bolts holding the 79 m wire termination to the bell mouth were unscrewed and the

**Figure 14. NTAS-18 drifting buoy recovery. The buoy has been recovered and the EM chain removed. Yale grips and Klein grips are used to take up tension on the wire below the bell mouth.**

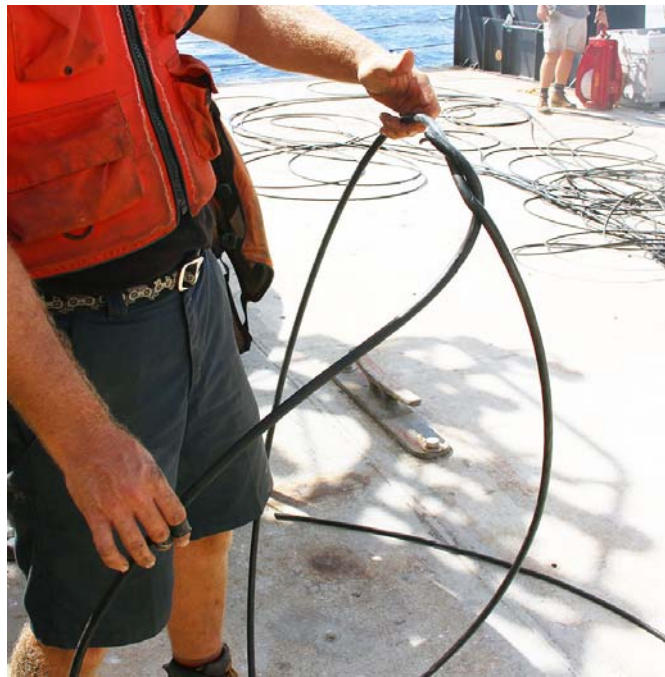
**Figure 16. Lower end of the broken 500 m wire section from the NTAS-19 mooring. Permanent kinks indicated that the wire had looped back on itself.**

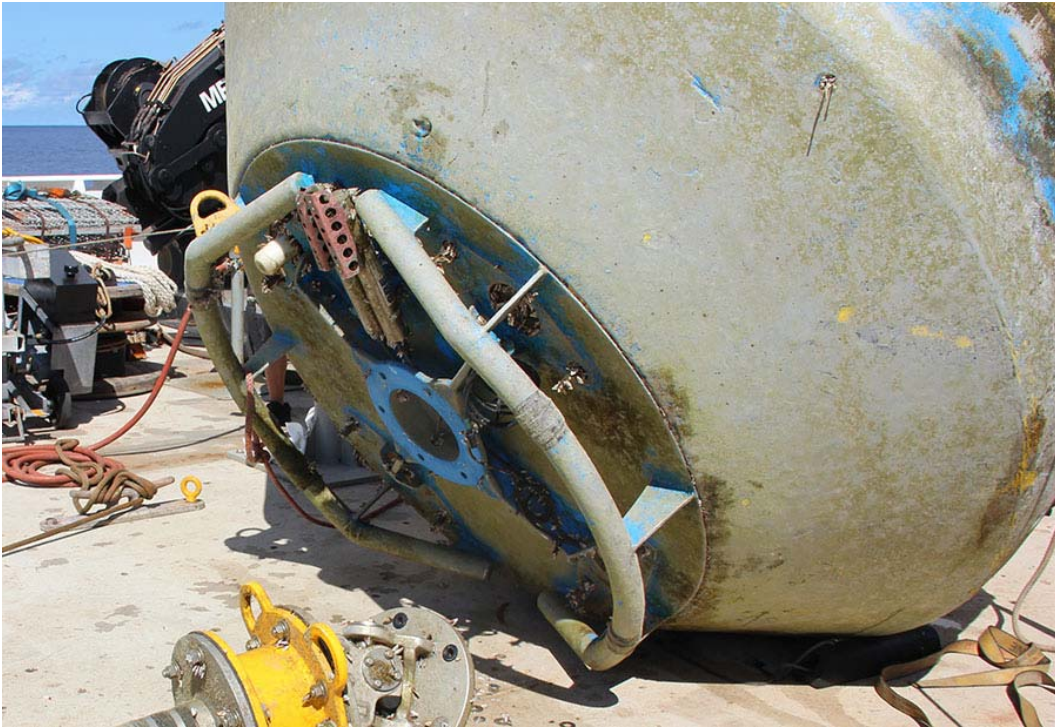
**Figure A3-1. NTAS-18 buoy hull.**
