**TR-322  
2008**

## **Water Loss Test Results for the West Main Pipeline United Irrigation District of Hidalgo County**

**March 20, 2007**

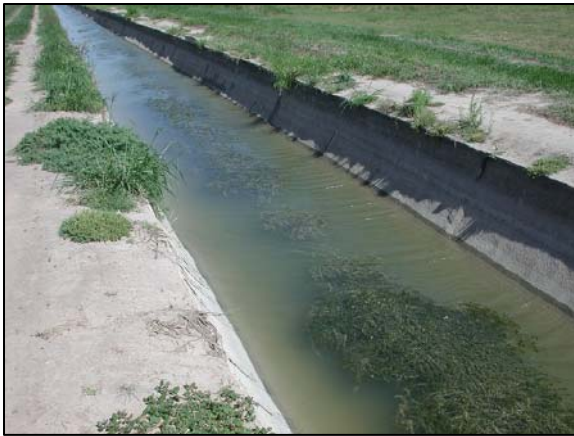
Figure 1. West Main Canal

In 2004, United Irrigation District of Hidalgo County (United) replaced 1.7 miles of their West Main Canal with underground reinforced concrete pipeline (Figure 3). The West Main, a concrete lined canal (Figure 1), meanders northward for approximately 10 miles, beginning at the district's 3<sup>rd</sup> re-lift pump station at 2 Mile Road and just east of Inspiration Road. Over this stretch, the canal reduces in capacity and narrows in top width from 24 to 3.5 feet.

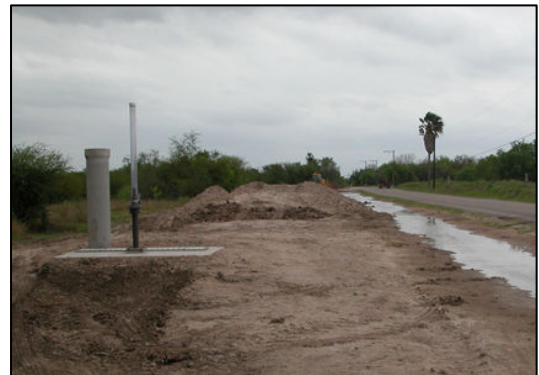
Figure 2. Visible leaks shown after construction

Following minor repairs, due to the apparent leakage occurring along side of the pipeline (shown in figure 2); we retested the pipeline in July 2004 and again in May 2005 and August 2006. Test results found that losses were reduced on average by 1448 gal/mile/day or a projected annual loss of 1.6 ac-ft/yr; a 95.7% water loss reduction compared with Test 2, and as much as **99% savings** when compared to the original canal losses.

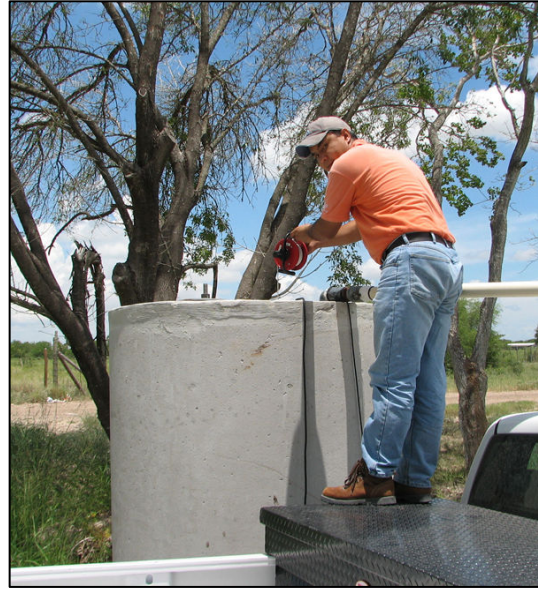
Figure 4. Askar is shown here measuring the drop in water level with the sounding meter.

After the head gate was shut, water surface elevations were measured at selected standpipe stations with a water sounding meter shown in Figure 4 and referenced to the inside top rim of the standpipe. Each test lasted between 2.5 to 4 hours, taking a measurement at 30 minute intervals (6-9 measurements per test).

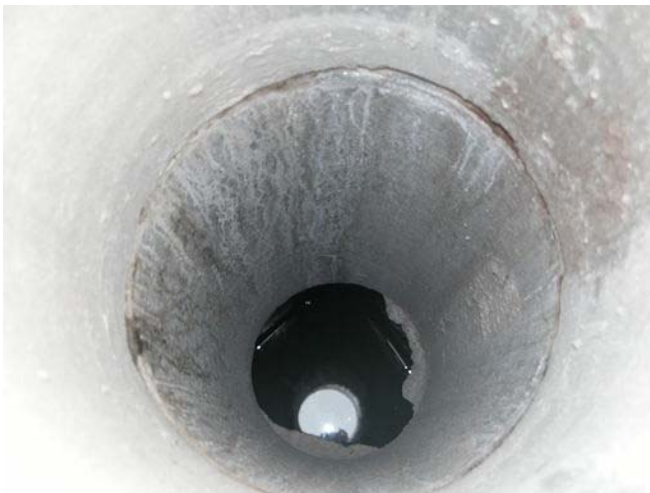
Figure 5. Inside view of a 12 inch standpipe and box structure.

- All box structure walls and ceilings are one foot thick;
- The 12 inch standpipe nor the box structure at station 1+20 was consider in the test segment due to the location of the head gate within the box structure;
- That all 12 inch standpipes due not extend past the inside ceilings of the box structures. Once the water level drops below the bottom of the standpipe the surface area and volume of the box structure as assumed (Figure 5).

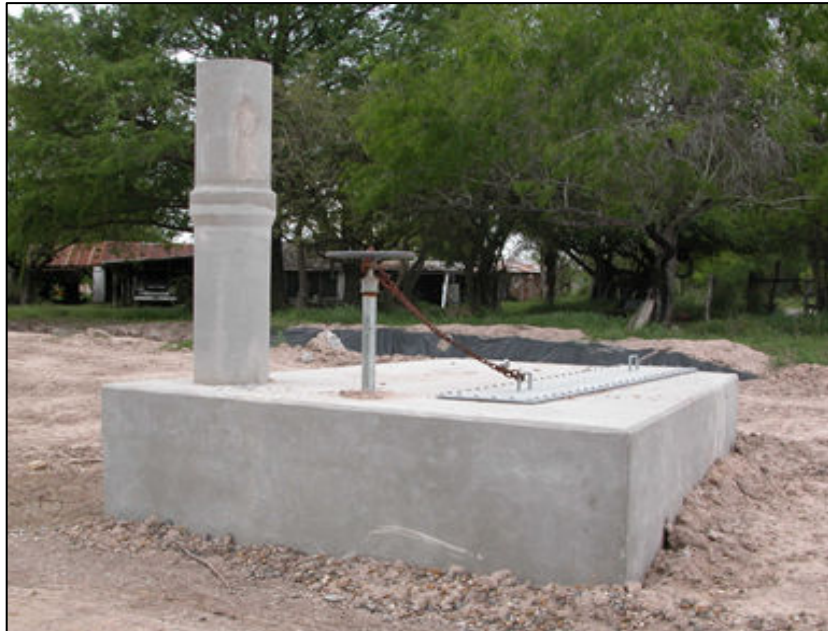
Figure 6. Showing an exposed box structure

The box structures and selected standpipes were surveyed and referenced using a survey grade GPS instrument and a transit unit. The box structure elevations are based on an average of the GPS measurements on 3 or more corners (see Figure 6). Table 4 provides the survey measurements in Appendix A, and a foldout diagram of the pipeline is provided at the back of the report.
