**Water Loss Test Results
Main 'J' Canal
Delta Lake Irrigation District**

WATER LOSS TEST RESULTS

MAIN 'J' CANAL

DELTA LAKE IRRIGATION DISTRICT

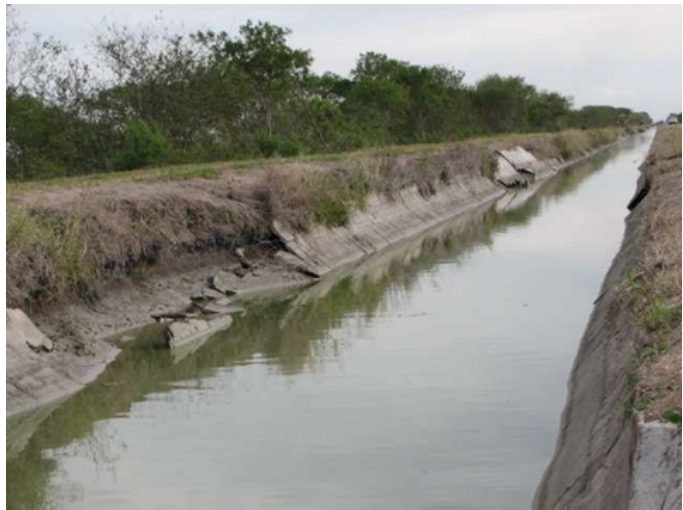
Figure 1. Main 'J' Canal

The Main 'J' Canal (Figure 1), the concrete lined section of the main supply canal that feeds the City of Raymondville, flows west to east in the northeastern sector of the district (see figure 2); located approximately four miles west of US Hwy 77 and a mile north of FM 490.

The tested segment was approximately 2500 ft long, varying from 15.5 to 18.0 feet in width and 6 foot in depth.

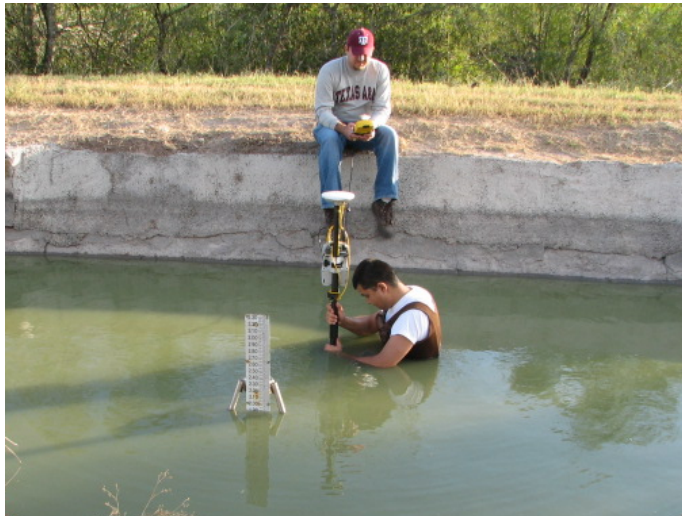
Figure 3. Shows the GPS survey and a staff gage

Water loss rates are measured using the ponding method. In this method, the two ends of a canal segment are closed or sealed with earthen dams. Once sealed, water elevations are taken for approximately 48 hours. Four staff gages were placed in the test segment and water stage levels were recorded manually. During the test, staff gage stand elevations and canal dimensions, including cross-sections, depth and side slopes are surveyed and measured using a GPS survey-grade instrument (Figure 3). This information is used in combination with water level changes to

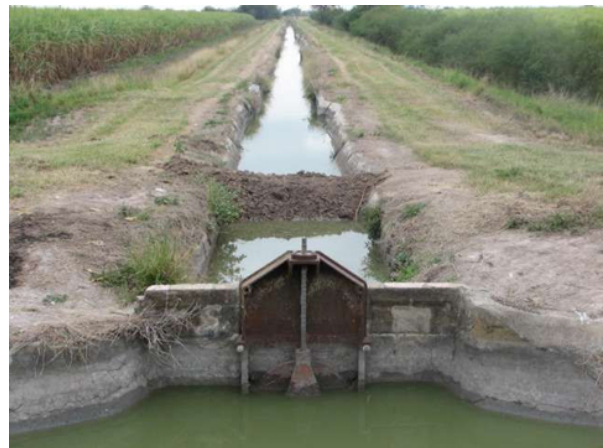
Figure 4. Lateral gate & earthen dam downstream

The test segment DL3 did contain two farm turnout valves and one small head-gate for a southbound lateral canal; thus, the total loss rate was measured. Upon the start of the test, measures were taken to limit water losses through the mentioned control structures. Pretest inspections of the farm turnout valves and the lateral head-gate were performed to check for visible signs of leakage. A small earthen dam was also constructed of just downstream of the lateral head-gate in attempt to rule out losses due to the lateral canal (Figure 4).
