# DEMONSTRATION OF ROAD IMPROVEMENT BY LOCAL INHABITANTS AT THE BAYTSEMAL VILLAGE IN THE SOUTH OMO ZONE IN SOUTHERN ETHIOPIA

ABSTRACT The SATREPS-MNGD Project implemented a demonstration of participatory road improvement with local inhabitants at the Baytsemal village in the South Omo Zone in Southern Ethiopia from November 25th, 2019 to December 9th, 2019. The activity lasted for 12 days. The first five days were for the preparation, including measuring, designing, and information sessions for the local inhabitants to build consensus on work plan, whereas the remainder for the actual implementation.

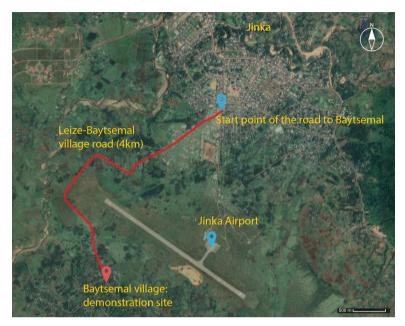
Figure 1. Site Map (wide)
(This map was created by authors based on the google maps data.)

The demonstration site is located at the Baytsemal village in Jinka, South Omo Zone of Southern Ethiopia (Figures 1 and 2). The Baytsemal village is connected to a pavement road, Airplane-marefiya road, by a 4-km-stretch unpaved road called "Leize-Baytsemal village road." Among several options for the demonstration, the team decided on a 100-m stretch of a short path from Leize-Baytsemal village road to a primary school after discussing with the villagers. The path was unpaved and mainly used by school students. Figure 3. shows the condition of the site before the construction. Rainwater from the Leize-Baytsemal village road runs on the surface of the path, causing gullies in the middle of the path.

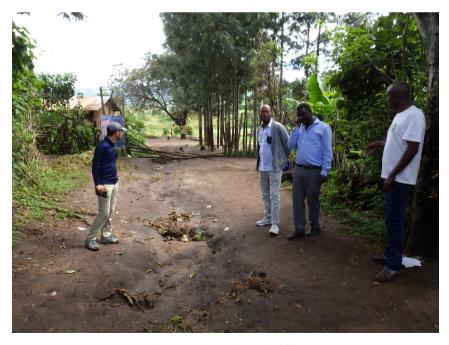
Figure 4. Discussion at the Site

The project team, a local coordinator (LC), and a lecturer of Jinka University (JU) visited the site in the morning and were received by the village chairperson and other villagers. They observed the condition of the site and discussed the implementation plan considering the drain system and the way to lead water away from the side drains to the adjoining land with attention the land use and ownership (Figure 4). Since the selected path for the demonstration was connected to a primary school, they carefully considered constructing the drainage around the school entrance (Frontispiece 1).

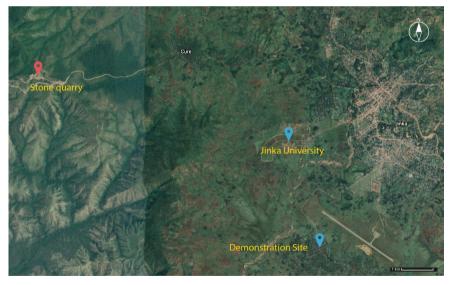
**Figure 6. Stone Quarry Location** (This map was created by authors based on the google maps data.)

In the afternoon, the project team and the *LC* purchased the construction tools, besides hoes and shovels, around Jinka town. Also, they went to a stone quarry (managed by a Bako Dawla woreda office), which was 12 km away from Baytsemal, to select the gravel sand needed for the construction (Figures 6 and 7). They determined the required type of gravel sand, negotiated the transportation cost with the owner, and made a deal.

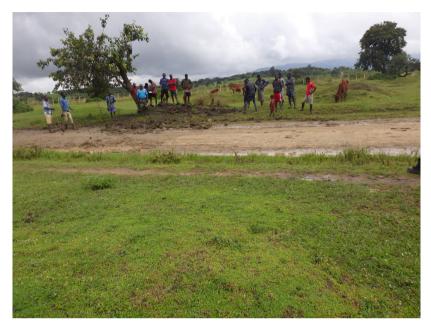
Figure 8. Villagers' Community Work

The community work was organized by the Baytsemal village council and performed by the villagers. They divided themselves into two groups of around 20 people and engaged for about 3 h from 7:00 am to 10:00 am (Figure 8). The team observed the villagers' work on *Leize-Baytsemal village road* and was updated by the village chairperson daily. They excavated the drainage along the road and heaped the excavated mud on the main surface of the road, which made the road muddy, to fill the gullies and puddles (Figure 9).

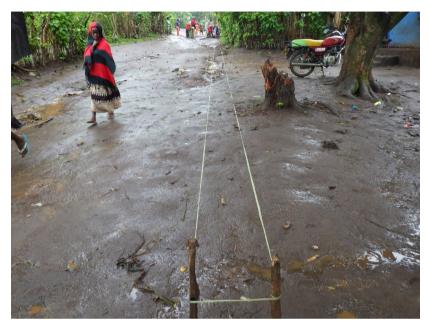
Figure 11. Drainage Excavation Preparation
The Yellow String Indicates the Drainage Location

The villagers gathered at the demonstration site around 7:30 am. The work started at 8:30 am and 150 villagers were present at the site. Yellow strings were stretched by the project team and some villagers to mark the location and shape of the designed drainage (Figure 11). The villagers performed the community work for 2 h and excavated the trenches by using their shovels and hoes (Figures 12 and 13). In front of the primary school gate, a crossing trench was made to drain the water off from one point (Figure 14).

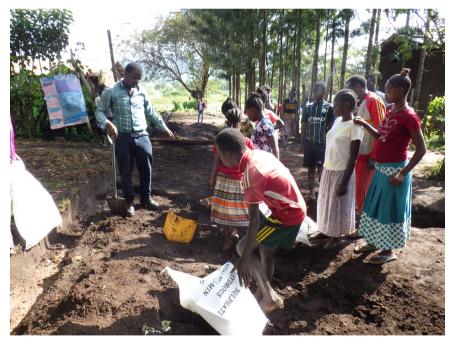
Figure 15. Villagers Putting Excavated Soil into the Do-nou Bags

The excavated soil from the trench was put into Do-nou bags and used to level the gullies (Figures 15 and 16), by laying them in the gullies and compacting them using local compactors. The team expected that the leveling by Do-nou bags would be completed in one day, however, the villagers engaged in the work for just 1 h and completed only 30 m of the 100-m work.

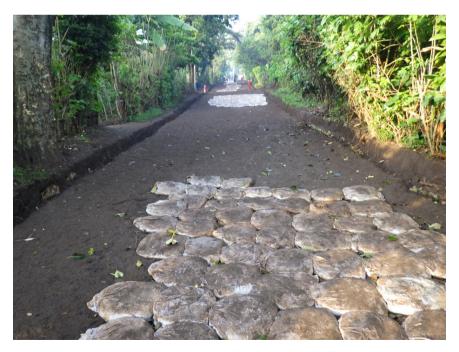
Figure 17. Do-nou Bags Placed in Deep Gullies

The villagers started construction work as early as 7:00 am. They finished filling the deep gullies and leveling the rest of the work (20-m of the 100-m work) for 1 h (Figure 17). After filling and leveling, they formed and smoothed the drainage (Frontispiece 2). The discarded soil from the drainage was scattered on the surface of the path or the Do-nou bags and compacted to level the surface (Frontispiece 3 and Figure 18). Afterward, the project team went to the Bako Dawla stone quarry in the afternoon and confirmed the type of gravel sand and its delivery time.

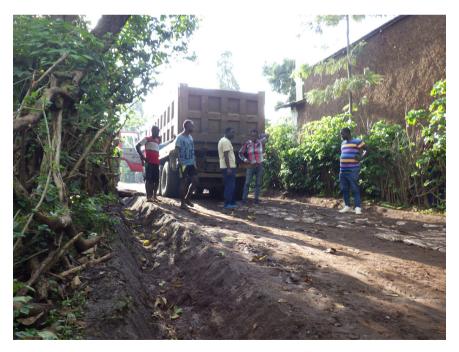
Figure 19. Trucks Arriving at the Site

It rained heavily in the early morning, making it impossible to transport gravel sand from the Bako Dawla stone quarry. Hence, the villagers had no work. The rain stopped in the afternoon and the gravel was delivered. Two trucks were used to transport 32 m³ in total (16 m³ in each truck) (Figure 19). Carriers were fabricated from iron sheets by a local workshop due to the scarcity of wheelbarrows in the town (Figure 20).

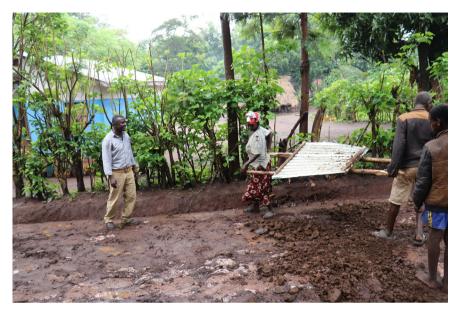
Figure 21. Gravel Pavement (1)

Fifty villagers showed up at the site in the morning and they worked for 3 h from 7:30 am to 10:30 am. They scattered the gravel on the road and leveled the road surface (Frontispiece 4). The gravel was carried in pairs, while others compacted the surface with hand-made compactors (Figures 21 and 22). 70 m of the path was completed.

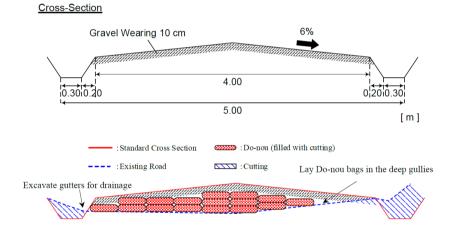
Figure 23. Proposed Plan

- Construction distance: Approximately 5 m × 100 m
  - Figure 23 shows the cross section of the proposed plan.
- Construction period:
  - o 5 days for surveying/design/resident explanation and enlightenment.

- Construction method and procedure
  - O Determine the position of the gutter and excavate.
    - Create a crossing ditch in front of the elementary school gate.
  - Fill Do-nou bags with the excavated soil from the ditch and lay them.in the deep gullies. Then compact the surface for leveling.
  - O Shape the gutter.
    - Excess soil was sprinkled on the surface of the roadway for leveling.
  - Scutter the path with the gravel and compact it.
    - Large-sized gravel was used for score checking of gutters
  - Add a slope in the crossing direction of the road (6%)
  - o Paving the cross gutter near the elementary school with concrete.
